# Field Accident Evaluations and Experimental Study of Seat Back Performance Relative to Rear-Impact Occupant Protection

## ABSTRACT

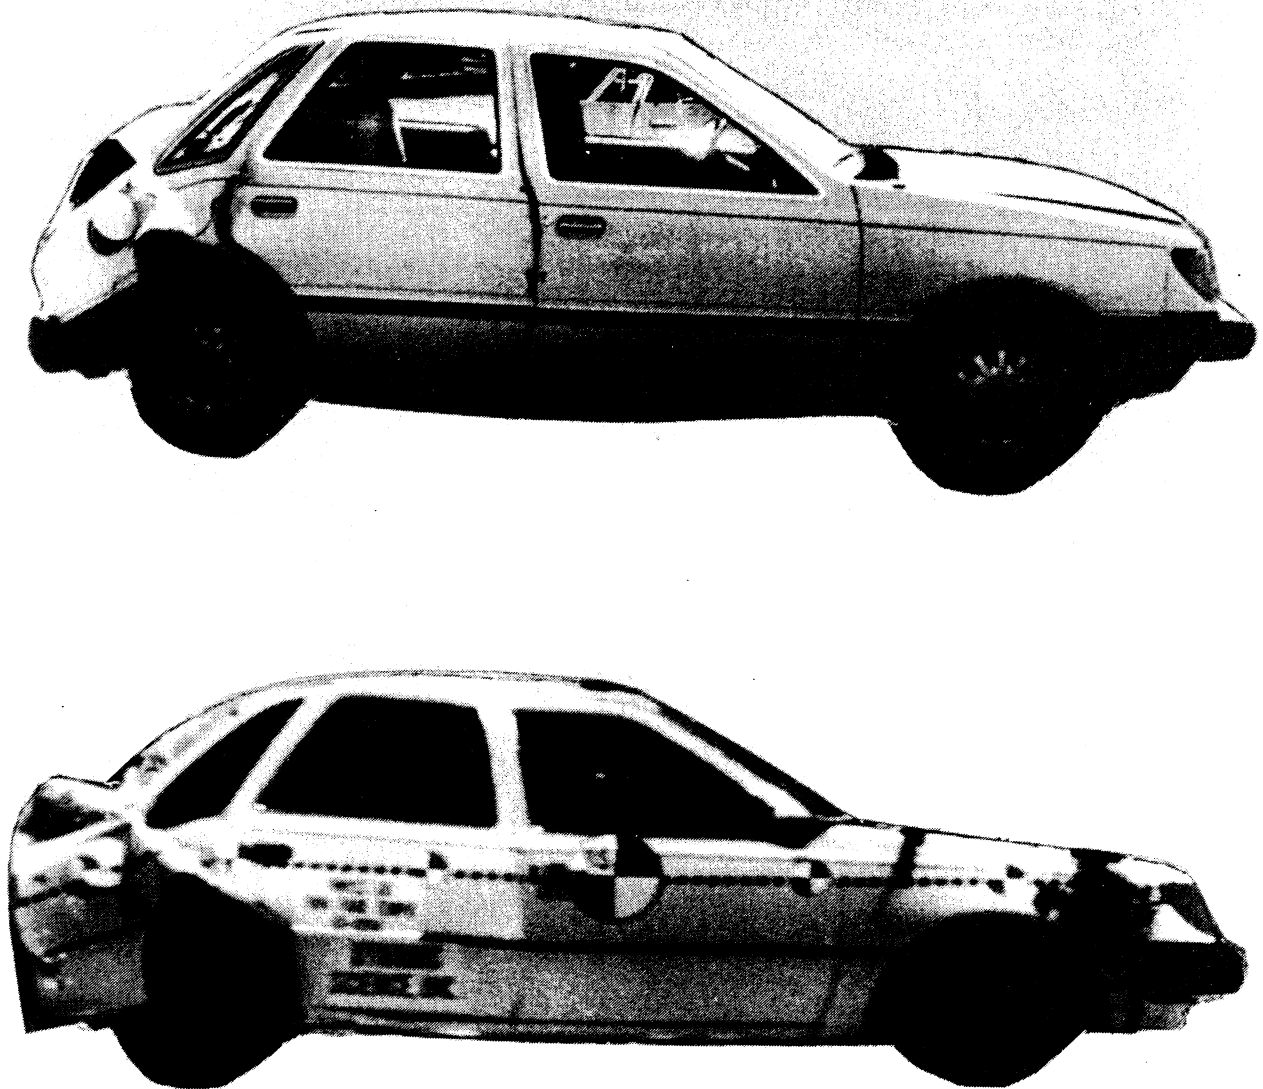
The rear end crush of both the accident target vehicle and the NHTSA test vehicle, as illustrated by figure 3, was almost identical. The final rest positions of the surrogates in the test vehicle were essentially the same as the rest positions of the actual occupants, with the heavier subject laying back in the collapsed seat and the lighter subject seated almost upright. Only the smaller (lighter) surrogate was apparently instrumented in the NHTSA test and the recorded loads indicated low non-injury producing acceleration levels and head injury criteria (HIC) as was the case with the small driver of the actual case vehicle. The test report also noted, however, that even though the larger (heavier) surrogate produced significantly more residual deformation in the driver seat of this test, there was no apparent contact of the dummy with the vehicle interior based upon post-test visual inspection.

Similarly, at first glance, the interior of the accident vehicle also showed no apparent contact damage. In light of the compressive load to the neck of the heavier occupant in the collapsed seat, however, it was clear that some action or reaction source must have provided a contact surface with sufficient resistance to allow the neck to be loaded compressively by the torso as the seat collapsed rearward. Removal of the rear seat back cushion revealed what appeared to be a small embossment below the forward edge of the package tray sheet metal structure just behind the head of the seriously injured right front passenger.

**Figure 3 - Accident and NHTSA Test Vehicle Damage**

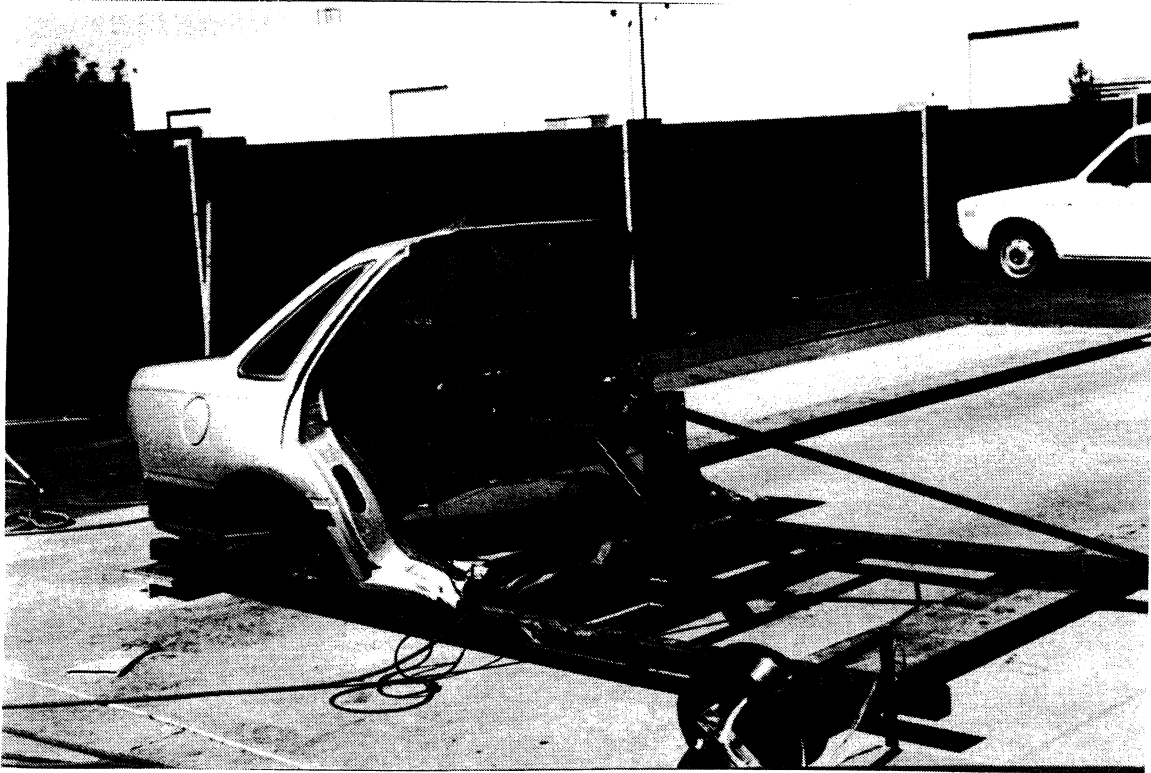
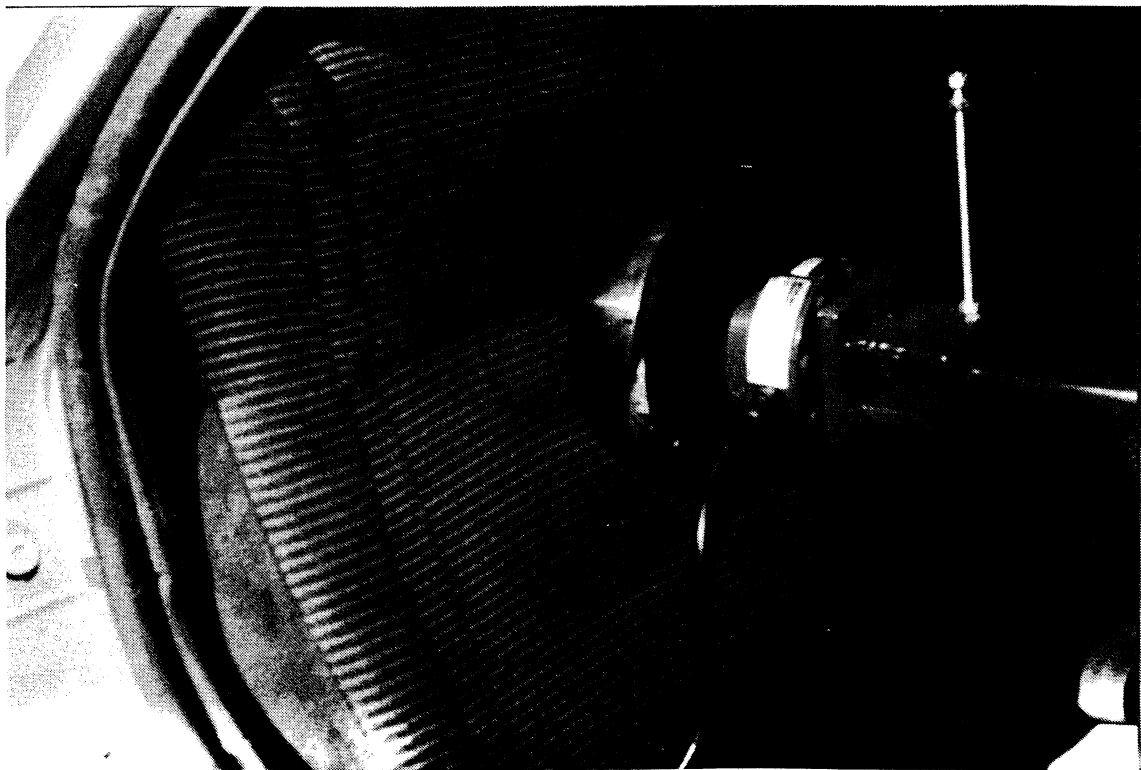
In order to determine if the embossment found was caused by a force of the magnitude and direction necessary to be consistent with loads generated by someone sliding rearward from beneath the restraint when the seat back collapses, an exemplar rear clip was purchased and a simulated head push test was

conducted. Figure 4 illustrates the structural test set-up to duplicate subtle damage and establish load levels on an exemplar clip. The results of the test confirmed that the load levels necessary to duplicate the damage would also have been large enough to cause the serious neck injury received by the heavier front passenger.

Figure 4 - Head Push Test on Exemplar Rear Clip

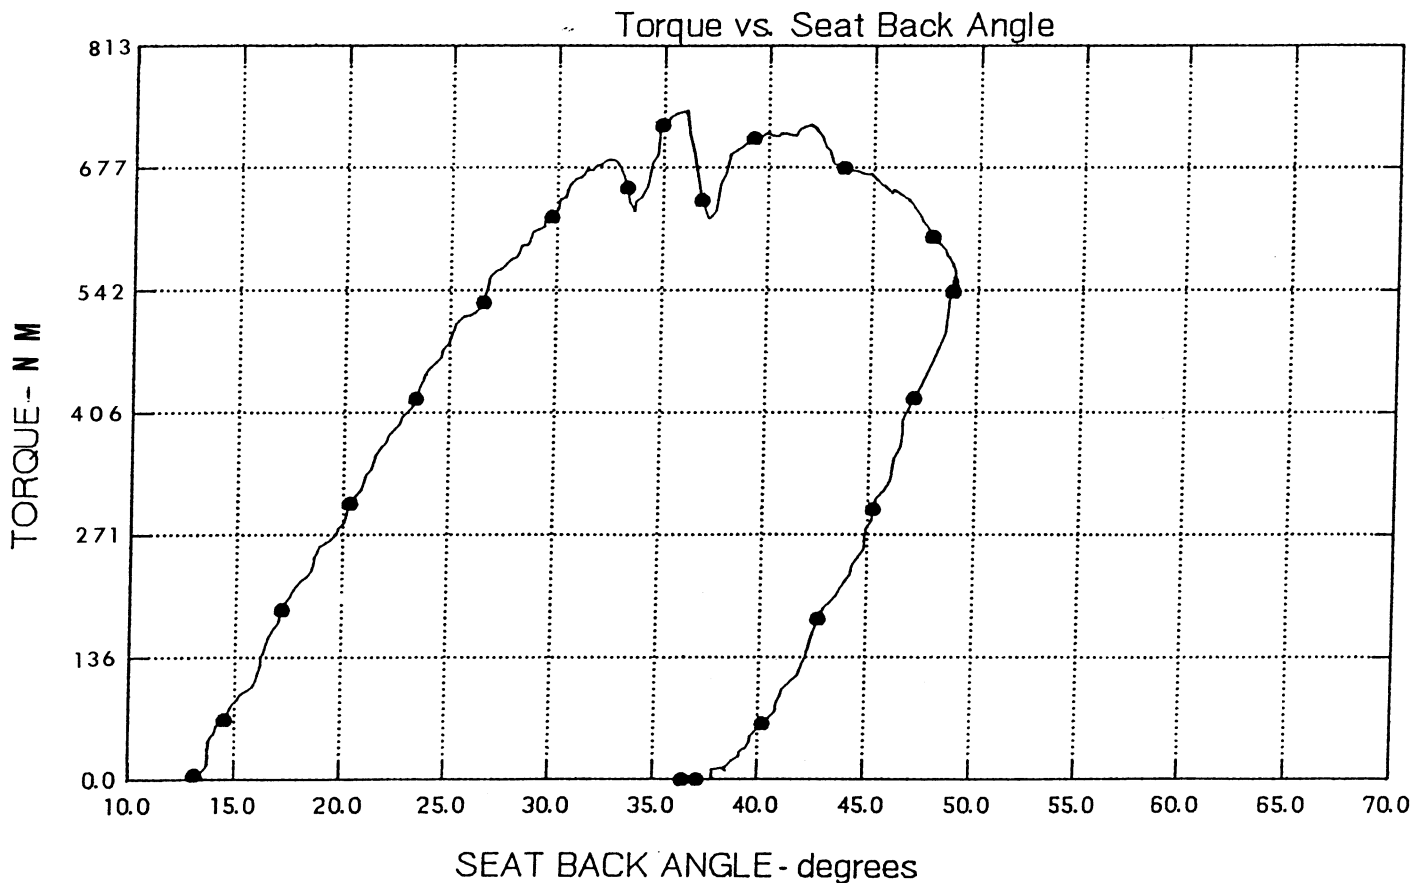
With regard to the energy absorbing capability of the collapsing seats, tests were run on exemplar seats to duplicate the damage found on the actual seat and determine the approximate amount of energy absorbing benefit received by the restrained passenger with the compressive neck injury. Figure 5 shown below illustrates the torque versus seat back angle curve generated for an exemplar seat which had essentially identical damage to the seat occupied by the seriously injured occupant. The test indicates that the seat absorbed approximately 300 N-m of energy, while the energy generated by moving the 50 percentile occupant's upper body at a velocity of about 30 km/hr would be approximately 1420 N-m. Thus, the collapsing seat would absorb some energy but not enough to prevent the body from continuing rearward with enough energy to forcefully impact into the rear structure of the vehicle.

Figure 5 - Torque Versus Deformation Angle for Exemplar Seat of Case I

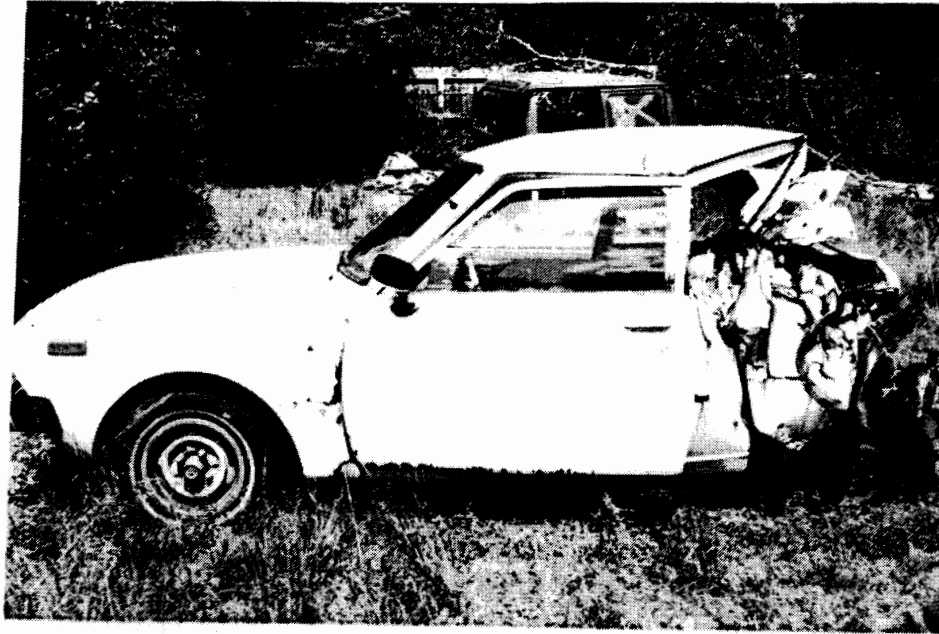
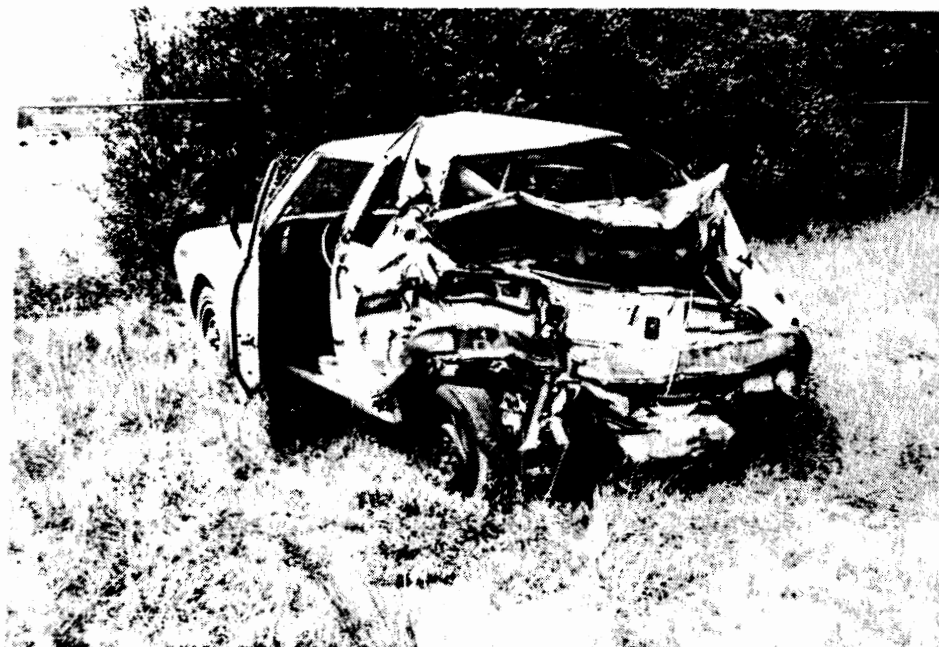
Case Study II - This case involves a rear impact to a 1977 Toyota Corolla, 2-door sedan struck in the left rear by a 1979 full size van. The target vehicle was occupied by 4 adult male passengers, two in the front and two in the rear. It was unknown if the passengers were restrained or not. The impact caused severe crushing of the left rear area and the calculated change in velocity of the target vehicle (Toyota) was about 44 Km/hr (26.4

mph). Figure 6 illustrates the severe crush on the left rear side of the vehicle.

Figure 6 - Damage to Case II Vehicle

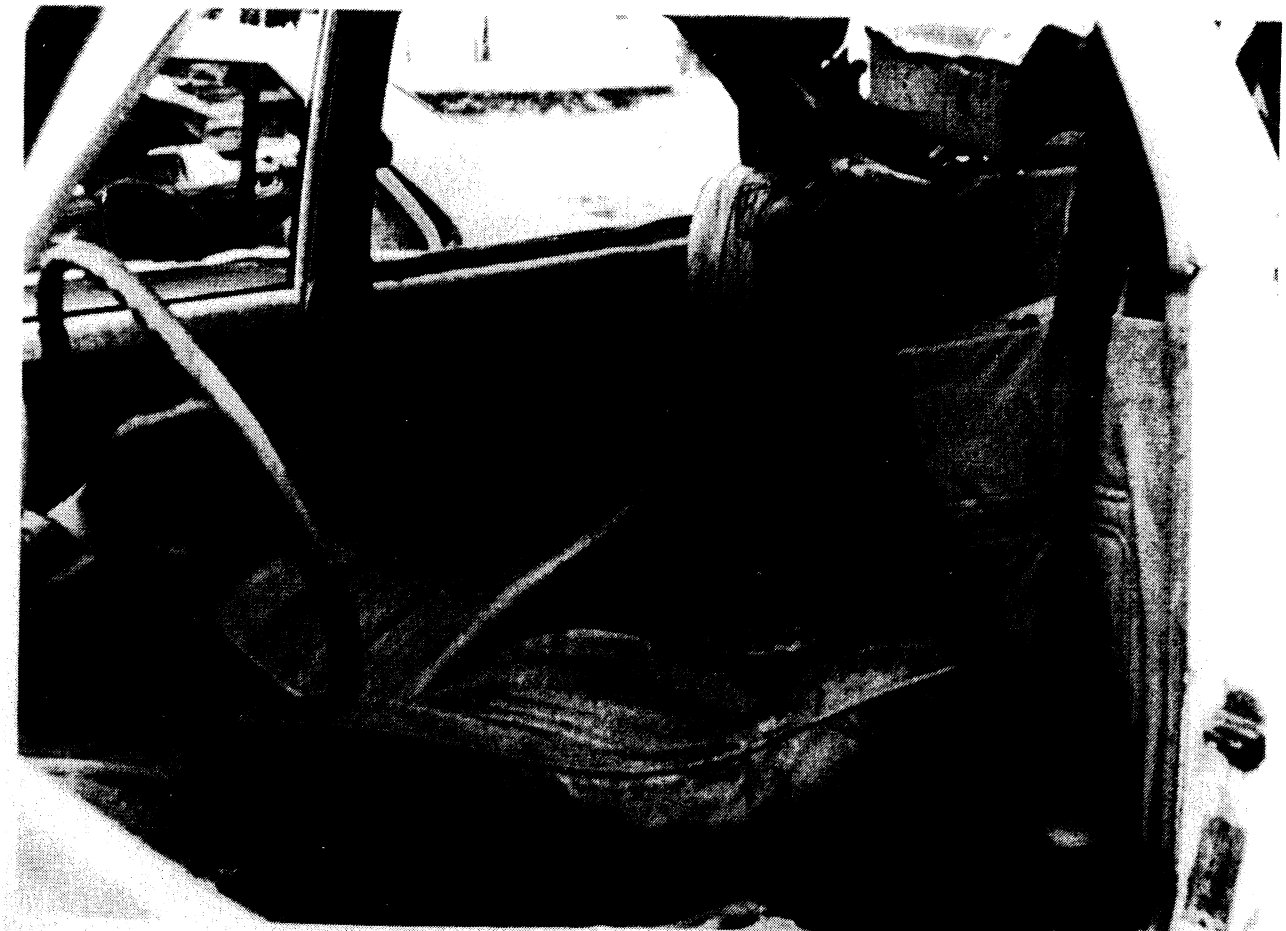
In this particular case the principal direction of force was at about a 15 degree angle from the left rear toward the right front and as a result the right front passenger was deflected not only rearward due to the collapsing seat but also somewhat toward the rear center of the vehicle between the two rear passengers. The 27-year-old right front passenger received massive head injury from impact with a hard surface and died of cardiac arrest secondary to the massive head injury. Figure 7 shows the area of protruding or inward buckle on the rear package tray which lines up with the predicted occupant path of the head of the right front passenger.

The driver of the vehicle moved rearward and inboard toward the load carrying recliner side of his seat back and as such there was not as much deformation noted in his seat. The driver sustained a left temporal head injury and simple fracture of some ribs. The passenger behind the driver was sandwiched between the vehicle crush and the collapsing seat of the driver. This passenger received moderate injuries which included simple fracture of the left clavicle and lower spine injury. The right rear passenger had internal injuries to the abdomen and also had lower spine injury. It is interesting to note that although there were no headrests on the rear seat, neither rear passenger received any neck injury as a result of the accident. The injuries to the rear passengers were attributed to the combined crush of the front passengers in collapsing seats and the rear crush of the vehicle. The injuries to both front passengers were attributed to the deformation of seat backs.

Figure 7 - Interior Impact Region of Case II Vehicle

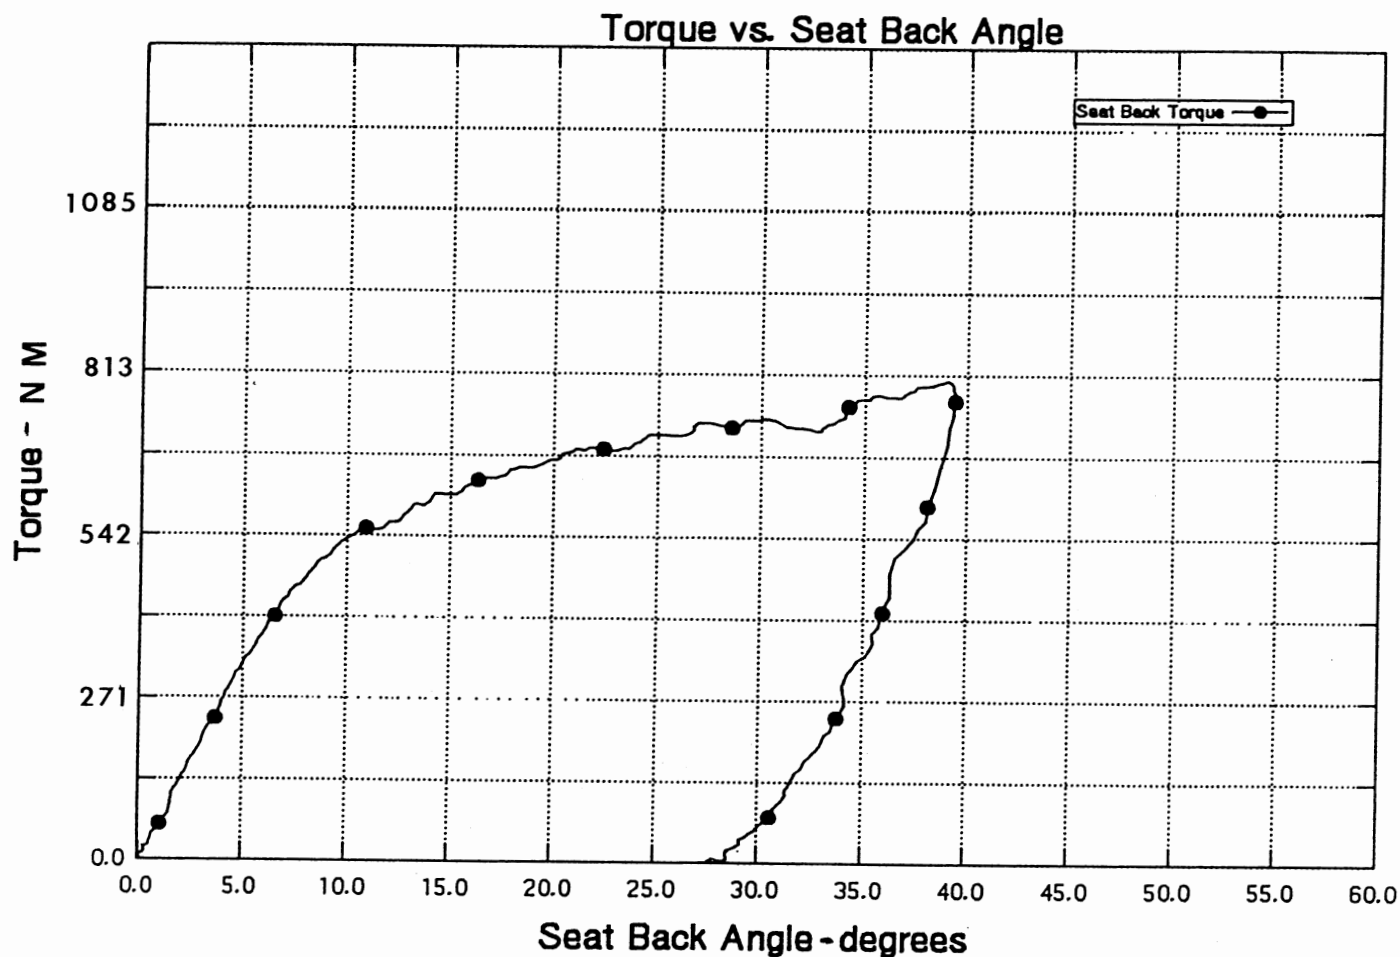
As in the previous case study, tests on exemplar seats were run to establish the approximate amounts of energy absorption afforded to the front seat passengers. Figure 8 illustrates the torque versus seat back angle data for the passenger seat test. The test data indicates

that the passenger seat absorbed about 340 N-m of energy; however, as in the previous case this level was much lower than the kinetic energy associated with the motion of the right front passenger.

Figure 8 - Torque Versus Deformation Angle For Exemplar Seat of Case II
