Program Summary:

A restoration reclaiming the cathedral's historic beauty, blending craftsmanship with modern systems and preserving its sacred character.

This 1916 Dutch Romanesque Revival church had undergone several renovations. The most recent in 1984 covered much of the original ornamentation. The building suffered from water infiltration, peeling plaster, and harsh acoustics due to a crudely installed HVAC system. The stained glass was obscured by yellowed Plexiglas that trapped moisture, and the lighting was ineffective. What began as a renovation soon turned into a reclamation of the church's original grandeur. Historic photos revealed its former beauty, guiding our approach to restore and enhance the space. We sought to blend the craftsmanship of artisans with modern innovations in acoustics, mechanics, and lighting engineers to create a design faithful to the past, but with an eye towards the future. The exterior was restored to prevent water infiltration, and the Plexiglas was replaced with vented glass to protect the stained glass. Interior plaster walls were repaired and adorned with artwork reflecting the church's 1916 heritage. Lighting was updated, and acoustics i

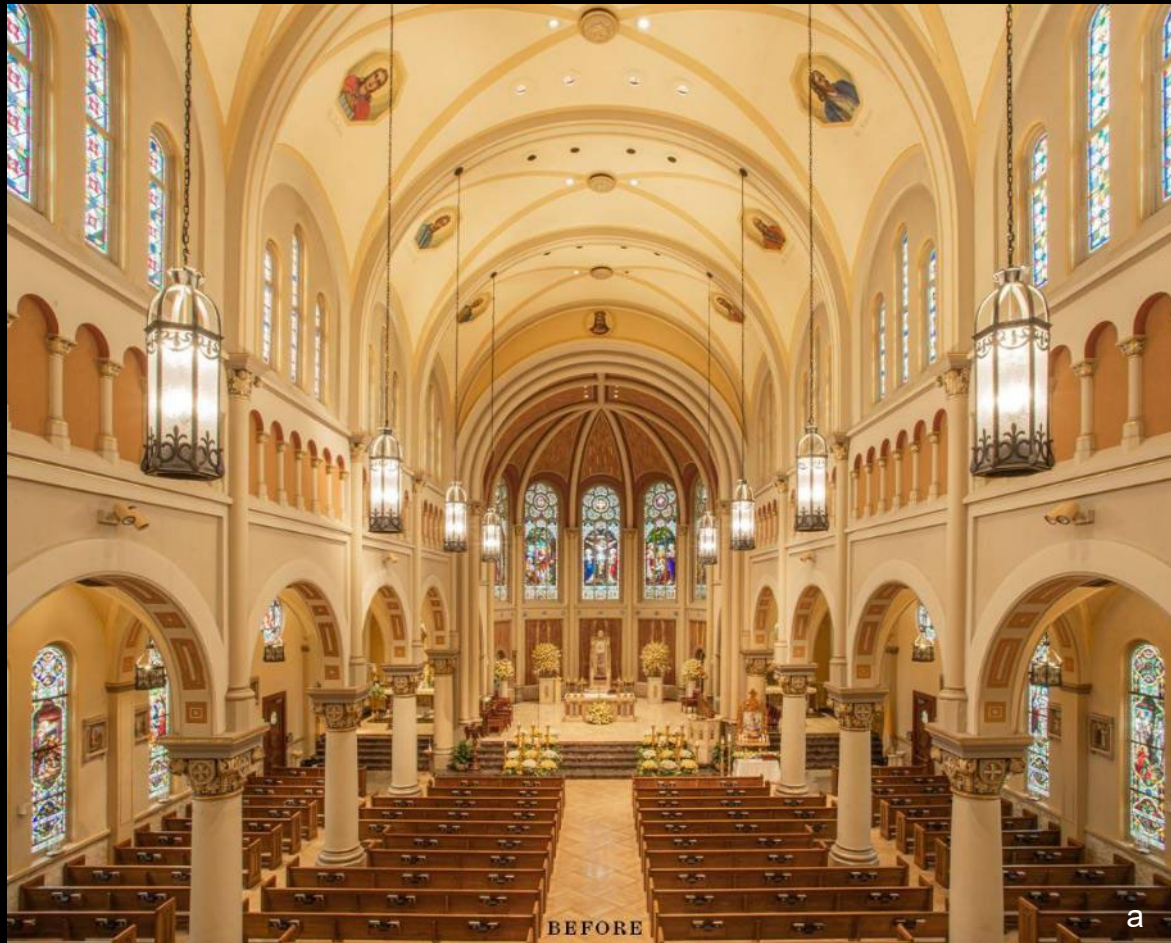
RR205.06

Photo from the choir loft before 2024 the renovation. Note the dulled color scheme and the lack of detail in the painting. (a)

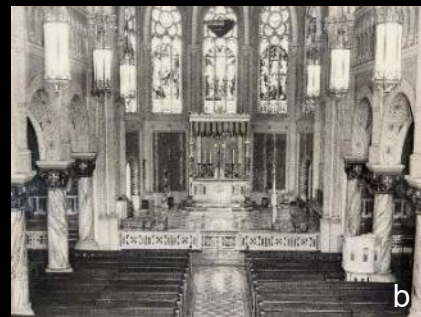
The black and white photo is an existing photo from the 1930's showing some of the painting detail that had been concealed by later renovations and an altar rail. (b)

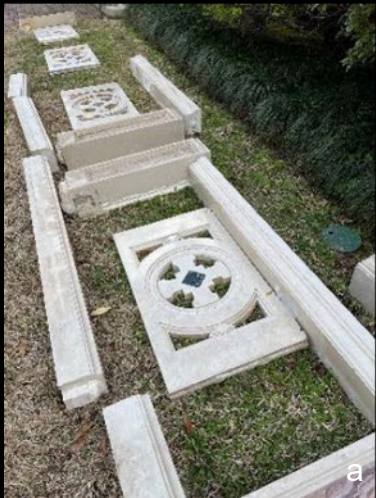
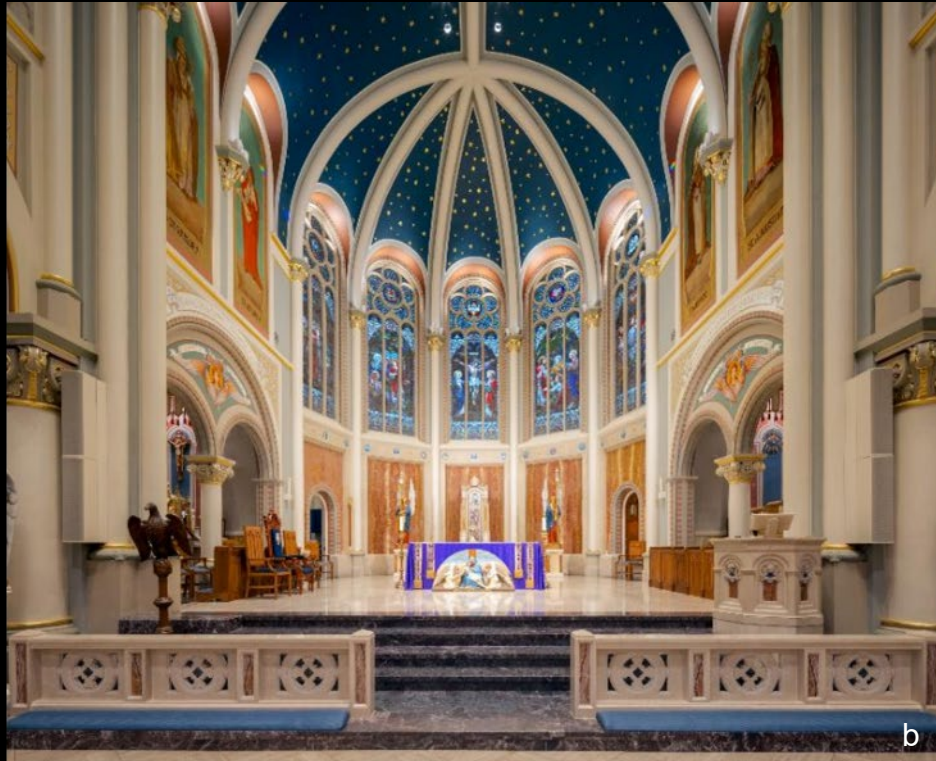
RR205.09

The altar rail, found in pieces in the basement, was like a puzzle to reassemble. (a)

After careful repair and restoration, it was successfully reinstalled on the newly extended altar step. (b)

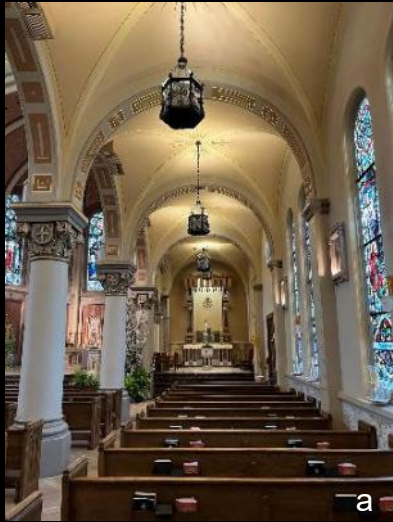
a

Note the dulled monochromatic color scheme, the obtrusive ductwork and diffuser, and the opaque glass on the light fixture that distort the light in the existing photo of side aisle and baptismal side shrine. (a)

Ineffective and distorted lighting was replaced with new or refurbished fixtures.

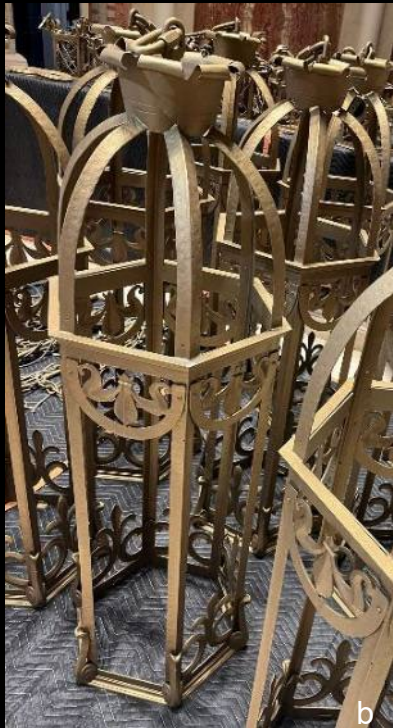
b

Light fixtures during restoration. (b)

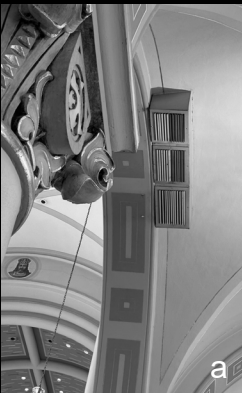
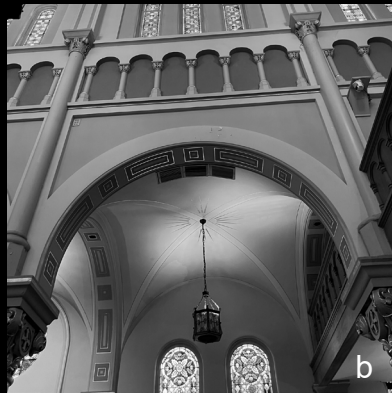
RR205.11

Existing diffusers and exposed ducts. (a) (b)

Ineffective, loud, and prominent diffusers and exposed ducts were replaced with a quieter and discreet diffusers that condition the air more evenly throughout the space.
