Hydropneumatic Tank Inspections and Replacement

FRWA Water Writes Article Fall 2007

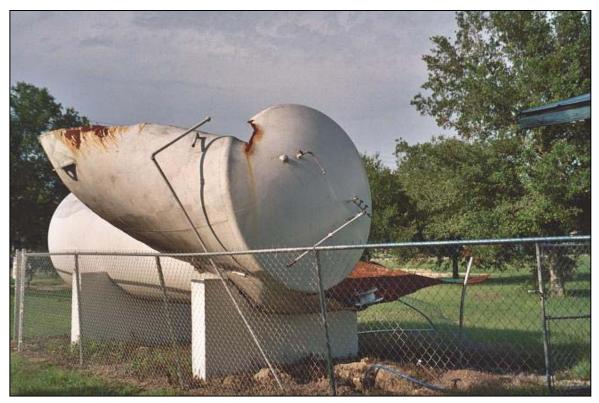
Hydropneumatic Tank Rupture

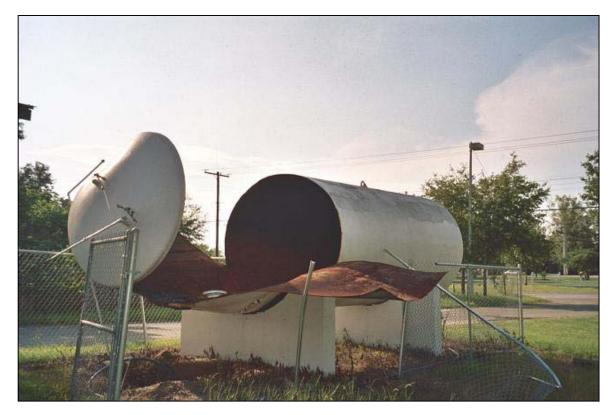
Hydropneumatic Tank Rupture

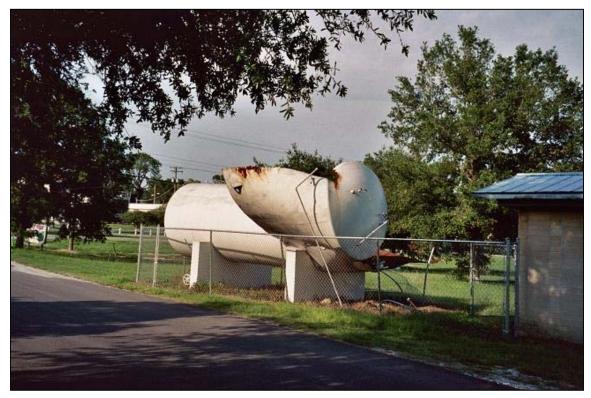
Hydropneumatic Tank Rupture

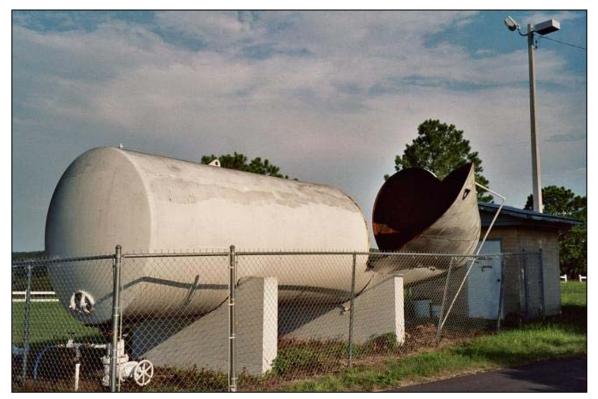
Hydropneumatic Tank Rupture
