**Ship Simulation Transit Scenario Modeling & Ship Pilot Study of the
Maritime Implications for Commercial Ship Transits of the Proposed
Houston Ship Channel Gate Complex**

Prepared for:
Greater Houston Port Bureau

Report Version 7.2, 11/30/2022

George B. Burkley MSc, Dennis Webb, P.E.
and Jonathan J. Pierce, Ph.D., Alaska Safeguard Marine LLC

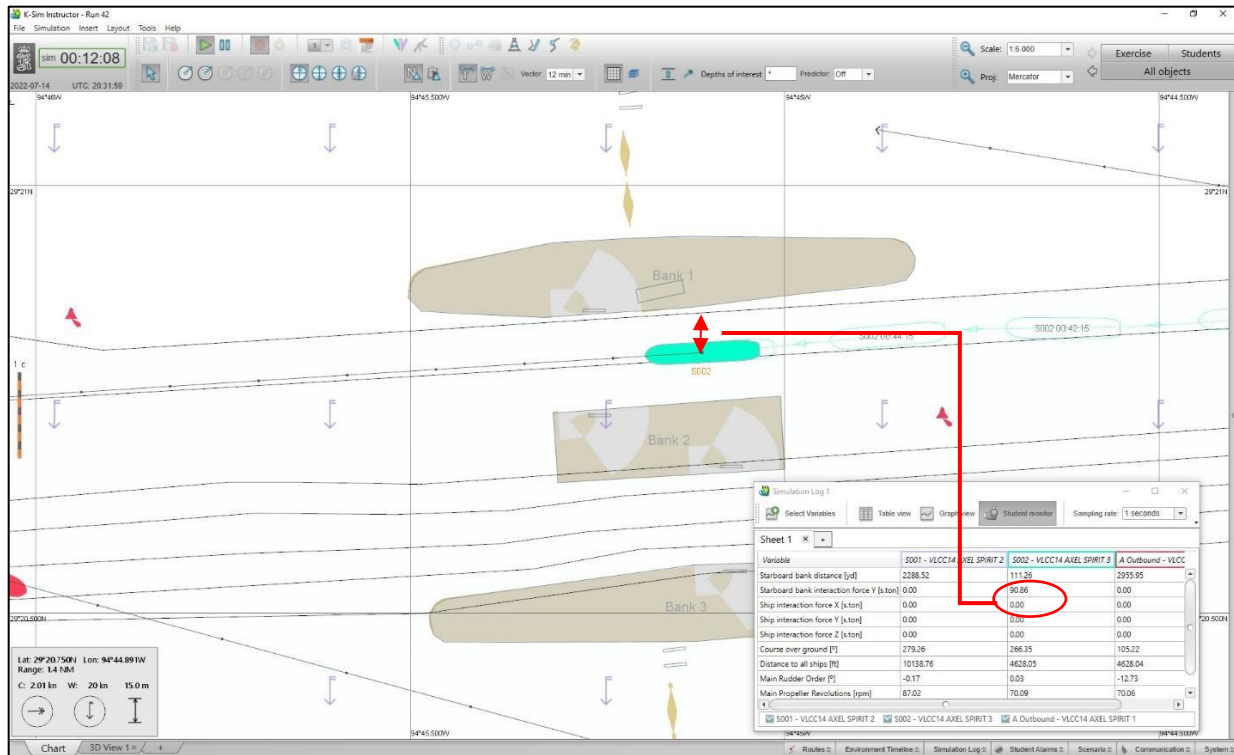
Figure 4. Aframax class tanker with 91 tons of bank force from gate system

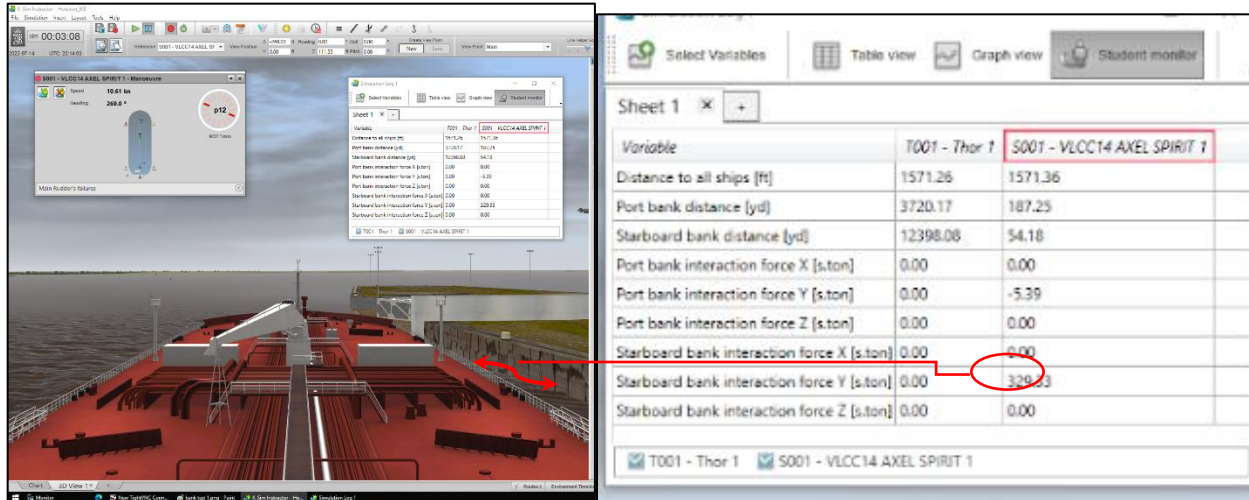
It is expected that vessels will become unaligned with the HSCGC's centerline while transiting through the gate, given random events, shipboard emergencies, and/or human error. Analysis of the shearing forces below on an unaligned tank vessel, passing through the tested gate system, shows that an Aframax-class tank vessel at a distance of 162' from the sidewall of the gate, at a speed through the water of 10.6 knots, generates 392 tons of shearing force on the vessel. This shearing force caused an out-of-control situation for this vessel.

Figure 5. Shearing Forces on misaligned Aframax class tank vessel passing through the tested gate system

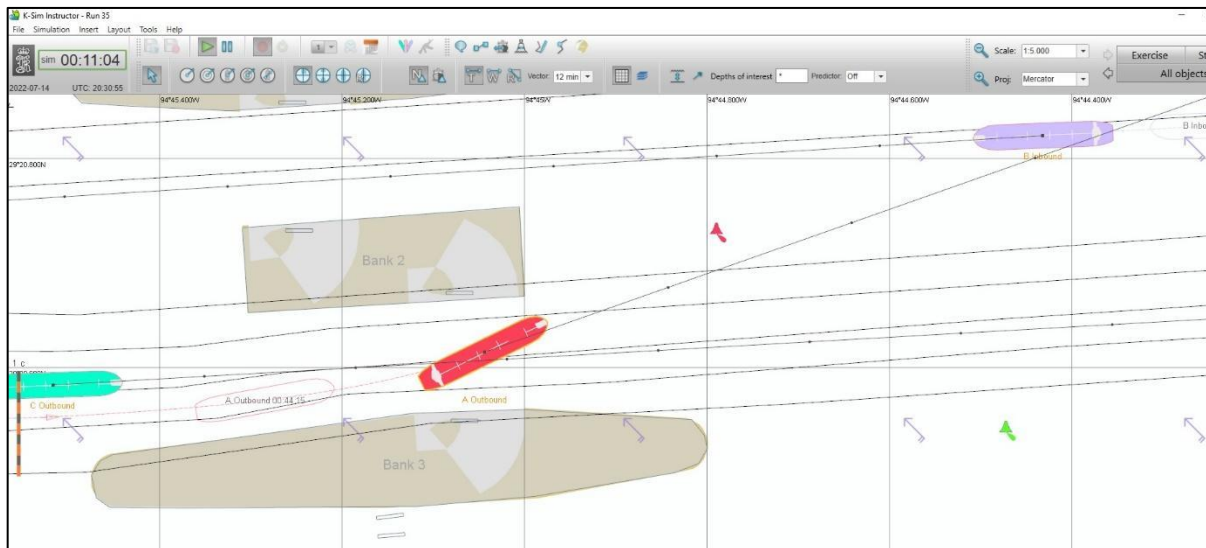
In the below example, the Aframax-class tank vessel (Red, A) was outbound through the HSC, transiting through the gate system, they are mis-aligned due to previous maneuvers with the other Aframax-class tank vessel outbound from the Galveston Channel (Turquoise C), which is closely following. This navigation setup causes the lead vessel (Red, A) to be misaligned and too close to the south wall of the gate system. The asymmetrical shearing forces due to close proximity to the oblong island wall upon entry of the HSCGC overwhelmed the piloting control of the vessel, and the vessel ran out of control, across the channel lanes and towards the north ship channel of the other gate.

Figure 6. Outbound Vessel out of control due to shearing forces in the tested gate system

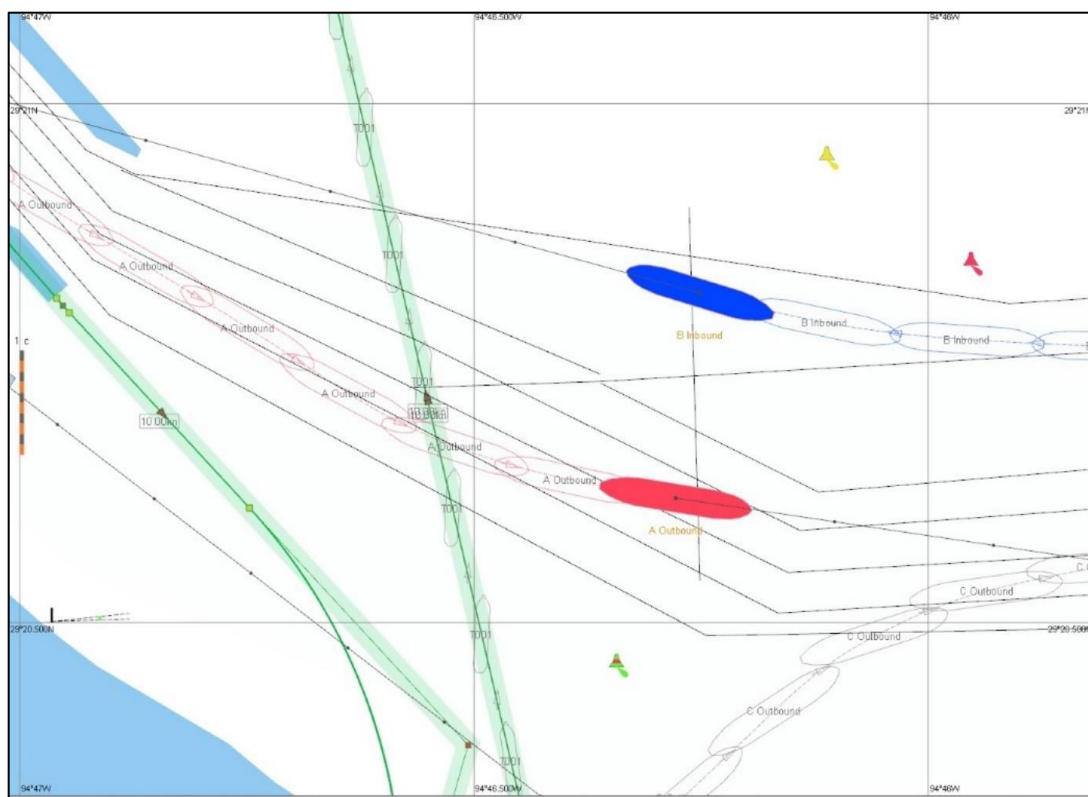
Figure 8. Run #25, Outbound ship has flood current, performing the turn at buoys 18 and 16, pilot using full ahead and full over to complete the turn

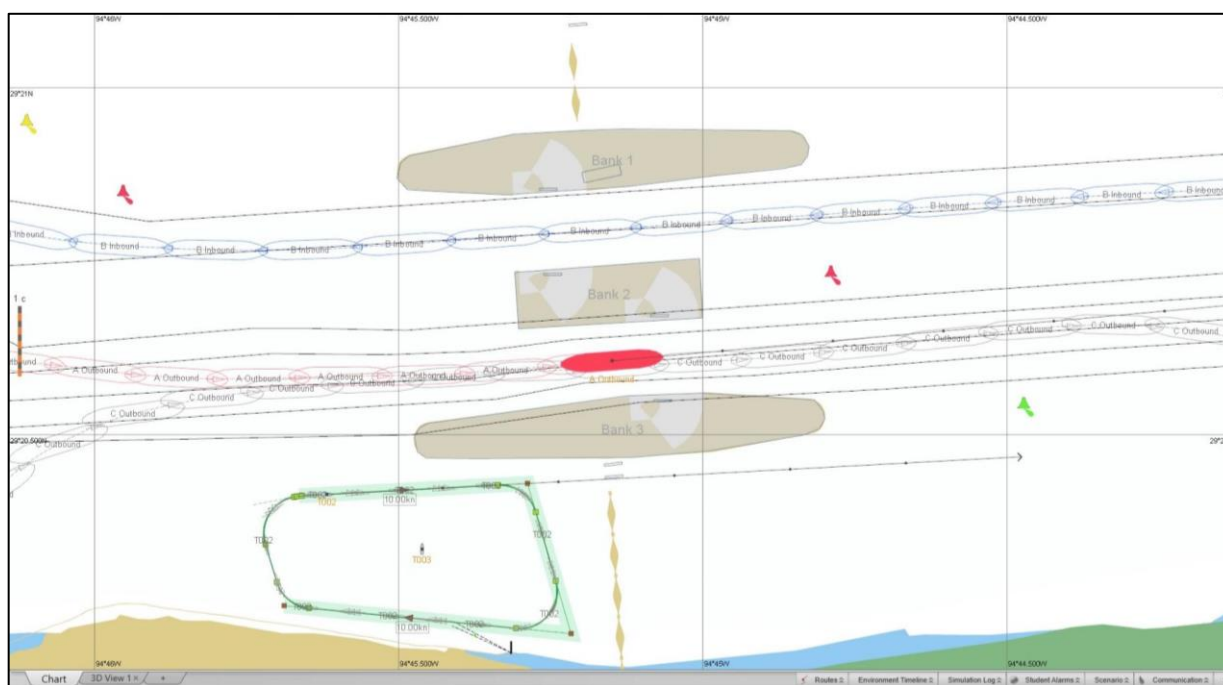
Figure 9. Run #25, Outbound ship has flood current, could not get aligned with gates after turn, entered gate system at an angle

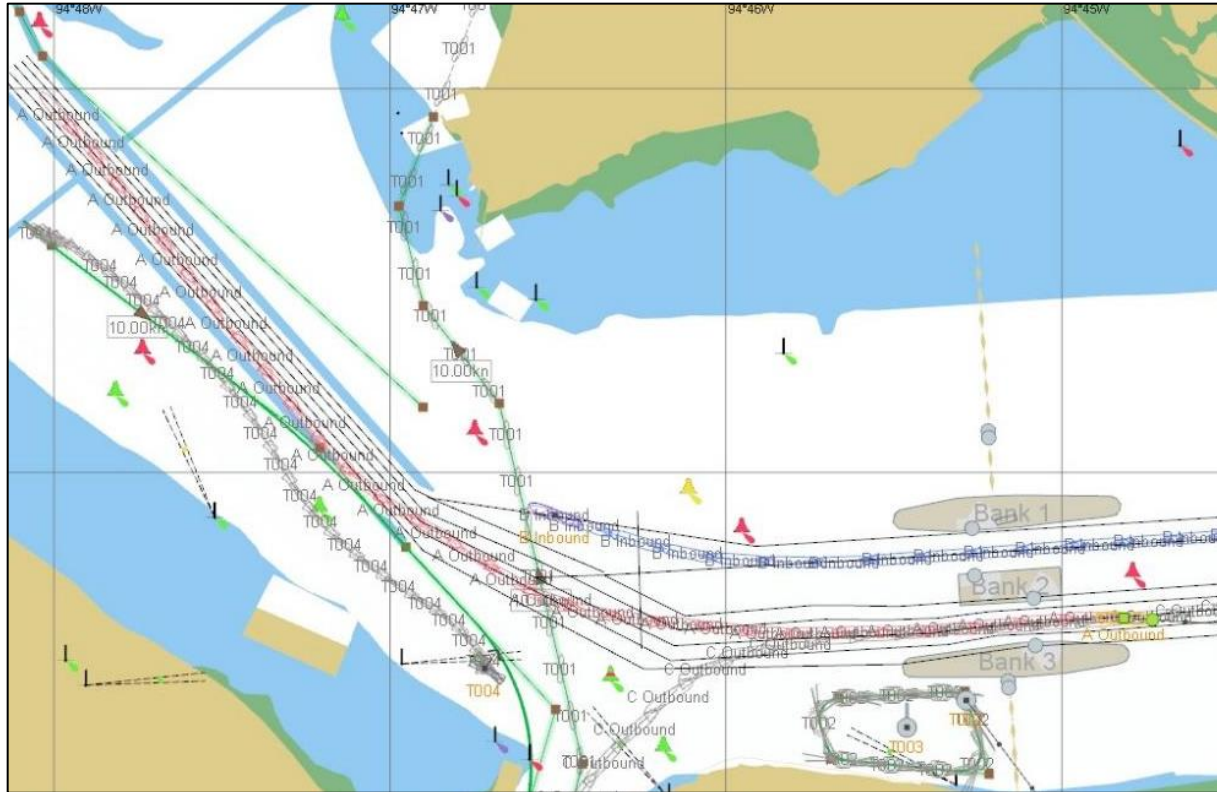
Figure 10. Run #25, Outbound ship has flood current, could not get aligned with gates after turn at buoys 18 and 16, entered gate system at an angle

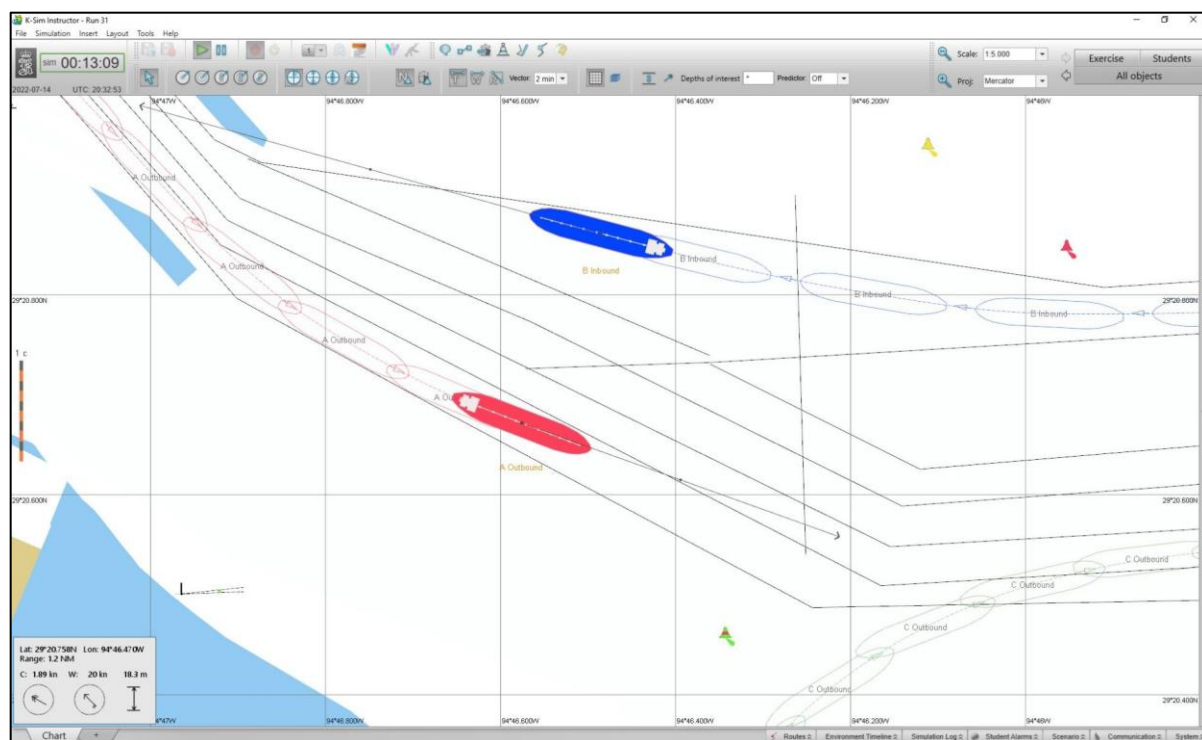
Figure 14. Run #31, outbound ship meeting inbound ship between buoys 18 and 16 making the turn deep in the HSC trying to recover to align with the south gate entrance

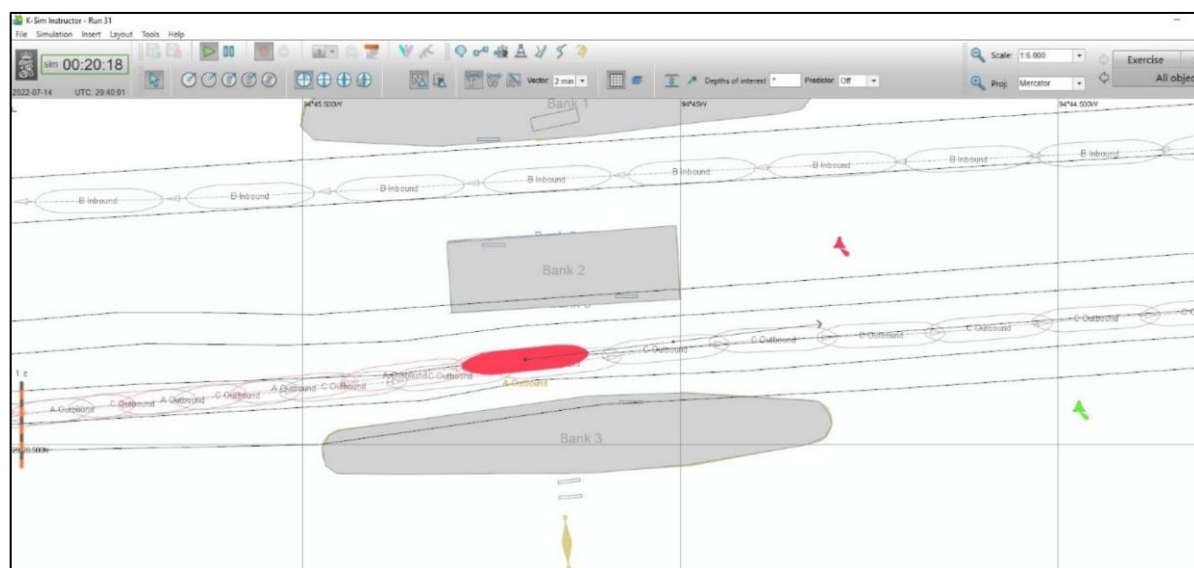
Figure 15. Run #31, outbound ship transiting through the south gate at a slight angle

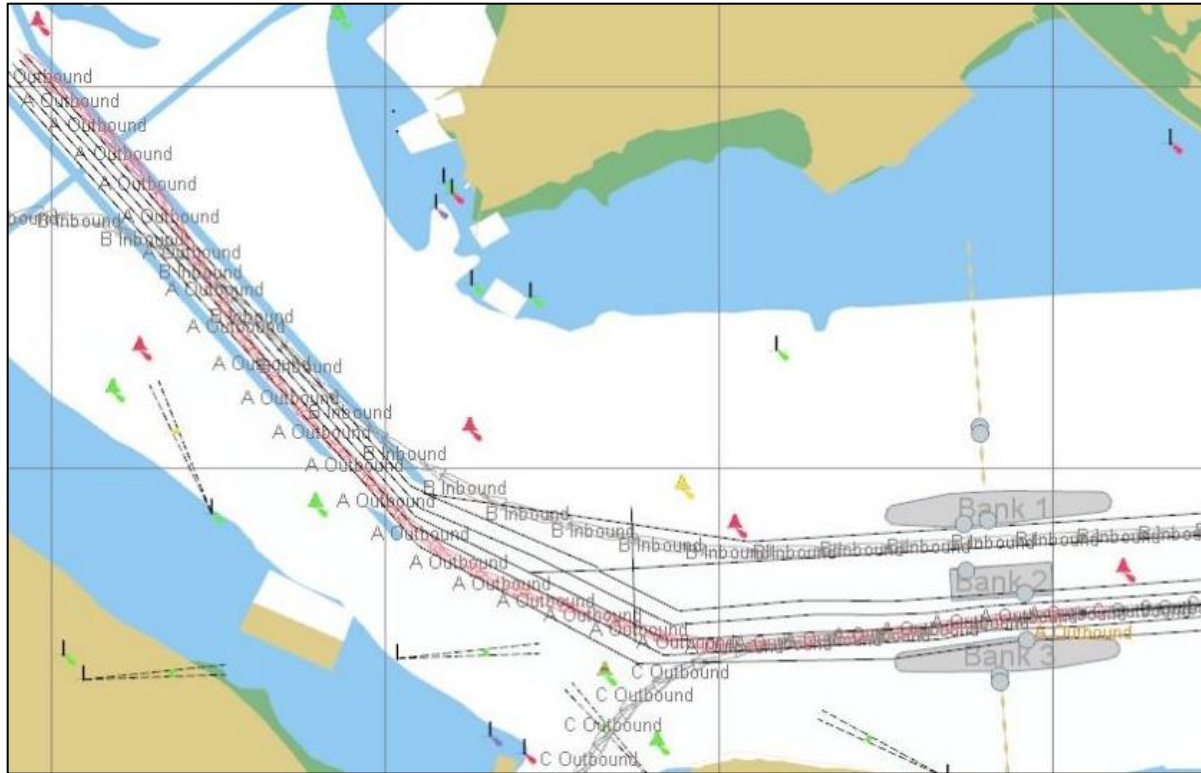
Figure 16. Run #31, outbound ship has flood current, could not get aligned with gates after turn at buoys 18 and 16, entered gate system at an angle

Runs #10, 25, and 31 are all examples of a similar hazard of an outbound ship in a flood current not being able to align with the entrance of the south gates. Overall, these scenarios demonstrate that given the design and siting of the HSCGC, there is a hazard for outbound vessels in a flood current.

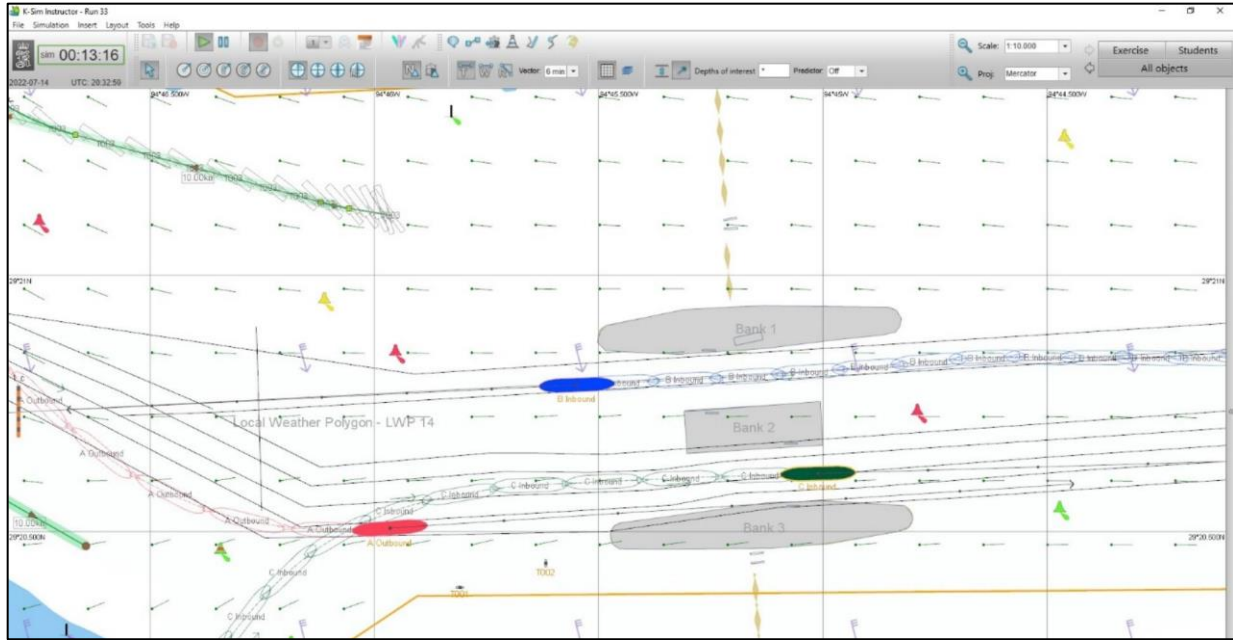
Figure 18. Run #33, Inbound ship with ebb current transited north gate above center line, Outbound ship from HSC transiting below center line about to enter south gates at angle

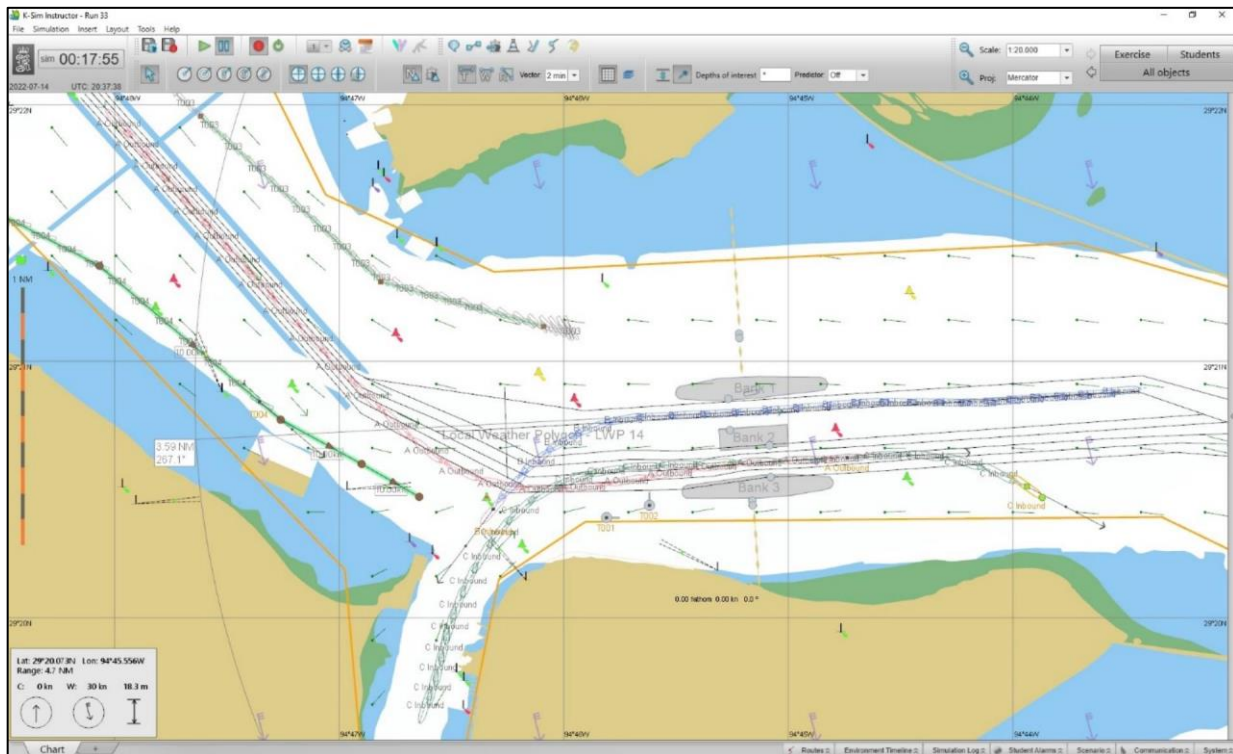
The result of this scenario is a GAR score of 2 Caution. Both outbound ships from HSC and Galveston entered the south gate at an angle and traveled across the center line in the gate. This was most pronounced for the ship outbound from HSC that transited from below the center line after performing the turn at buoy 16 to transiting above the south gate centerline extension. The inbound ship transited above the center line in the gate in order to limit the angle and thus make a safer and easier turn into Galveston Channel. Transiting off the center line in the gates and especially at an angle is a potential hazard as shown above in Figures 4 and 5. This is because the walls in the gate system cause shearing forces, and if the ship is unaligned, it can cause the ship to lose control as shown in Figure 5.

Figure 19. Run #33, Inbound ship with ebb current transited north gate above center line, outbound ship from HSC entered south gate at an angle transiting from below to above center line in the gate system

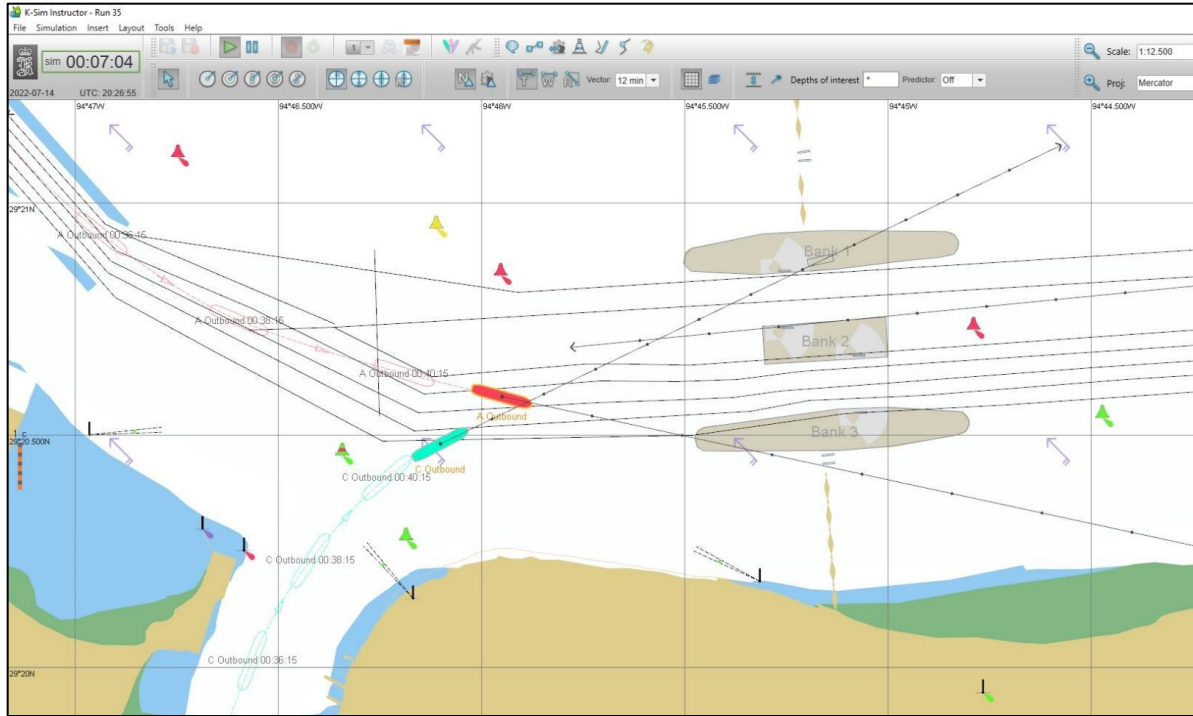
The result of this scenario is a GAR score of 3 High Concern. Both outbound ships from HSC and Galveston almost had a collision on approach to the south gate. Emergency ship handling was required. This caused the outbound HSC ship to enter the south gate system misaligned and at an acute angle. The piloted ship, experiencing shearing forces from the bank and attempting to not have an allision with the gate, had a near allision with the center island of the gate system. Again, emergency ship handling was required. The pilot aboard the ship outbound from HSC describe the maneuver as very unsafe and described losing control of the ship due to bank effect. Fortunately, they were able to regain control before colliding with the inbound ship transiting into the north gate.

Figure 21. Run #35, outbound ship from HSC transits in front of outbound ship from Galveston Channel with a near missed collision

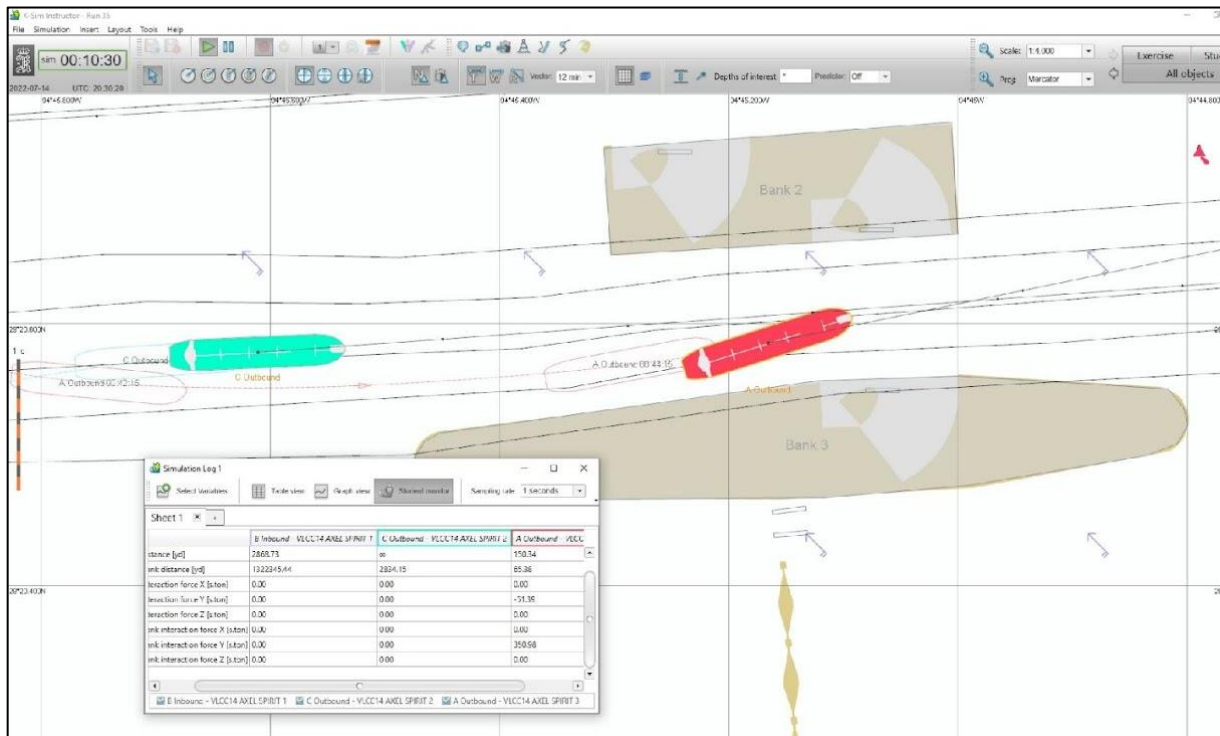
Figure 22. Run #35, outbound ship from HSC transiting in south gate at an angle and feels shearing forces from the bank effect

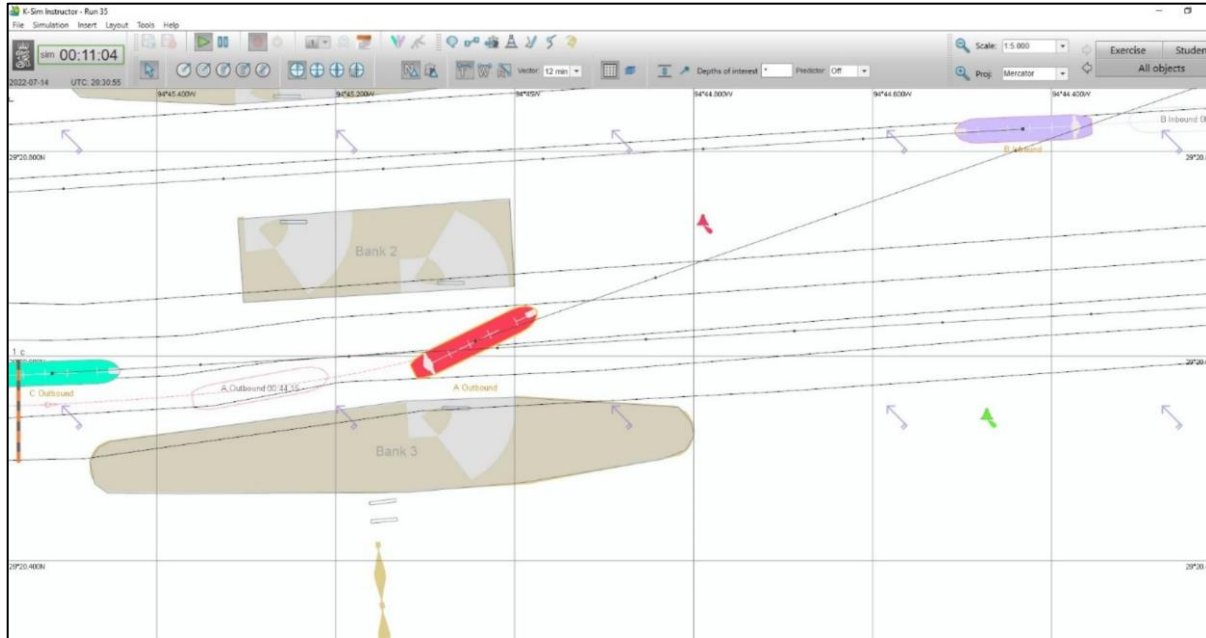
Figure 23. Run #35, outbound ship from HSC nearly allides with center island of gate system due to losing engines from shearing bank effect

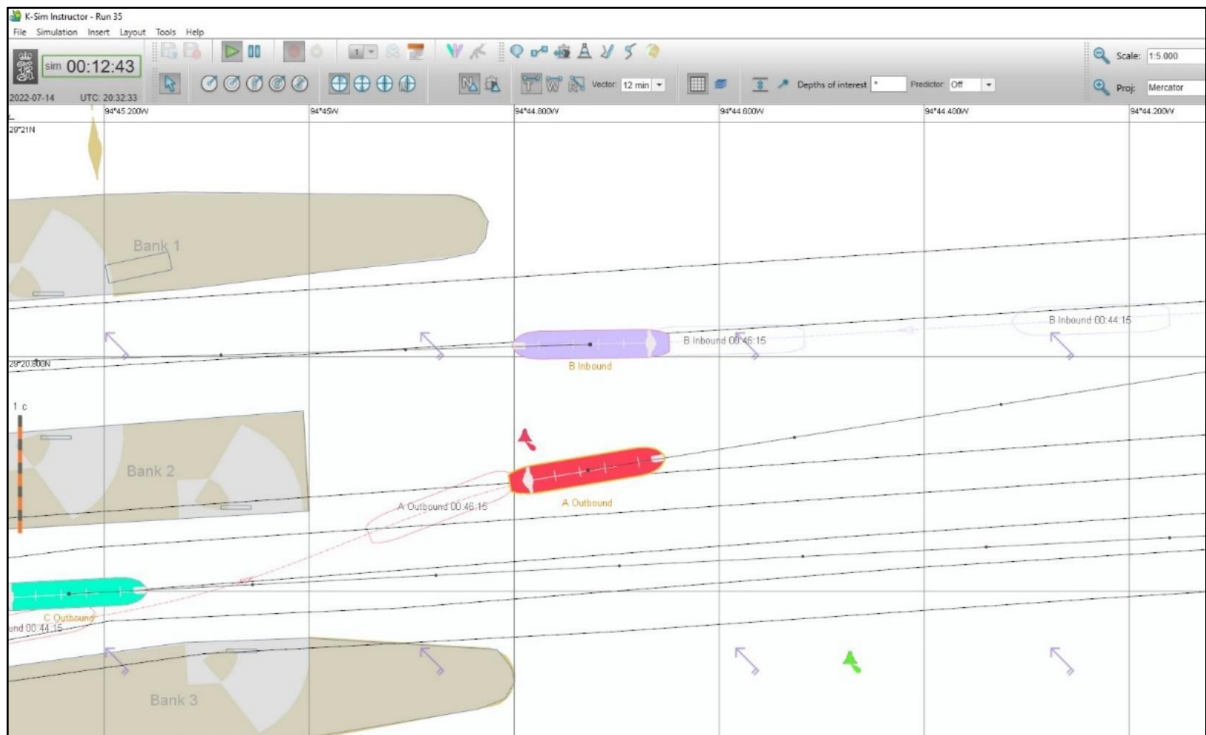
Figure 24. Run #35, outbound ship from HSC nearly collides with inbound ship on center line through north gate crosses above traffic line for gate system

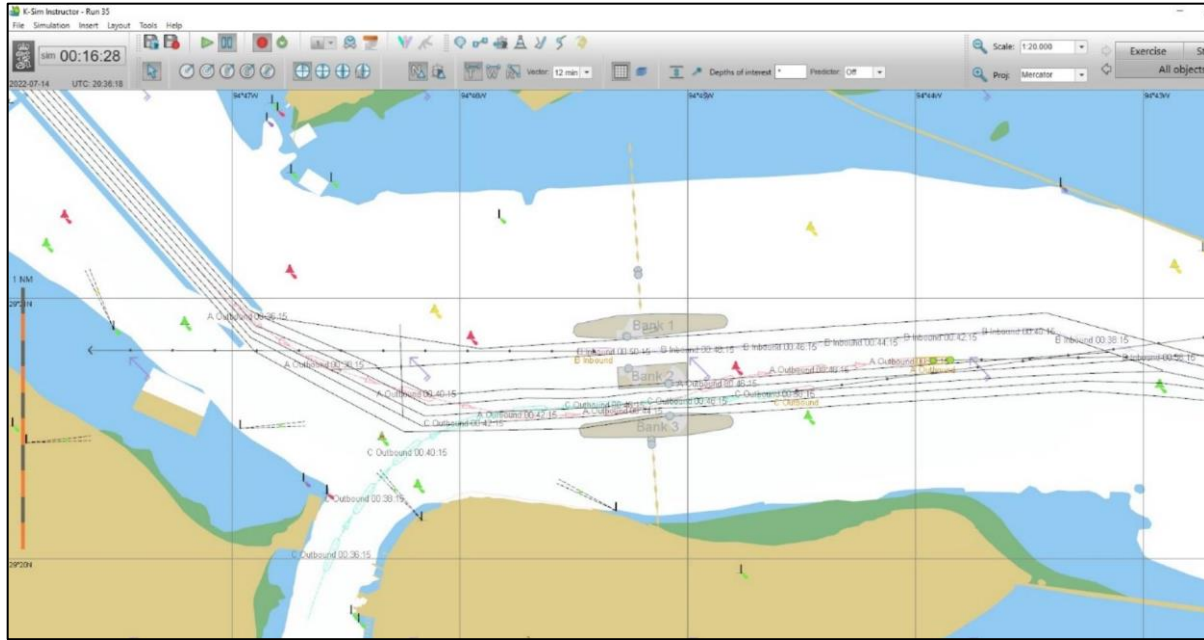
Figure 25. Run #35, completed run shows the near collisions between outbound HSC ship and other ships, as well as near collisions between the outbound HSC ship and the gate system

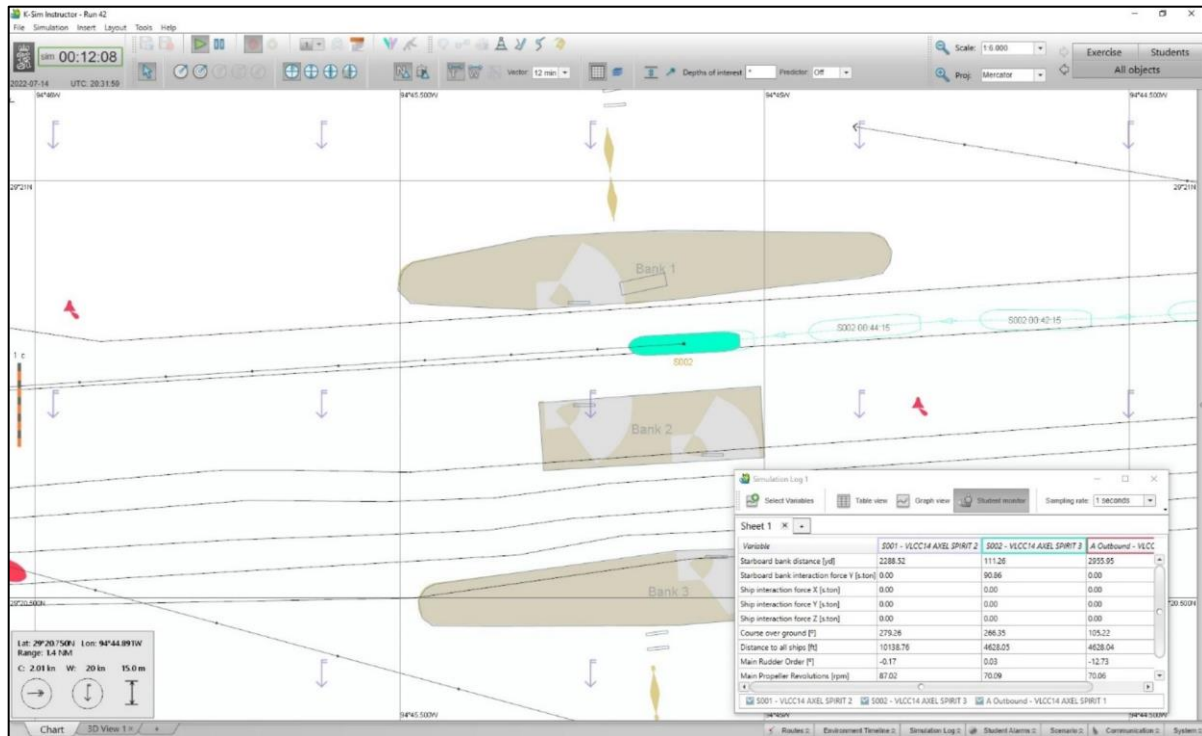
Figure 27. Inbound ship experiencing shearing forces from the banks even on center line

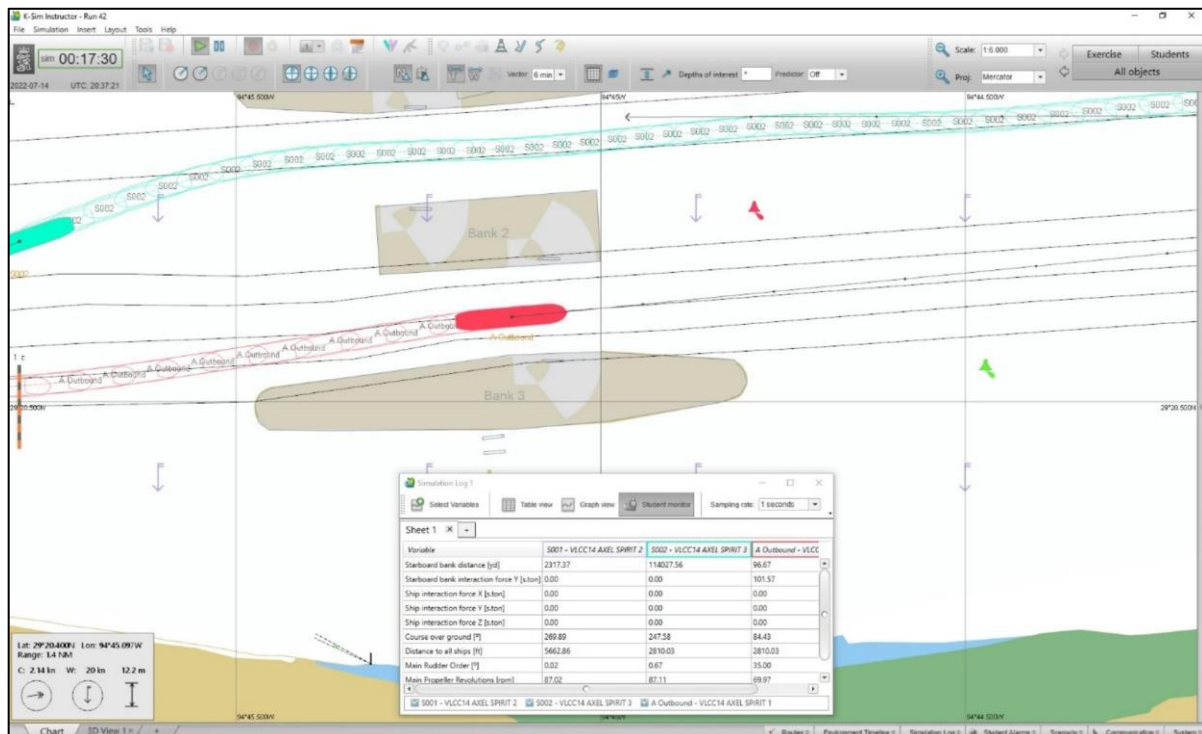
Figure 28. Outbound ship experiencing shearing forces as entered south gates at an angle

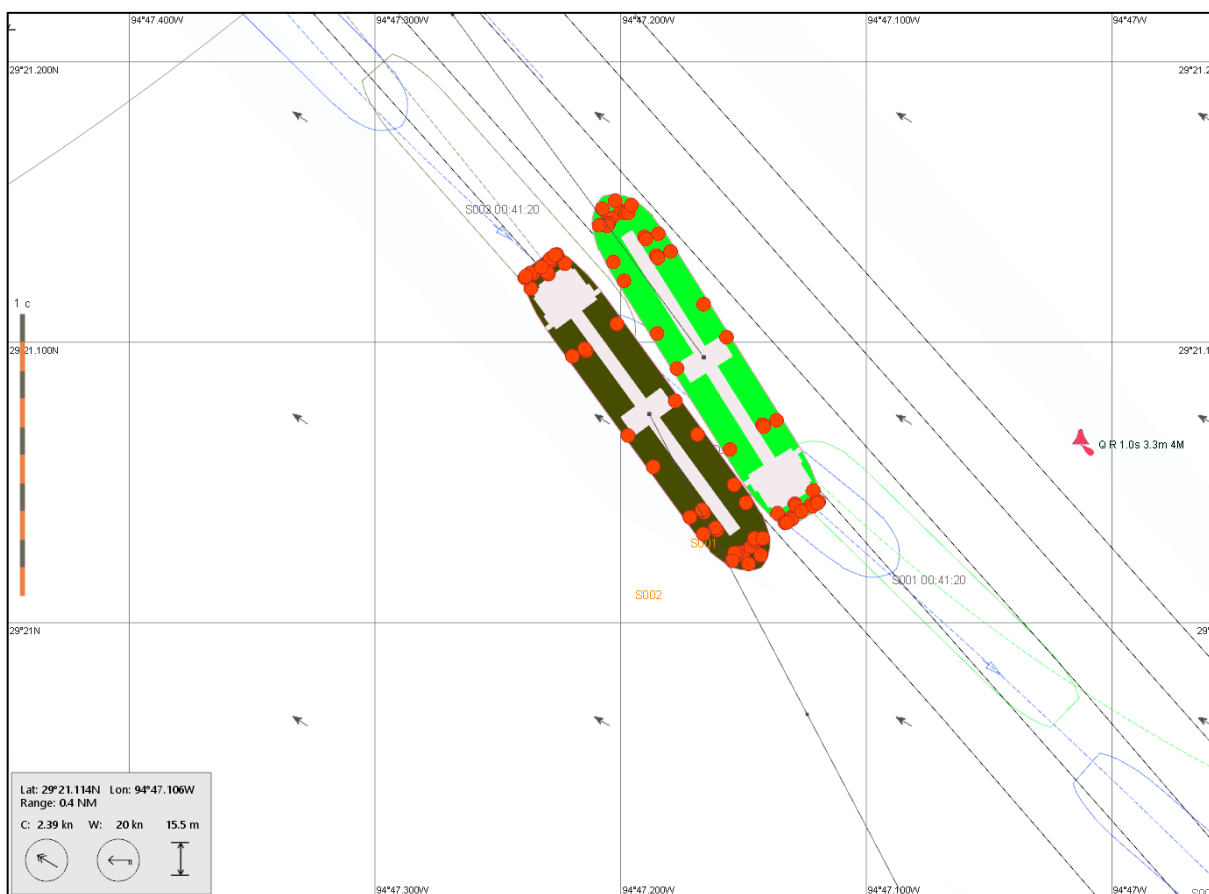
Figure 30. Run #4, Second Outbound Ship and Inbound collision near buoy 18

During Run #4, GAR score 3 High Concern, the outbound and inbound ships had a collision near buoy 18. This collision was between two Aframax-class tank vessel models, which was the smallest vessel tested. There was limited visibility due to fog conditions. The inbound ship had completed its transit through the north gate and had met the first outbound ship. When the second outbound ship was aligning with the north gate, it collided with the inbound ship. The pilots stated the collision was due to visibility issues combined with the flood current. They reported it was difficult to make the turn at buoy 18, and thus the outbound ship had the collision. They stated that if they were transiting through the south gate, they would have had more time and space to maneuver. Therefore, two-way commercial ship traffic should not utilize a single gate complex. Instead, a single gate-complex should only utilize one-way commercial ship traffic.

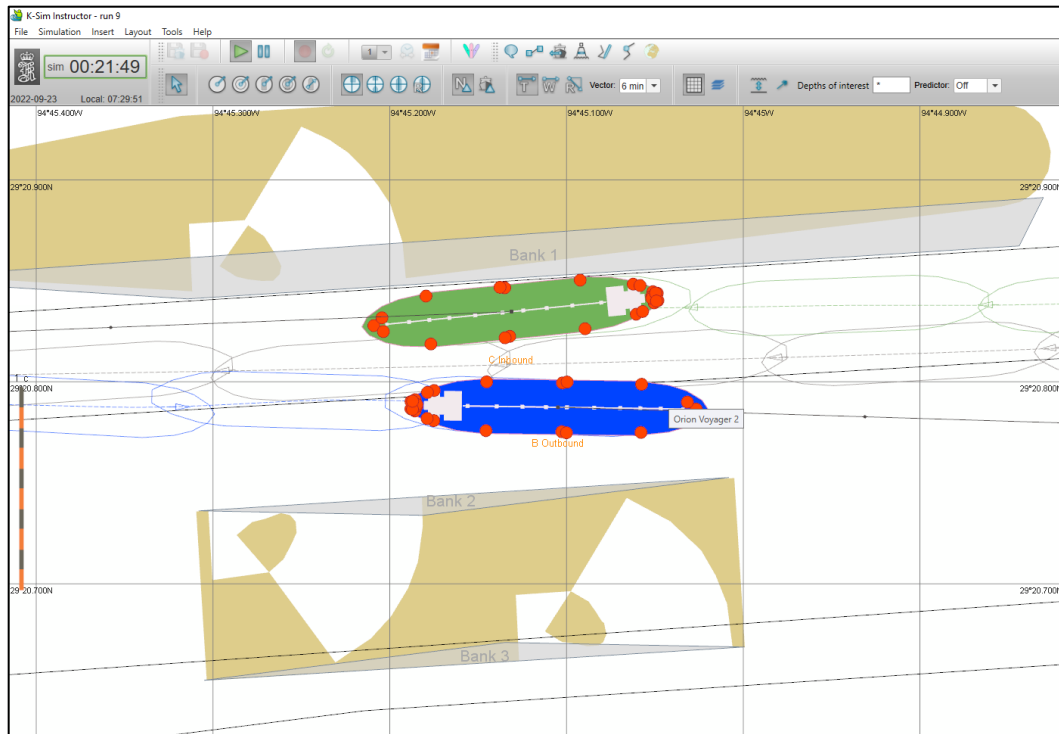
Figure 32. Run #9, Near Collision between Outbound ship and Second Inbound Ship in North Gate, Skin-to-Skin 70'

During Run #9, GAR score 3 High Concern, the outbound and second inbound ships had a near collision inside of the north gate. This was with the Suezmax class of tank vessel and in clear daylight conditions. The first inbound ship had completed its transit through the north gate and had met the outbound ship. When the outbound ship was aligning with the north gate on the center line it unexpectedly collided with the second inbound ship inside of the gates. The outbound ship reported that they were not aligned when entering the north gate. Rather, they entered the north gate complex at an angle and off centerline. The flood current made it more difficult to line up properly with the north gate complex. This event was unplanned. The starting position of the outbound ship was near buoys 25/26 and the starting position of the second inbound ship was near buoys 7/8. This is further evidence that two-way commercial ship traffic should not simultaneously use a single gate complex, but instead, utilize a one-way traffic scheme when sharing a single gate.

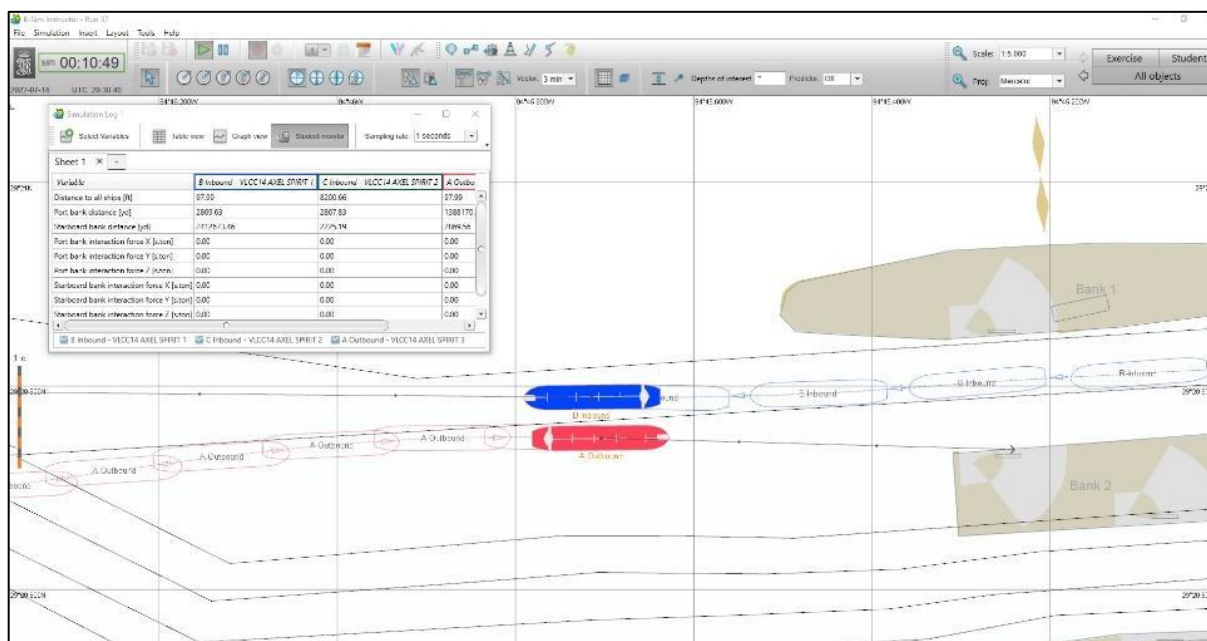
Figure 34. Run #37, Unsafe Meeting between Outbound and First Outbound Ships near the North Gate, Skin-to-Skin 95'

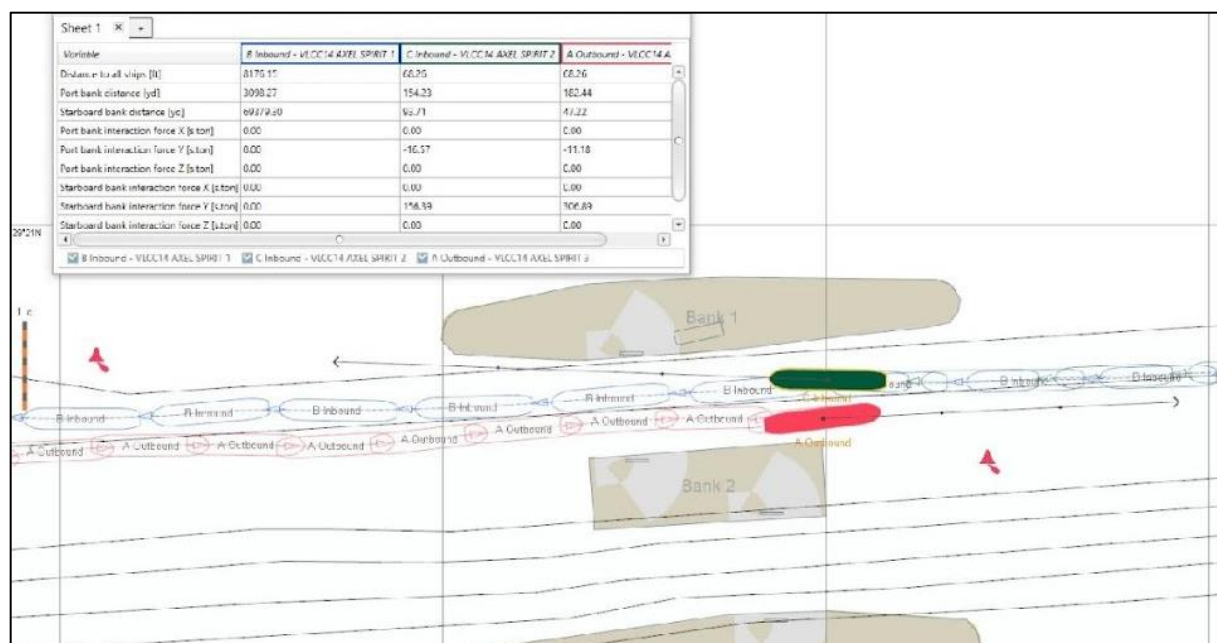
Figure 35. Run #37, Unsafe Meeting Inside of North Gate with Shearing Force Calculations Inbound Ship (Green) 156 tons, Outbound Ship (Red) 307, Skin-to-Skin 65'

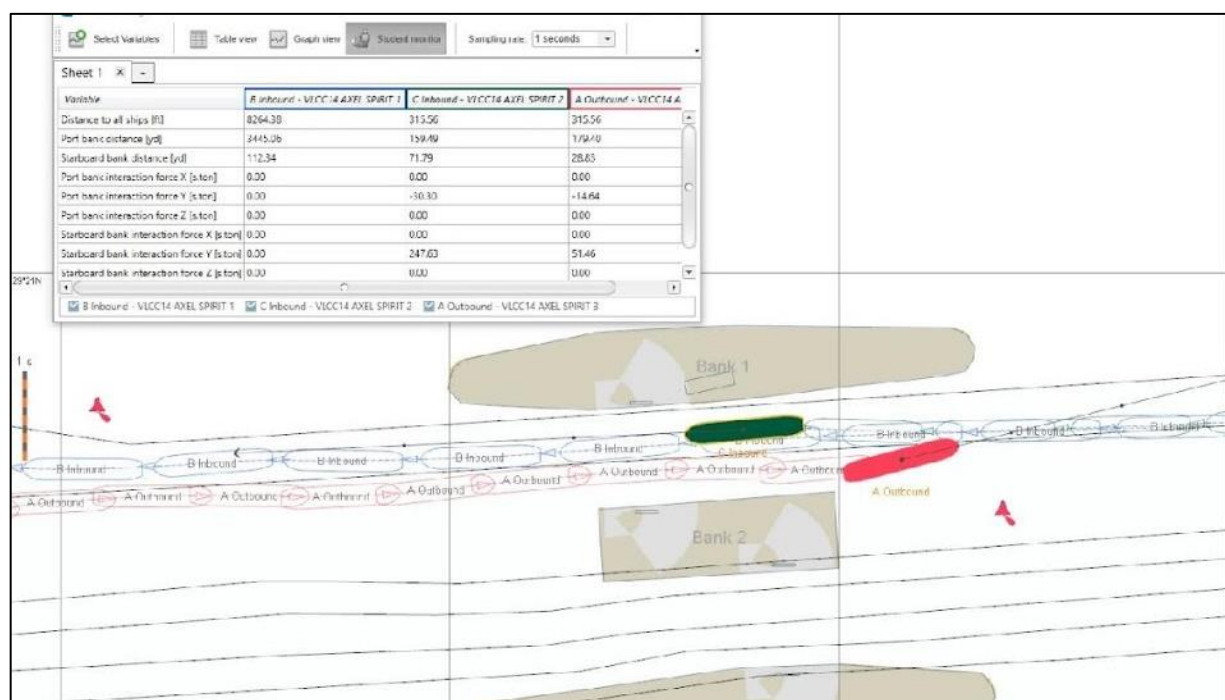
Figure 36. Run #37, Result of Unsafe Meeting in Gate with Shearing Force Calculations, Inbound Ship (Green) 248 tons, Outbound Ship (Red) 51 tons

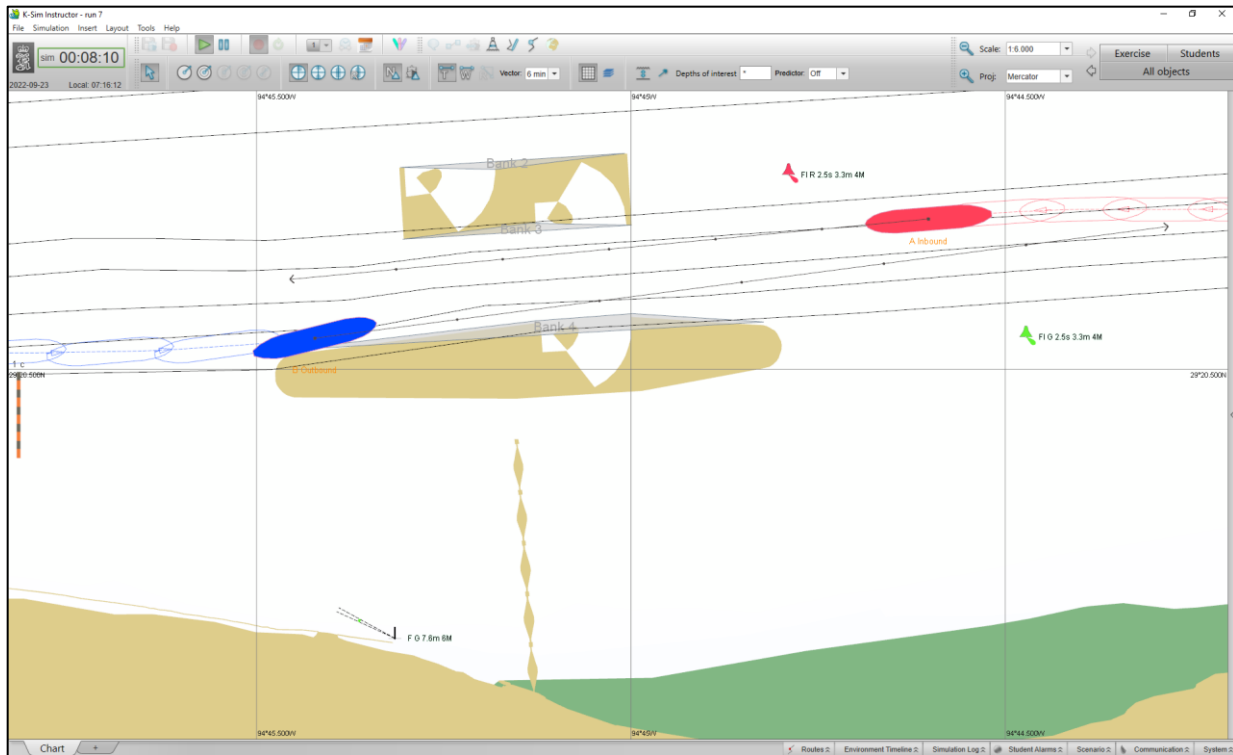
Figure 38. Run #7, Outbound Vessel Alisson with South Gate Island,

During Run #7, GAR Score 3 High Concern, the pilot was unable to successfully complete the turn outbound at buoys 18 and 16 from HSC in a 2.5 knot ebb current. This occurred using an Aframax-class tanker, which was the smallest test vessel. This simulation demonstrates that the distance from buoy #18 to the gate complex is foreshortened and needs to be extended. The ebb current (2.5 knots) further extends the turn requirements for vessels. Therefore, the gate complex is sited too far to the west in the Bolivar Roads, it needs to be sited further east and away from the turn at buoys 18 and 16 in the HSC.
