**Ship Simulation Transit Scenario Modeling & Ship Pilot Study of the
Maritime Implications for Commercial Ship Transits of the Proposed
Houston Ship Channel Gate Complex**

Prepared for:
Greater Houston Port Bureau

Report Version 7.2, 11/30/2022

George B. Burkley MSc, Dennis Webb, P.E.
and Jonathan J. Pierce, Ph.D., Alaska Safeguard Marine LLC

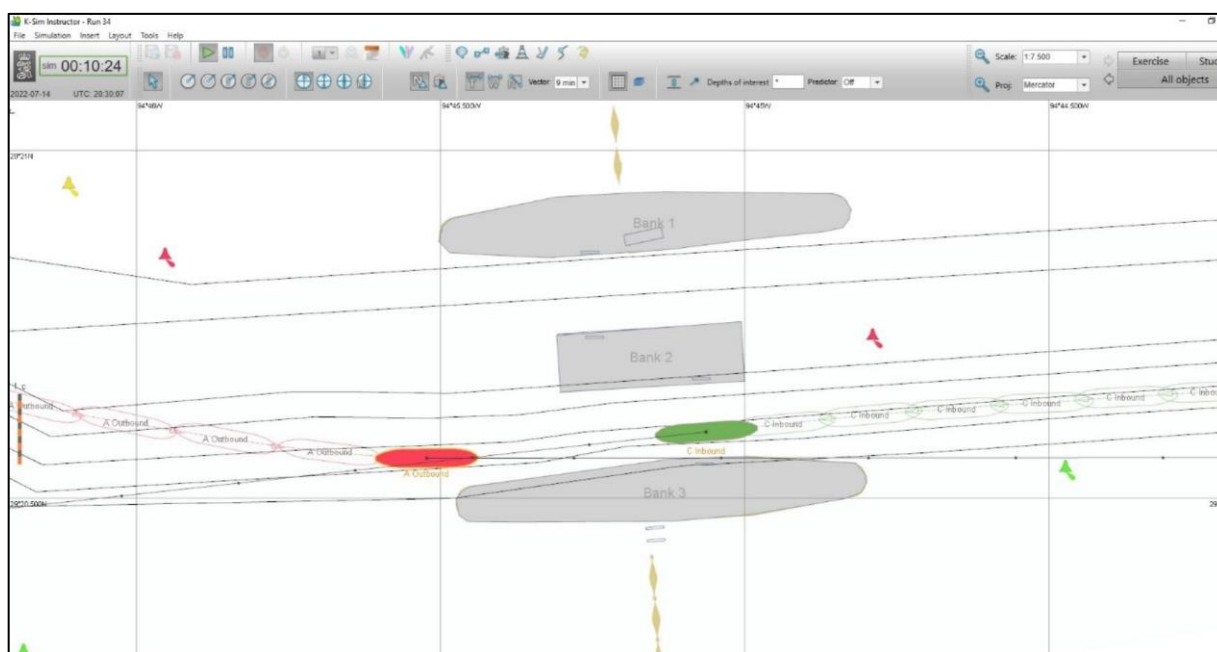
Figure 40. Run #34, Emergency Head-on Situation in the South Gate

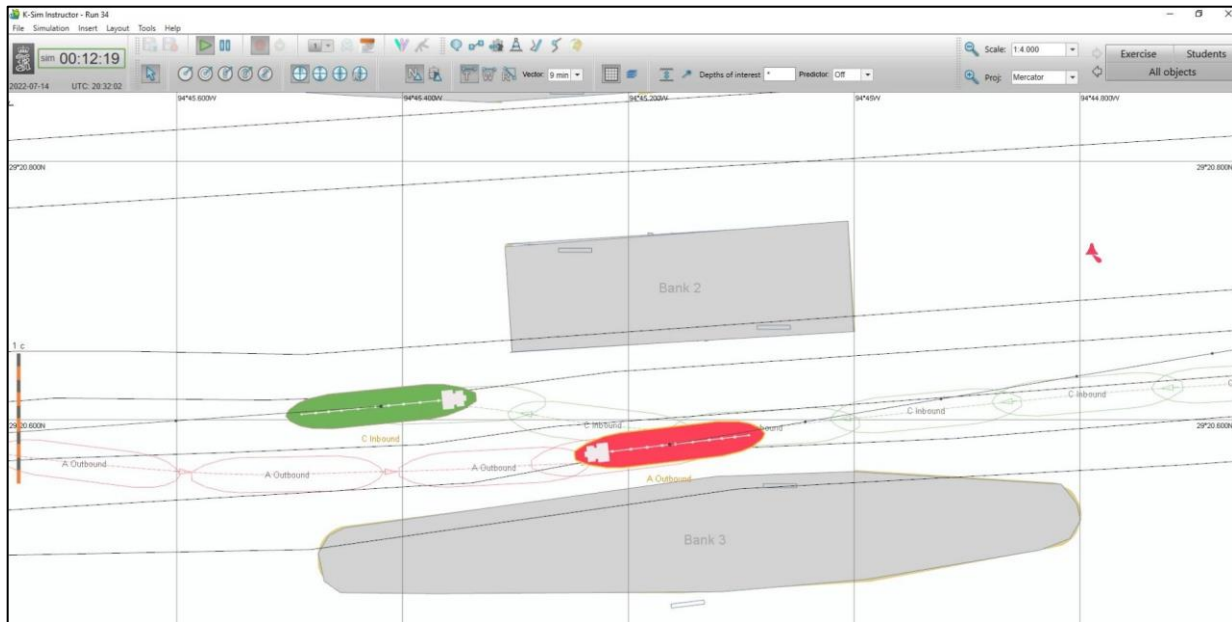
Figure 41. Run #34, Emergency Head-on Situation in the South Gate, Skin-to-Skin was 2'

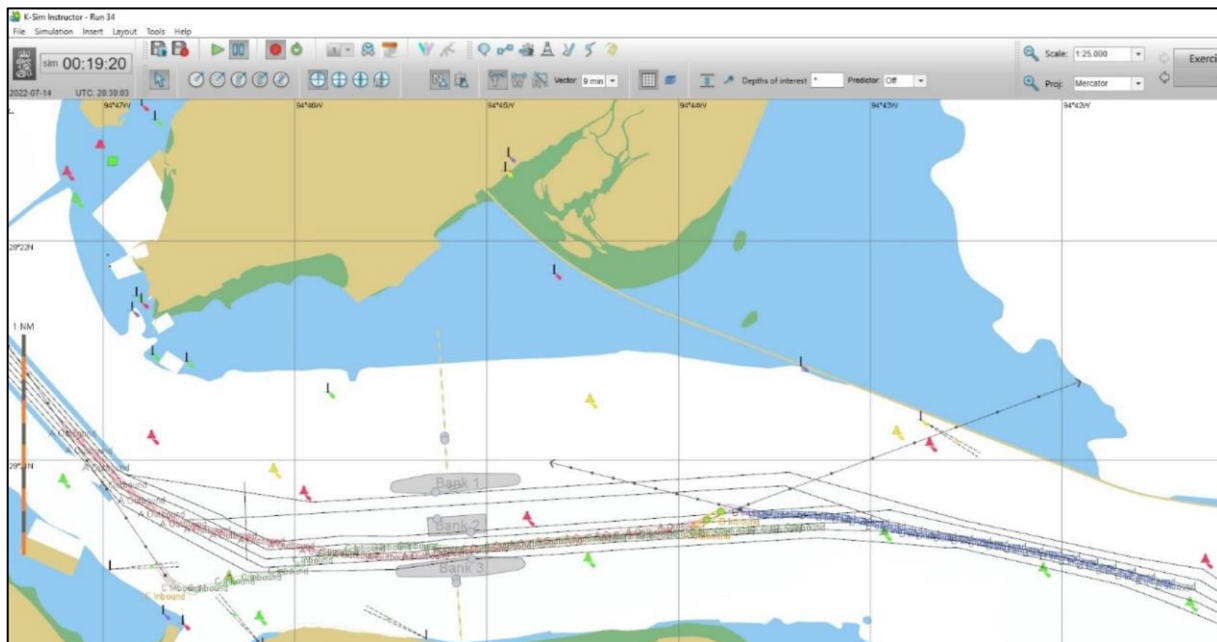
Figure 42. Run #34, End of Scenario, Outbound and Second Inbound Ship had Collision

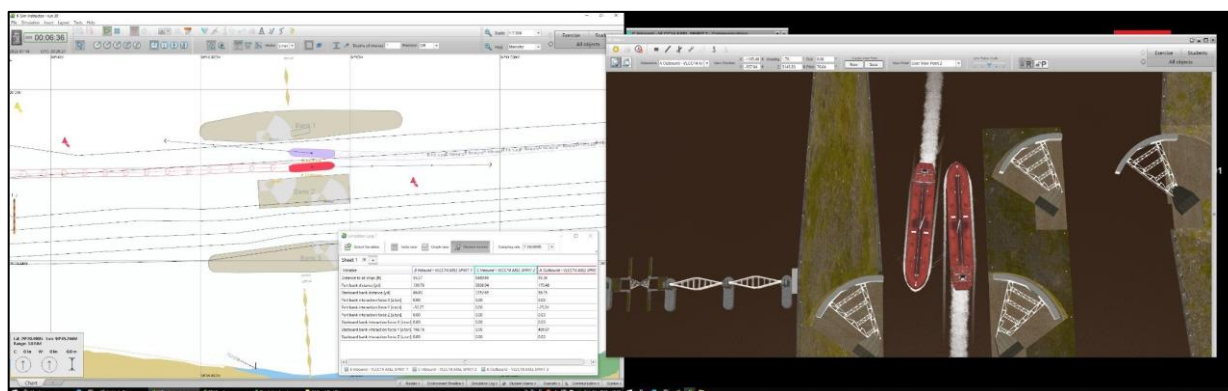
Figure 44. Run #39, Unsafe Meeting Between Outbound and Inbound Ships in North Gate with Overhead Visual View, Skin-to-Skin 55'

Run #39, GAR score 3 High Concern, had two Aframax-class tank vessel models meet in the north gate complex. The result was a near miss between the ships. The outbound ship experienced shearing forces and was out of position to meet the second inbound ship. After this transit scenario the pilots made multiple recommendations that there should not be any ship meetings within 2 miles of the gates during clear daylight conditions; that there should never be ship meetings inside of the gate complex; and the USCG should establish safety zones in and around the gate complex preventing non-piloted boat and ship traffic from meeting piloted commercial ships. Additionally, the pilots want to research the forces using man model simulation.

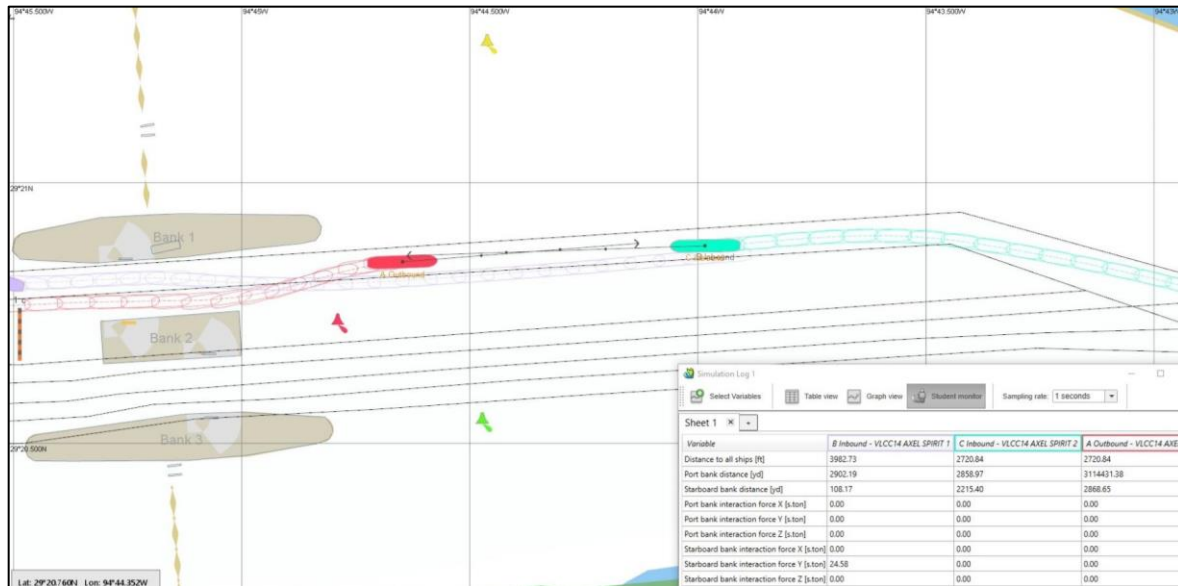
Figure 45. Run #39, Outbound Vessel Shears off Gate Wall towards Inbound Ship

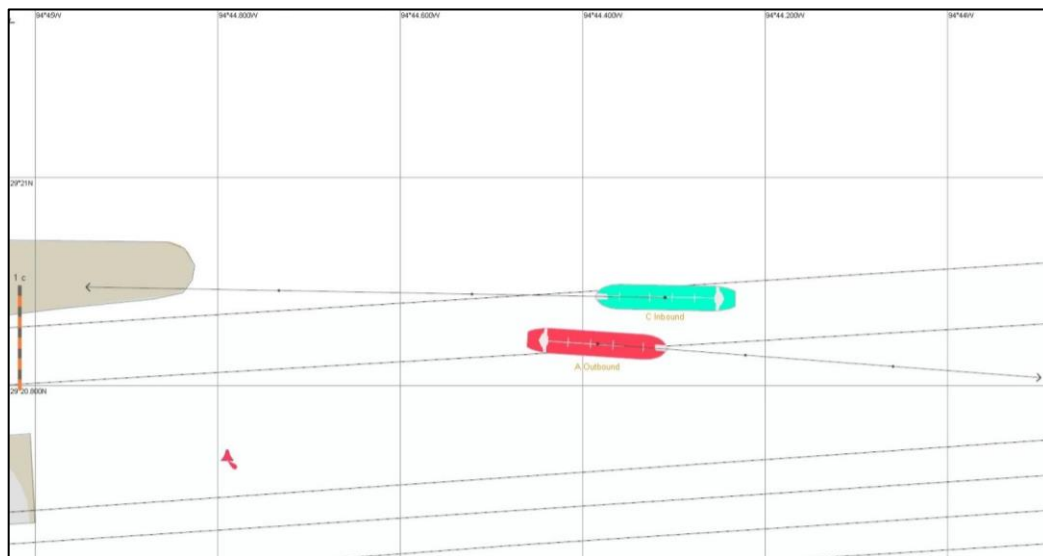
Figure 46. Run #39, Unsafe Meeting Between Outbound Ship Shearing off Gate Wall towards Inbound Ship, Skin-to-Skin 128'

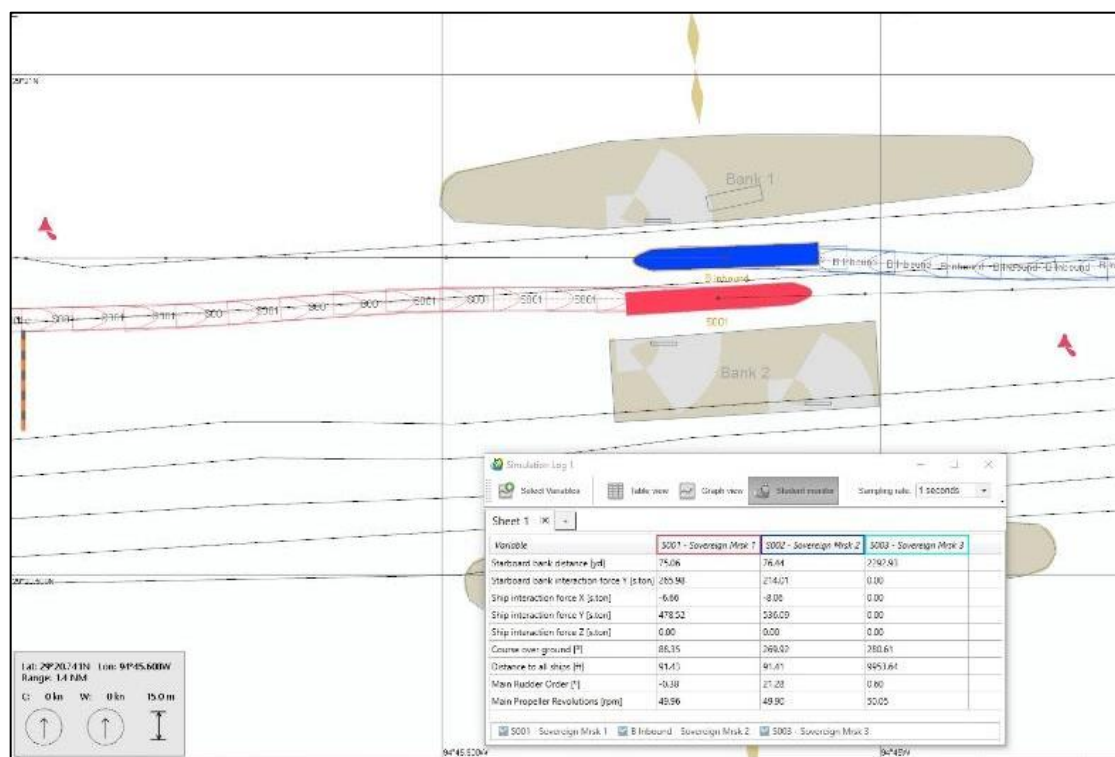
Figure 48. Run #40, Unsafe Meeting Between Container Ships in North Gate, Skin-to-Skin 90'

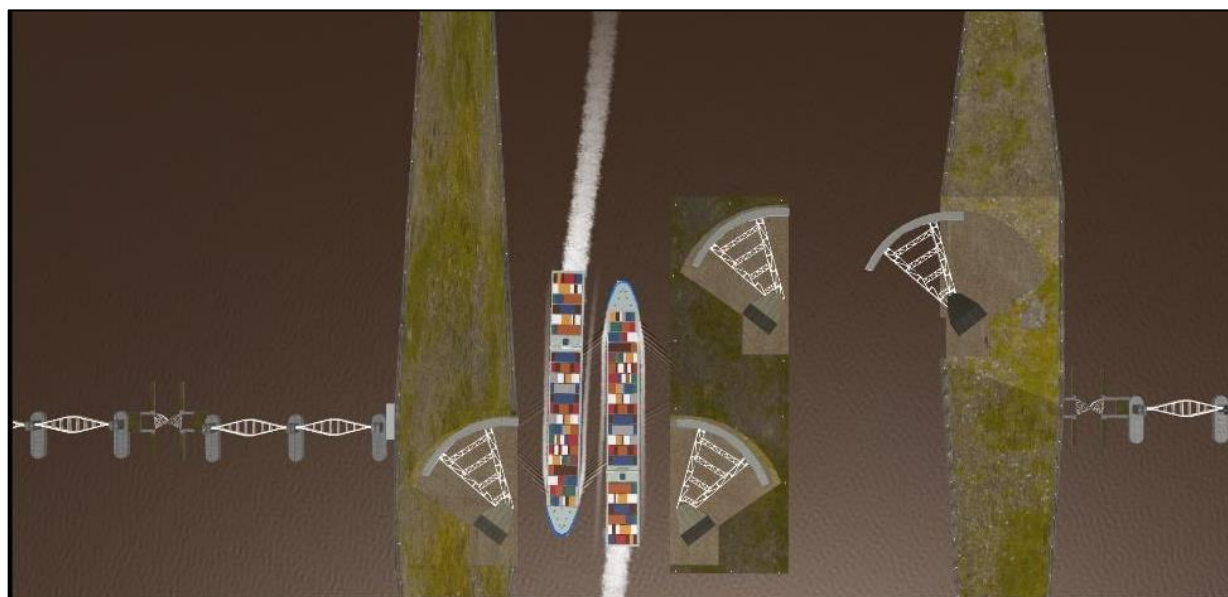
Figure 49. Run #40, Unsafe Meeting in North Gate, Overhead View, Skin-to-Skin 90'

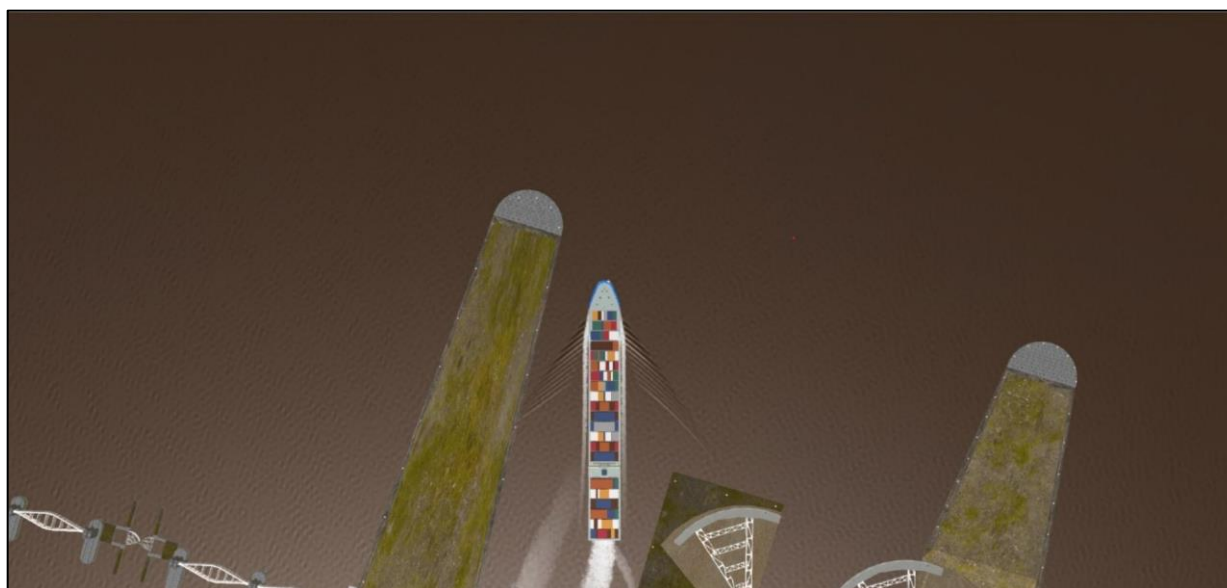
Figure 50. Run #40, Containership Shearing Out of Control after Meeting Outbound Ship in North Gate, Overhead View

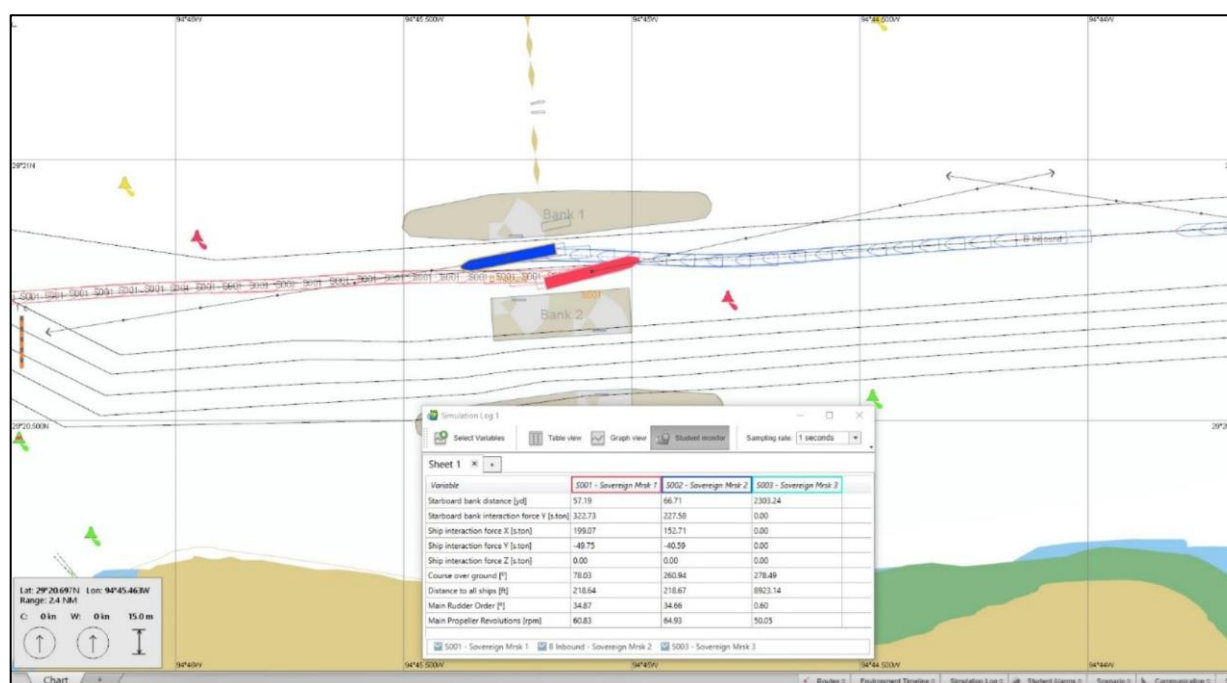
Figure 51. Run #40, Containerships Shearing Out of Control Along Gate Walls, Outbound (Red Ship) 322 tons Shearing Forces, Inbound (Blue Ship) 227 tons Shearing Forces

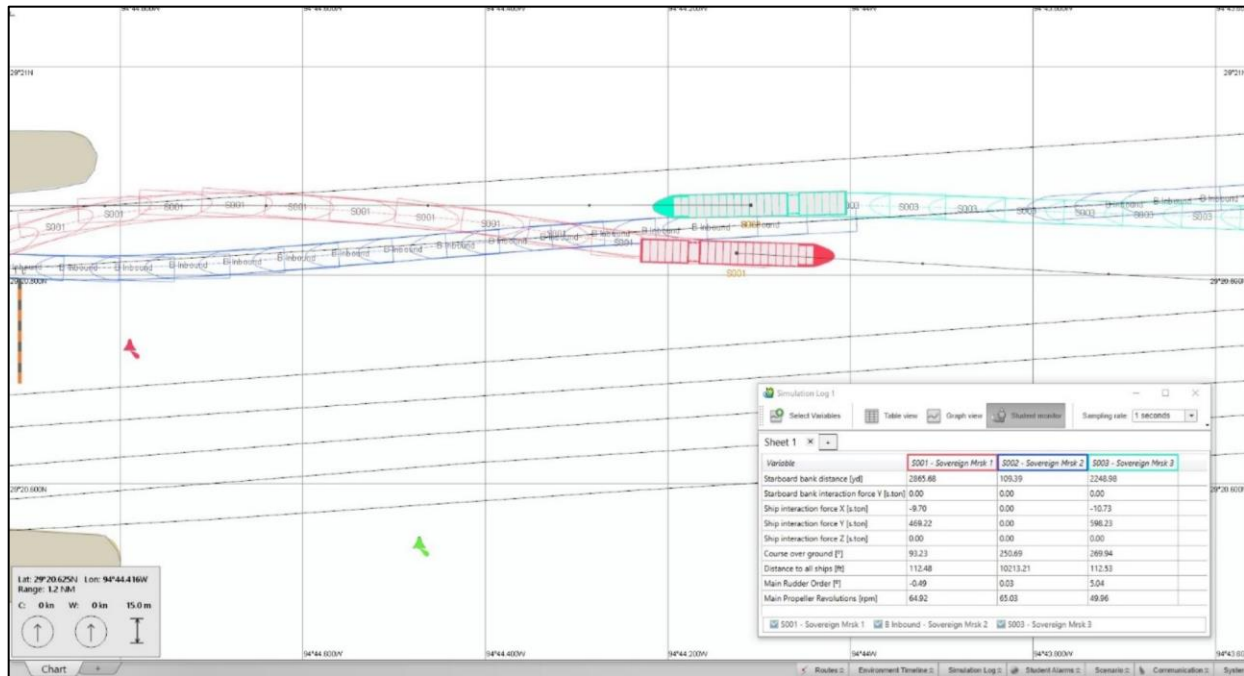
Figure 52. Run #40, Containerships in Emergency Maneuvers After Gate Shearing Event, Skin-to-Skin 112'
