# **Flexible Pavement Committee**

## **Asphalt Research Update**

# FDOT Research Avenues

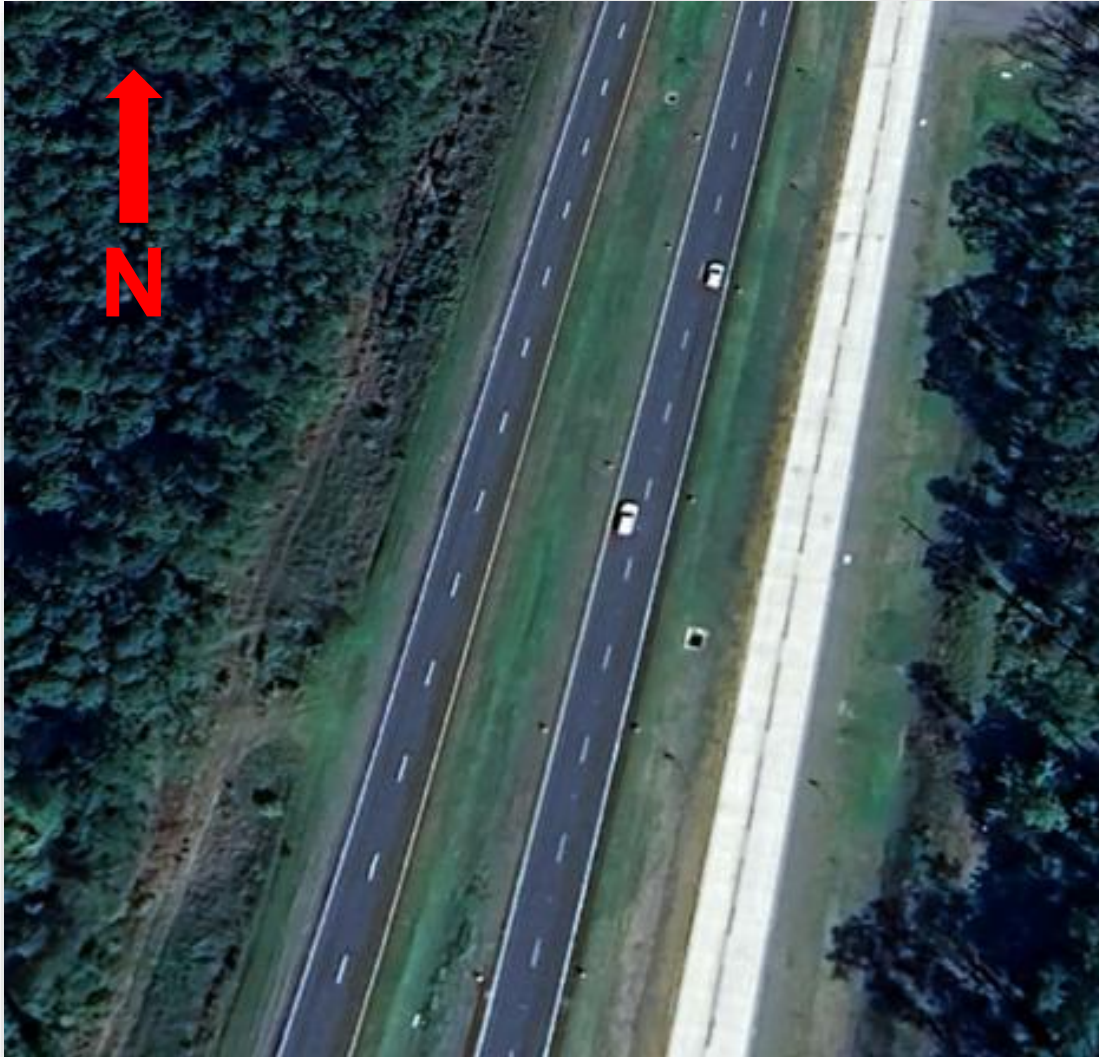
- Southbound travel lanes:
  - Asphalt Test Road
- Northbound travel lanes:
  - Concrete Test Road
- Middle lanes:
  - Diversion Lanes

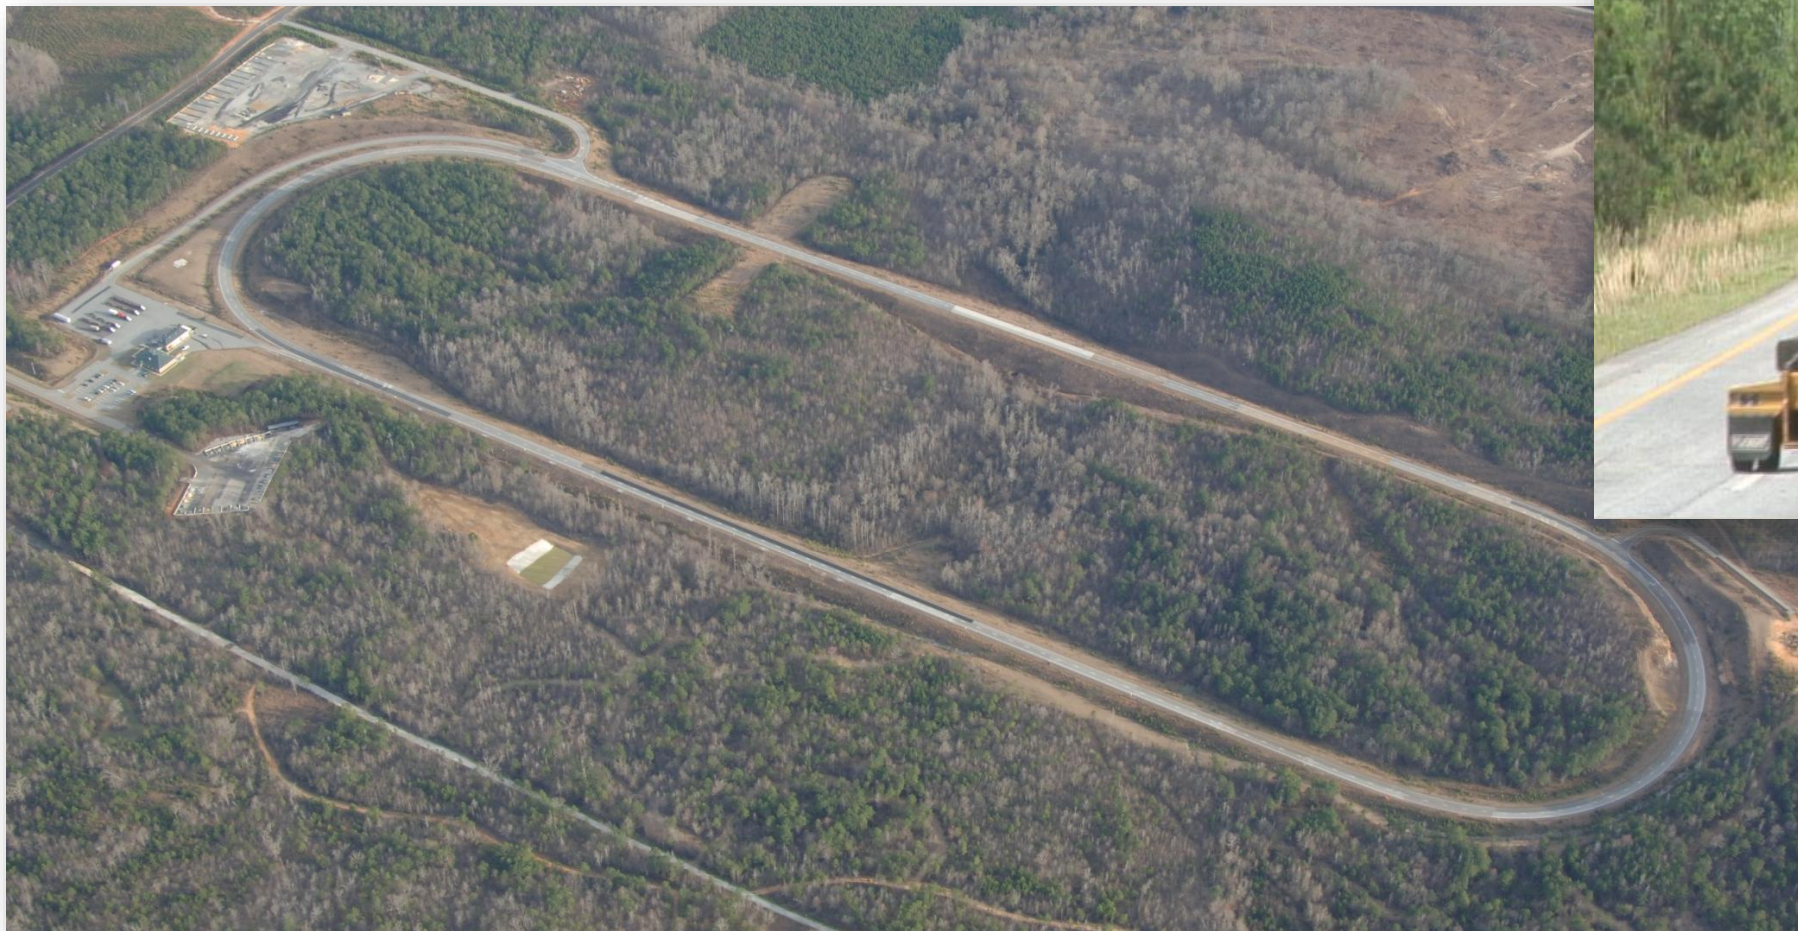
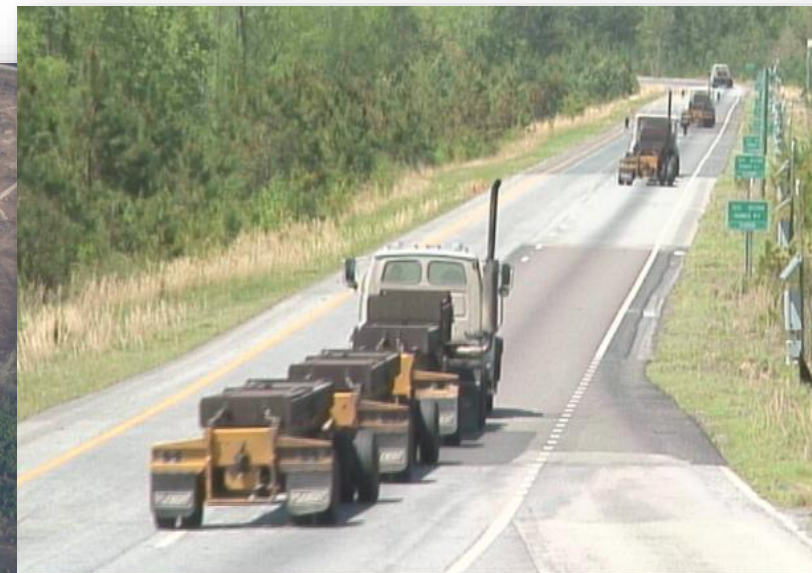
- Auburn, AL
- 5 trucks
- 46 test sections
- 5 million ESALs /year

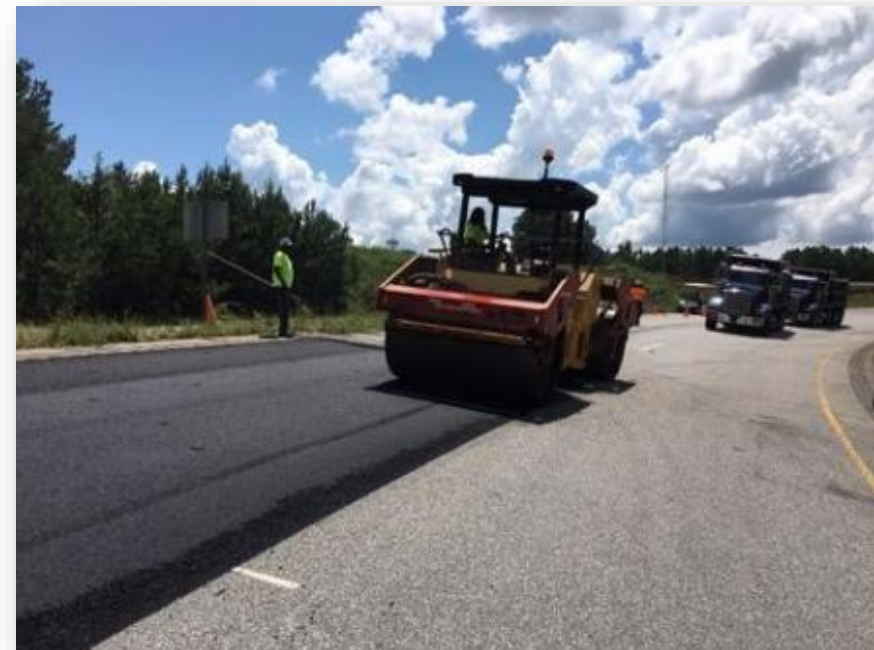
| Section | In-Place Density, % of Gmm | |
| | As-Constructed | Dec. 2025<br>23+ MESALs |
| | Average | |
| E5A | 93.6 | 96.3 |
| E5B | 92.0 | 94.6 |
| E6B | 89.7 | 92.0 |
| E6A | 87.8 | 93.2 |

- Low in-situ density has a negative impact on cracking resistance
- Binders from the sections with lower in-place densities have aged more as indicated by most recovered binder properties
- The binder in the upper  $\frac{3}{4}$ " has aged much more than the next  $\frac{3}{4}$ " for the well-compacted test sections.

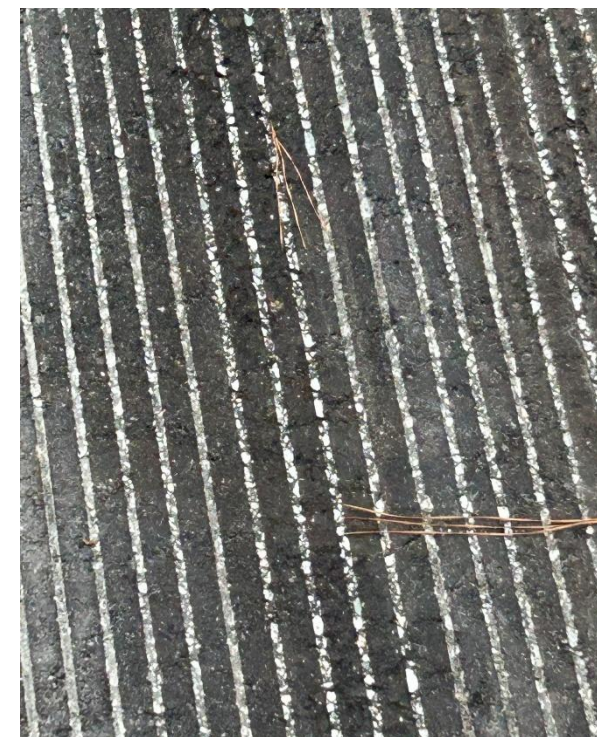
- **Grooving pattern #1:**  $\frac{3}{4}$ " (19 mm) spacing,  $\frac{1}{8}$ " (3 mm) width,  $\frac{1}{8}$ " (3 mm) depth
- **Grooving pattern #2:**  $\frac{3}{4}$ " (19 mm) spacing,  $\frac{1}{8}$ " (3 mm),  $\frac{1}{4}$ " (6 mm) depth

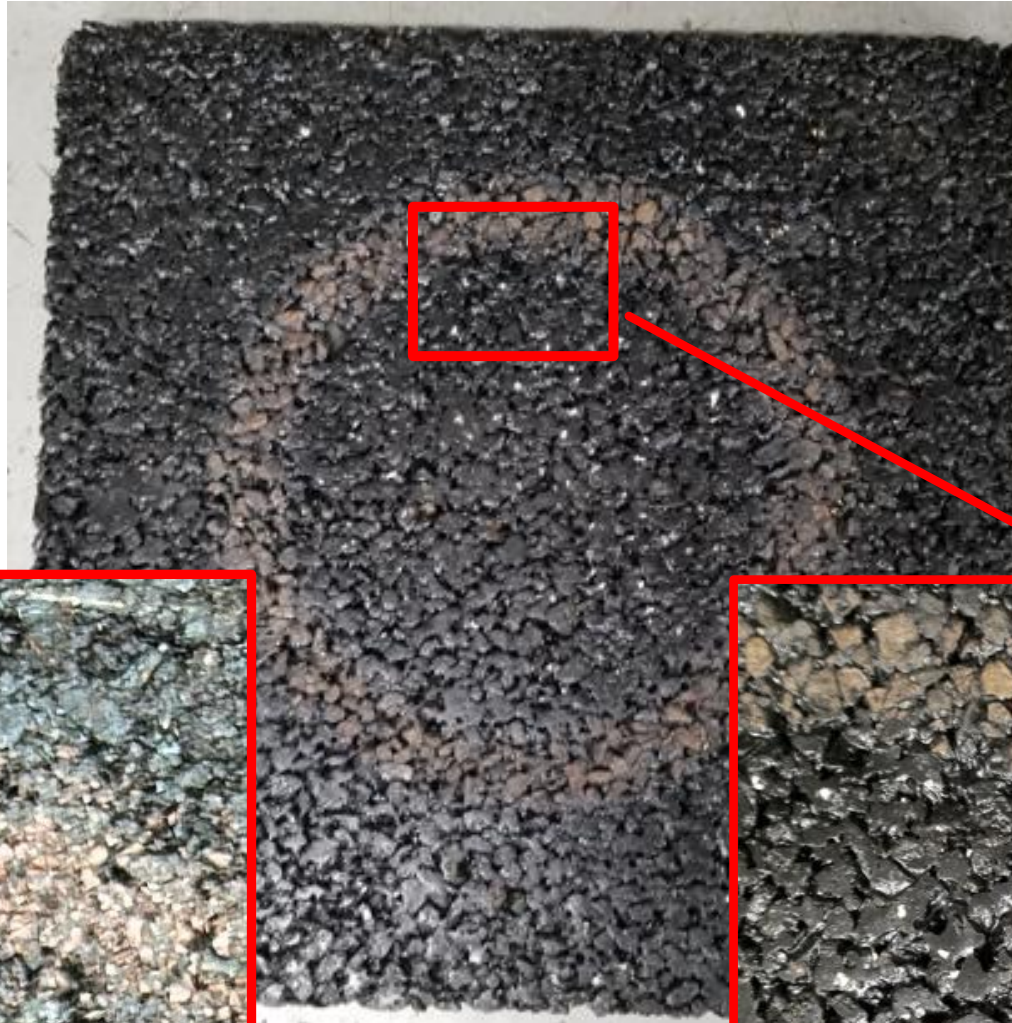
**High Friction Number (FN)**
