# Rio Grande Gorge Bridge

- Designed : In-house
- Constructed : 1964 to 1965 (about 60 years old). Cost = \$2,153,000
- Continuous Steel Deck Truss (300', 600', 300"). Rio Grande Gorge - 650' deep and 1200' wide.
- Combination of built-up steel box members and rolled I beams
- T1-Steel
  - High strength steel – AASHTO M244 Grade 100
  - Welded joints in tension susceptible to cracking due to hydrogen contamination / hydrogen embrittlement

# FHWA Memorandum

# DISCOVERY & DOCUMENTATION OF WELD DISCONTINUITIES

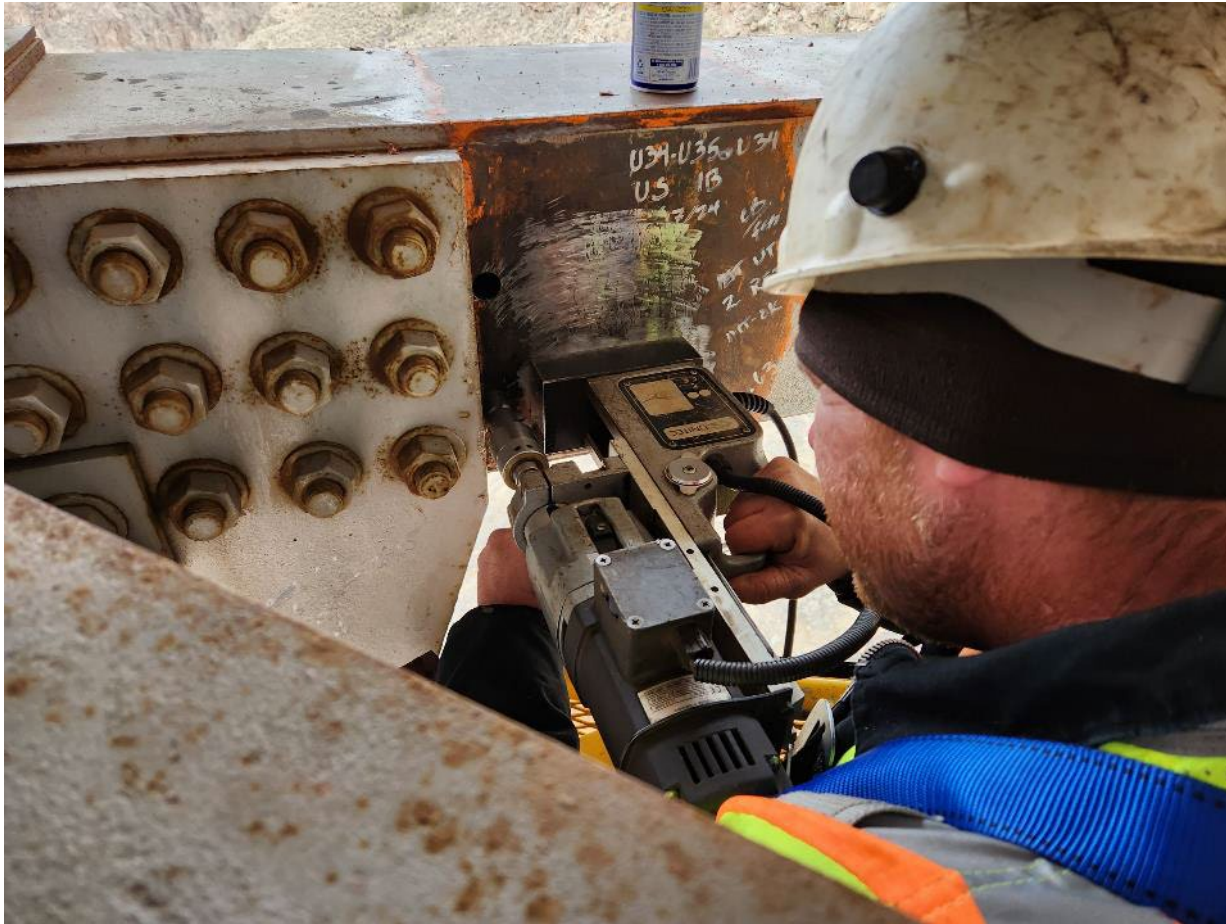
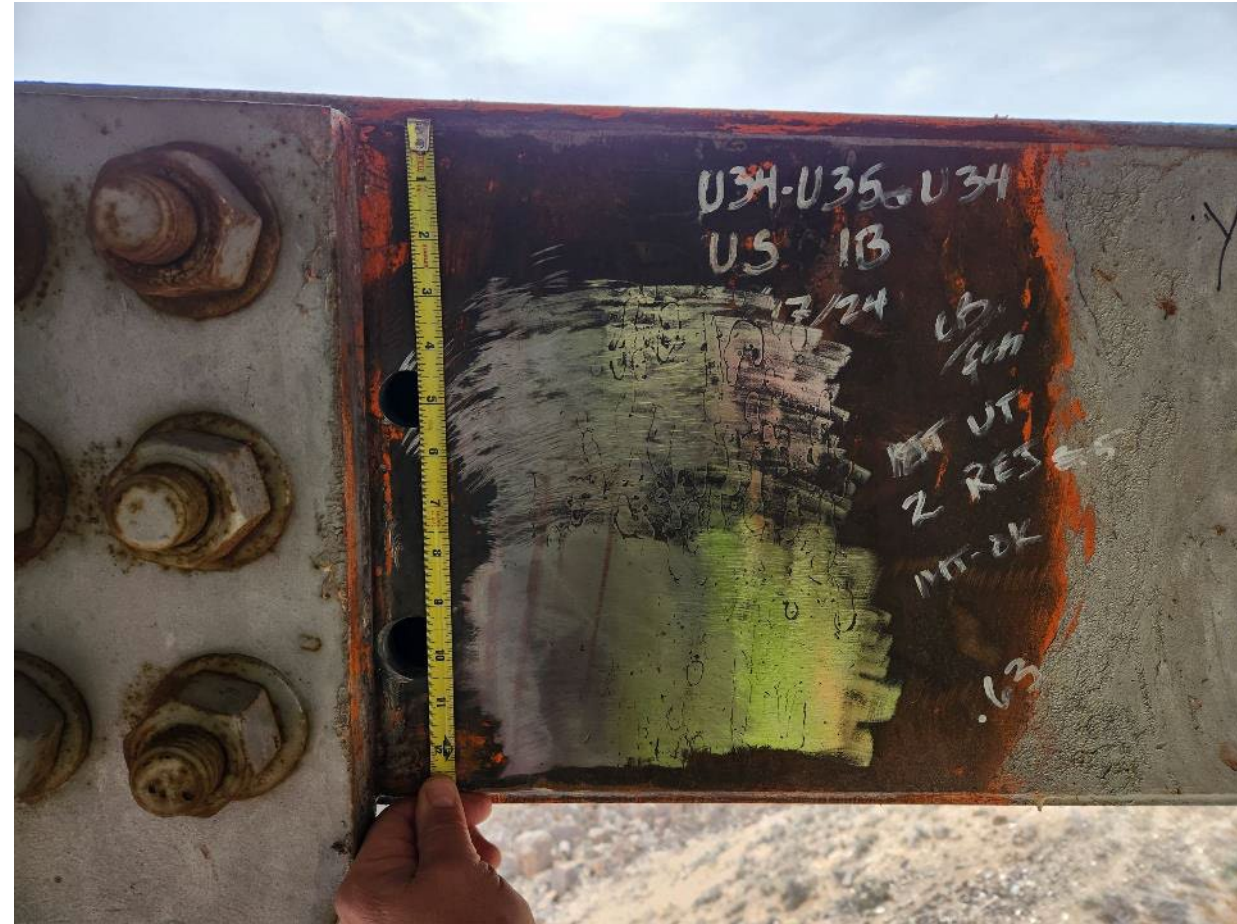
# CORING REPAIRS

- Lack of fusion or slag inclusion
- Varied from 0.5” to 2.25”
- None were found to be crack-like or surface breaking
- None warranted load posting or structure closure

92 T-1 BUTT WELDS IN NSTM INSPECTED AND TESTED  
12 DISCONTINUITIES IDENTIFIED AND REPAIRED  
NO STRUCTURE CLOSURE OR POSTING REQUIRED  
MINIMAL DISRUPTION TO TRAVELING PUBLIC  
COMPLIANT WITH FHWA MEMO
