**PERFORMANCE OF MODIFIED  
ASPHALTS USED ON THE  
NCAT PAVEMENT TEST TRACK**

# ORIGINAL 2000 EXPERIMENT

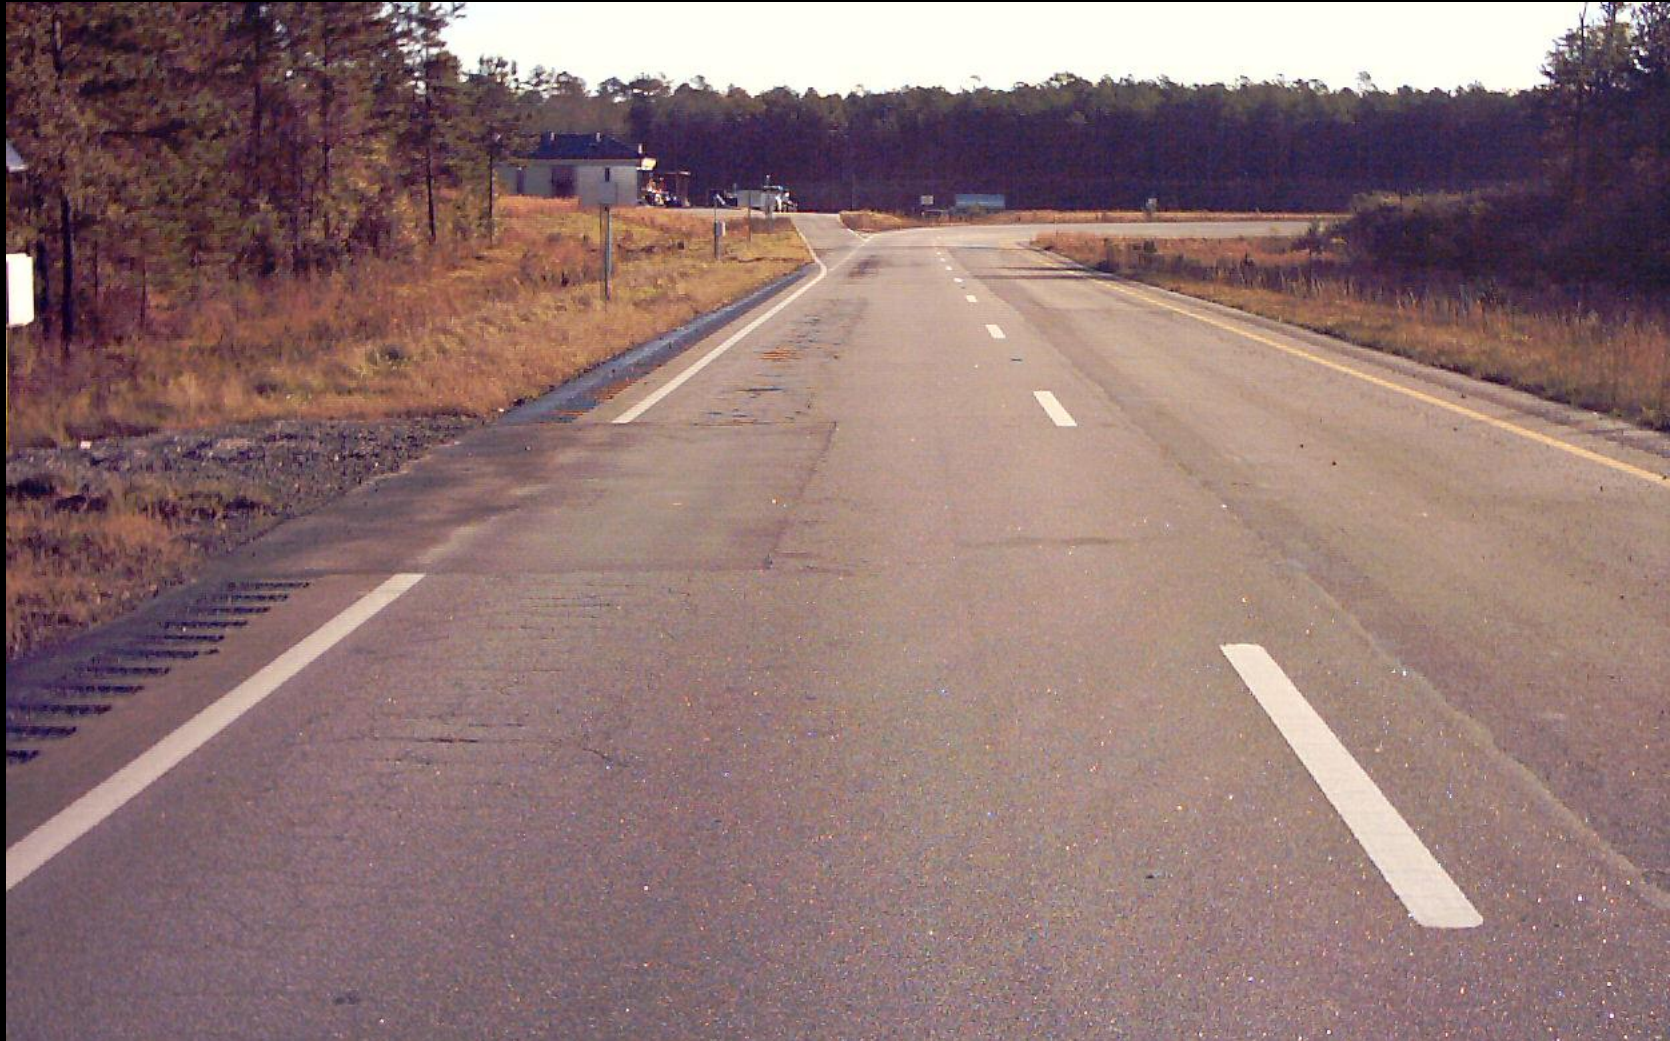
# N2 FATIGUE CRACKING

- Both 5" Sections Failed (Slightly Later than Expected)
- Some Fatigue Cracking in 7" Sections (Much Later)
- No Cracking Observed in Either 9" Section

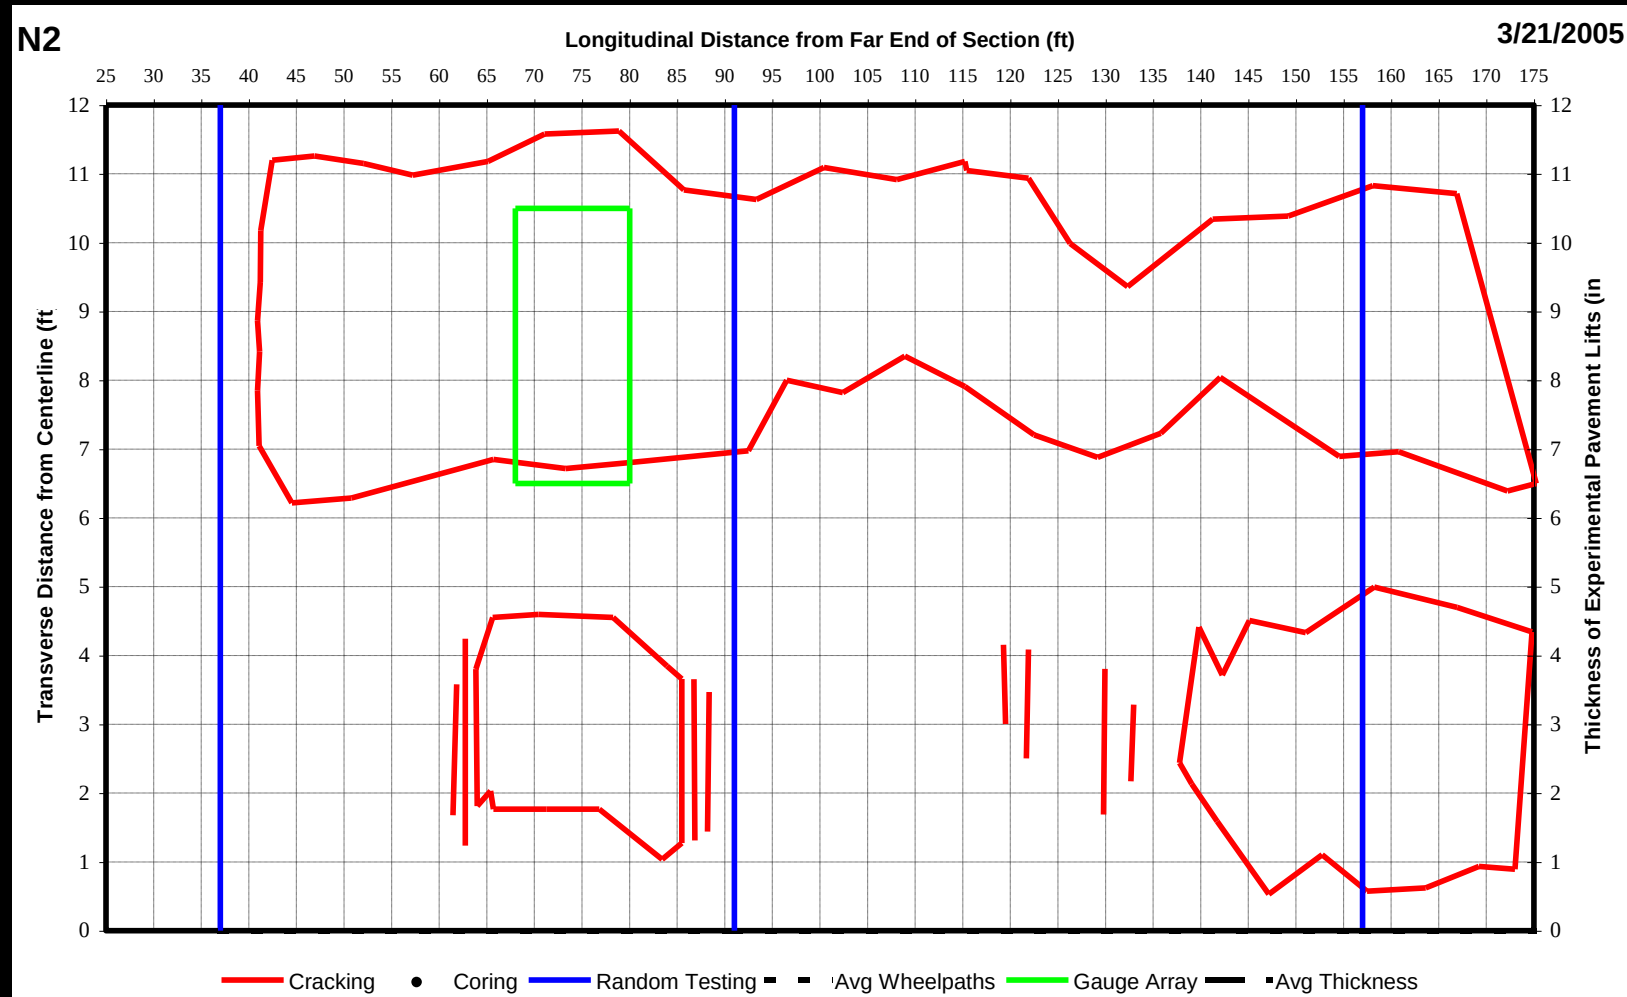
# TERMINAL N2 CRACK MAP

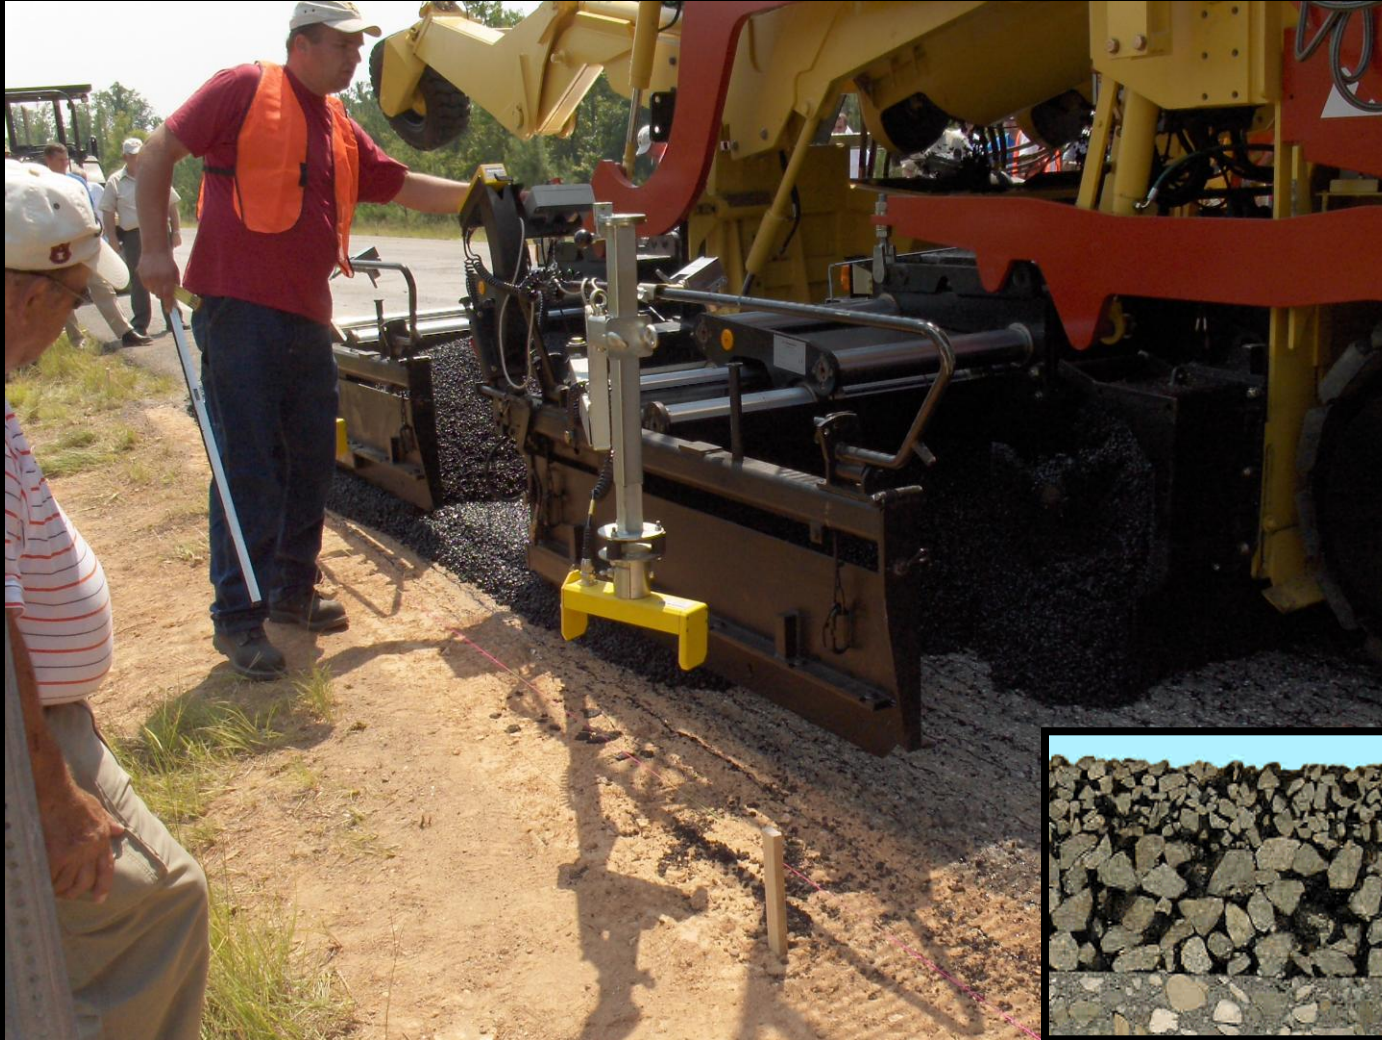
# TWIN LAYER PAVING

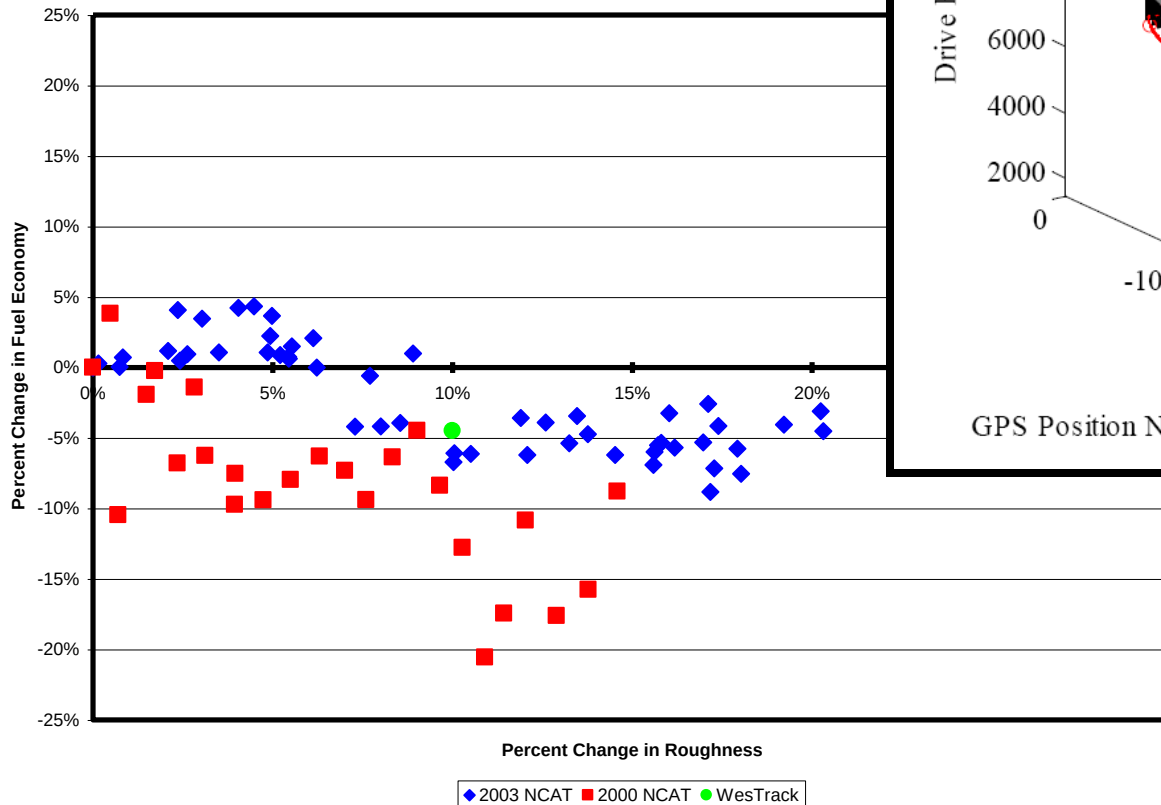
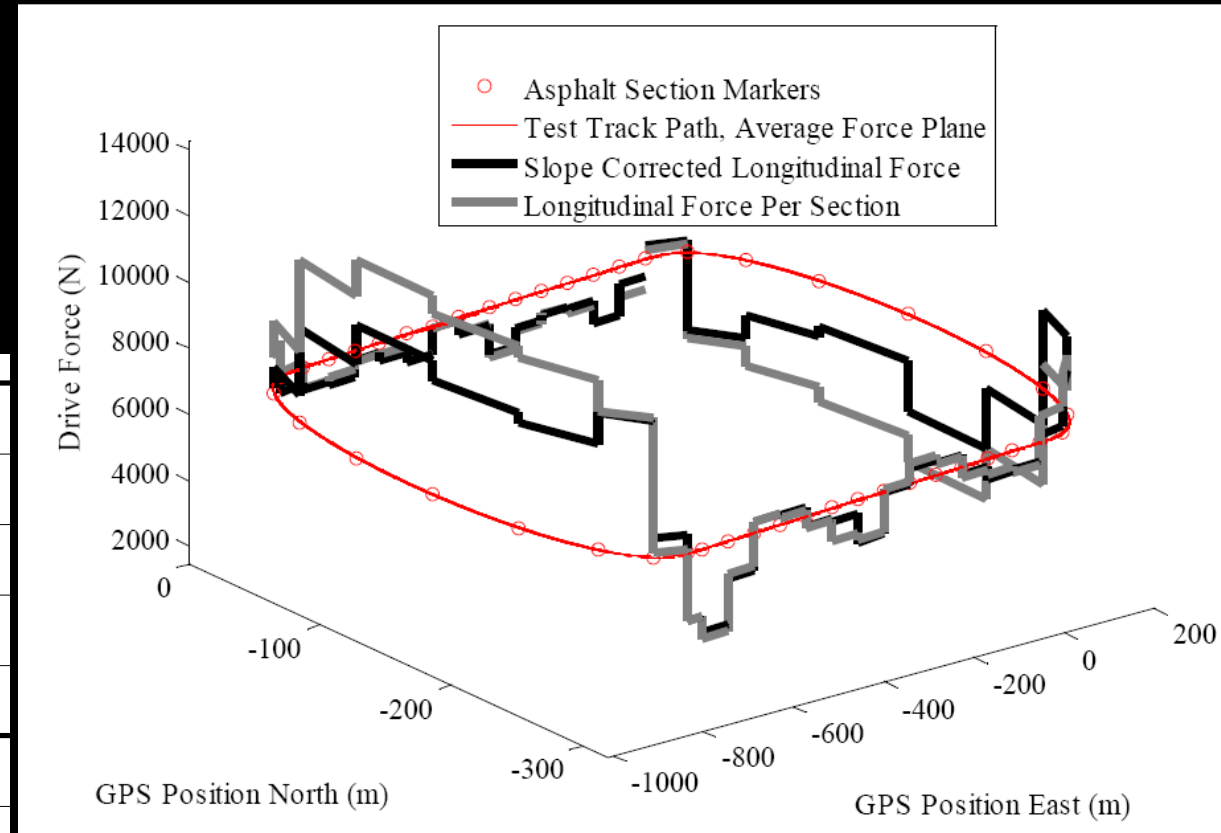
# PAVEMENT ROUGHNESS
