Alaska Department of Transportation & Public Facilities

Alaska's Success Partnering With the PMA Industry

Newton Bingham PE

February 2018

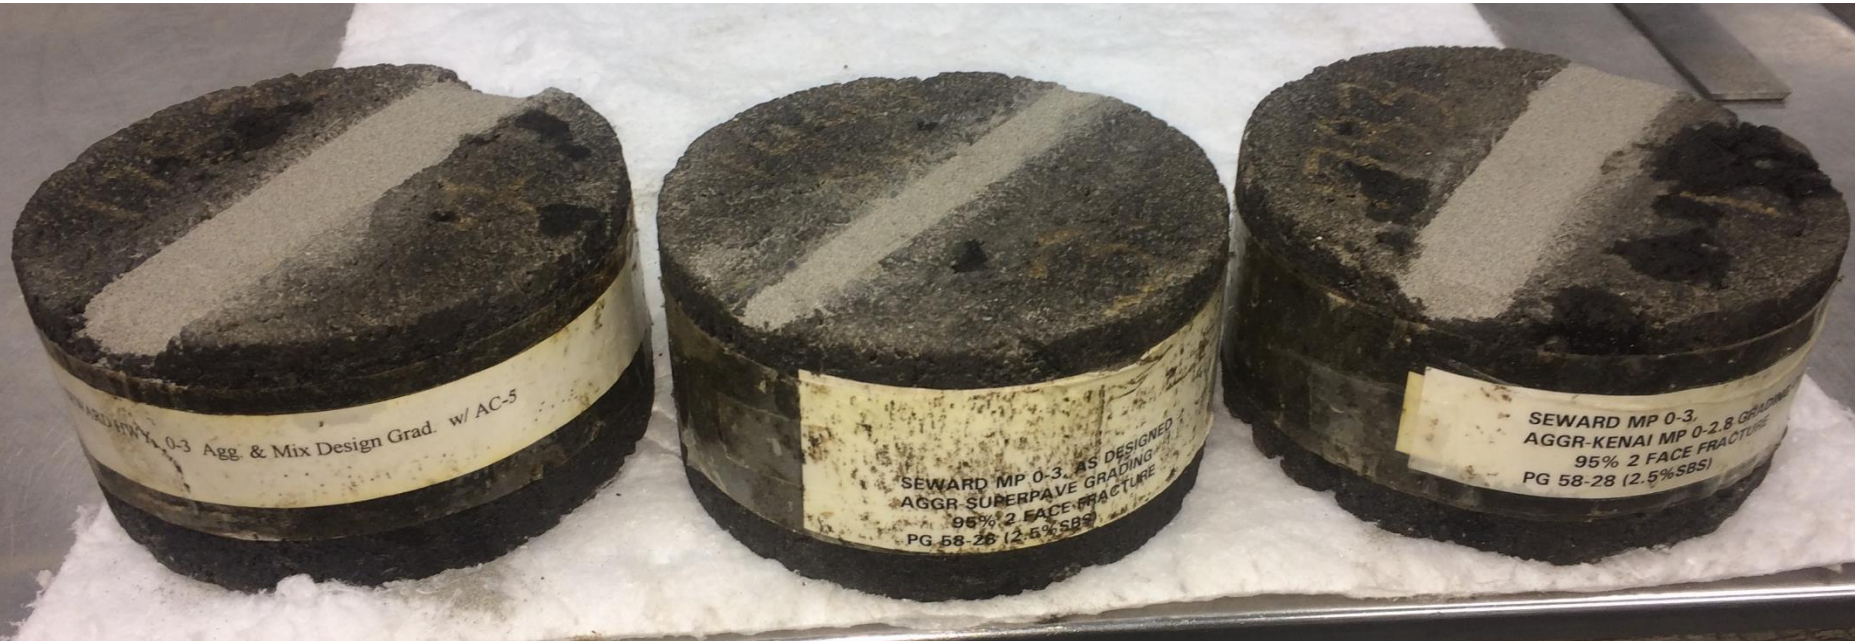
Binder or Aggregate Solution?

Design Aggregate Gradation
Change AC to AC-5 (No SBS)
RUT: 10.3mm

Design: Aggregate Gradation
PG58-28 (2.5% SBS)
RUT: 0.8mm

Different
Aggregate Gradation
PG58-28 (2.5% SBS)
RUT: 7.2mm

Change in Aggregate or Asphalt Binder Can Cause Plastic Deformation

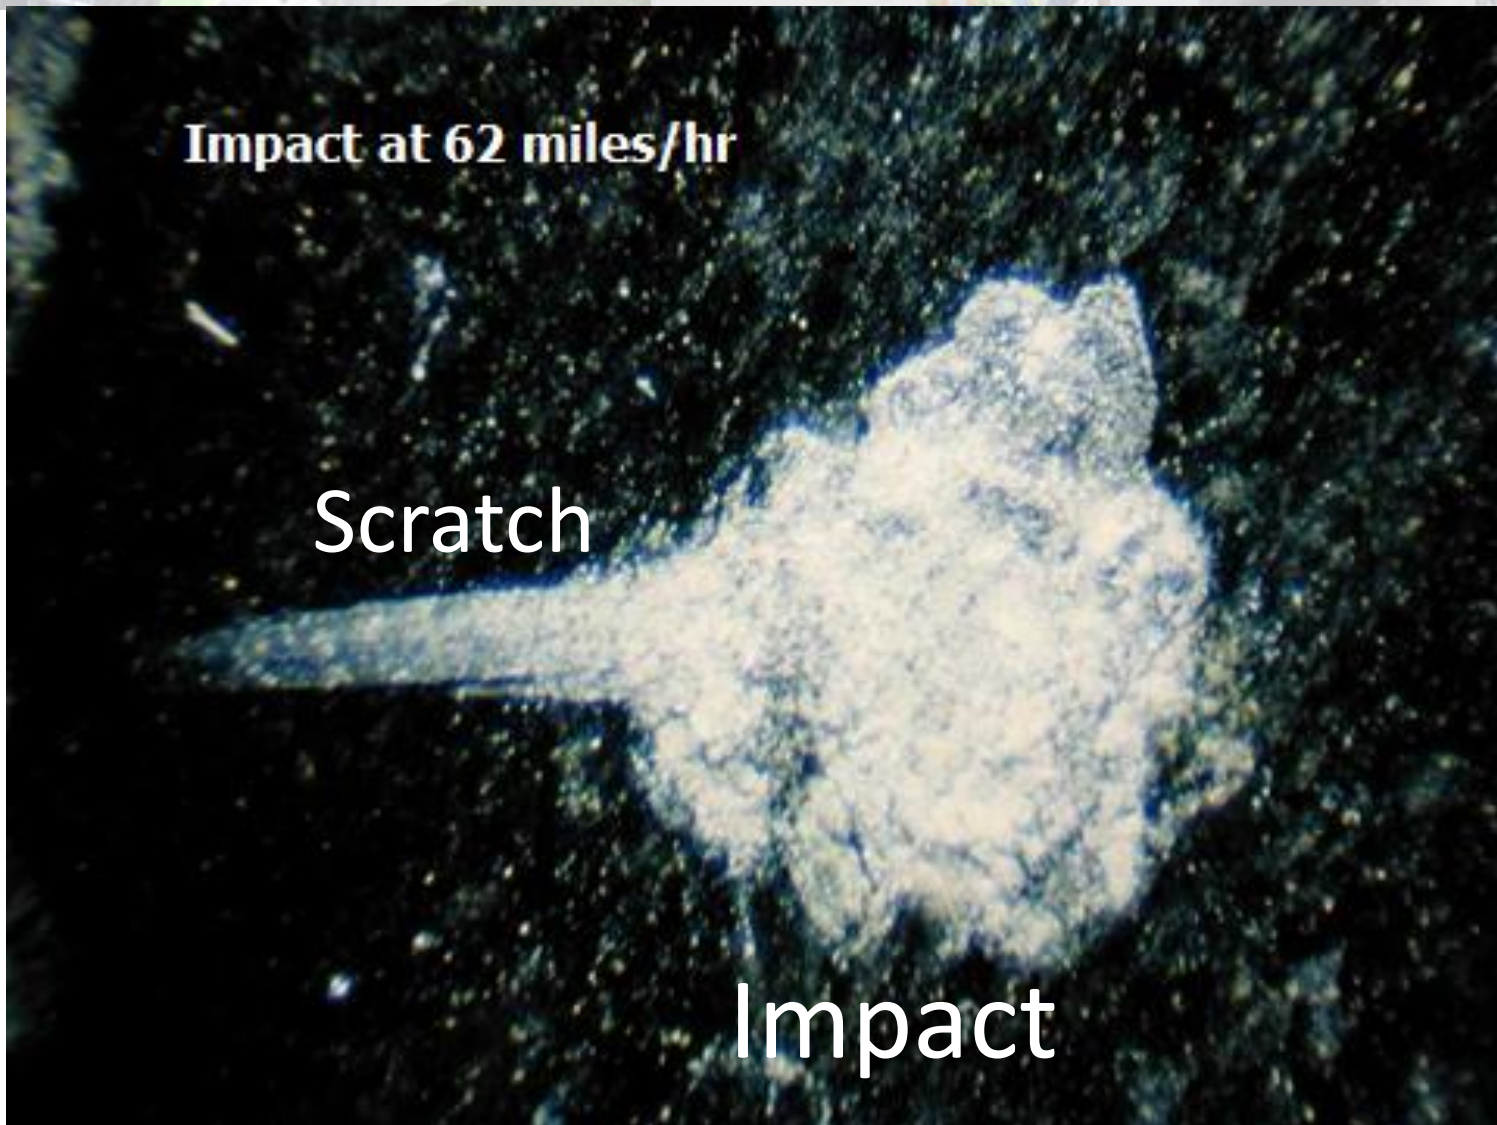
Pavement Marking

Impact at 75 miles/hr

Scratch

Impact

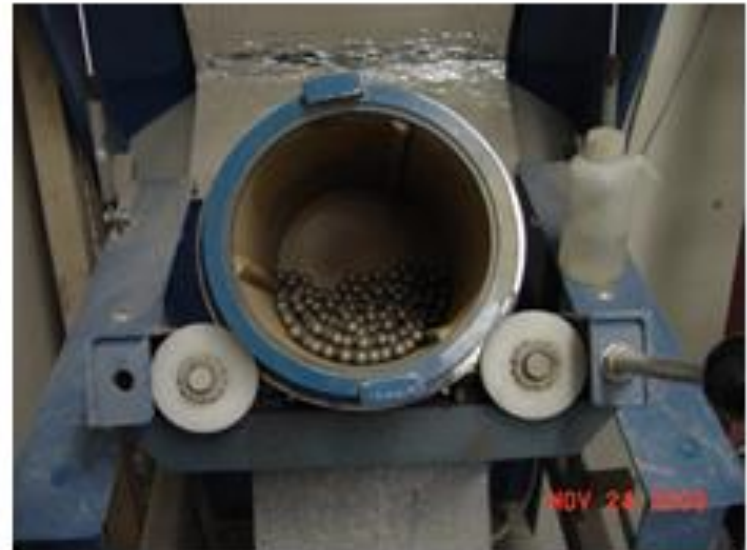
Nordic Ball Mill Test

- Ribbed test chamber
- Wet abrasion test
- 5400 revolutions @ 90 rpm
- 7000 g shot charge, 2000 g sample
- By comparison: Micro Duvall = 1.97 x Nordic Ball Mill

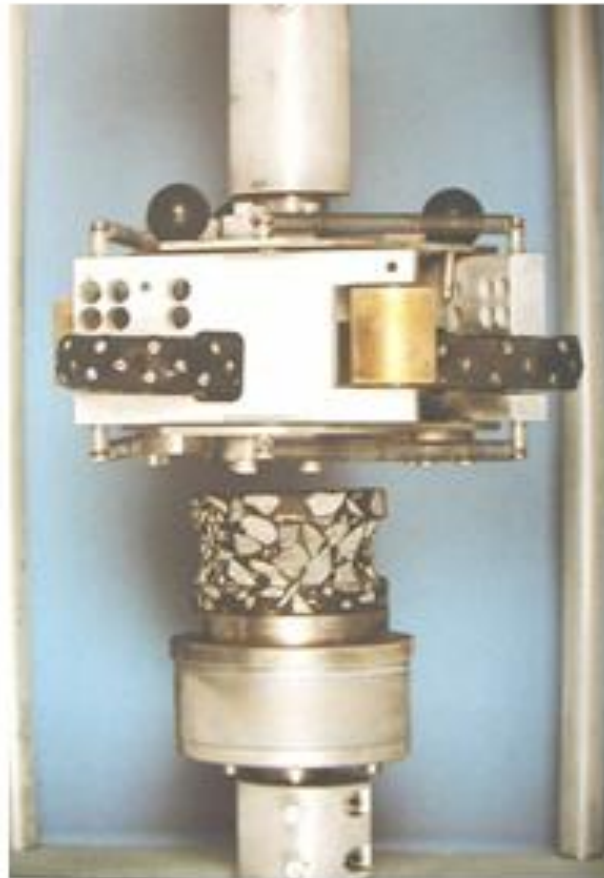
SRK Wear Testing of Pavement

3 studded
tires
wearing the
sides of the
sample

SRK is not as
commonly used
in Europe as the
Prall Test

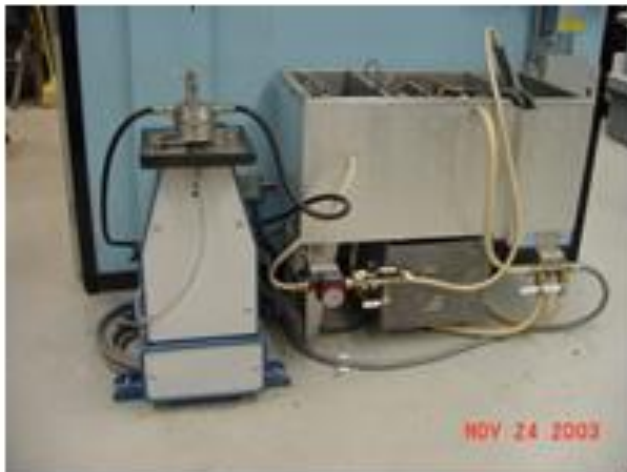
Prall Test

- Core samples conditioned 20hrs @ 5°C
- Impact of 40 steel bearings for 15 minutes @ 950 rpm
- Cooling water (5°C) flows over sample during test
- Results are reported in volume loss (cm³)

Prall Testing Hot Mix To Simulate Studded Tire Wear

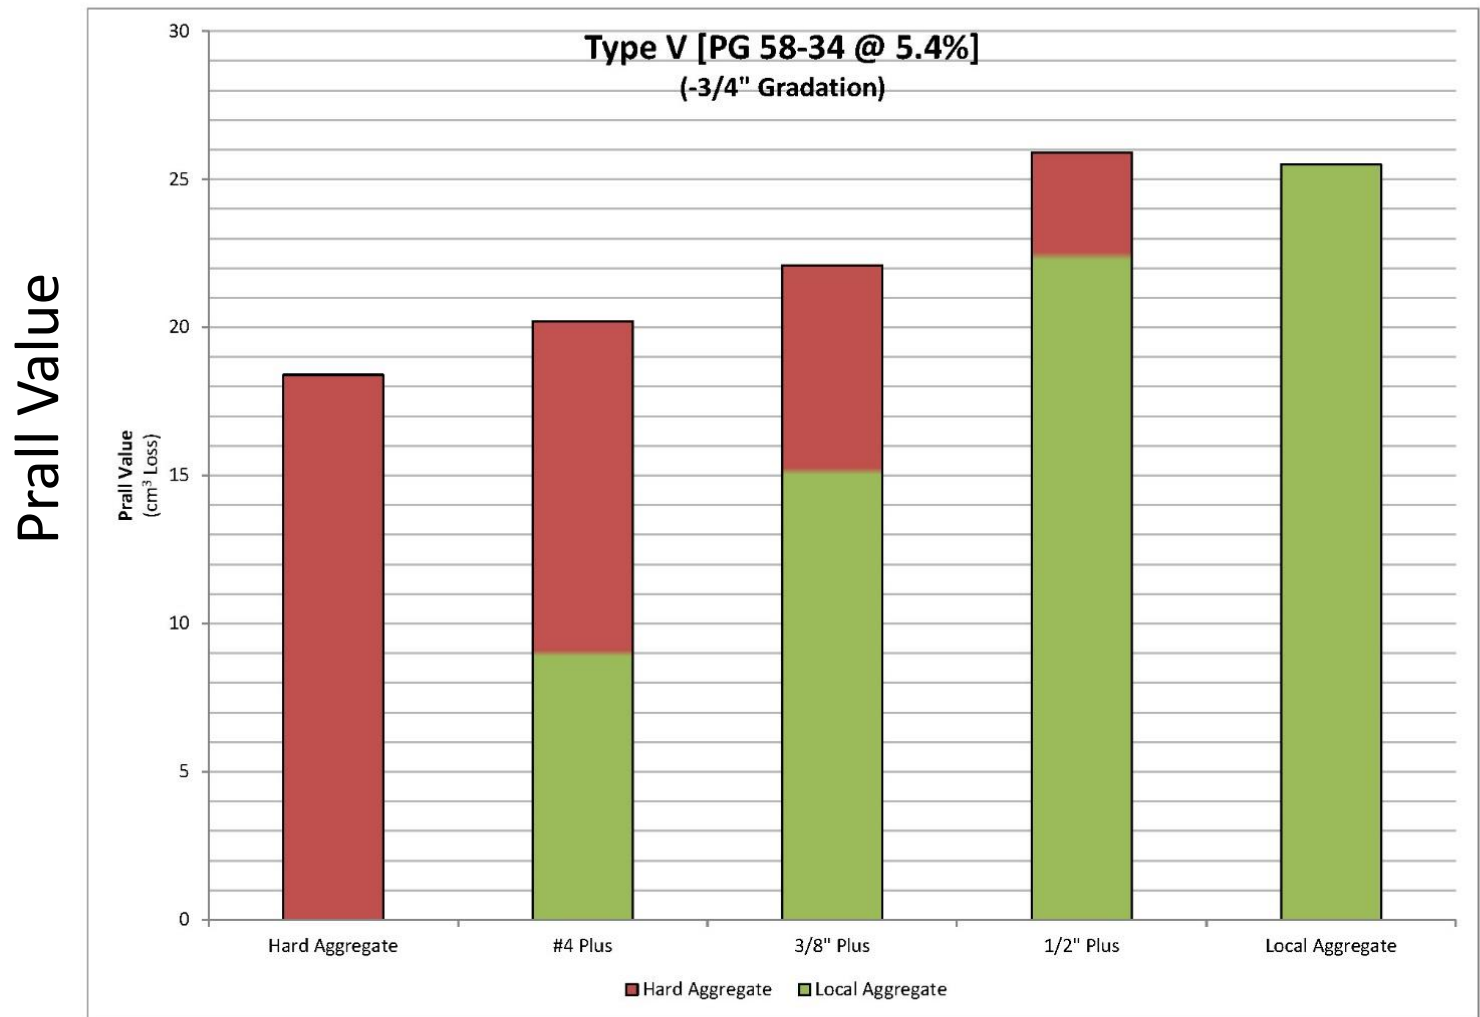
% Hard Aggregate vs Prall

Hard Aggregate has Nordic value < 8

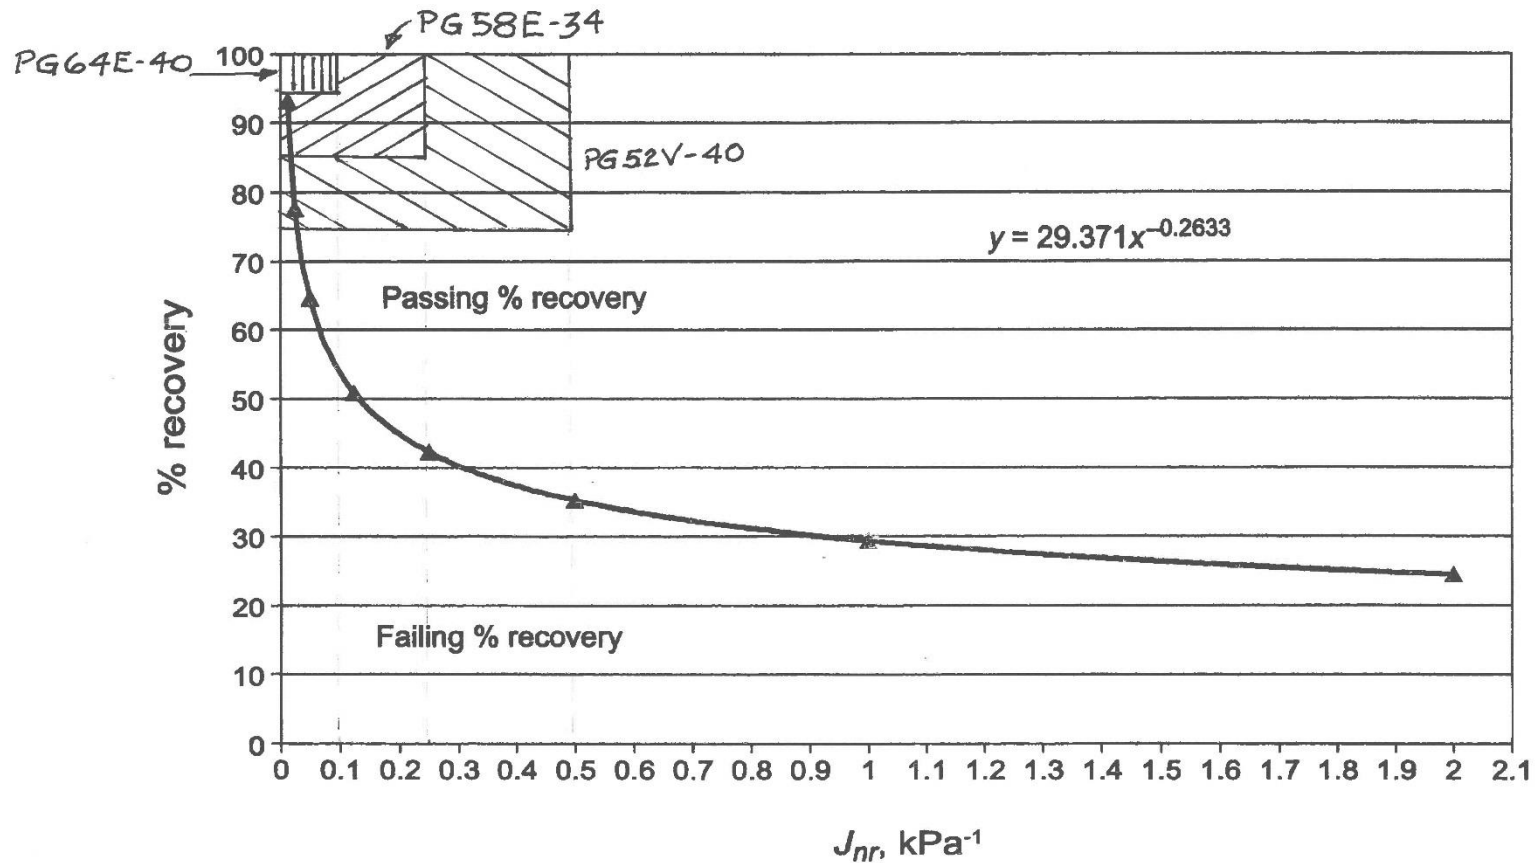
MSCR Values on M332 Graph

- PG 52-40, $\text{Rec}_{3.2} = 85 \%$, $J_{\text{nr}3.2} = 0.33$
- PG 58-34, $\text{Rec}_{3.2} = 89 \%$, $J_{\text{nr}3.2} = 0.22$
- PG 64-40, $\text{Rec}_{3.2} = 96 \%$, $J_{\text{nr}3.2} = 0.07$

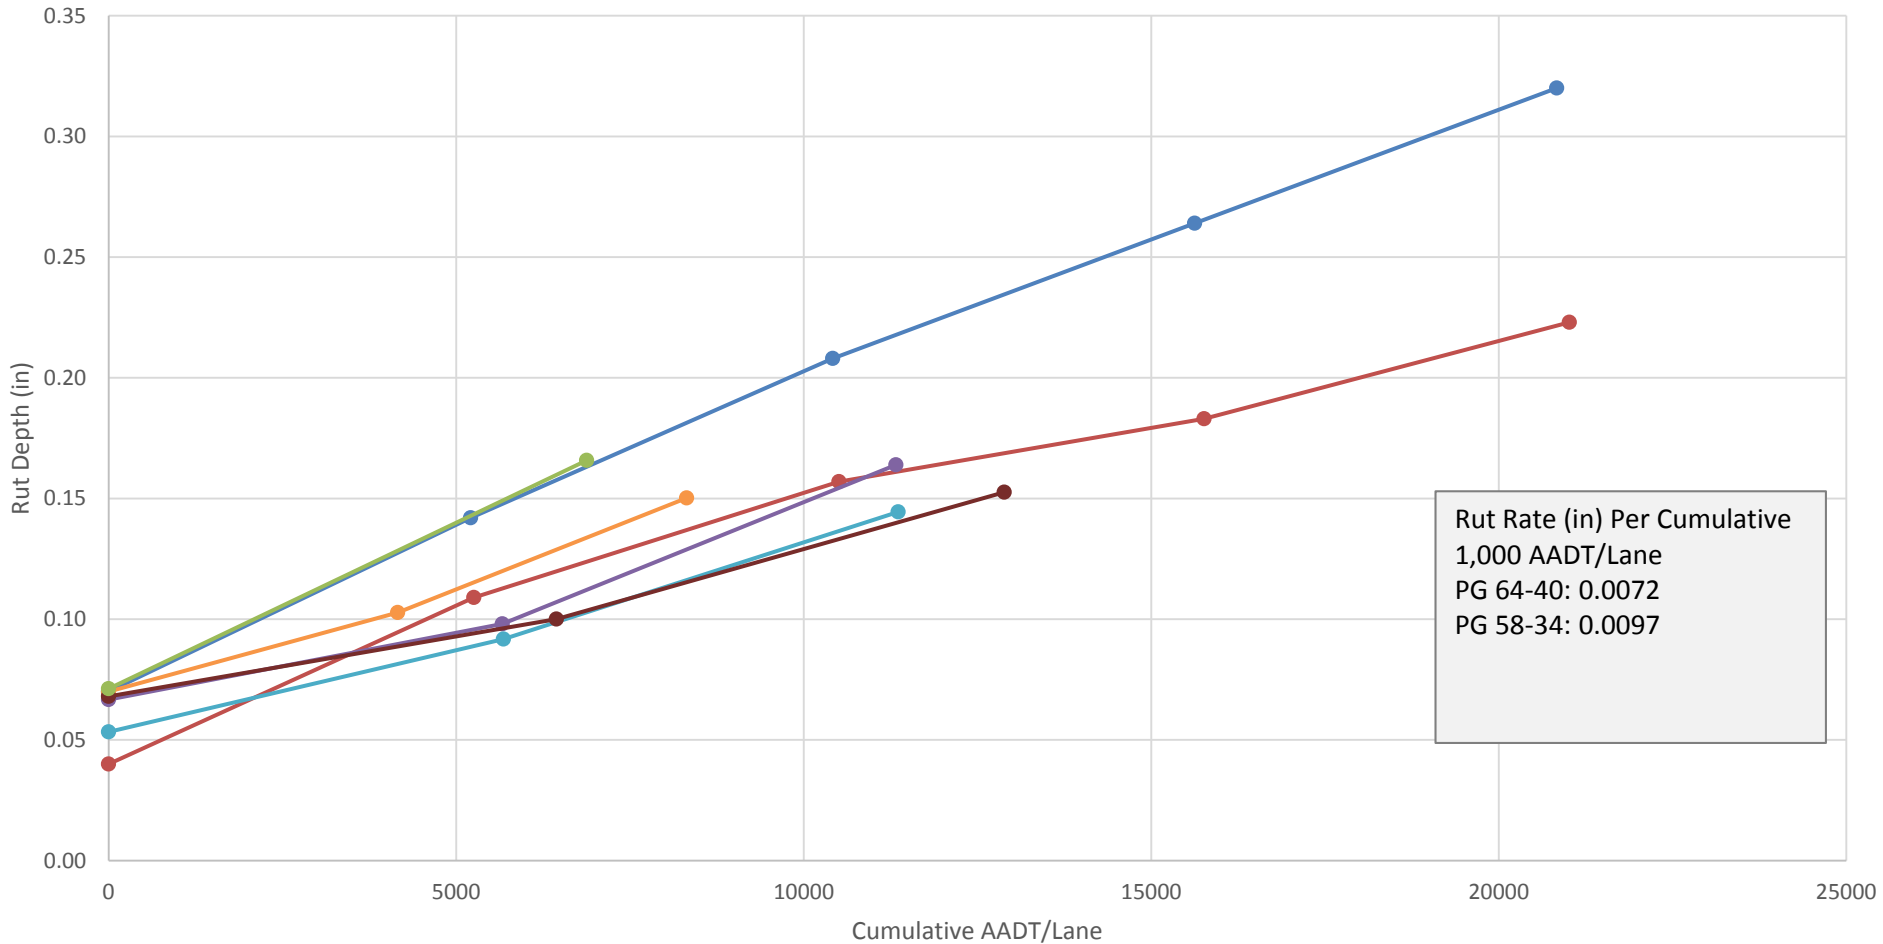
Cumulative AADT/Lane vs. Rut Depth

PMS Rutting Rate

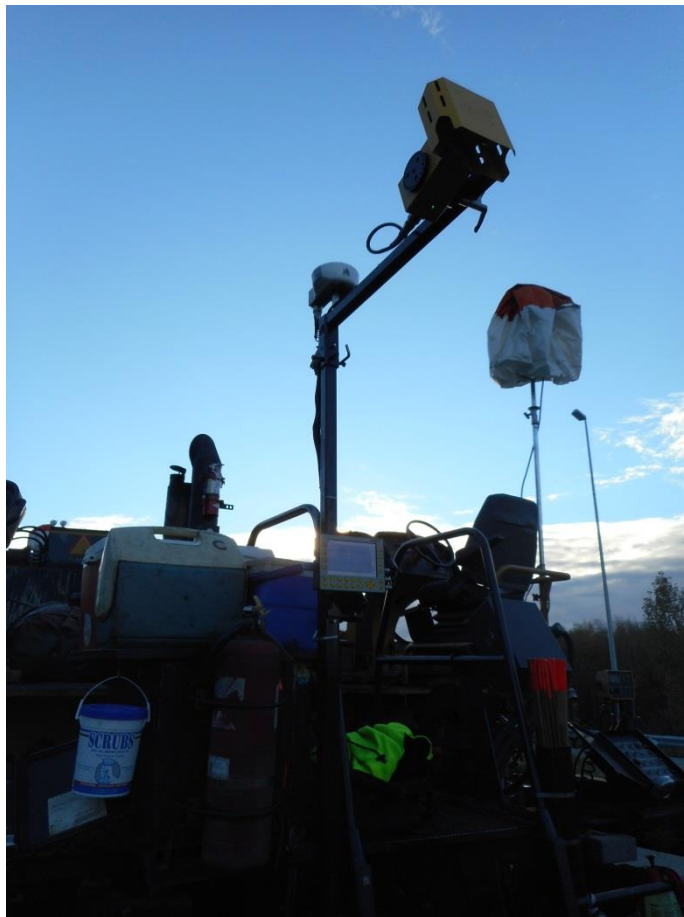
Pave IR Scan

Temperature Scan
Full Width of Lane
1' width

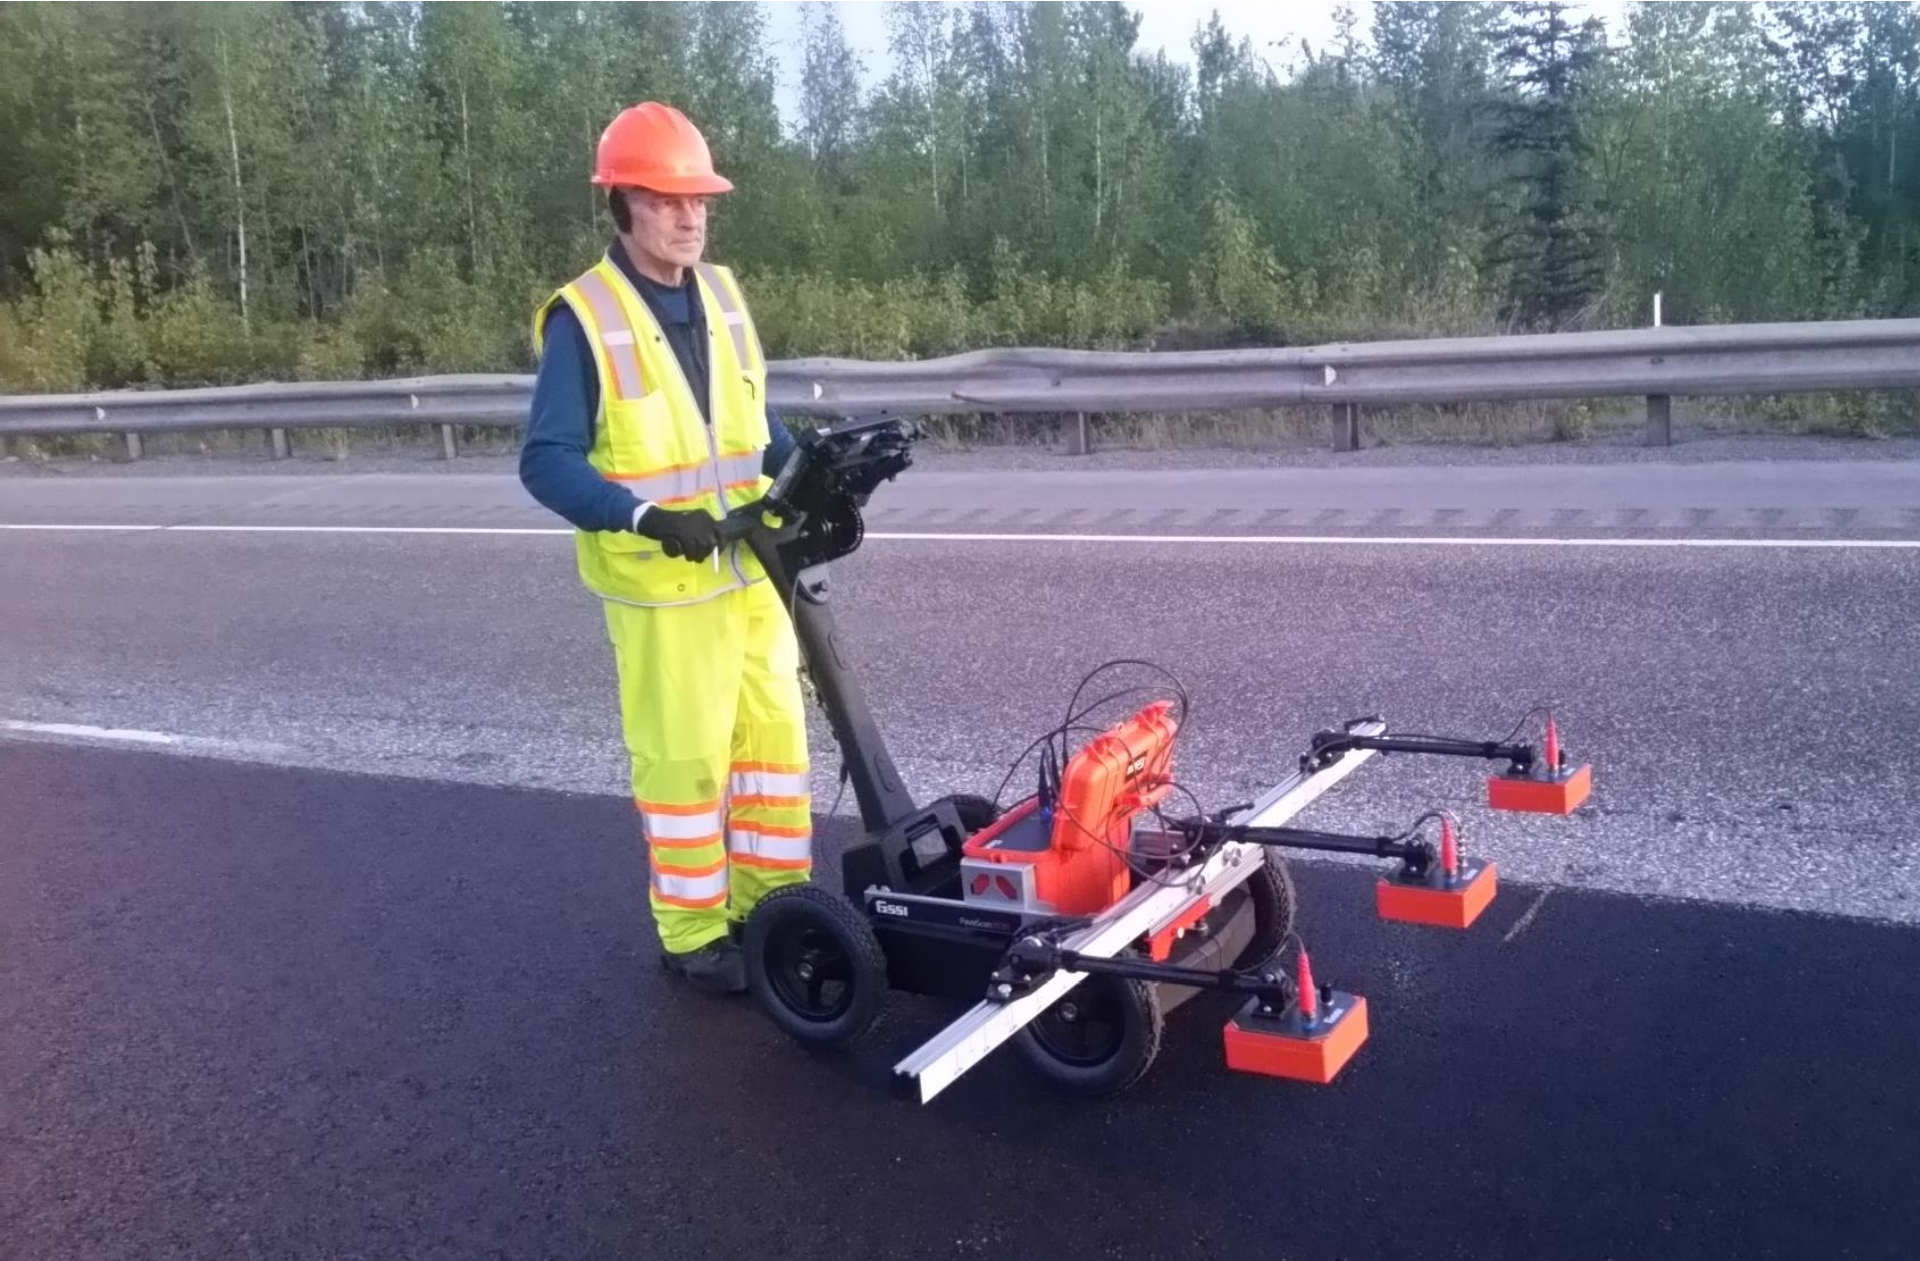
PaveScan RDM (2017)

- PaveScan Rolling Density Meter Provides:
 - Geo-located Data
 - 60 scans (dielectric readings) per second recorded to Raw Data File
 - ~10 Dielectric readings per foot of travel at 4 mph walking speed per antenna

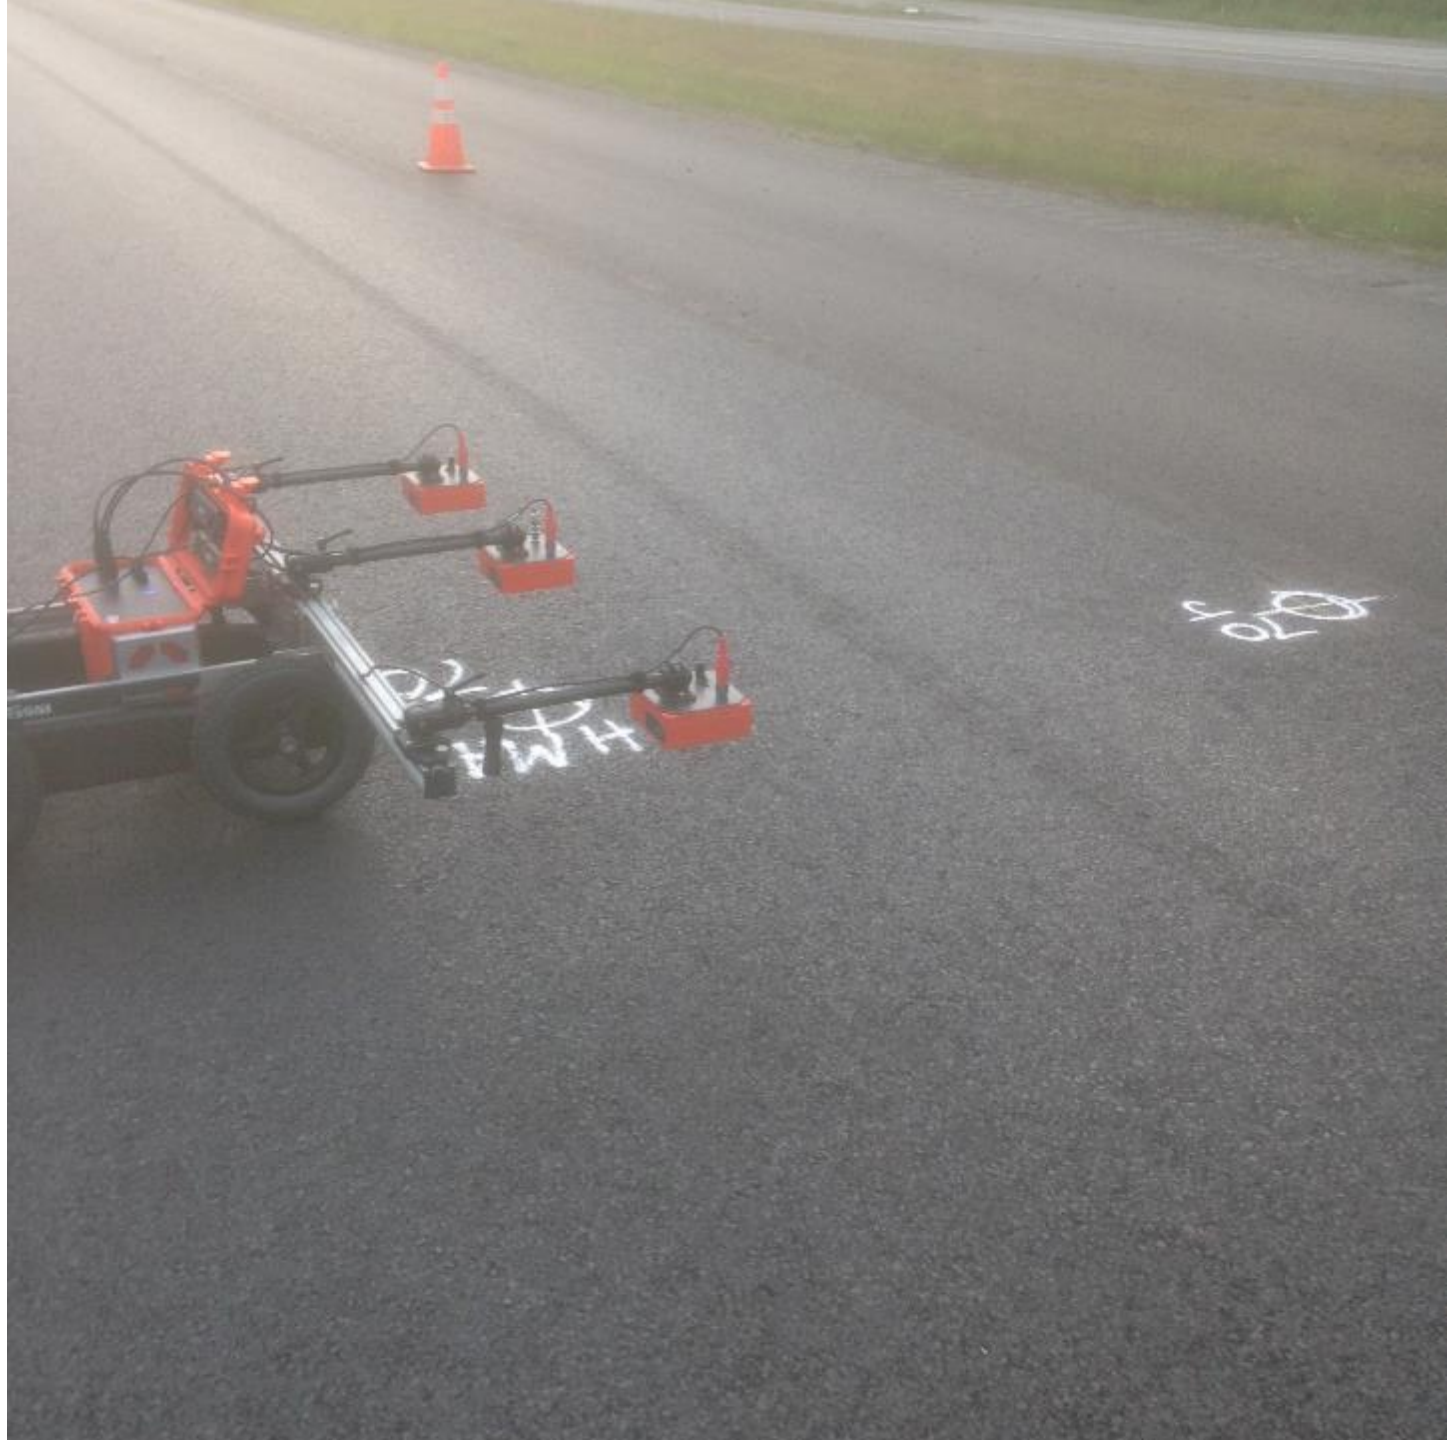
GPR of Lane

Core 70J (91.7%) – Resolution 0.25 ft
