AMAP Conference  
Las Vegas, Nevada  
February 2, 2005

# The Use of Modified Binders in Bridge Deck Overlays

- Martin Luther King Bridge

# Martin Luther King Bridge Project

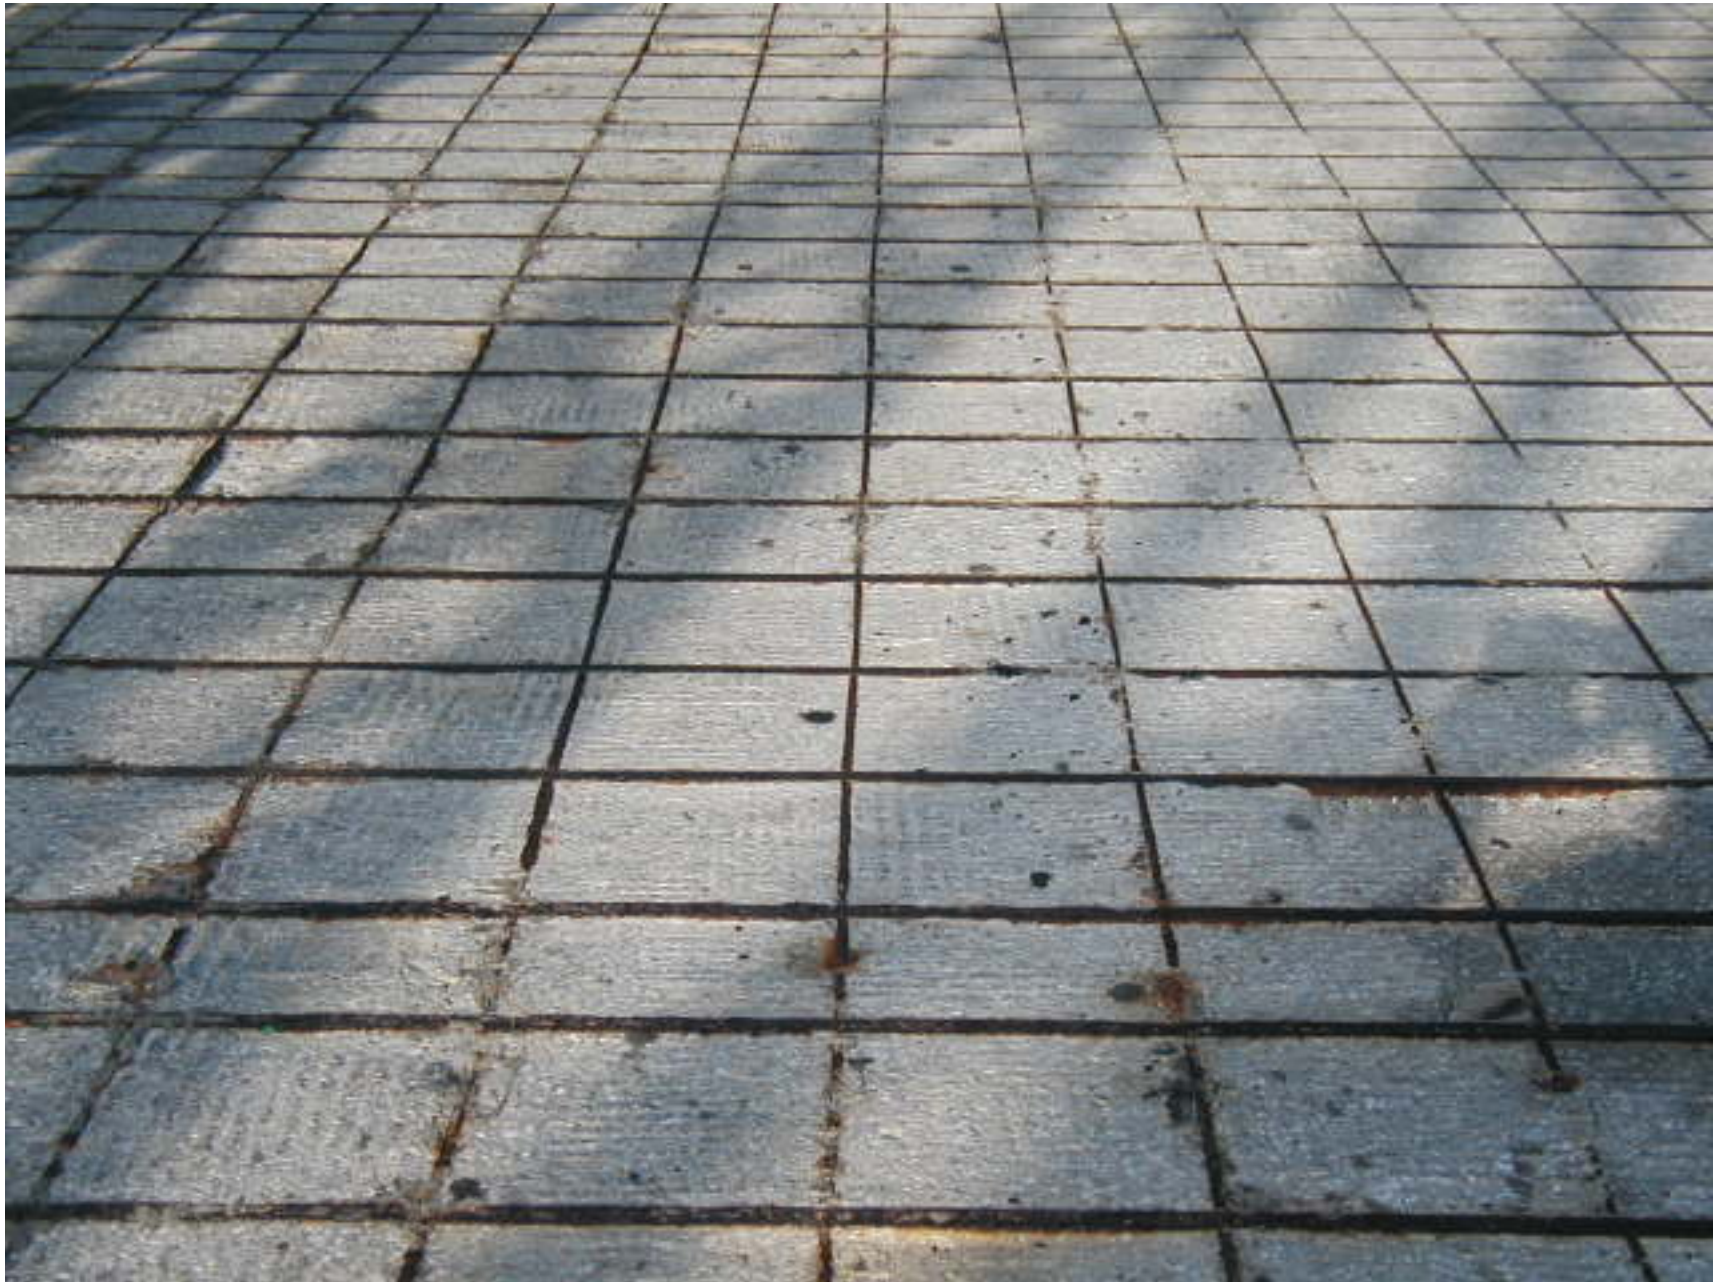
# **BRIDGE DECK**

- Cast in Place Concrete Deck
- Steel Grid Deck w/ Light Weight Concrete and Bituminous Concrete Overlay

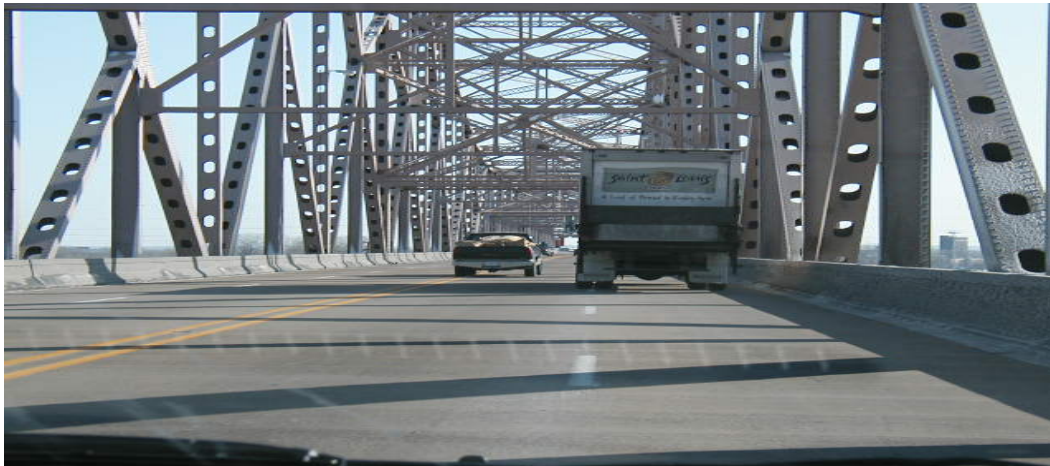
# Steel Grid Deck Section

- 3 Sections
- Total Length = 725'
- Four 10' Lanes
- Parabolic Curve

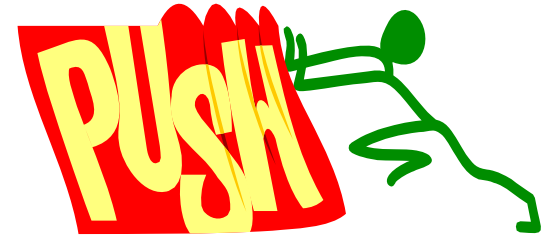
# First Sign of Trouble

- Mat movement – Push & Shove
- Coarse Texture
- Low densities

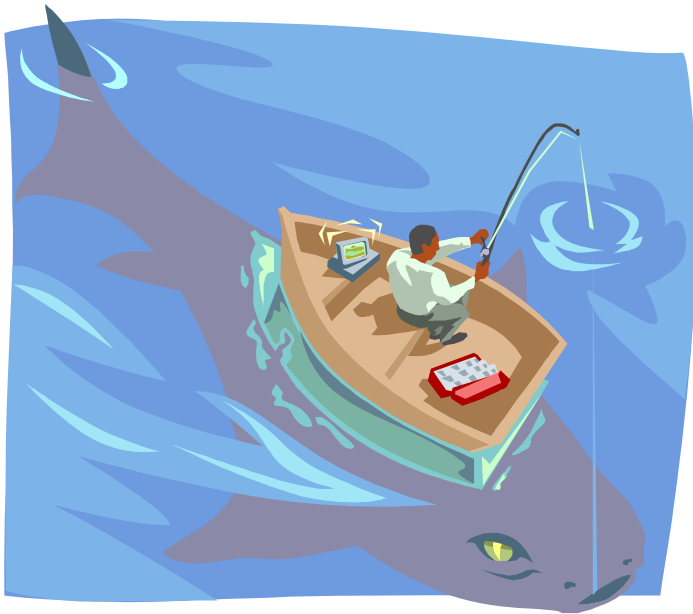
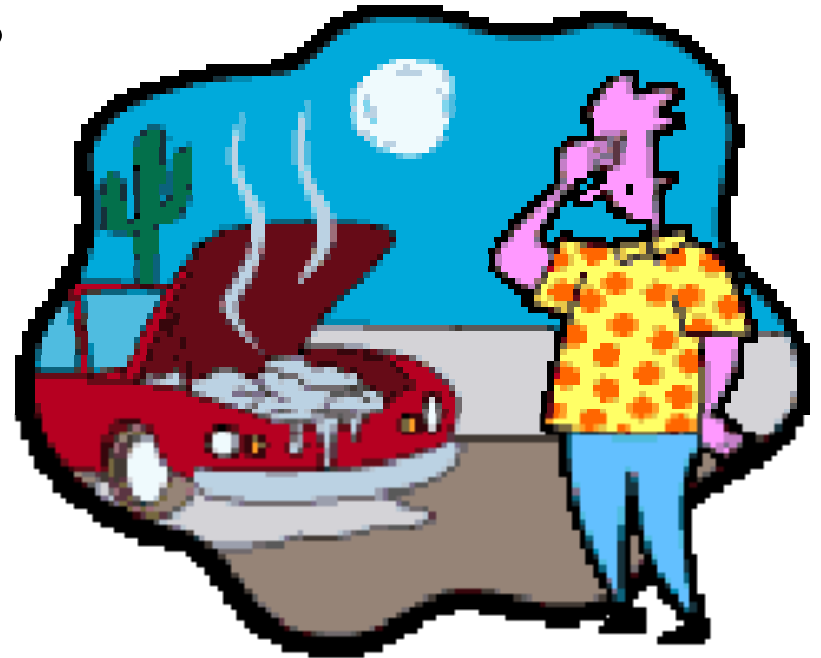
# More Signs of Problems

- Cracks Develop
- Mix Raveling

# Stop Water Infiltration

- Change the Mix Design
  - Aggregate Gradation
    - Tighter Mix
      - Increase Mat Density
  - Liquid Binder
    - Increase Content
      - Increase Mat Density
      - Increase Film Thickness

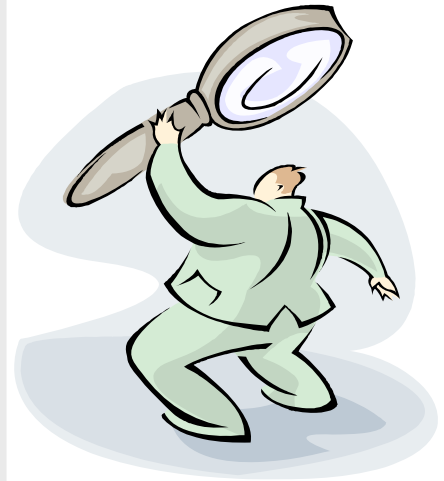
# Forensic Testing

- **CORES**
  1. Nuc-Core Correlation
    1. Density
  2. Ignition Burns
    1. Gradation
    2. Binder Content

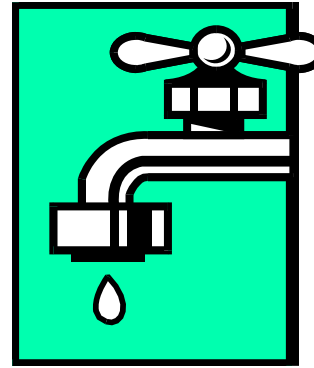
## 1. Water Infiltration

- Raveling

# Raveling

## Mix Characteristics – 75 Blow Marshall Mix

- Mat Thickness
  - Thin
- Aggregate Structure
  - Stiff/Brittle Mix
  - Coarse Graded
- Liquid Binder
  - Low content
