WHY NJDOT IS GOING MODIFIED

Robert W. Sauber
Supervising Engineer
for

AMAP Annual Meeting
Las Vegas, Nevada
February 1 & 2, 2005

Pavement Management and Technology Unit

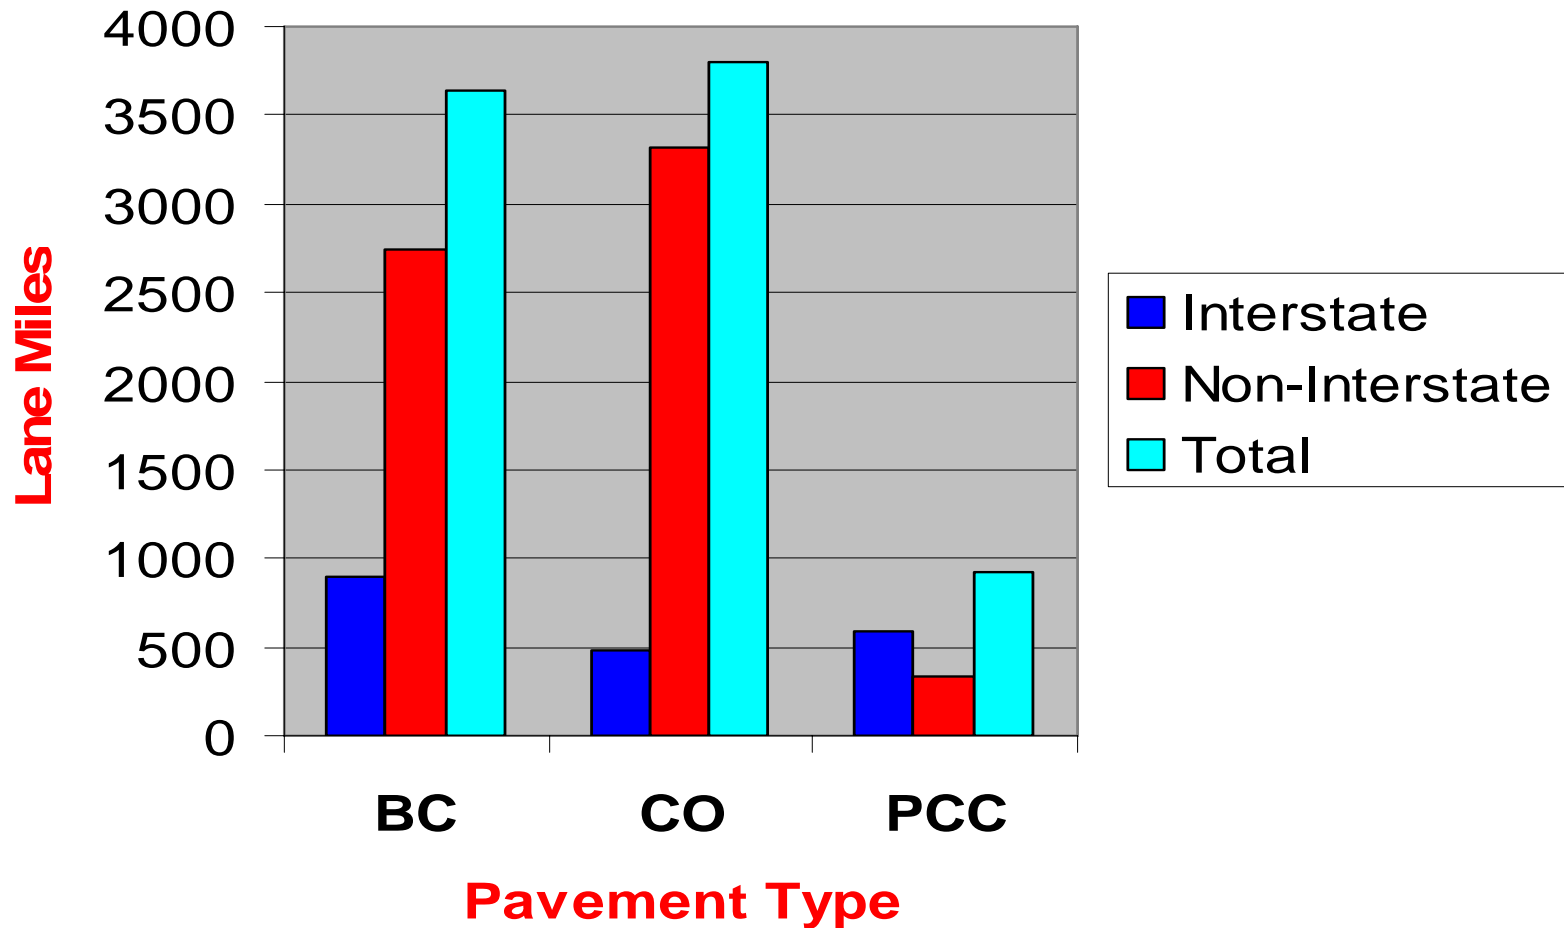
NJ State Highway System Breakdown By Pavement Type

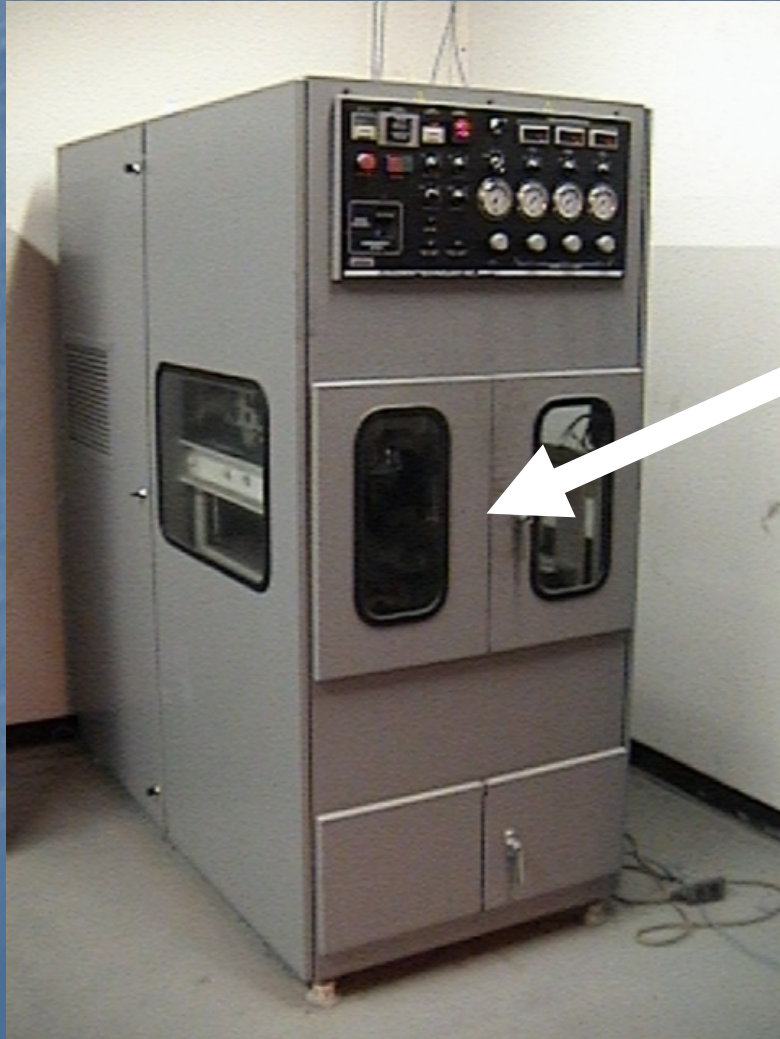
Asphalt Pavement Analyzer *(APA)*

- *Moving wheel load (100 lbs) applied*
- *pressurized hose (100 psi) which lies*
- *on top of asphalt samples*
- *Tested at 64°C for 8,000 loading*
- *cycles*

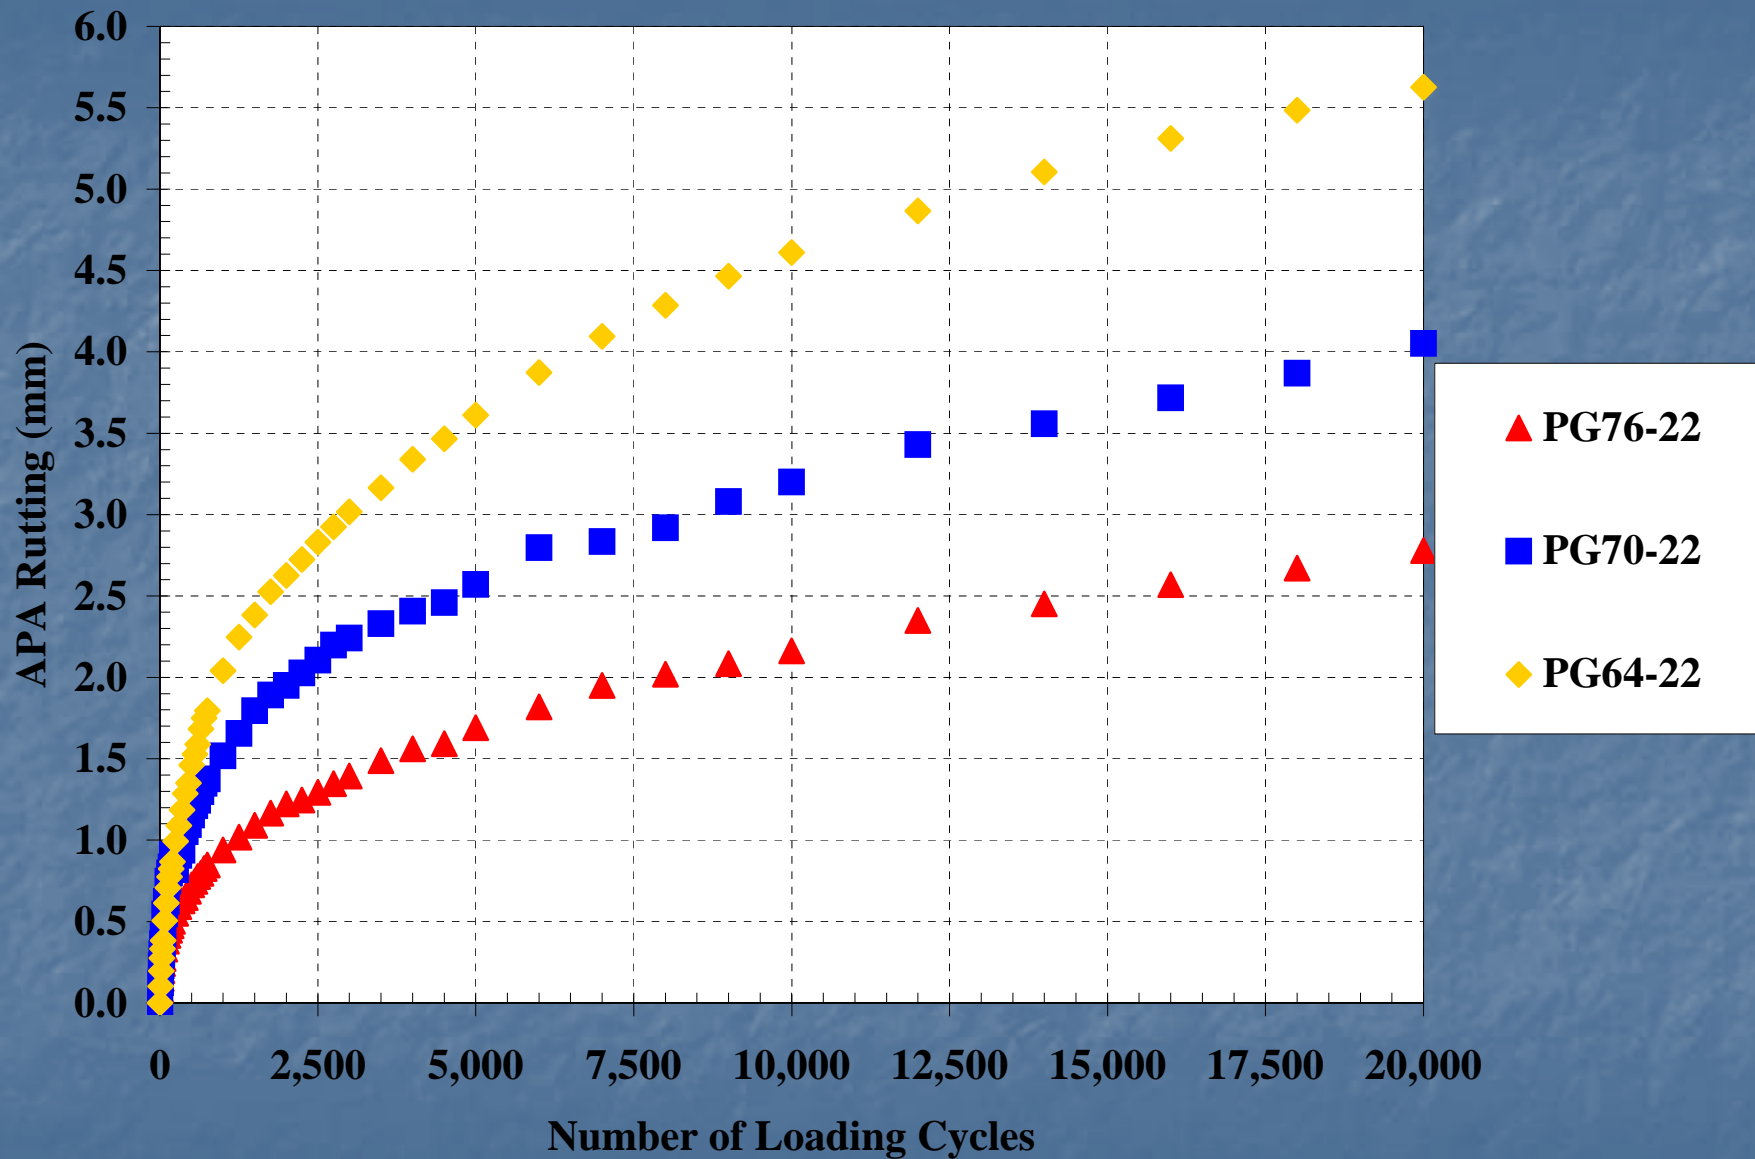
Average Rutting Depth (mm)

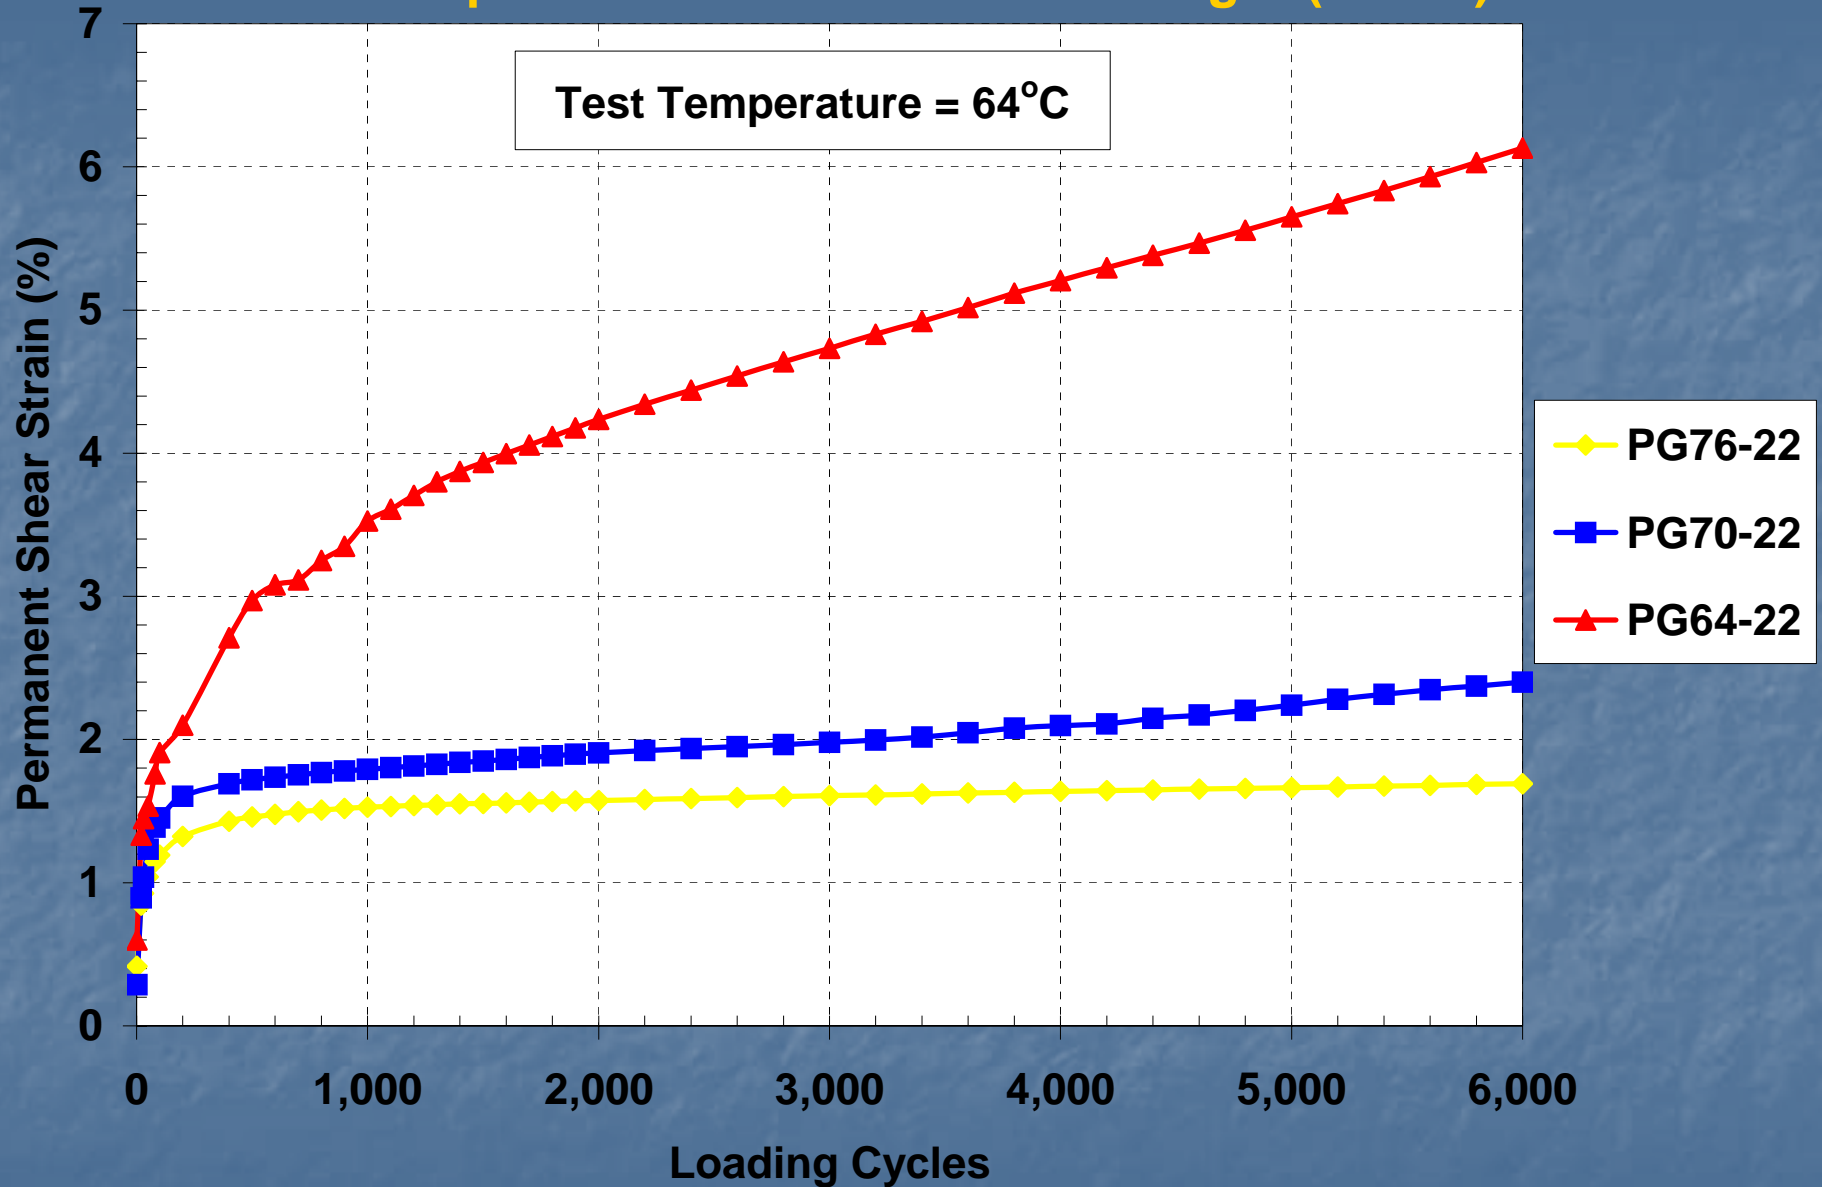
Repeated Shear at Constant Height (RSCH)

Test Temperature = 64°C

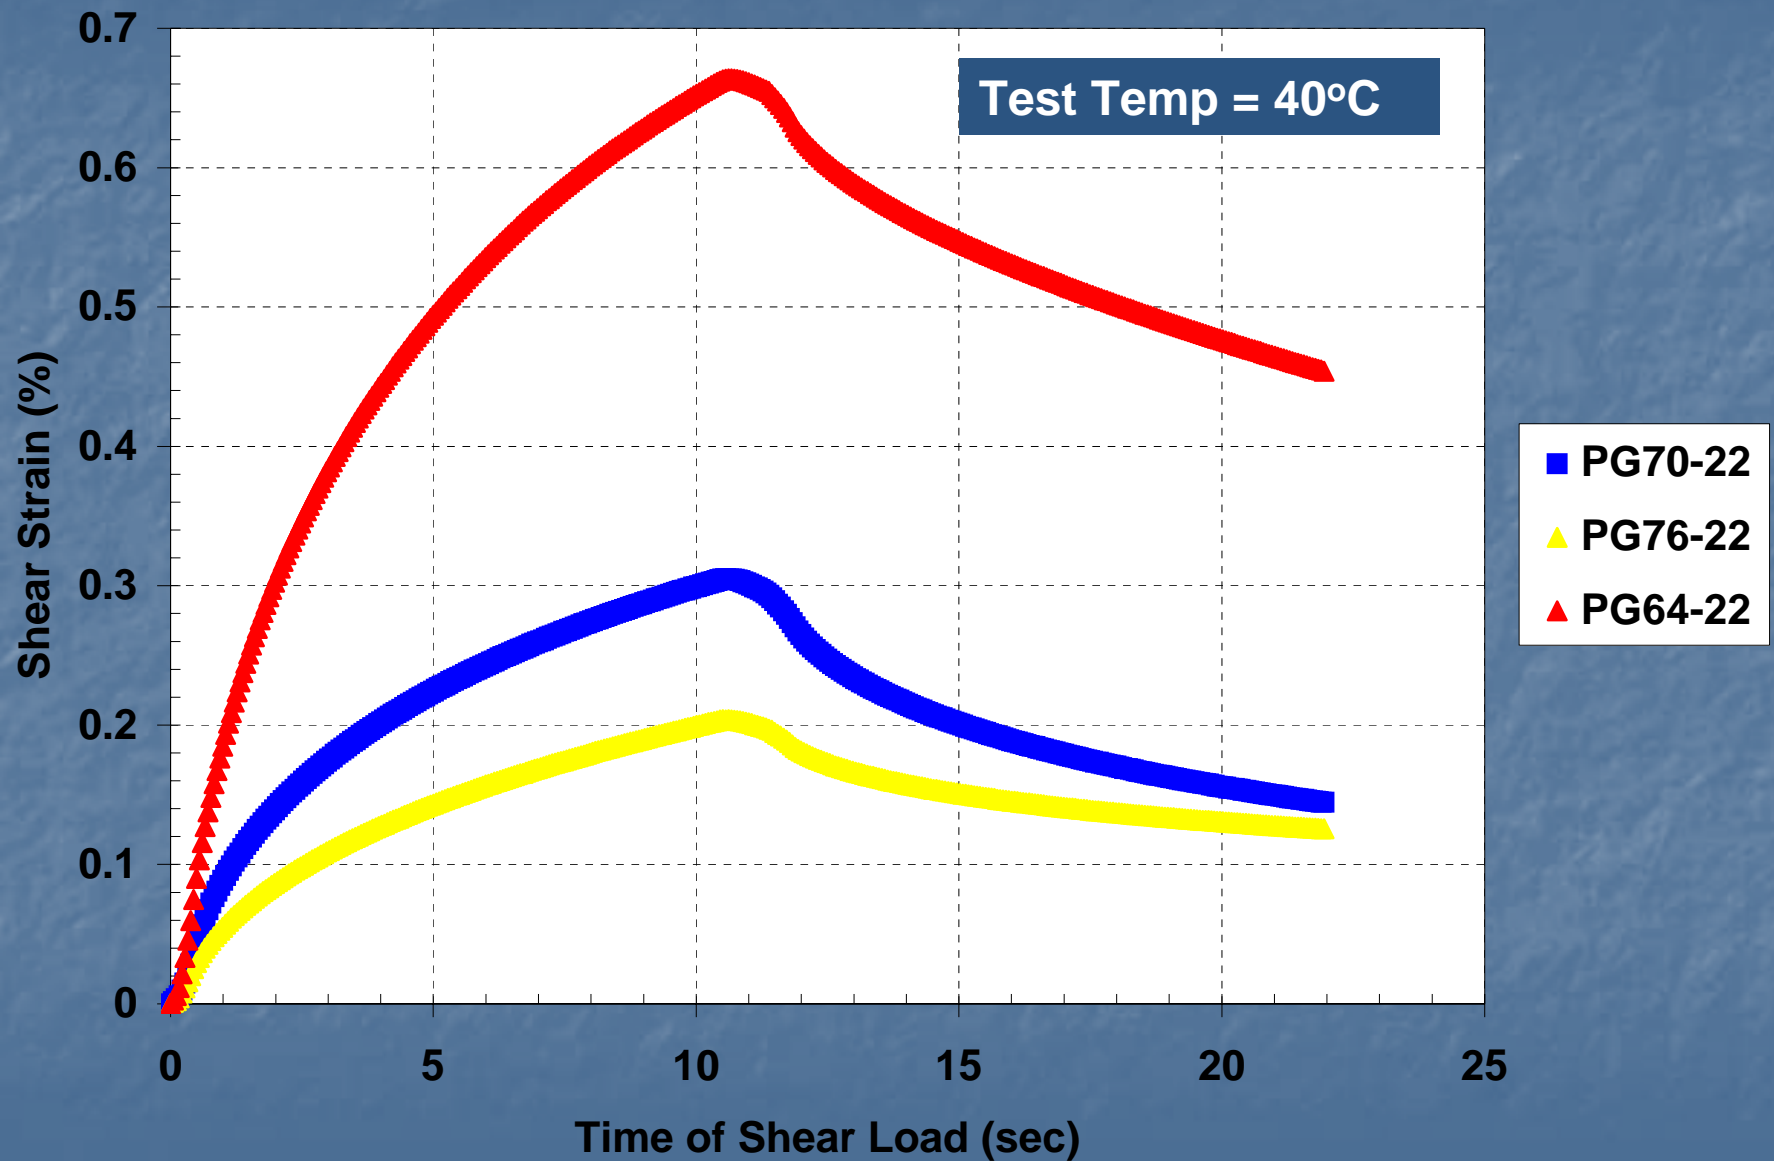
Simple Shear (Creep) at Constant Height (FSCH)

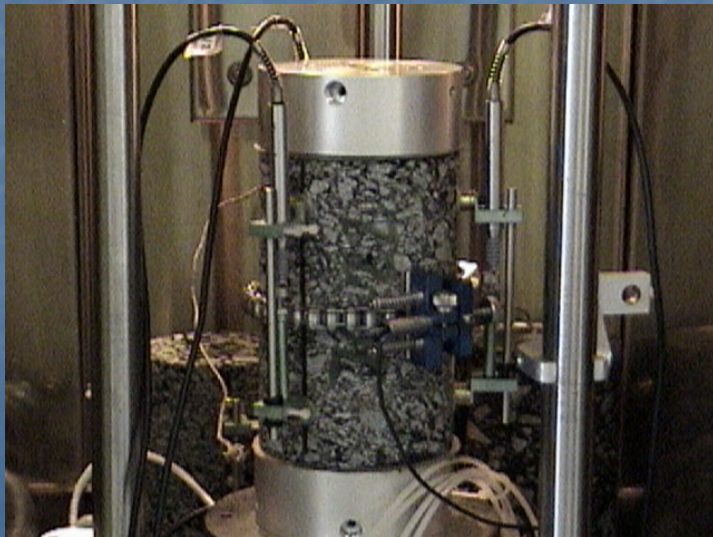
E* (Dynamic Modulus)

- Modified under current NCHRP research
- E* (dynamic modulus) defines the properties of a linear viscoelastic material subjected to sinusoidal loading
- Needed input for 2002 Mechanistic-Empirical Pavement Design Guide

$$|E^*| = \frac{\sigma_o}{\epsilon_o}$$

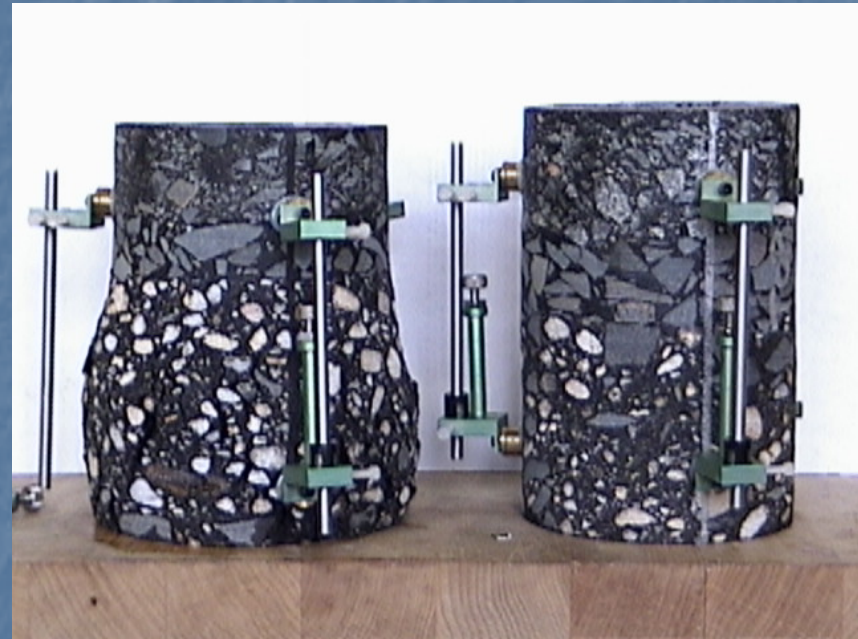
Simple Performance Test (SPT)

- Identical test set-up as dynamic modulus
- Consists of applying either a cyclic load or creep load and determine the time for tertiary flow (failure)
 - Typical test times
 - 3 hours per sample or until failure
 - Cyclic testing provides calibration parameters for rutting in 2002 Mechanistic-Empirical Pavement Design Guide

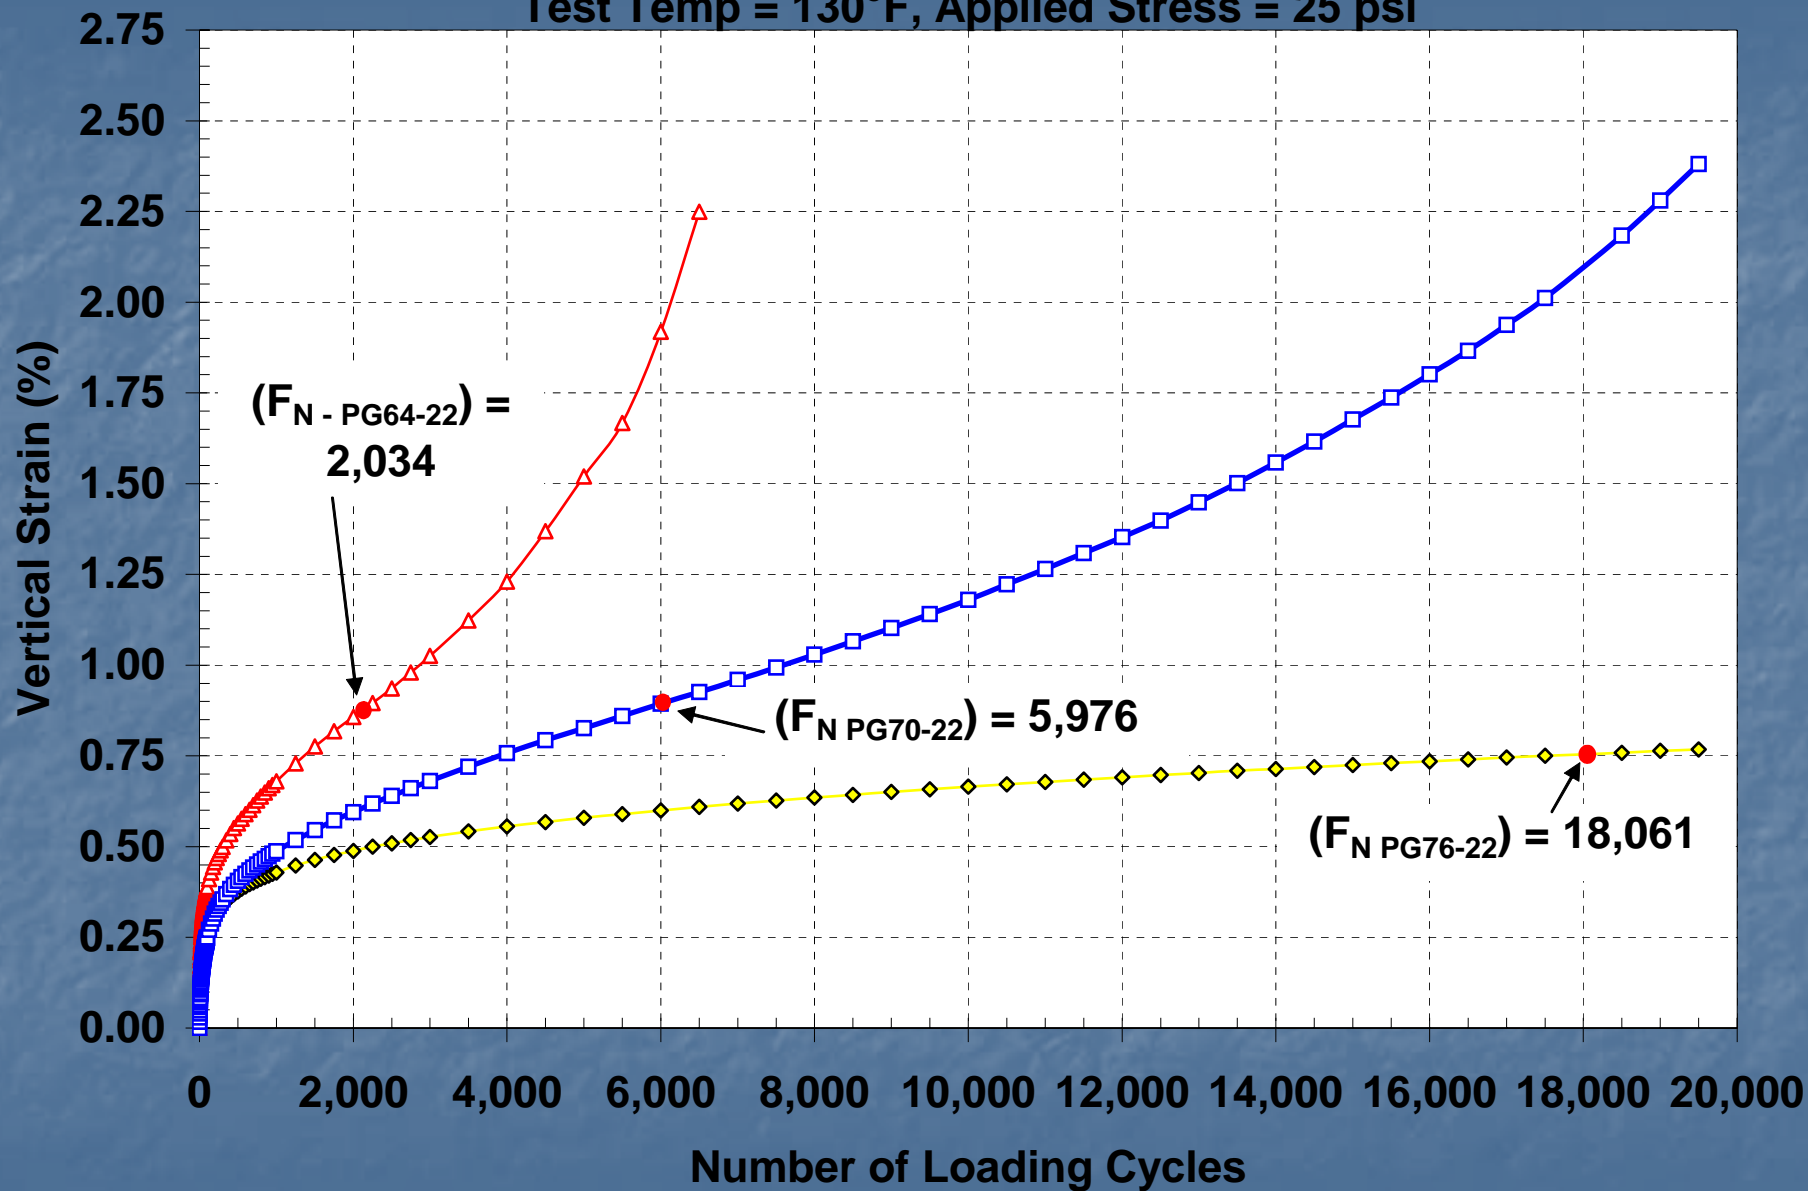
Test Temp = 130°F, Applied Stress = 25 psi

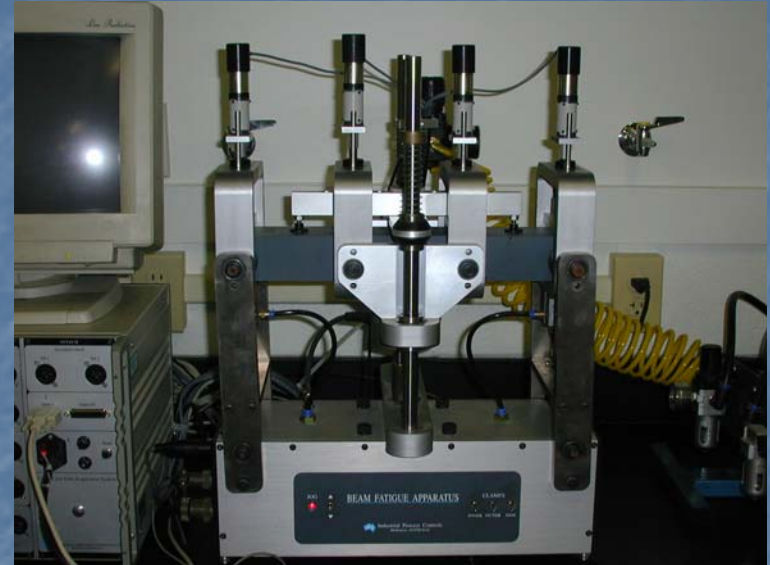
Flexural Beam Fatigue Device

- Evaluate the fatigue properties of HMA compacted beam samples
- Test under variety of stress and strain conditions, as well as temperature
- Parameters used to calibrate models in AASHTO M-E Design Guide

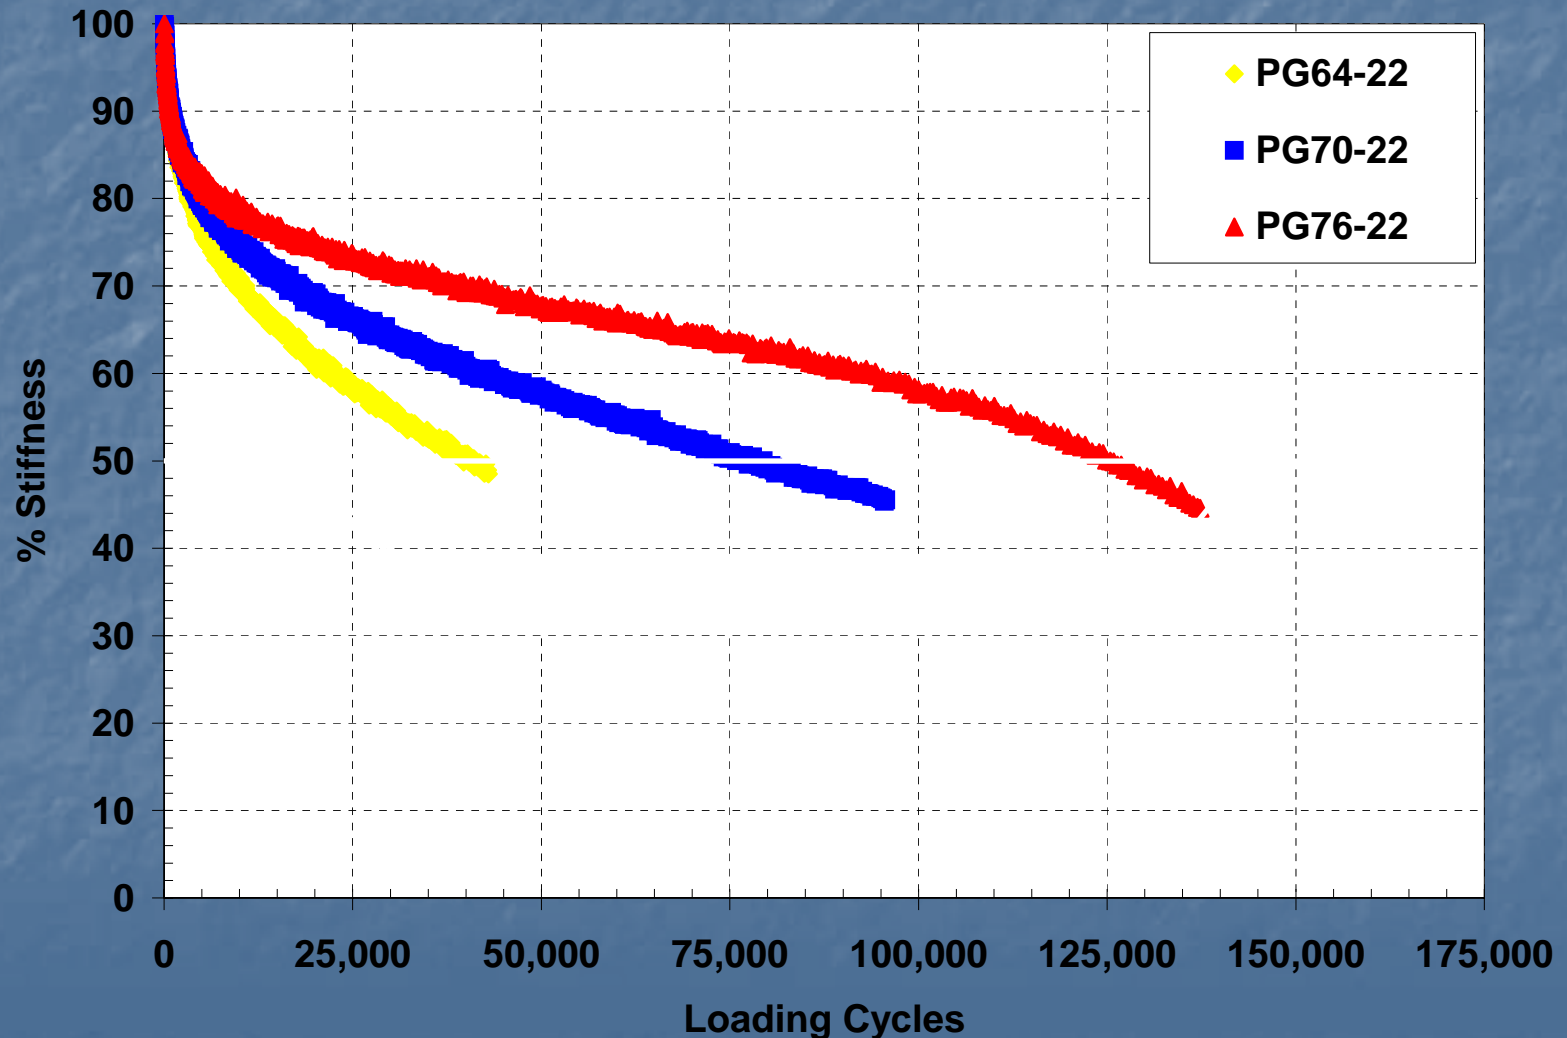
Example of Fatigue Results

Applied $\varepsilon_T = 500$ micro-strains

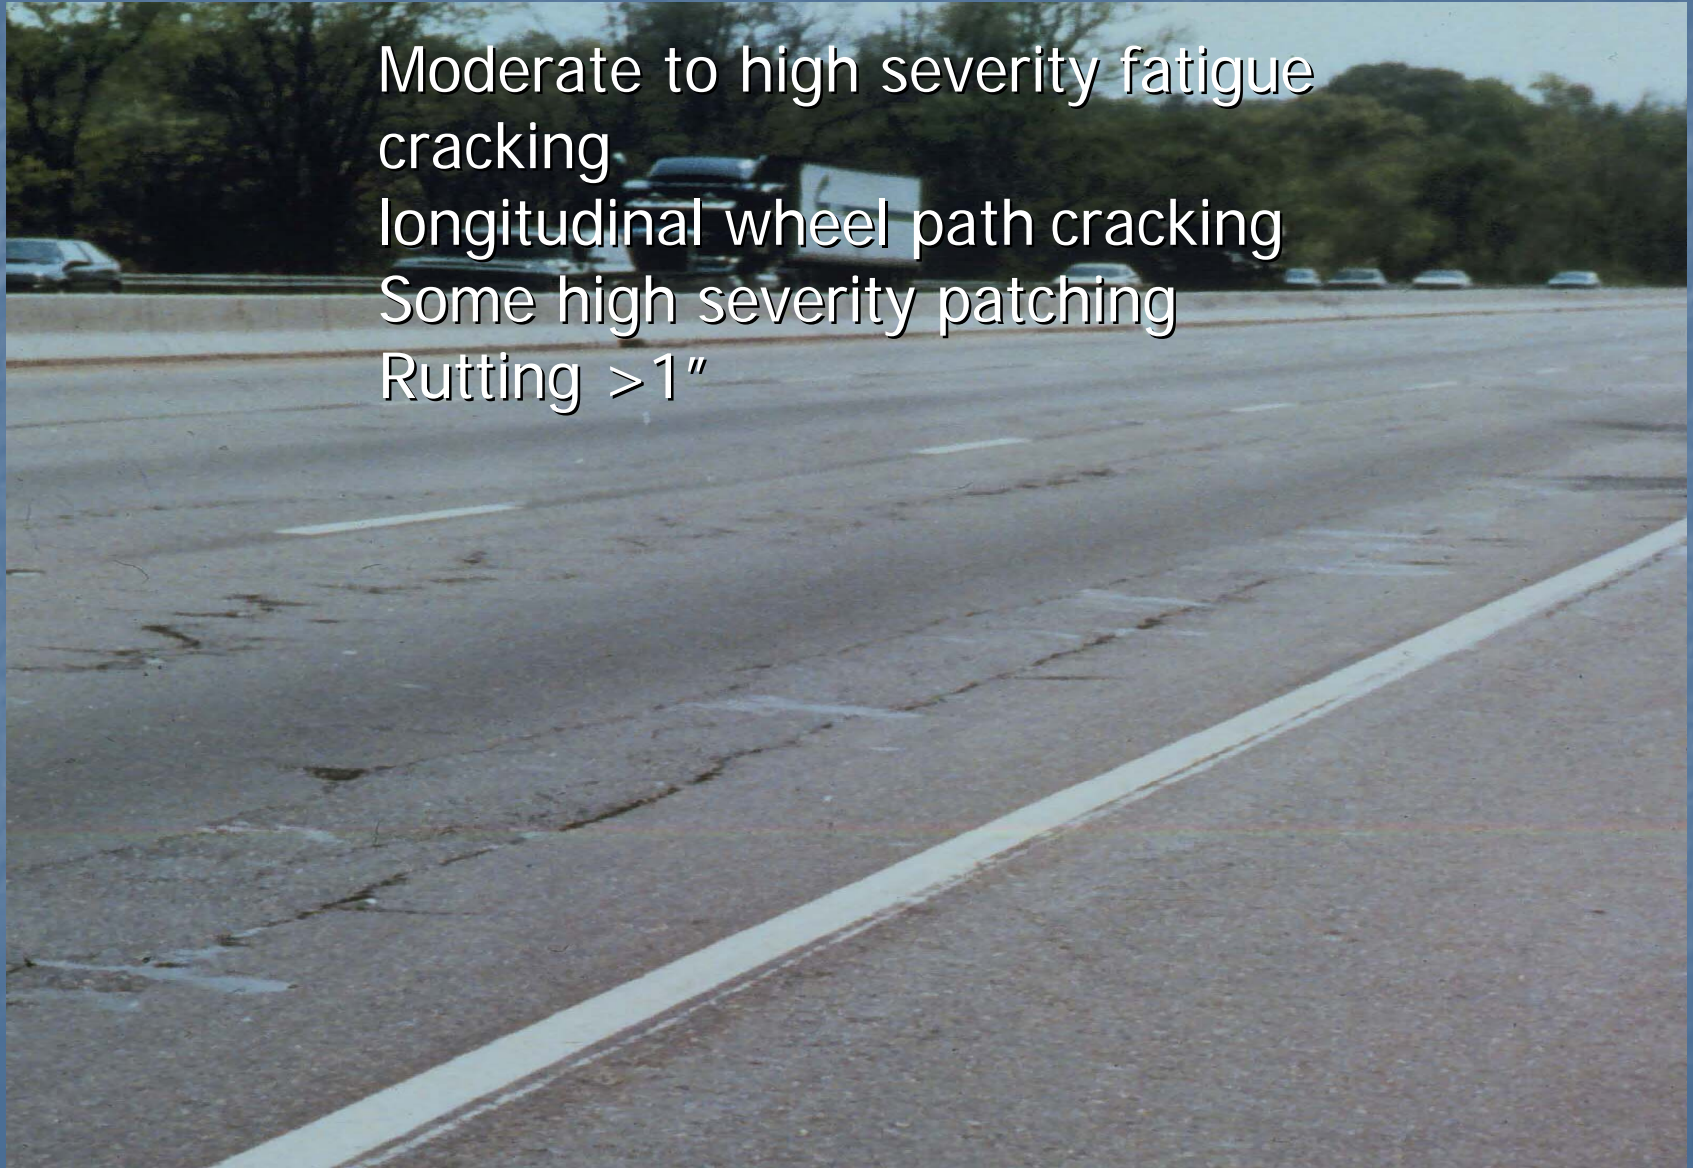
Rt. I-287 Surface Appearance

Moderate to high severity fatigue
cracking
longitudinal wheel path cracking
Some high severity patching
Rutting >1"

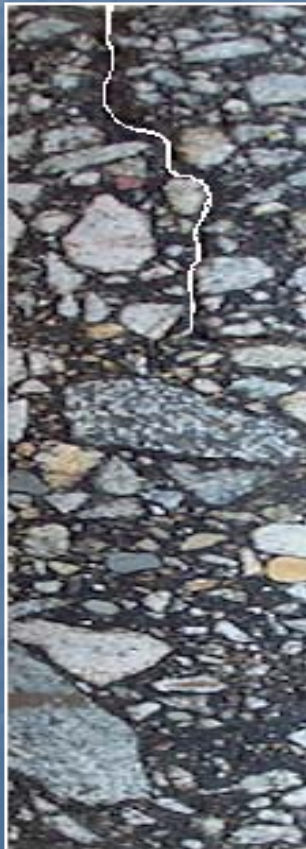
Penetration and Air Voids

REC. PEN

VOIDS

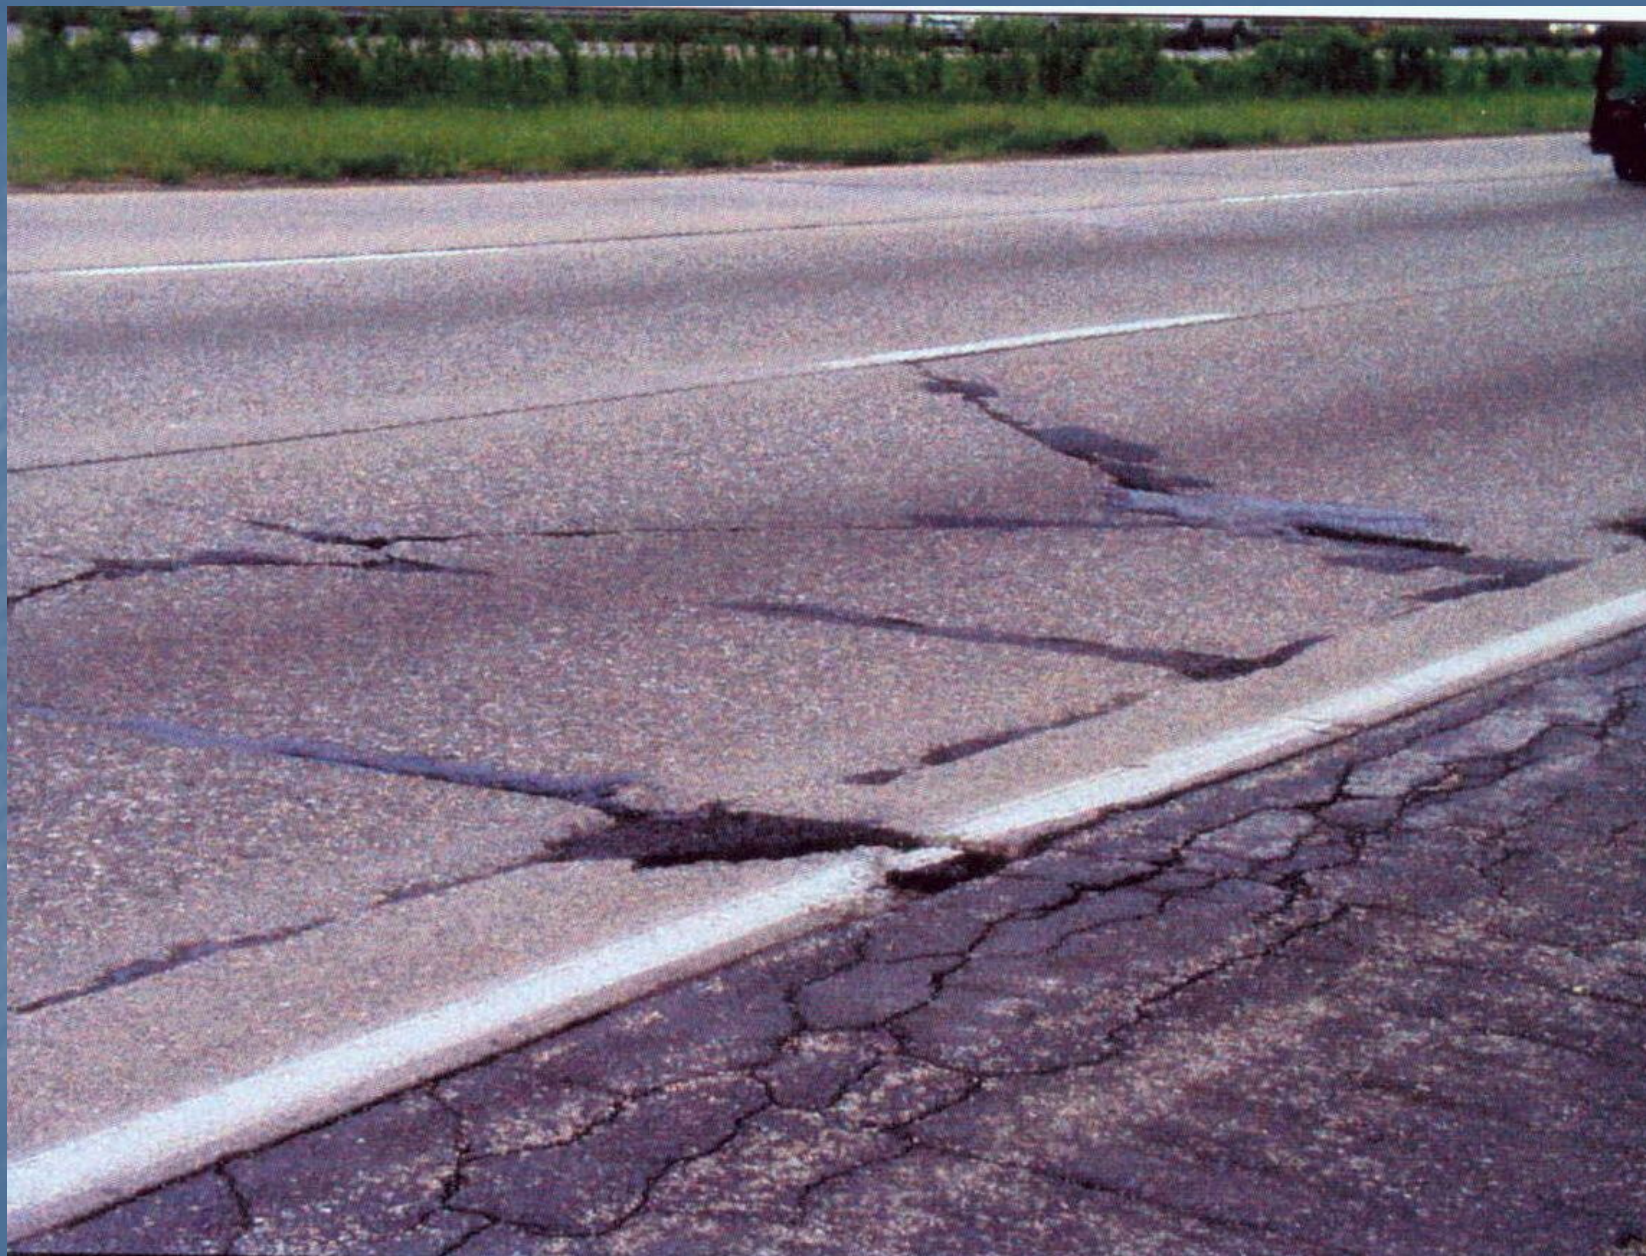
Rt. I-295 Typical Pavement Distress in Southern Segment

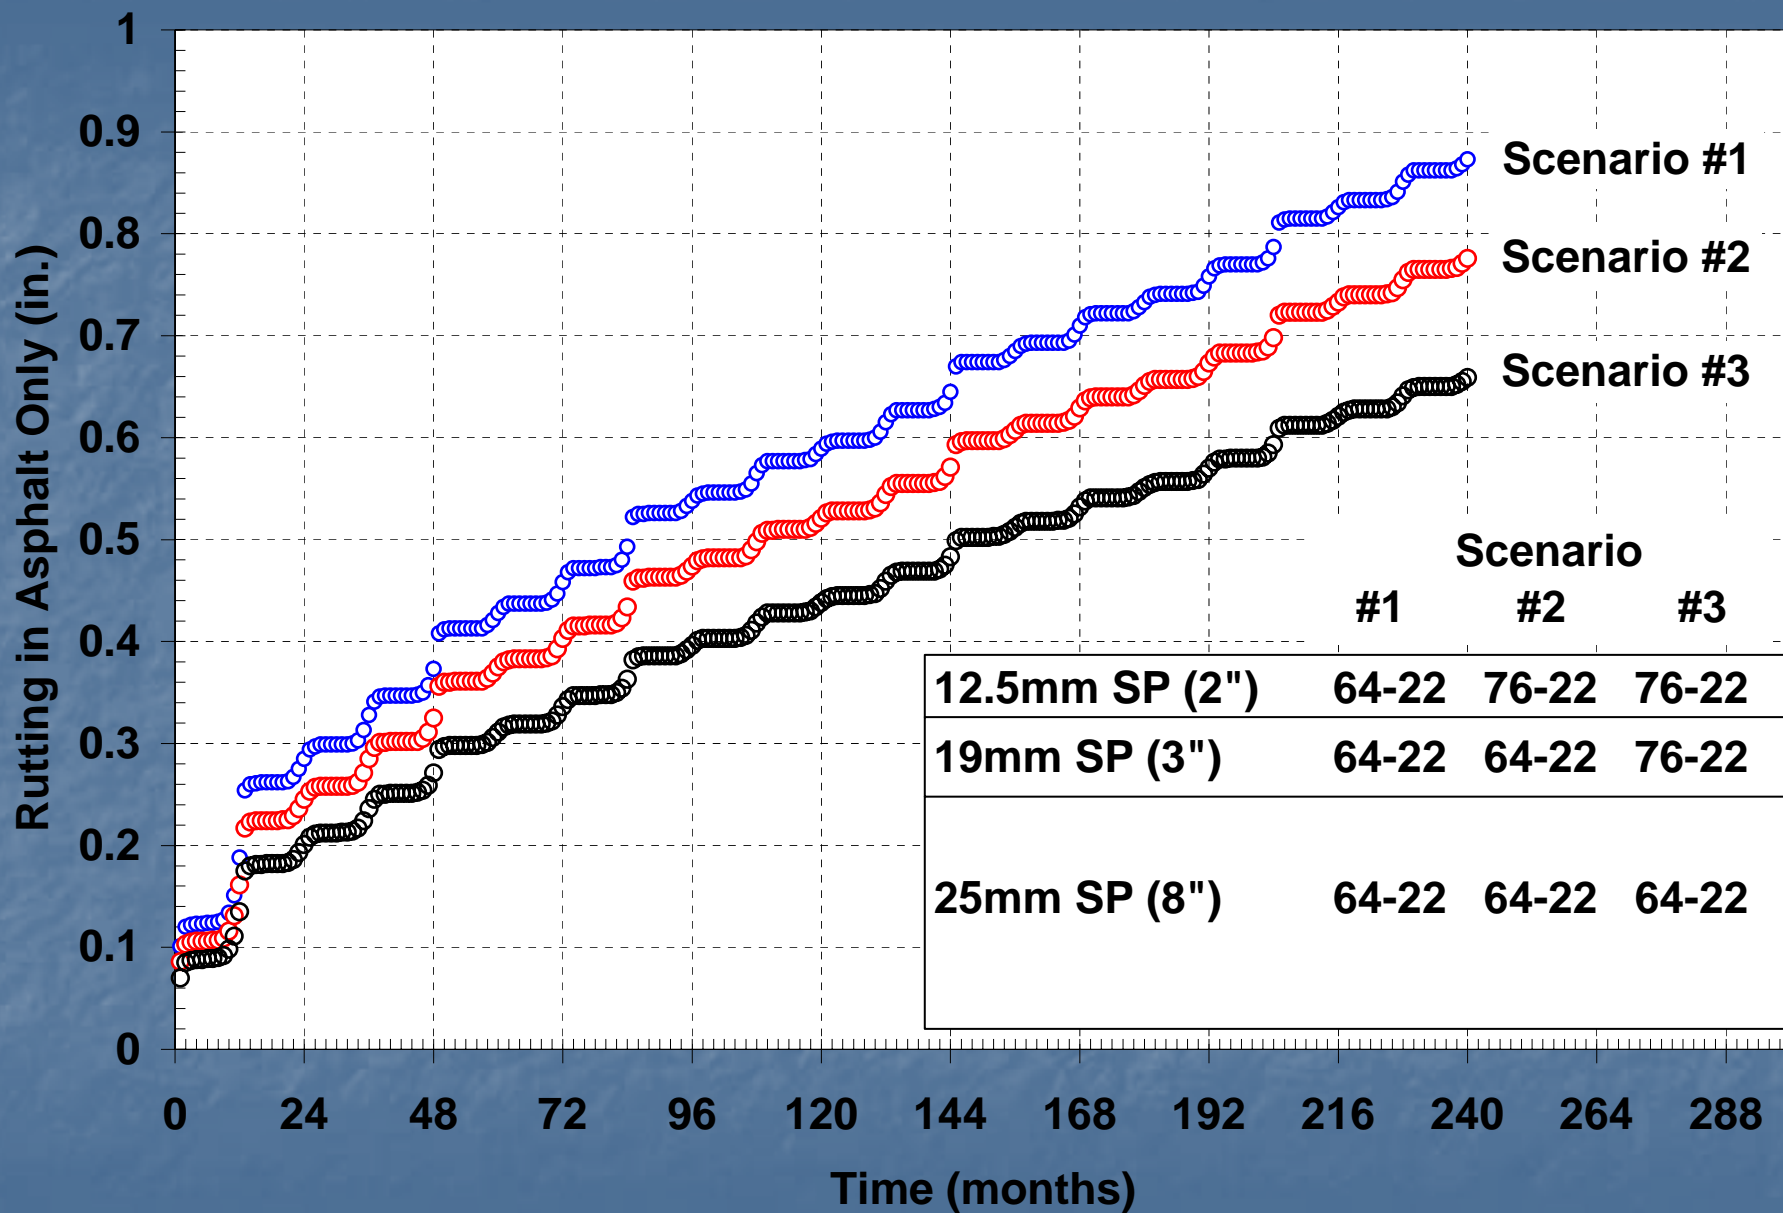
2002 Mechanistic-Empirical Pavement Design Guide

12.5mm Superpave HMA (2")

19mm Superpave HMA (3")

25mm Superpave HMA (8")

ASOG (4")

DGA (8")

Subgrade (A-6)

- 2-in Superpave HMA 12.5V76 Surface
- 3-in Superpave HMA 19V76 Intermediate
- 8-in Superpave HMA 25H64 Base
- 4-in Asphalt Stabilized Drainage Layer
- 8-in Dense Graded Aggregate Base
- Geotextile for stabilization/separation

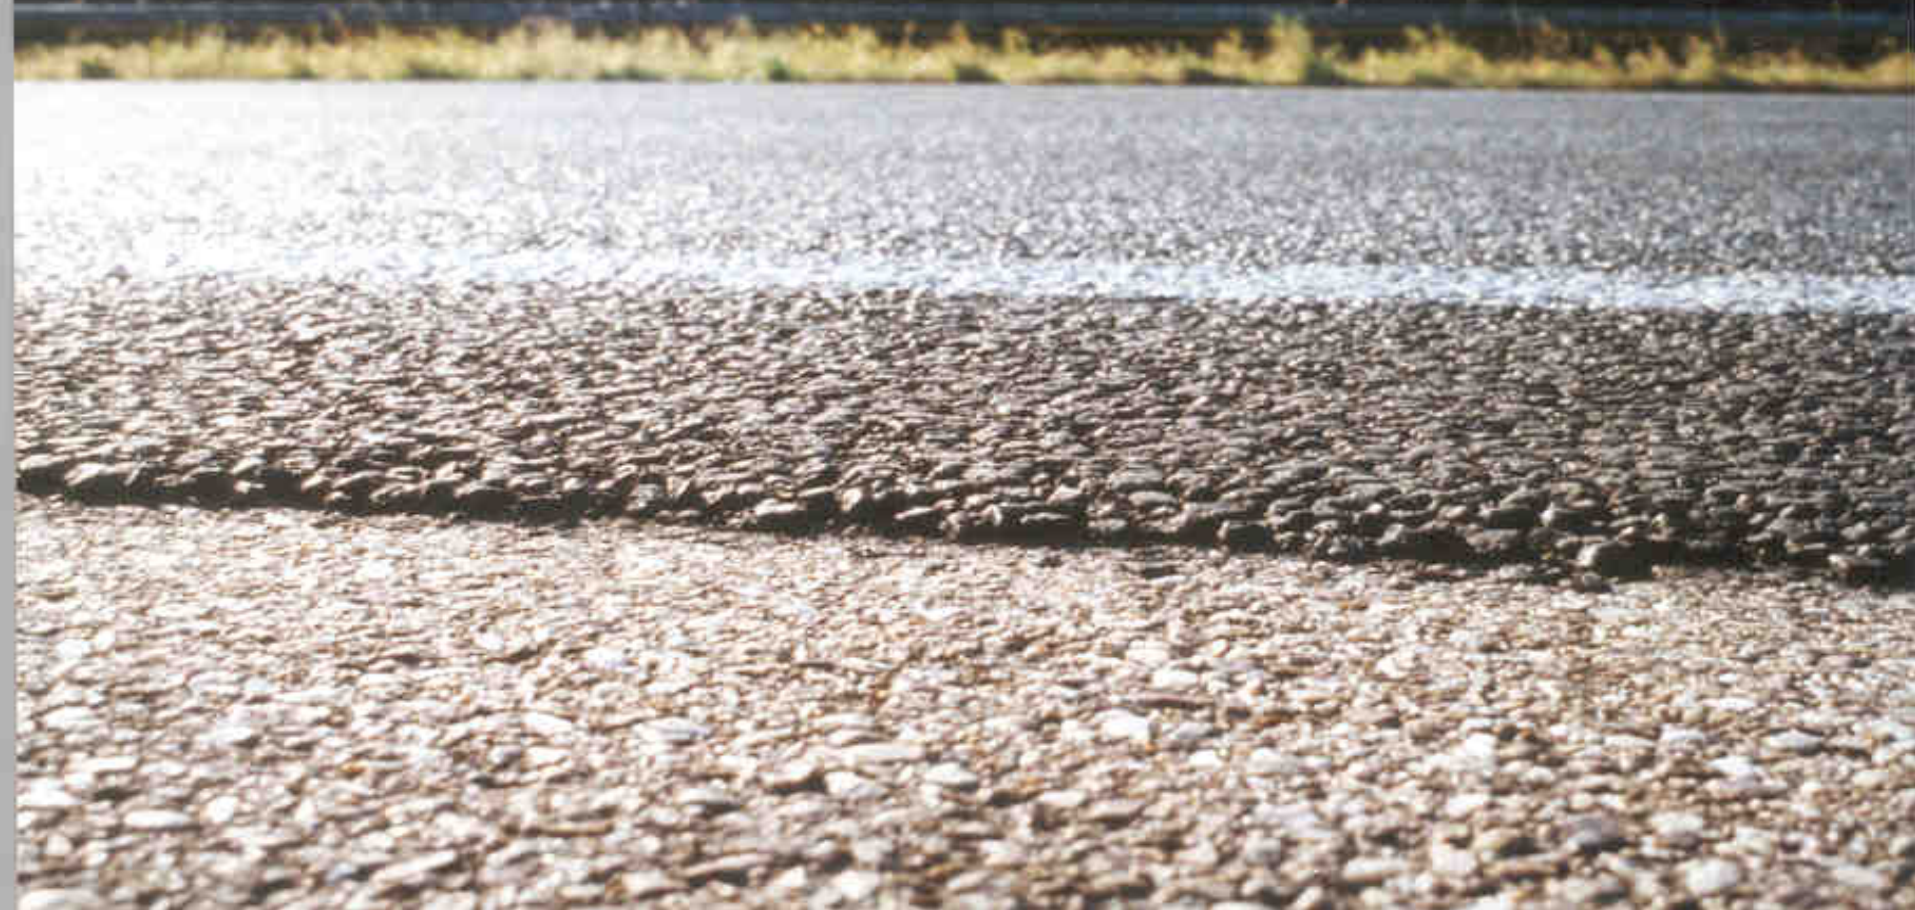
NOVACHIP Rt 195 WB
