# ***Performance: Neat & Modified Asphalt Mixtures***

***Follow up to “All PG 70-22s the Same?”,  
AAPT 1998***

***Phil Blankenship  
Koch Pavement Solutions***

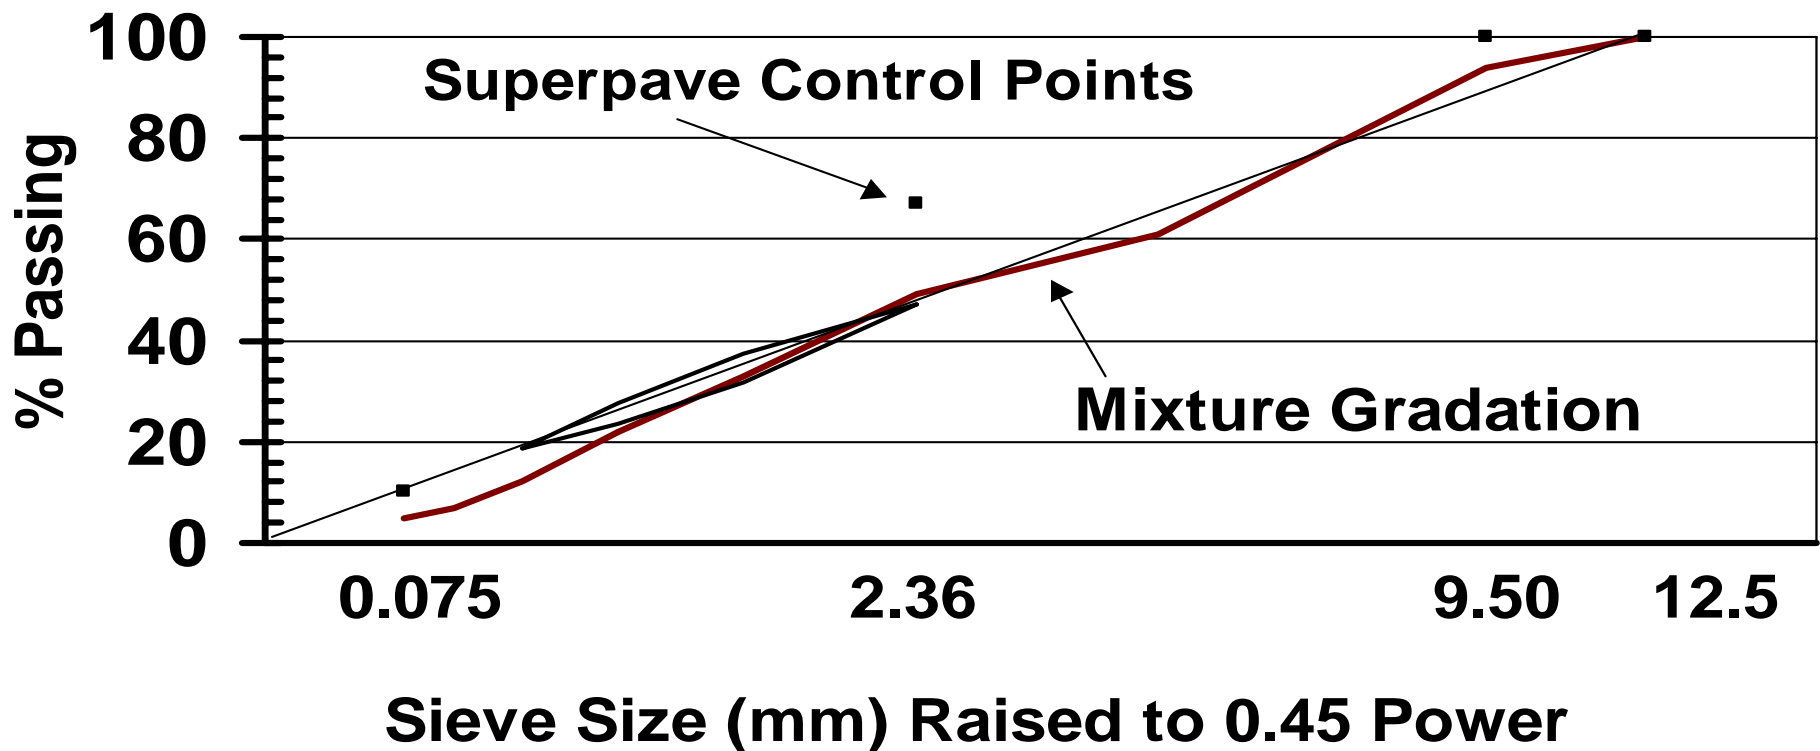
# ***Gradation***

## **9.5-mm Nominal Mixture**

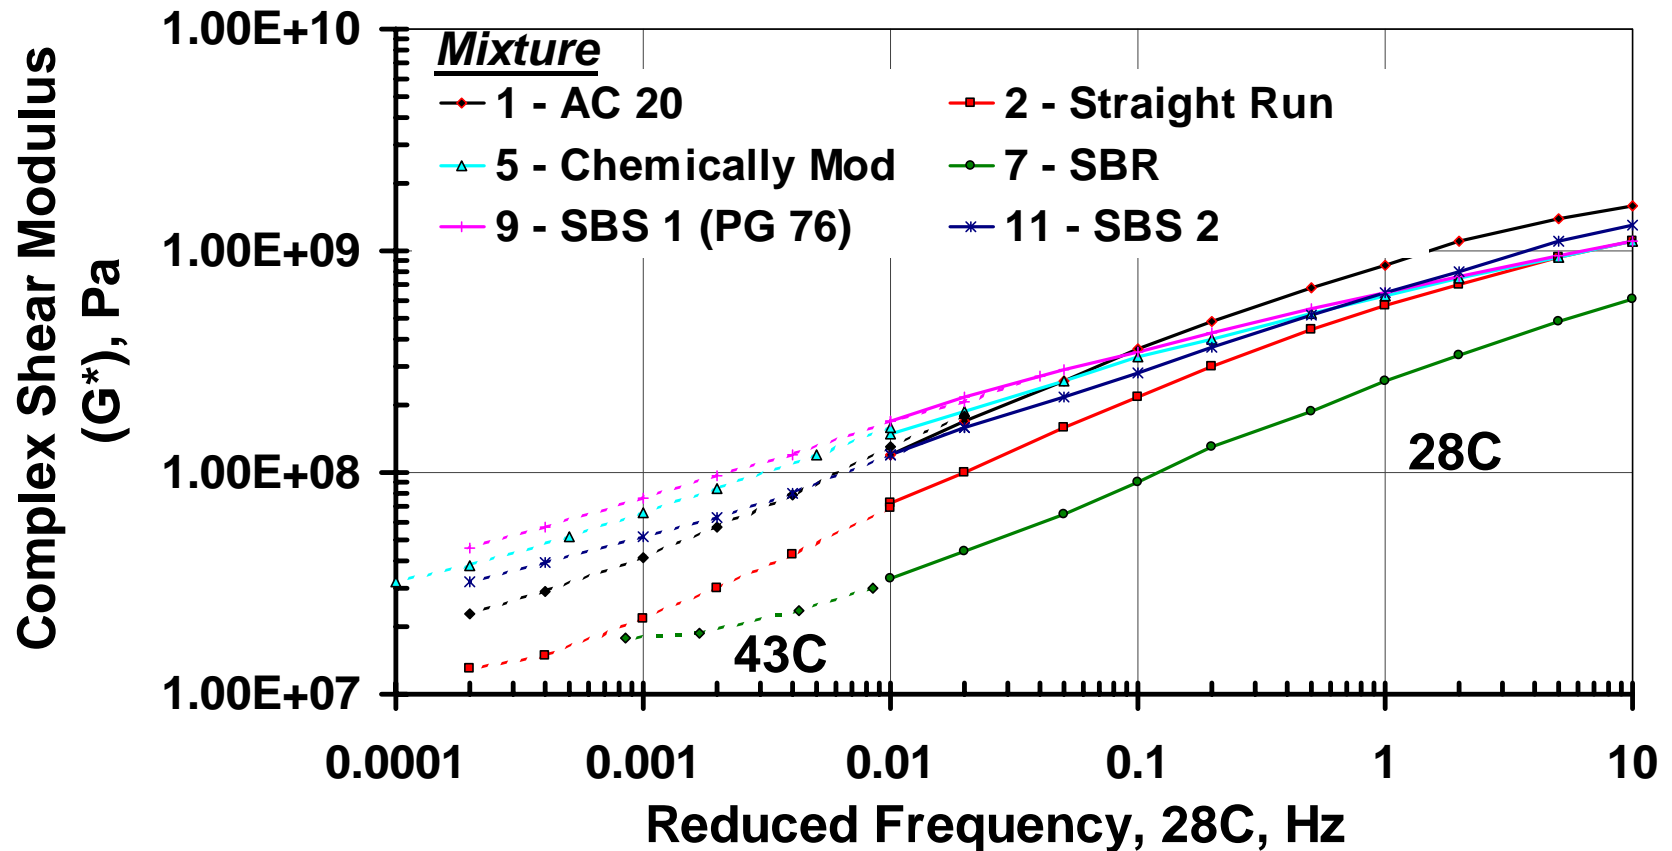
# ***Repeated Shear Test - Frequency Sweep***

***Lab modulus testing***

## Normalized at $T_{\text{eff}}$ (fatigue) = 28.0C

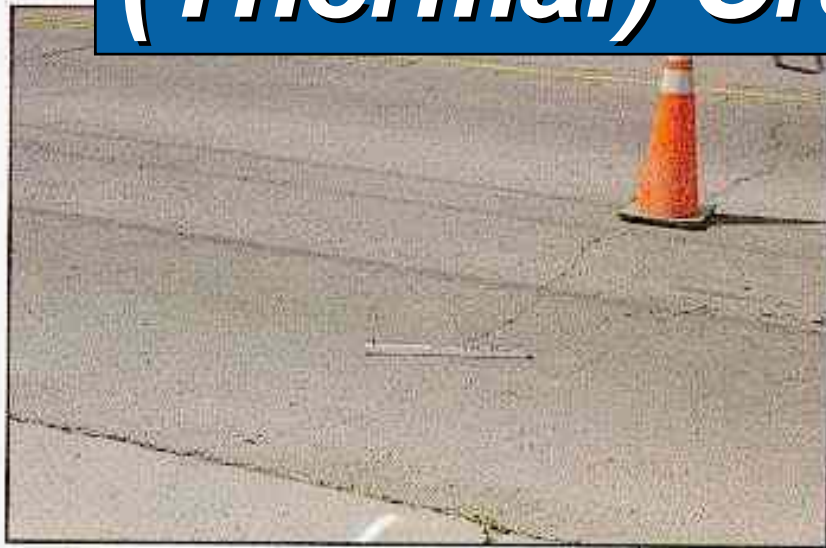
**FIGURE 20**  
ACP 6. Moderate Severity Transverse Cracking

# ***What Is Transverse (Thermal) Cracking?***

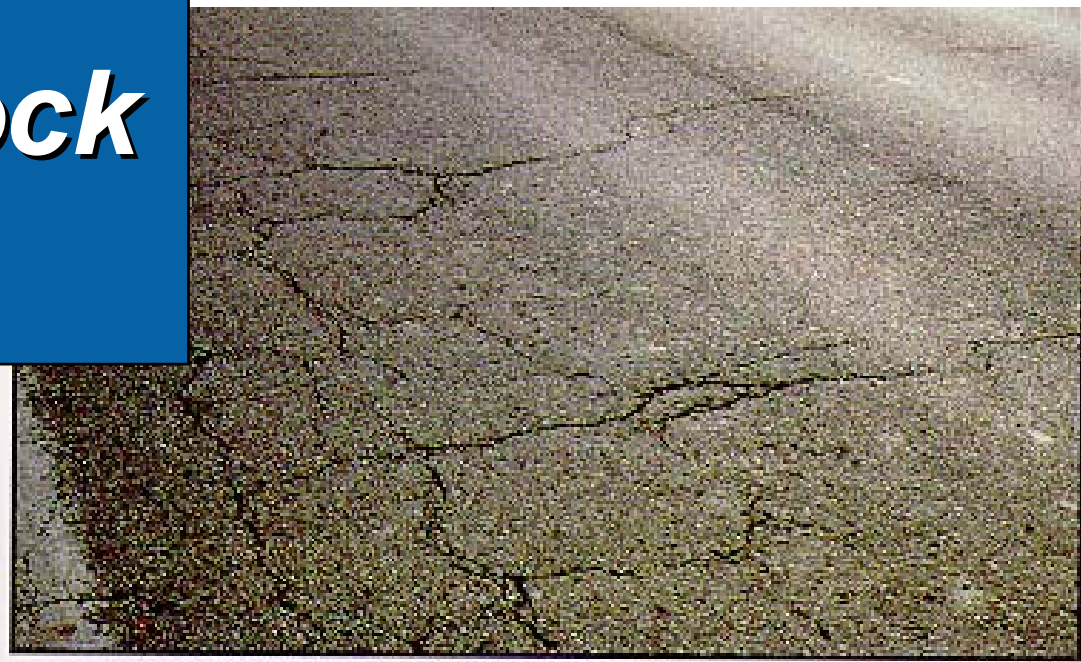
**FIGURE 10**  
ACP 2. High Severity Block Cracking

# ***What Is Block Cracking?***

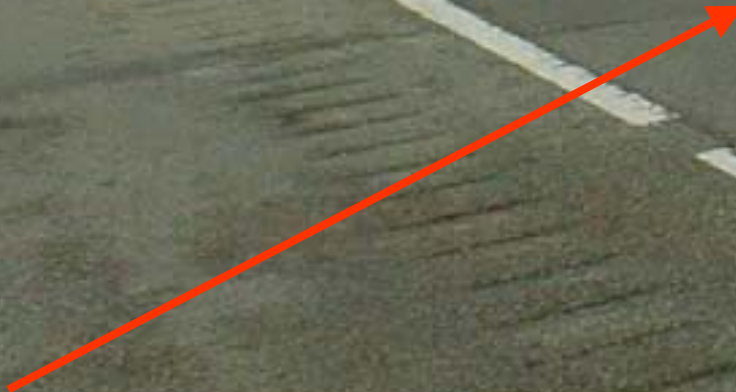
# ***Transition from Section 7 to Section 8, Nov. 2001***

**Section 7**

**Section 8**

**Color difference**
