**FORMED PLASTICS** INC.

ARM 2012 Product of the Year: A Case Study

# Ball Sanitizing Machine Housing

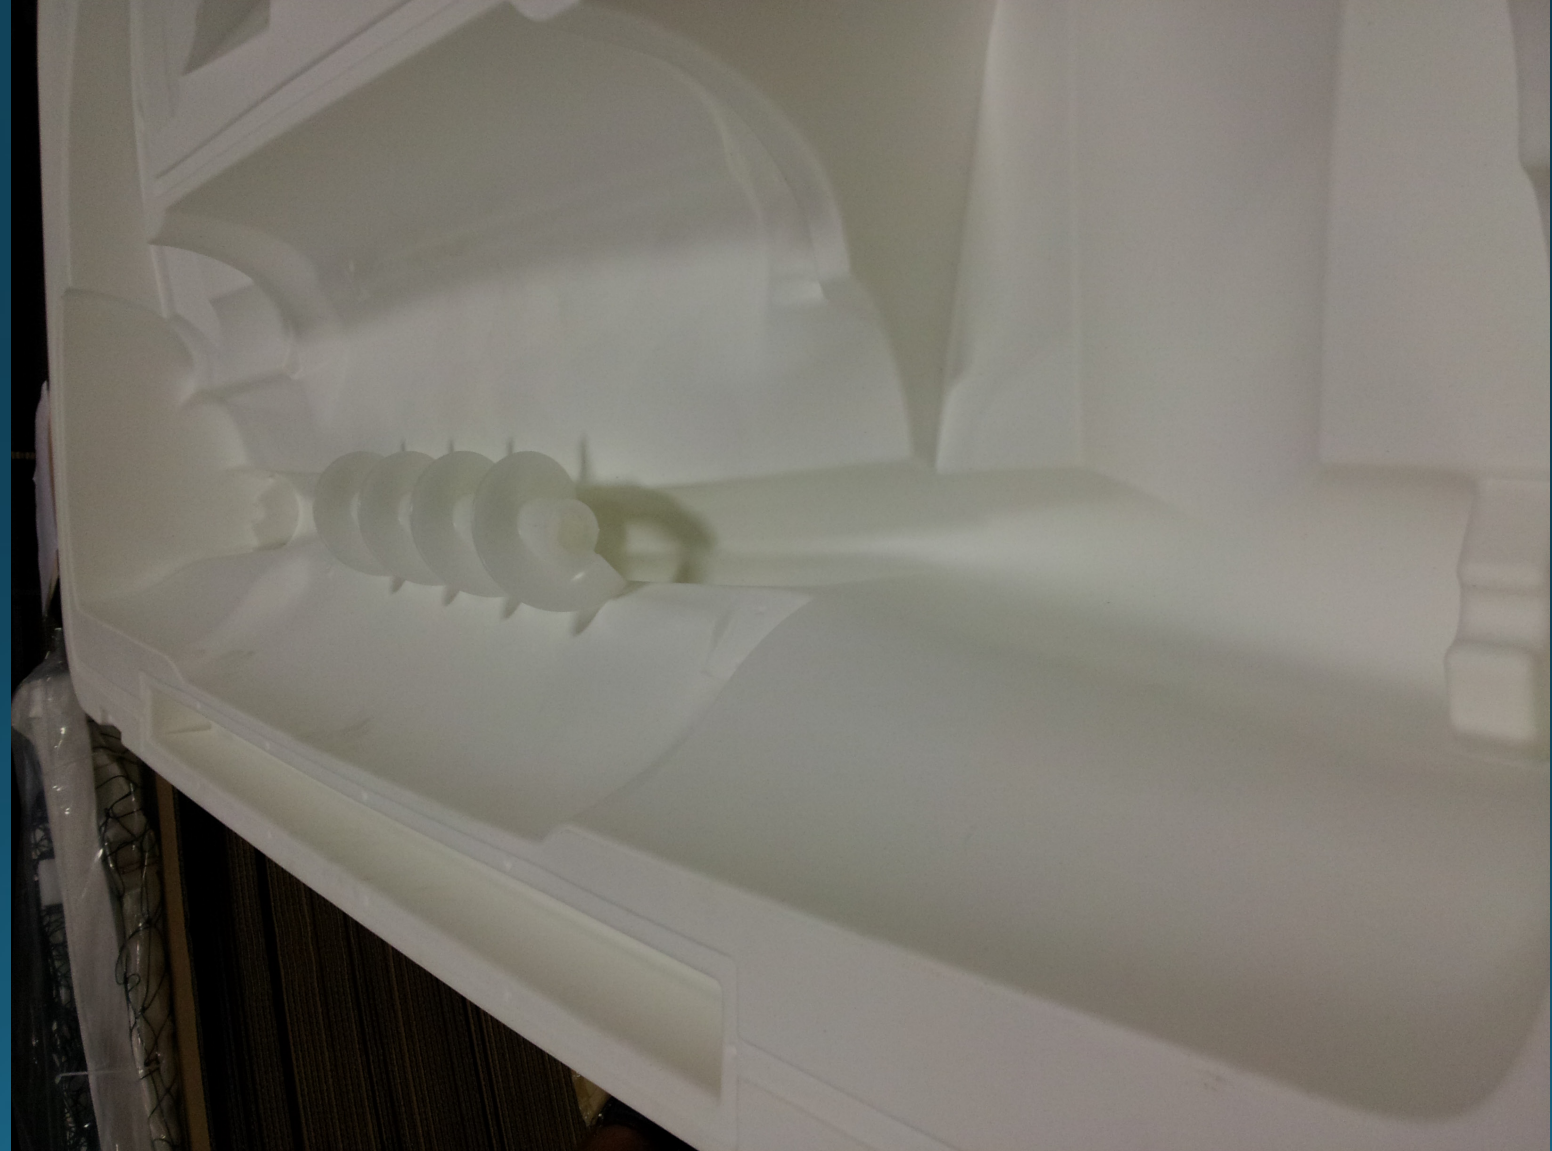
# Loss of Wall Thickness Weakens Part

- Walls in auger trough deformed
- Auger does not fit

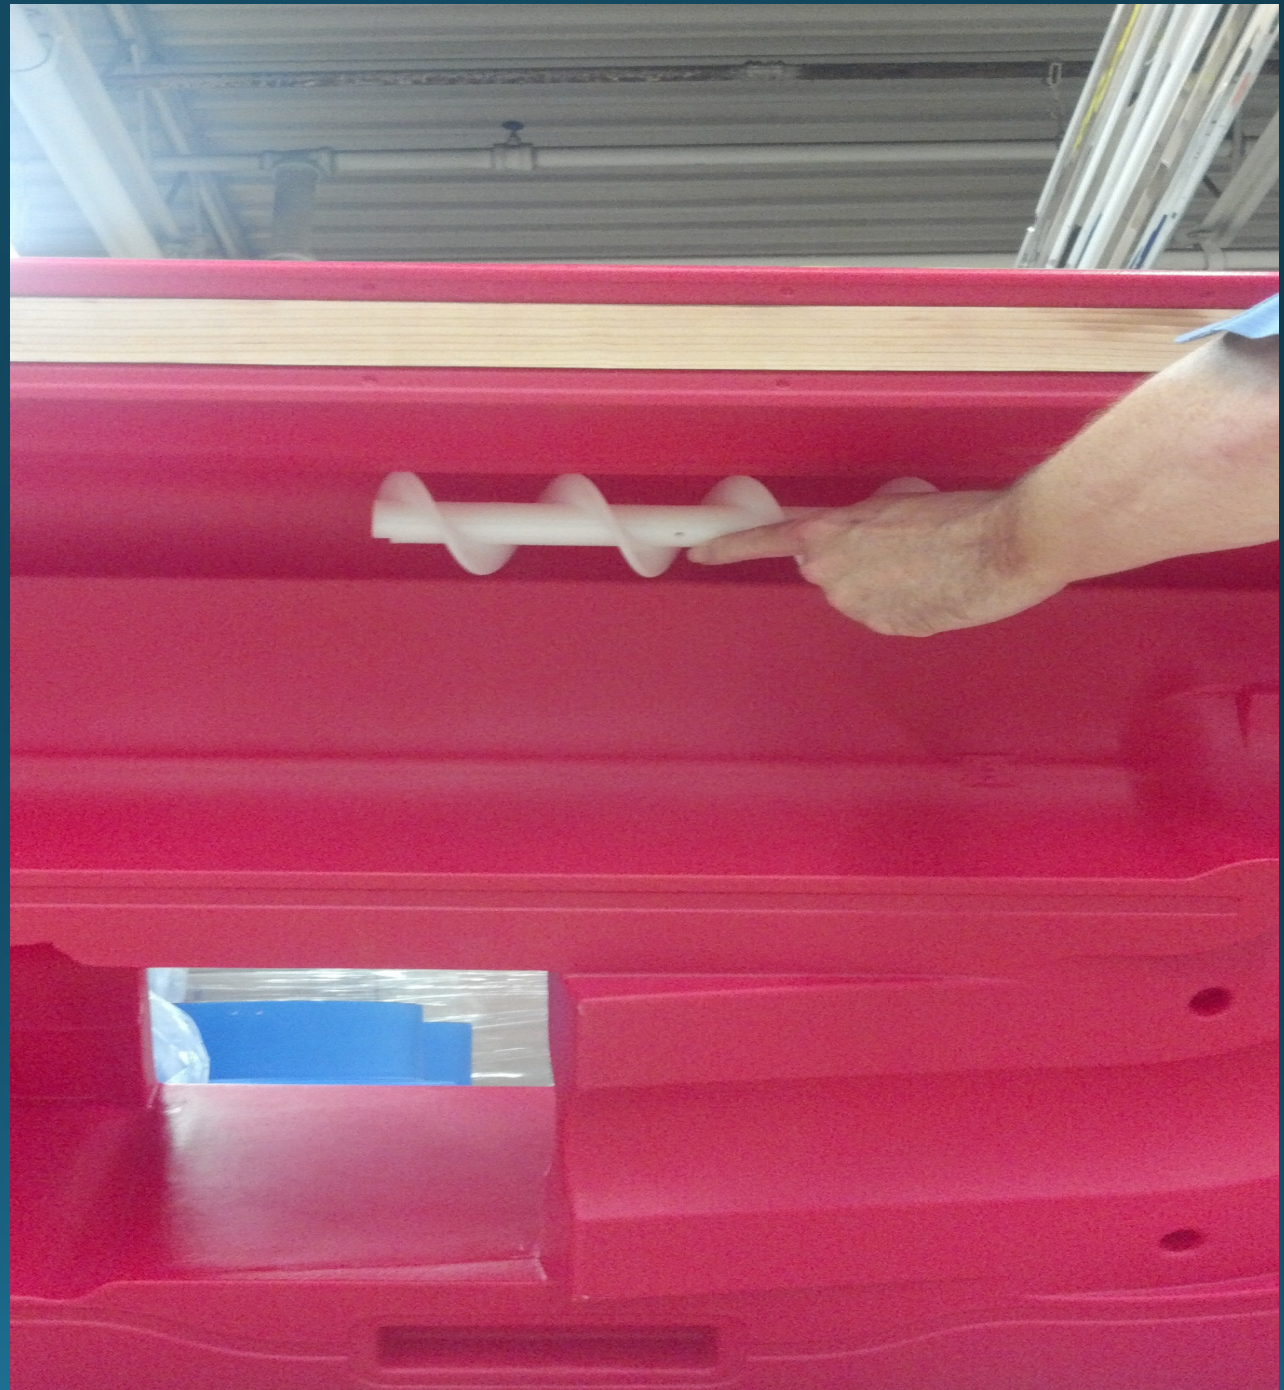
# After

- Good fit for auger
- Wood shipping fixtures maintain integrity of other key areas during transit

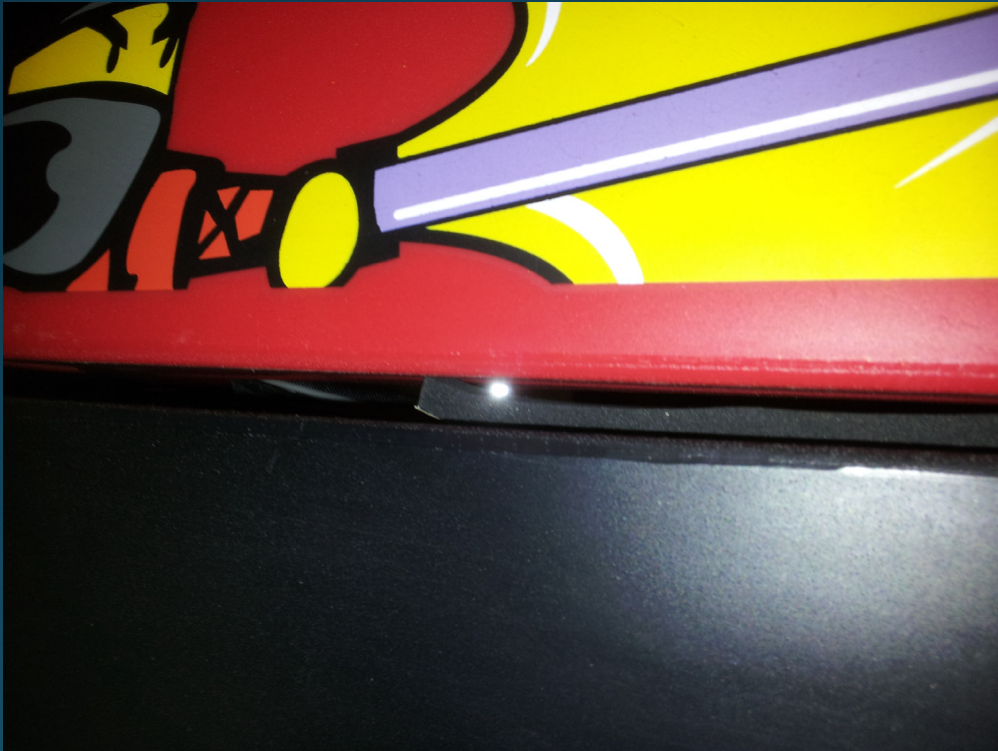
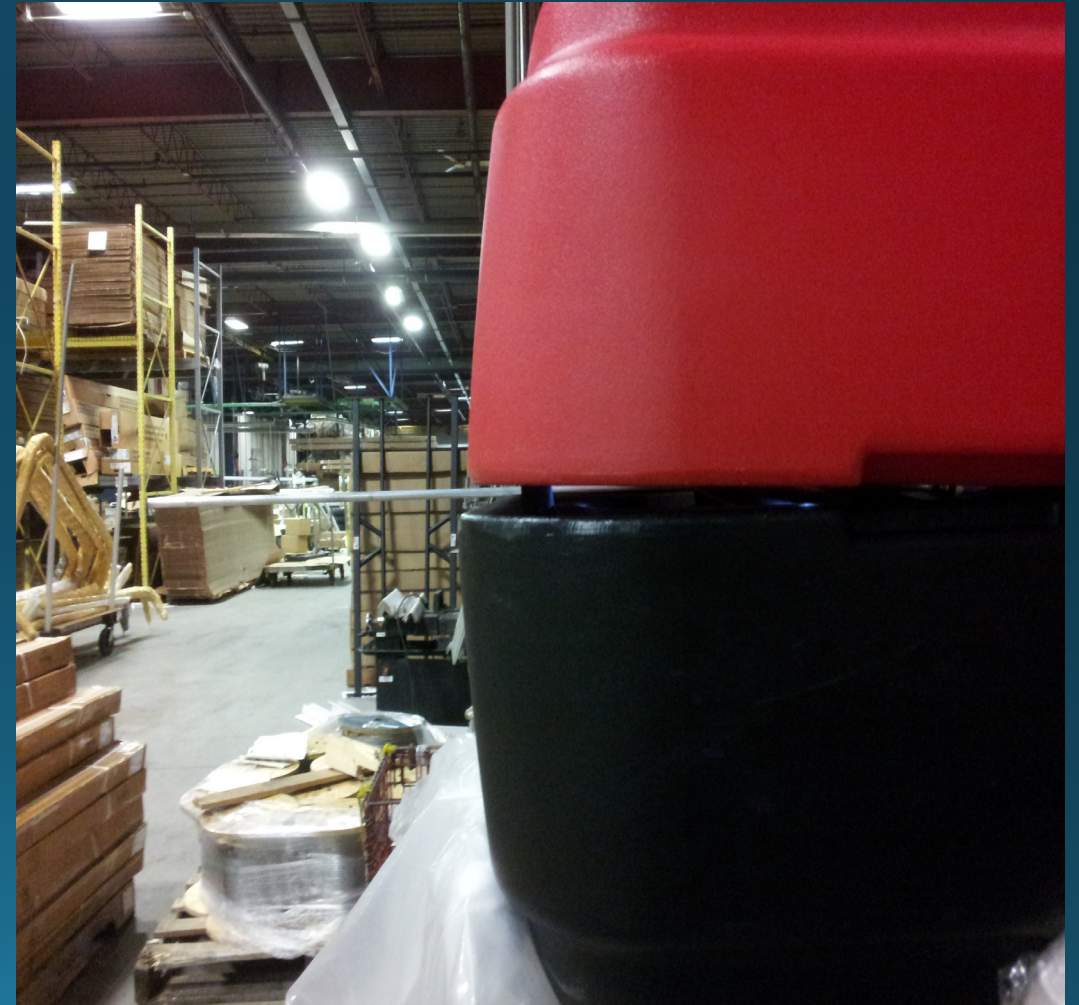
# Warpage Prevents Unit from Closing Properly

- Corners are especially problematic.

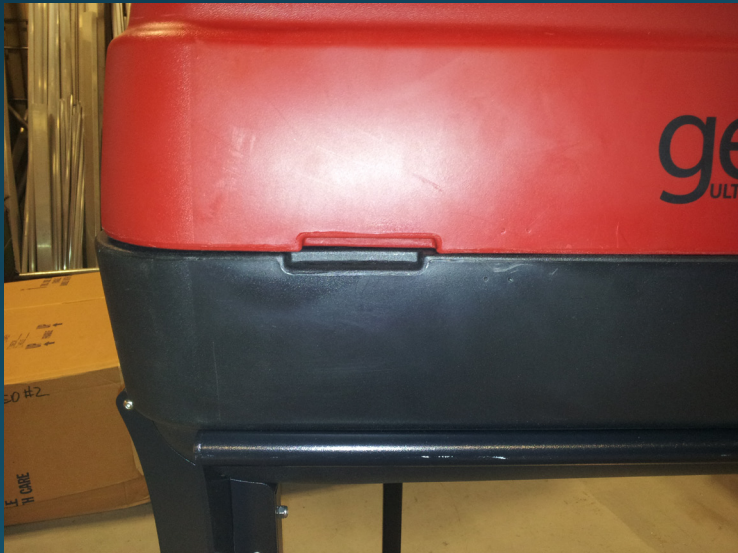
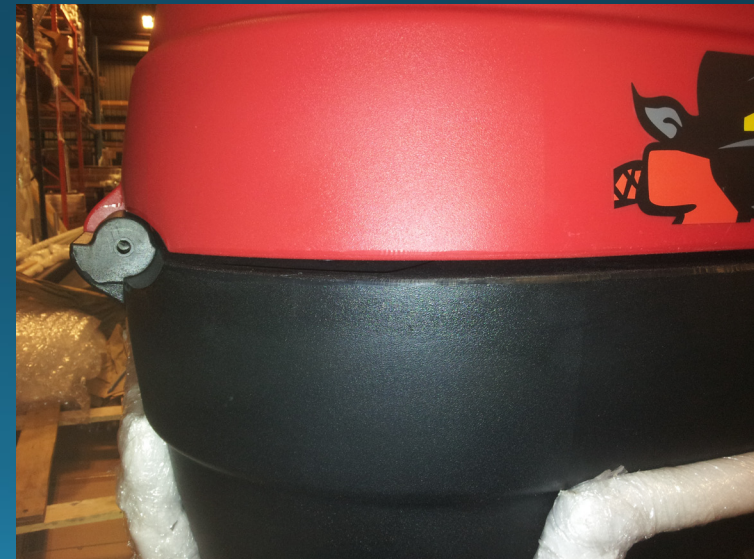
# Poor Alignment of Molded Features

- Recesses in front of unit misaligned.
- Oversized gap between hinge knuckles in back of unit.

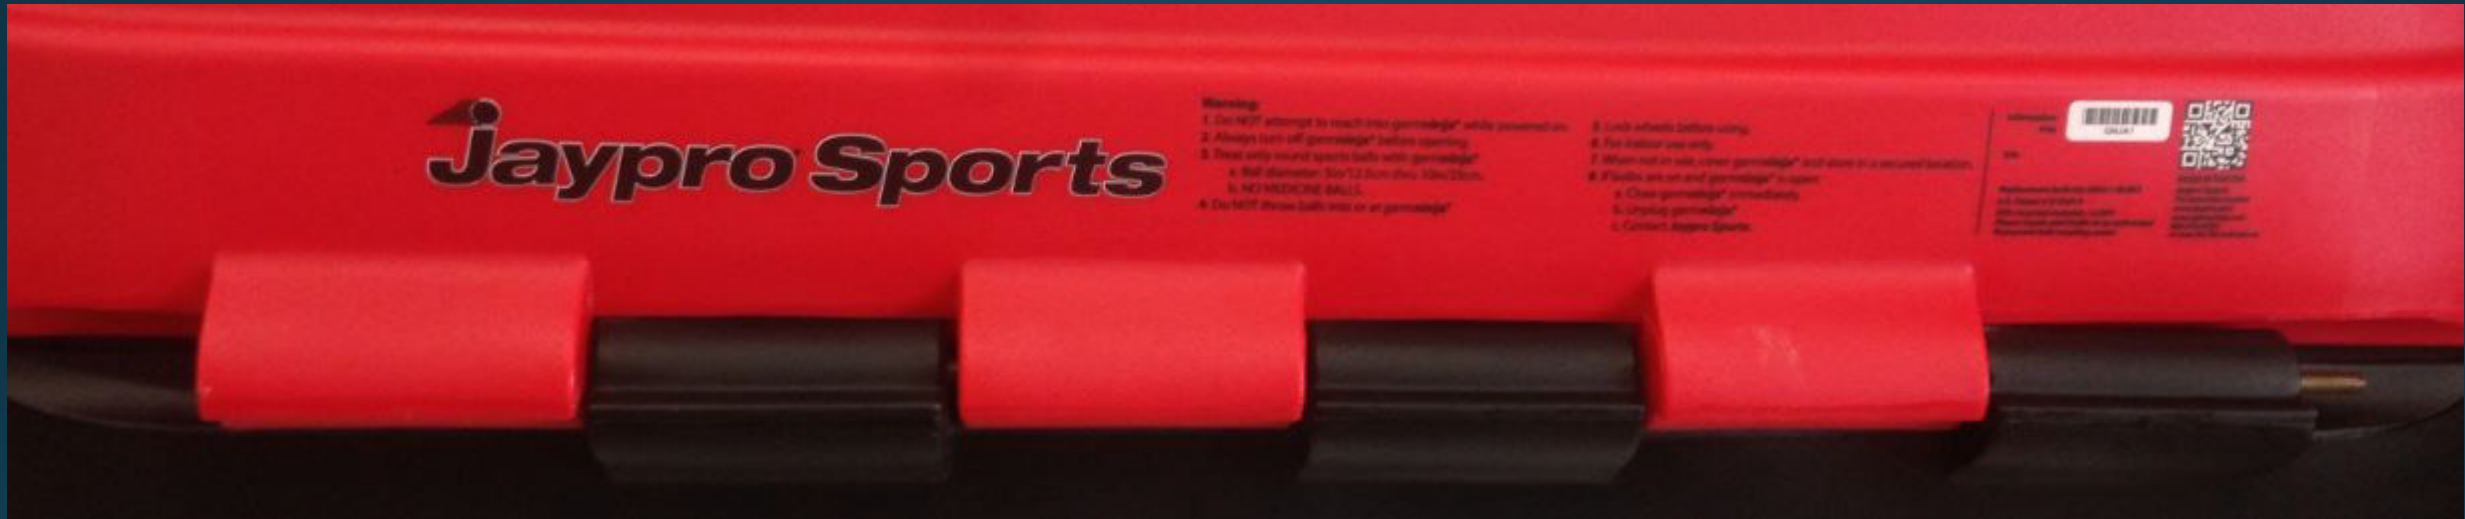
# After

- Correct spacing between hinges resolved several alignment issues.

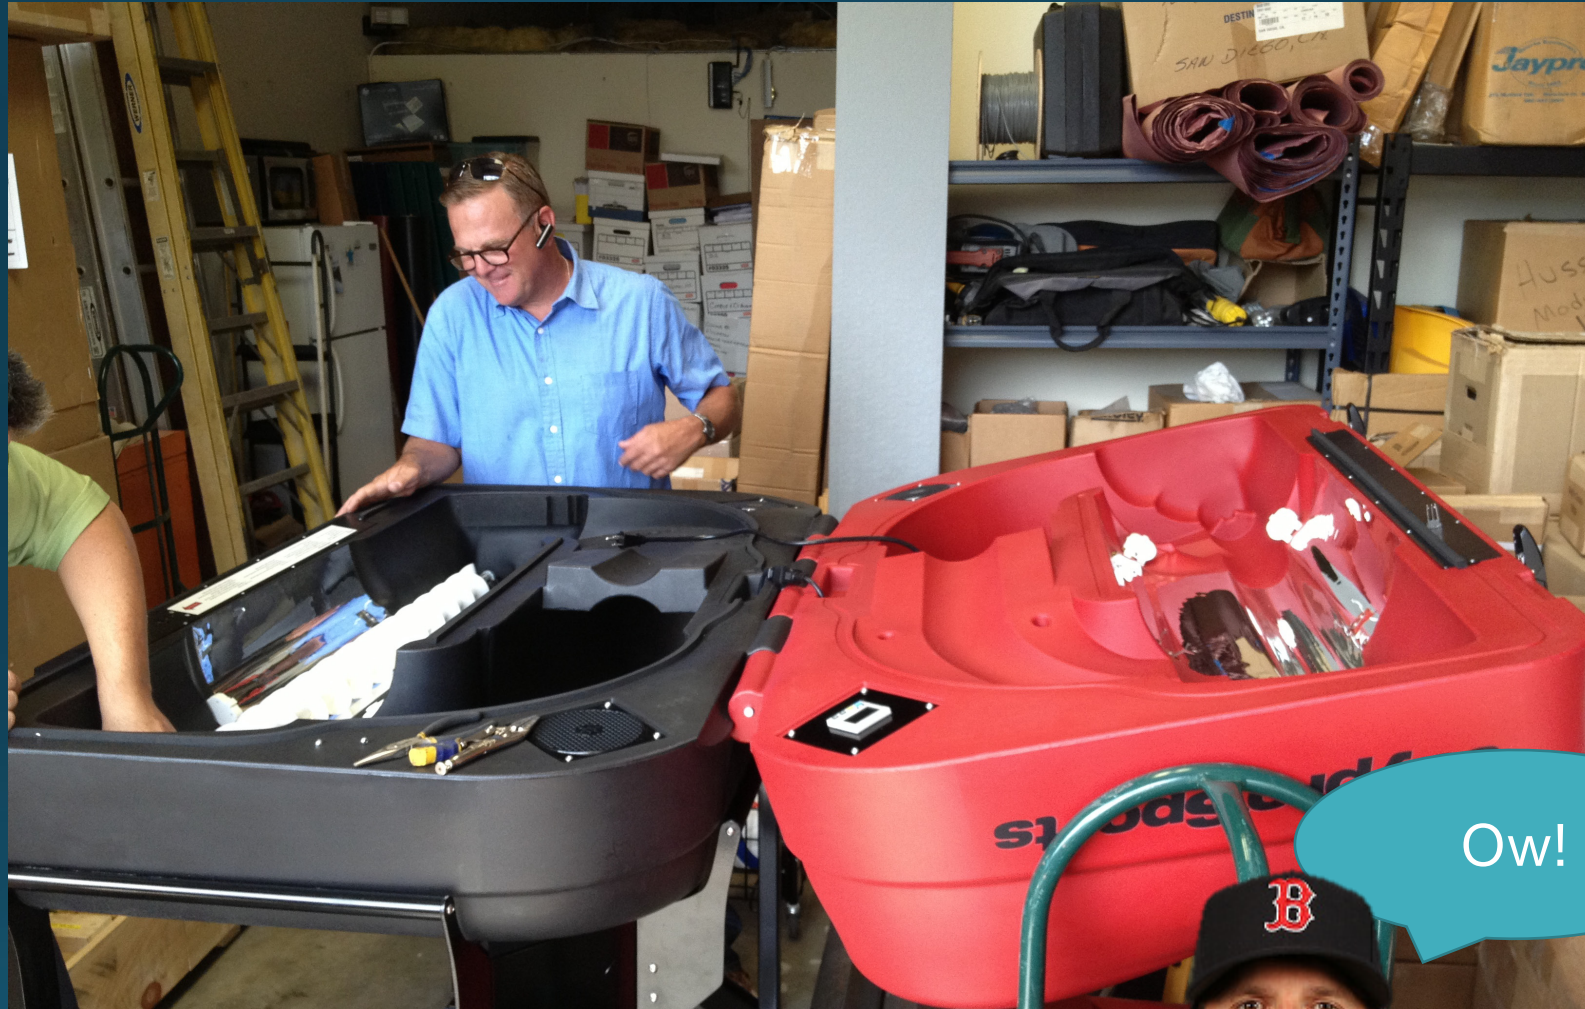
# Top Half Collapses

- Customer request: reduce weight by 10%. Resulting loss of wall thickness triggers problems in several key areas
- Warpage on flat faces where two halves meet caused the corners to bow open; unit would not close properly
- Key molded features not aligning properly from part to part
- Top half of part collapsing backwards when left open due to insufficient strength in hinge area
- Visible background on MIG deemed unacceptable
- Molded-in barcode not readable

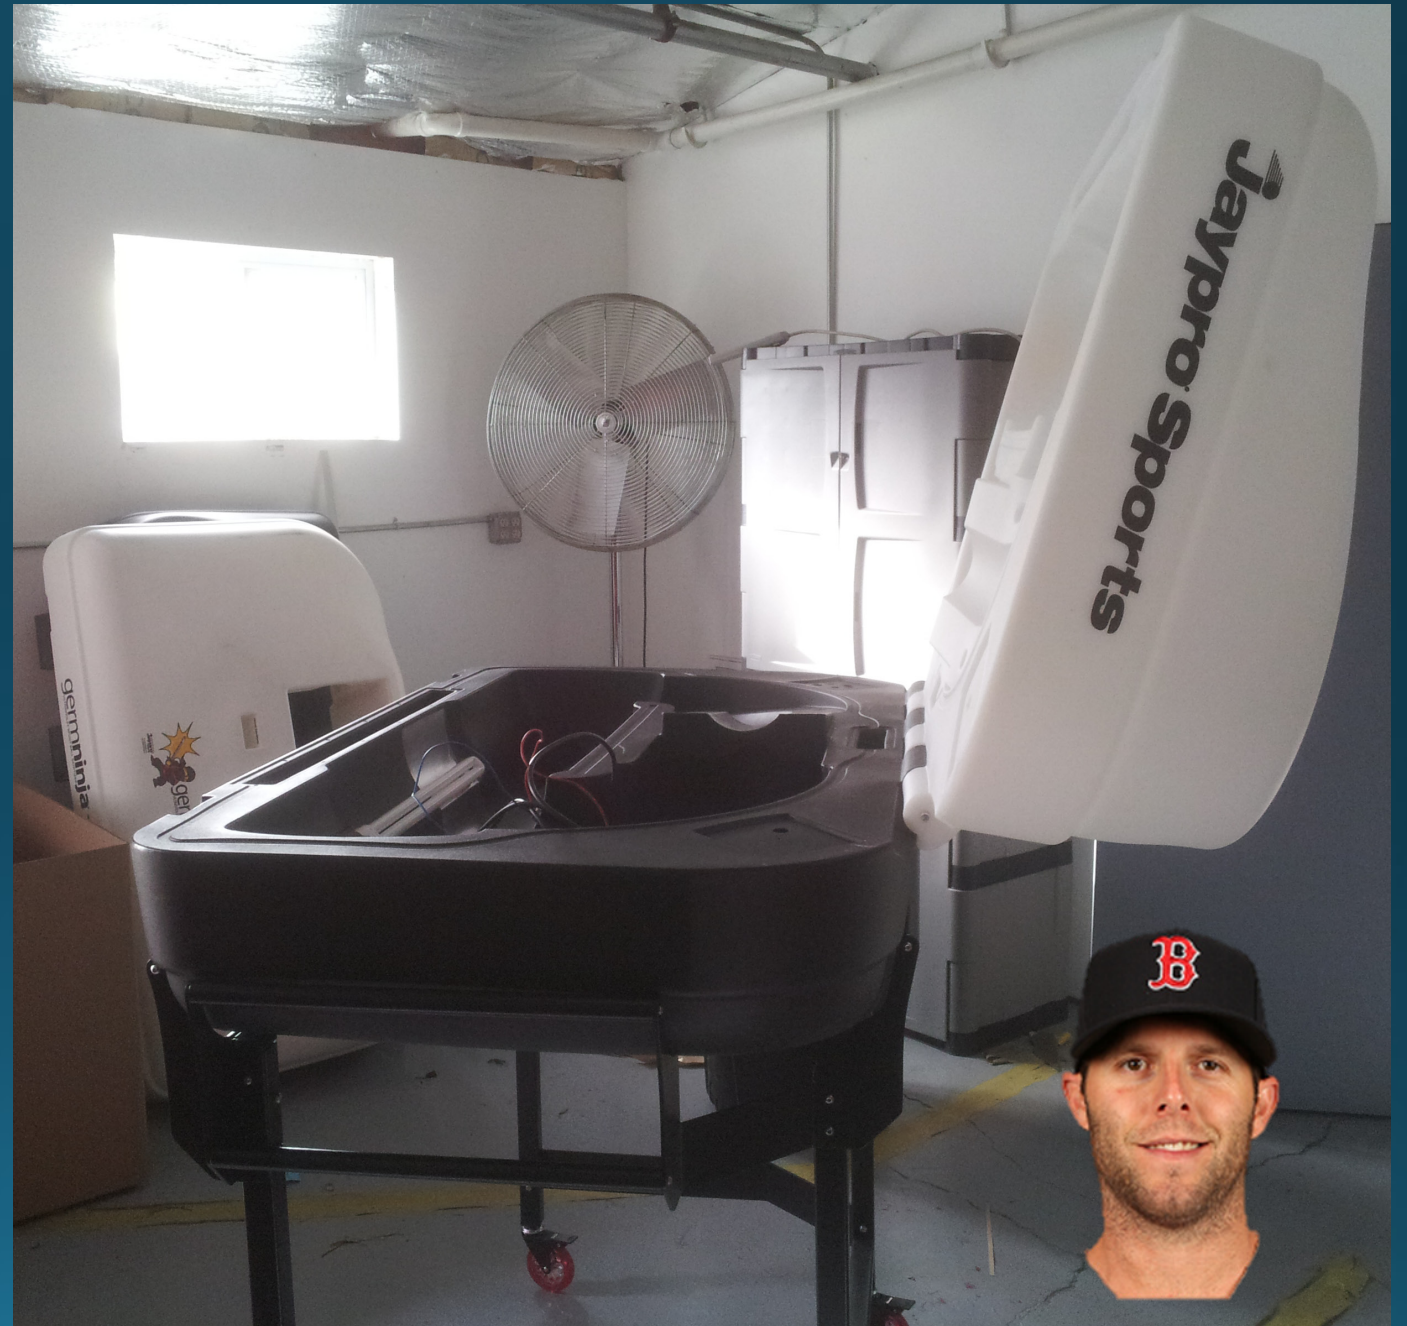
# After

- Unit strong enough to stay open until 2016 Olympics.

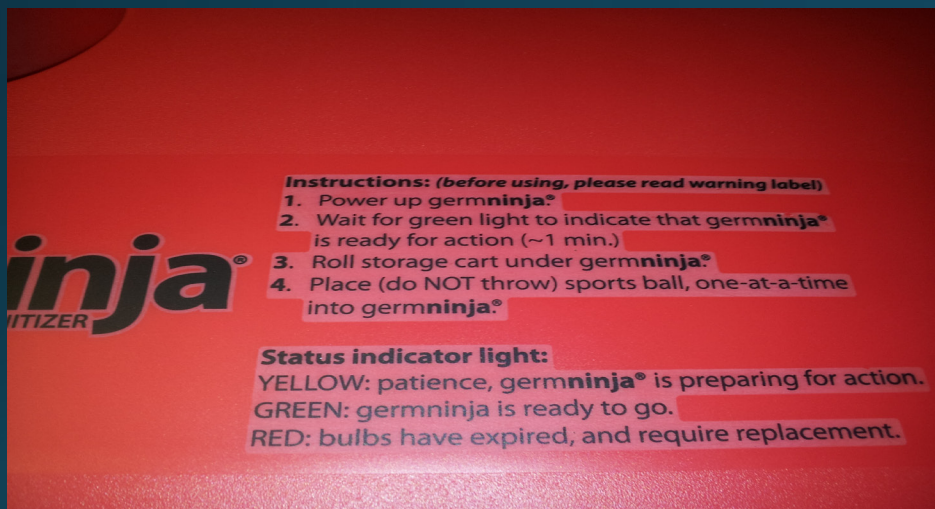
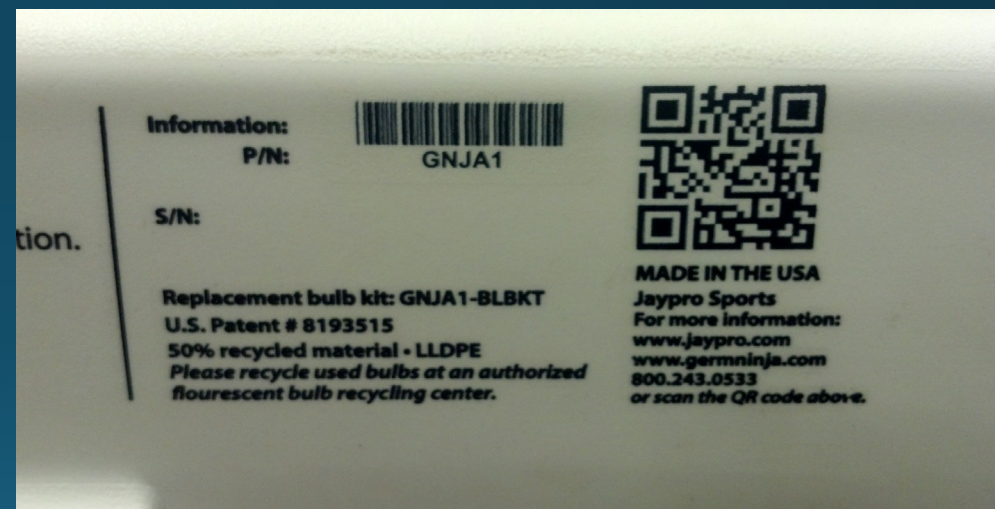
# Graphics Behaving Badly

- Background film visible in molded part
- Barcode not reading properly

- 100+ emails with Clark Boyce, visit from John Schreiner...  
Success!
