# Cleaning and Sanitizing with Electrolyzed Oxidizing (EO) Water

Ali Demirci, Ph.D.

Department Agricultural and  
Biological Engineering  
Pennsylvania State University

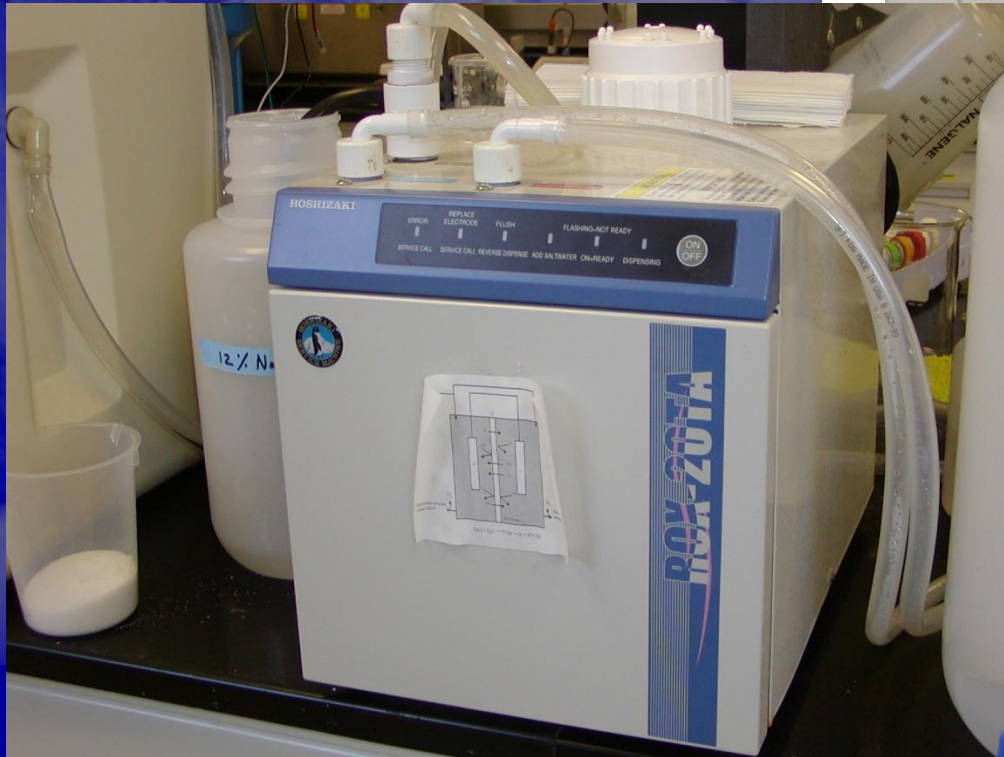
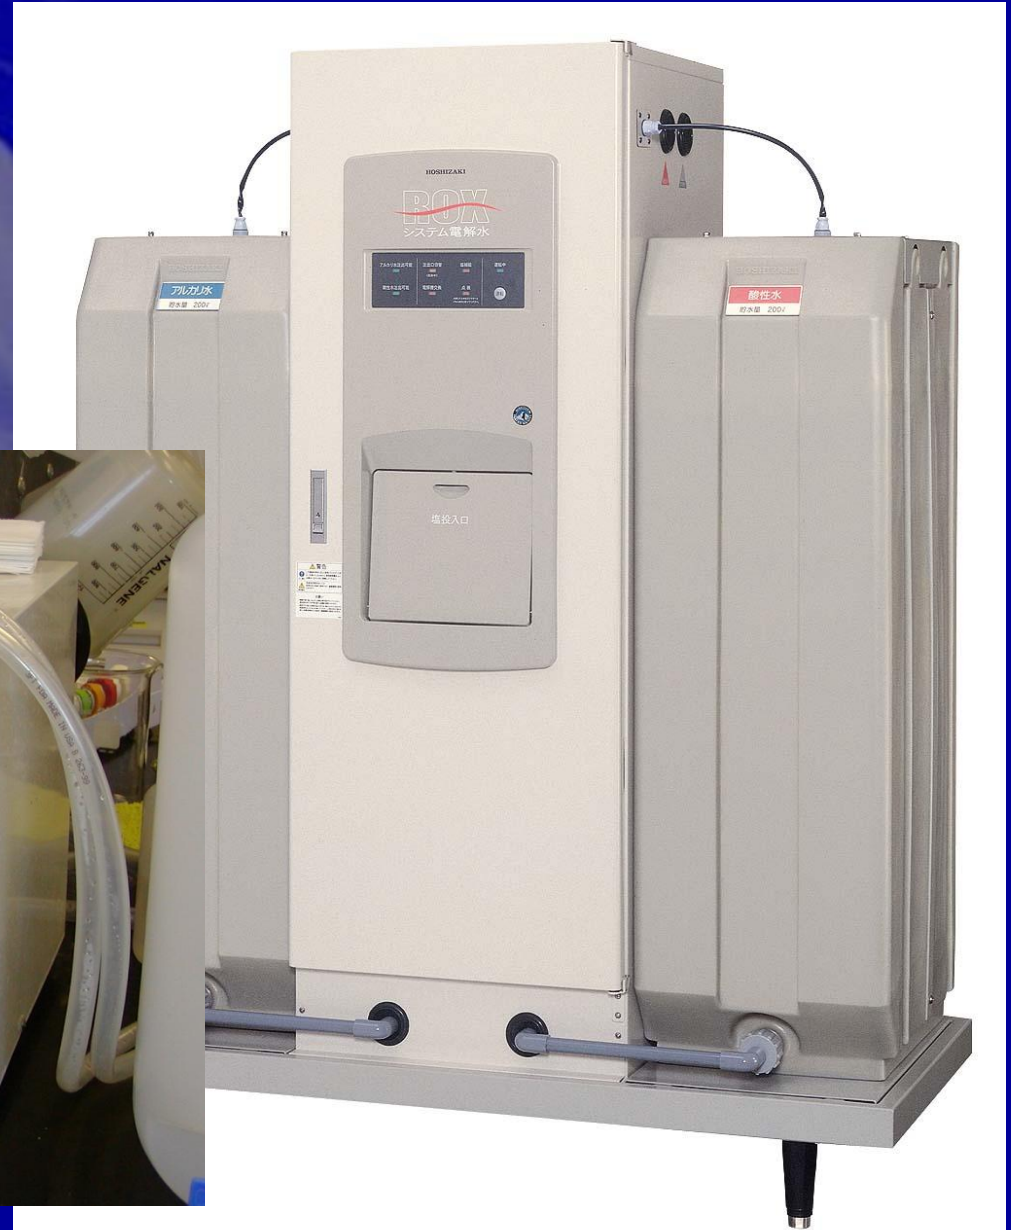
# EO Water Generator

- Separates chlorine ions from sodium ions in a weak sodium chloride solution
- Produces an alkaline solution (sodium ions) and an acidic solution (chlorine ions)

- pH of 11.4
- Oxidation Reduction Potential (ORP) of -795 mV

- pH of 2.6
- 50 - 80 ppm free chlorine
- ORP of 1150 mV

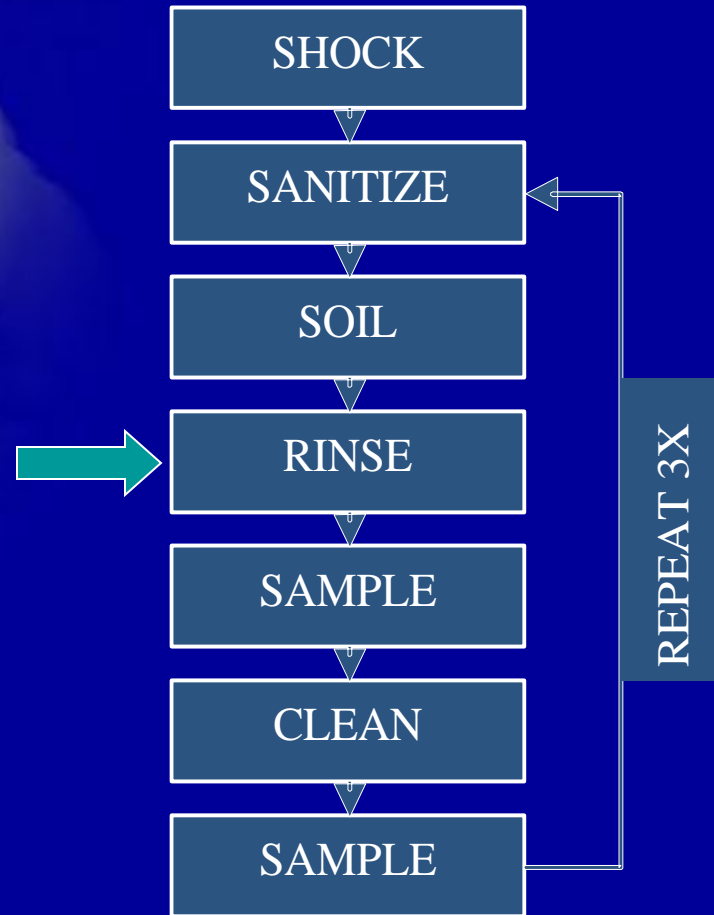
## Rinse

Rinse system with warm (about 40°C) water to remove fluid milk

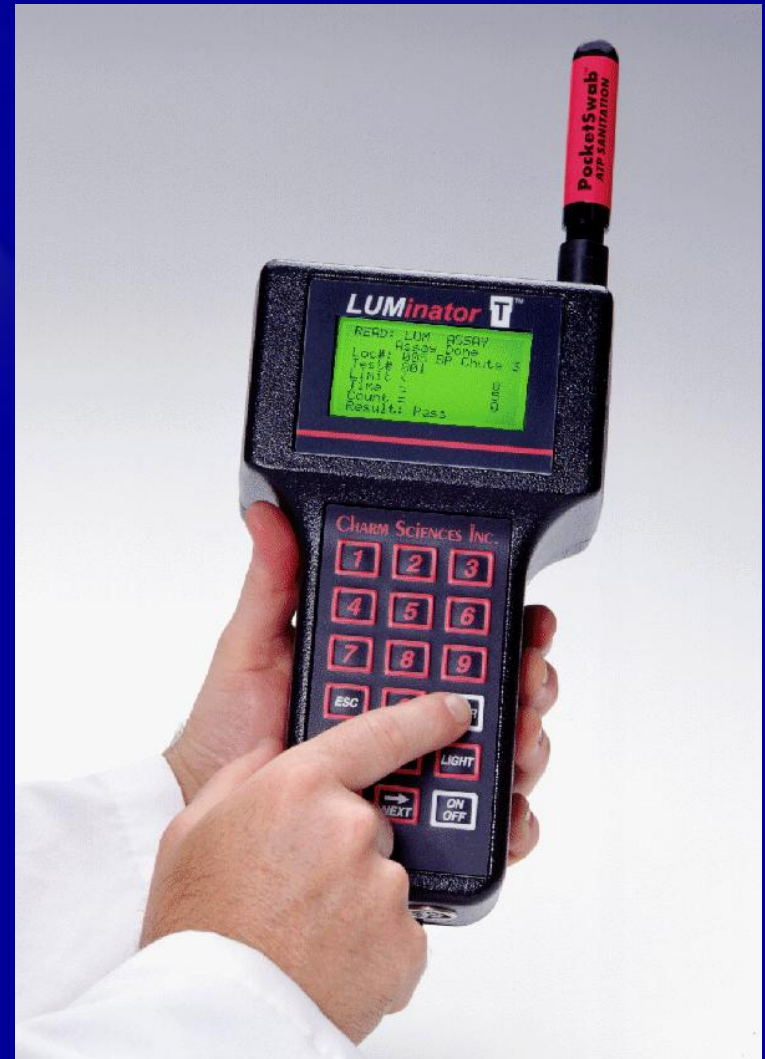
# LUM-T and PocketSwab Plus

- Enzyme luciferase catalyzes a reaction with ATP that emits light
- PocketSwab is self-contained pre-moistened swab including reagents
- Light levels are read by “Luminator” unit and reported as an RLU score

- After treatment, each sample was swabbed with PocketSwab Plus (Charm Science, Inc.), for 6 seconds, roughly covering the 10cm<sup>2</sup> area.
- Pocketswab was evaluated in LUM-T luminosity meter.
- Results were reported directly as RLU score (Clean = RLU score of 0 )
