Electrolyzed Water Technology

Electrolyzed Water Trial
At Evergreen Farms

October 21, 2010

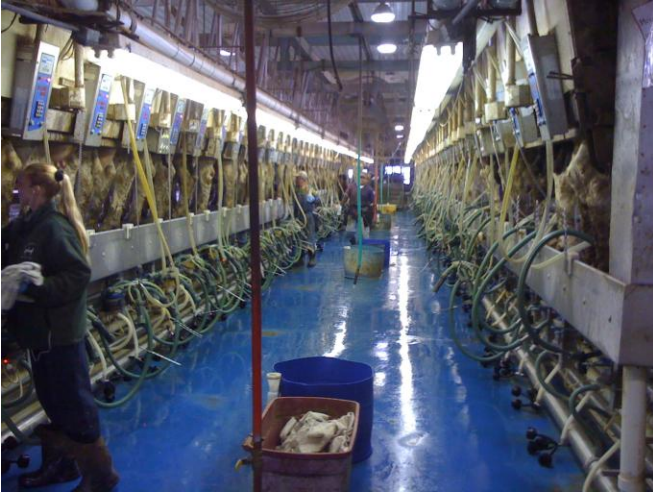
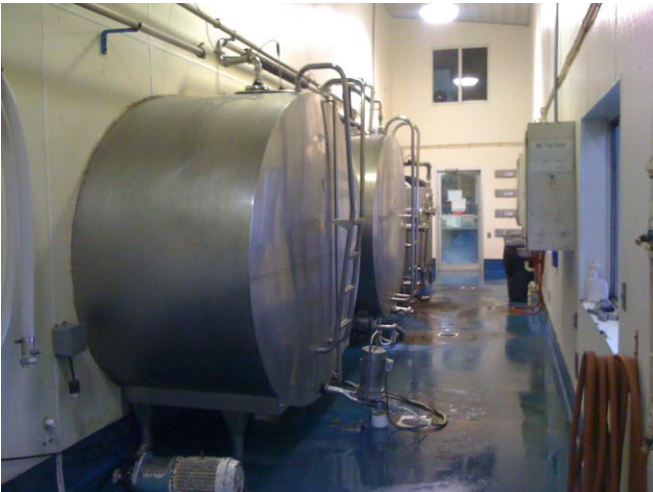
Evergreen Farms in Spruce Creek, PA

- Evergreen Farms is owned and operated by Wayne Harpster's three sons, and resides on about 5,000 acres in central Pennsylvania.
- As one of the largest dairy farms in PA, the Harpsters milk approximately 2,450 dairy cows three times a day.
- Evergreen Farms was the first to install a double 40 parallel parlor with a 4" low line that is cleaned three times a day.
- Evergreen Farms operates with two 6,000 gallon milk storage tanks that on average are each drained and cleaned twice a day.
- LFSS is working closely with Abe Harpster on the installation and field testing of its electrolyzed water based cleaning and sanitizing system.

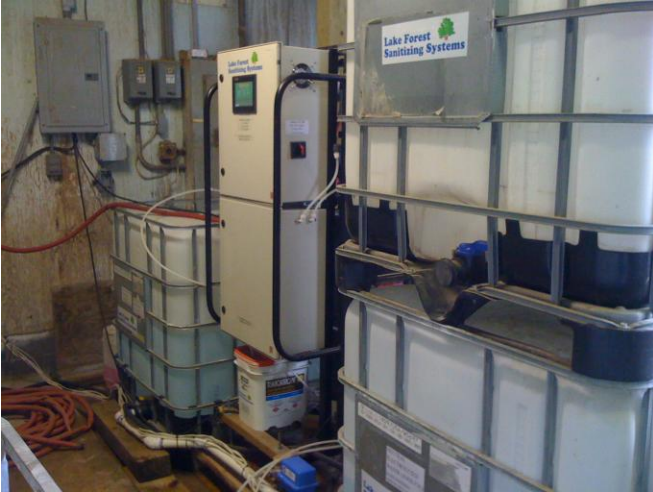
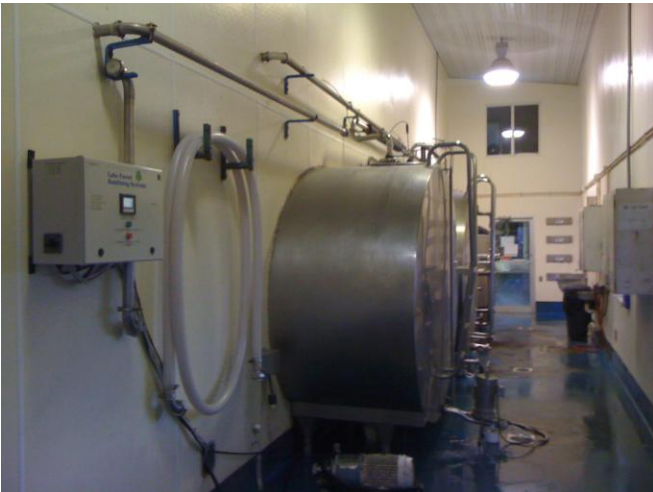
System Configuration

- The majority of the system components are located on the opposite side of the wall from the tank room. This includes the EW production machine, solution storage tanks, electronic flow valves, water supply pipes, hot water heater and a separate circuit breaker/power supply box.
- All of the solutions used in the cleaning and sanitizing process are pumped into the milk tank room via a single flexible pipe to avoid any potential contamination.
- A separate PLC unit was developed and installed to independently control the cleaning and sanitizing process.
- Throughout the entire trial, the original system remained in-place with the ability to reactivate it with the flip of a switch.

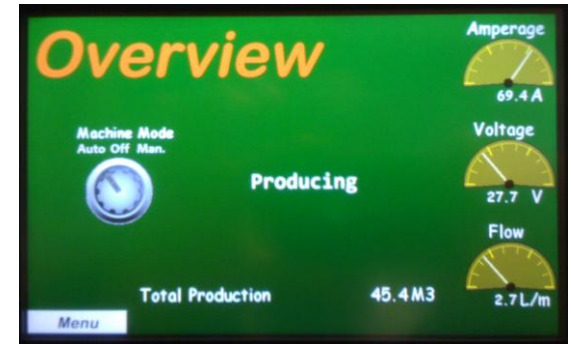
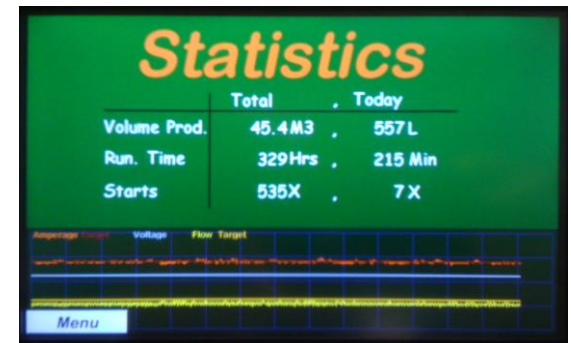
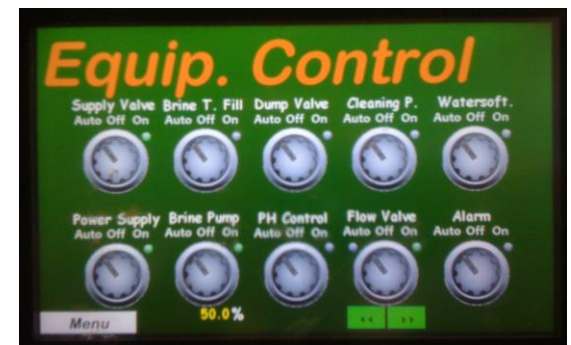
Electrolyzed Water Production Machine

The production machine is capable of producing up to 50 gallons of electrolyzed water per hour – 70% being hypochlorous acid and 30% being sodium hydroxide.

Once installed and configured, the machine should operate without any major maintenance – only the salt supply must be checked regularly.

A fully integrated PLC unit controls all of the critical processes. In a situation when an operating parameter is out of spec, an on-screen alarm will be activated and the machine will automatically shut down.

Only authorized personnel have access to the PLC program and, most importantly, the machine can be remotely monitored and controlled via a secure Ethernet connection.

This specific production machine has been approved by the EPA for on-site production and use under EPA Establishment #85215-PA-00.
