Welcome  
2019 Spring  
Apartment  
Report Panelist  
Rudy Munzel

**Apartment Report**

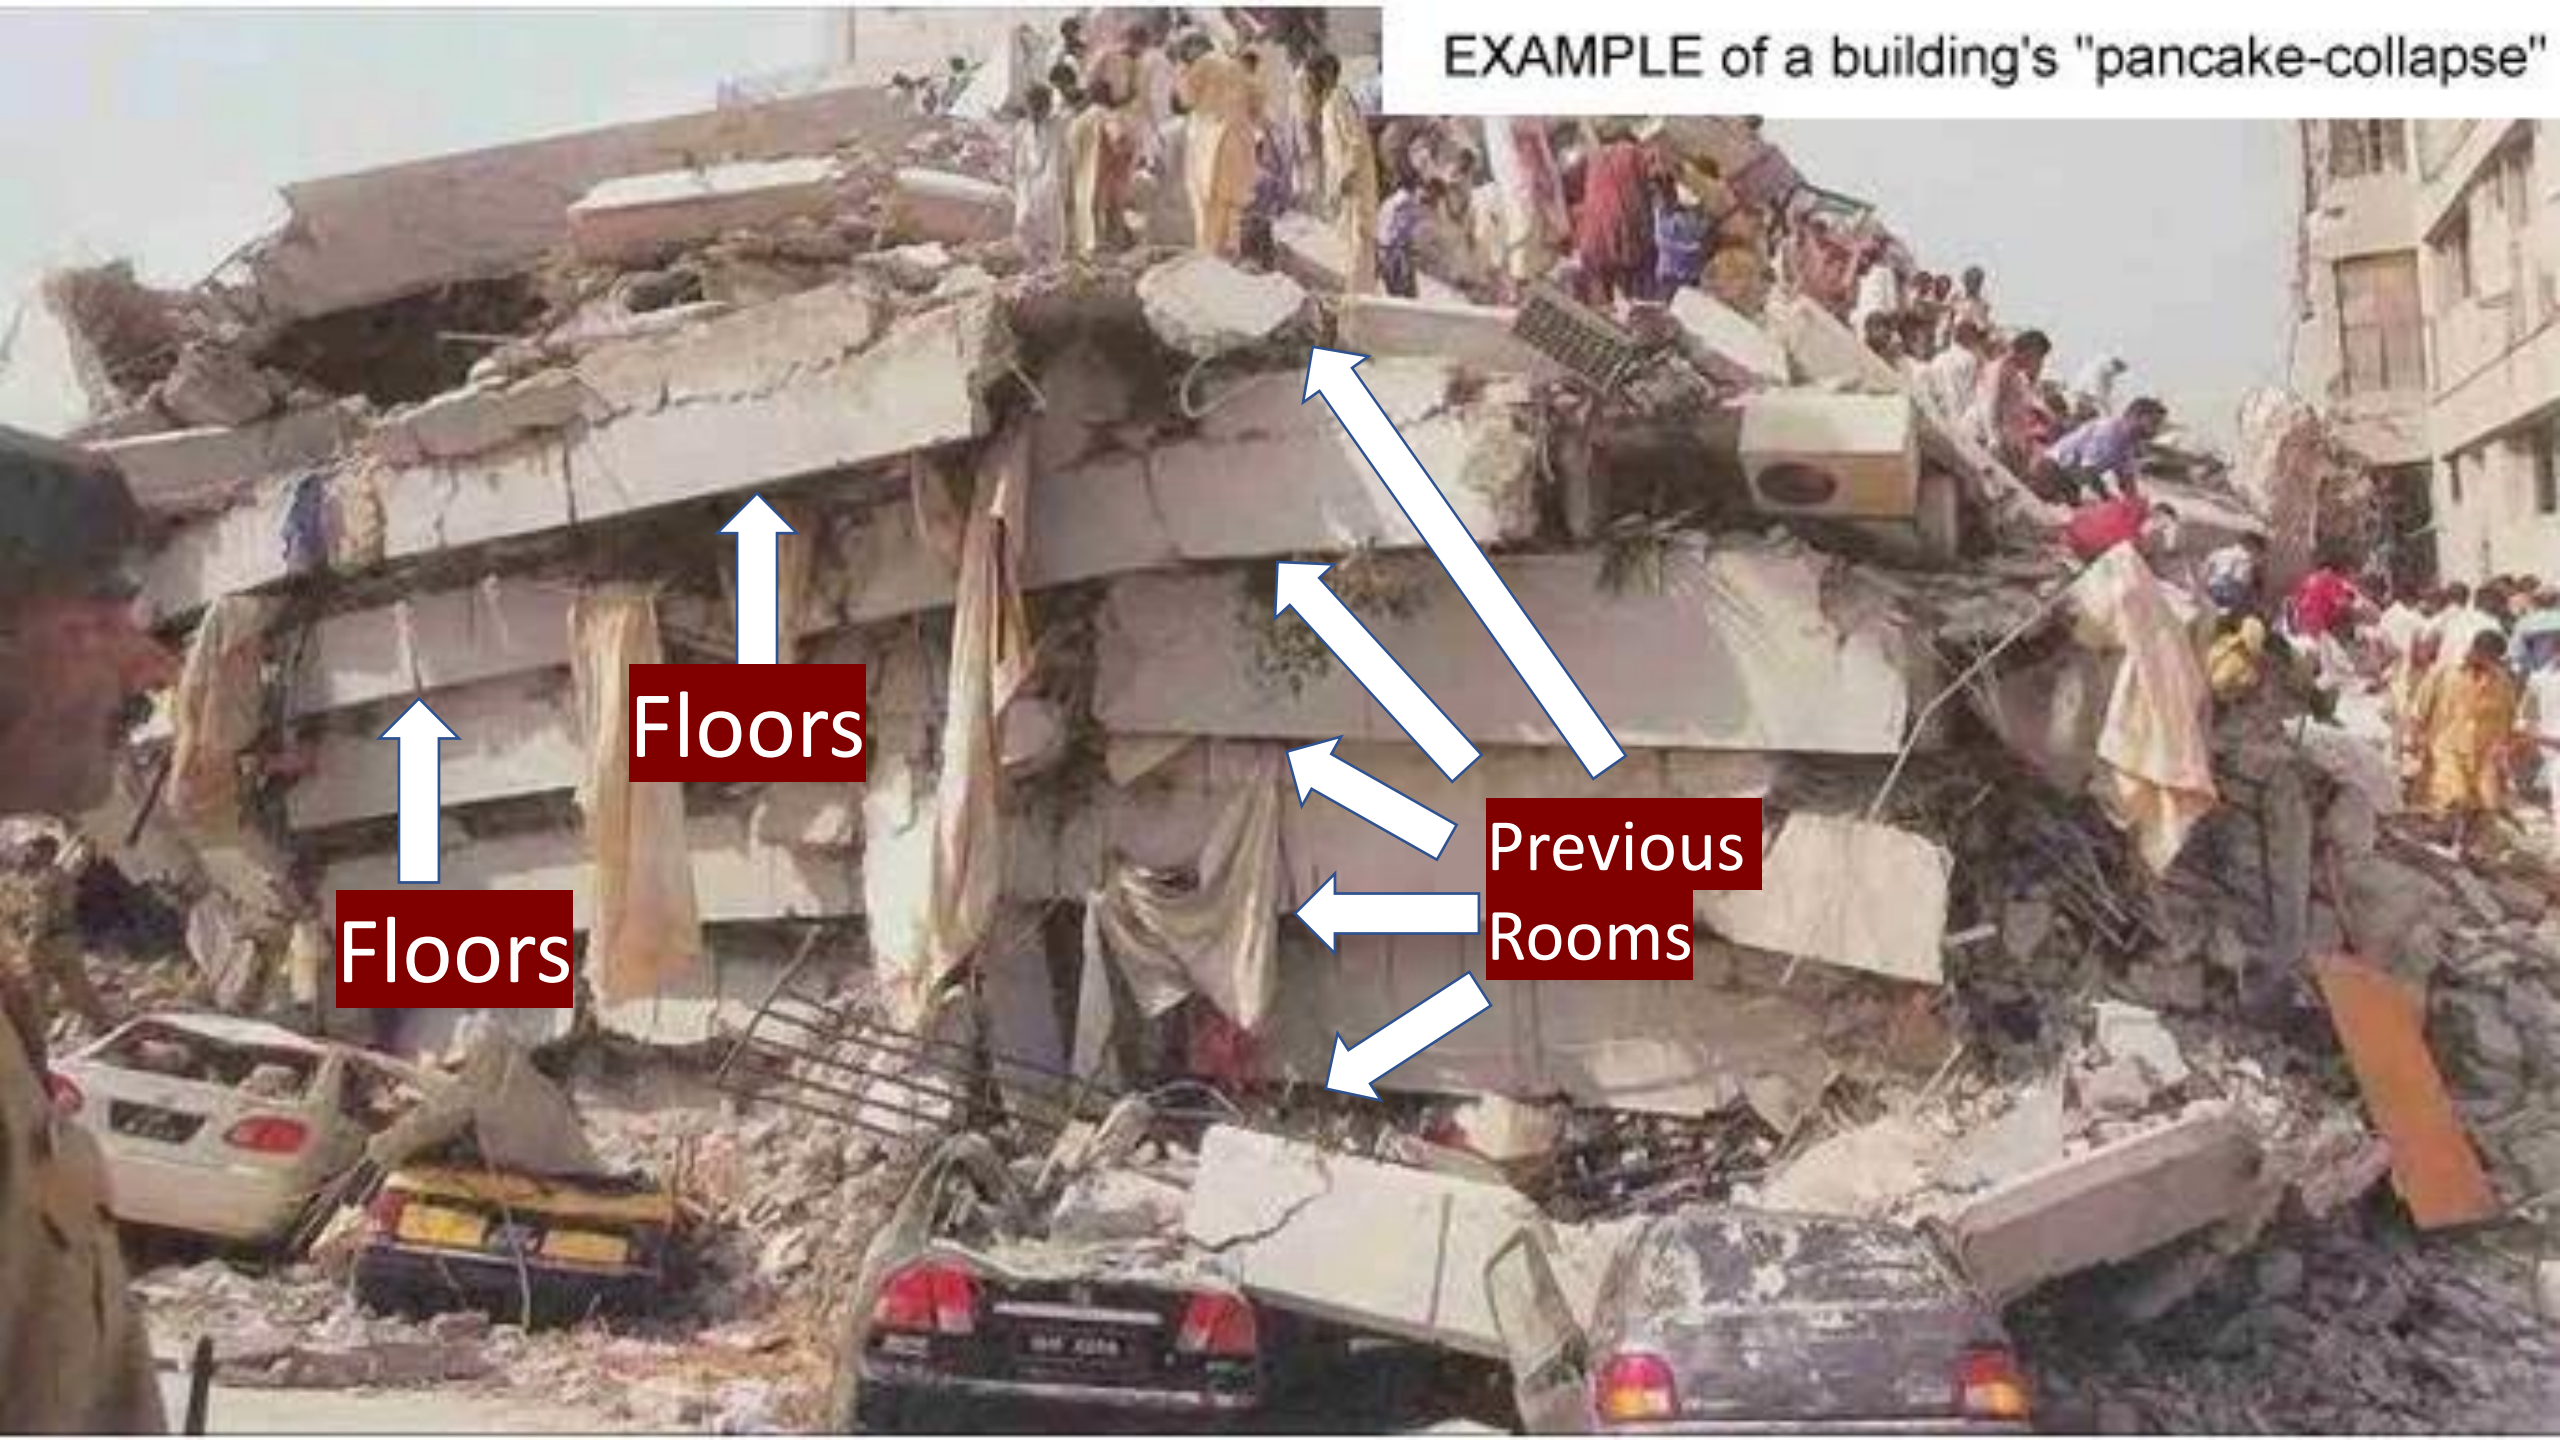
EXAMPLE of a building's "pancake-collapse"

Floors

Previous Rooms

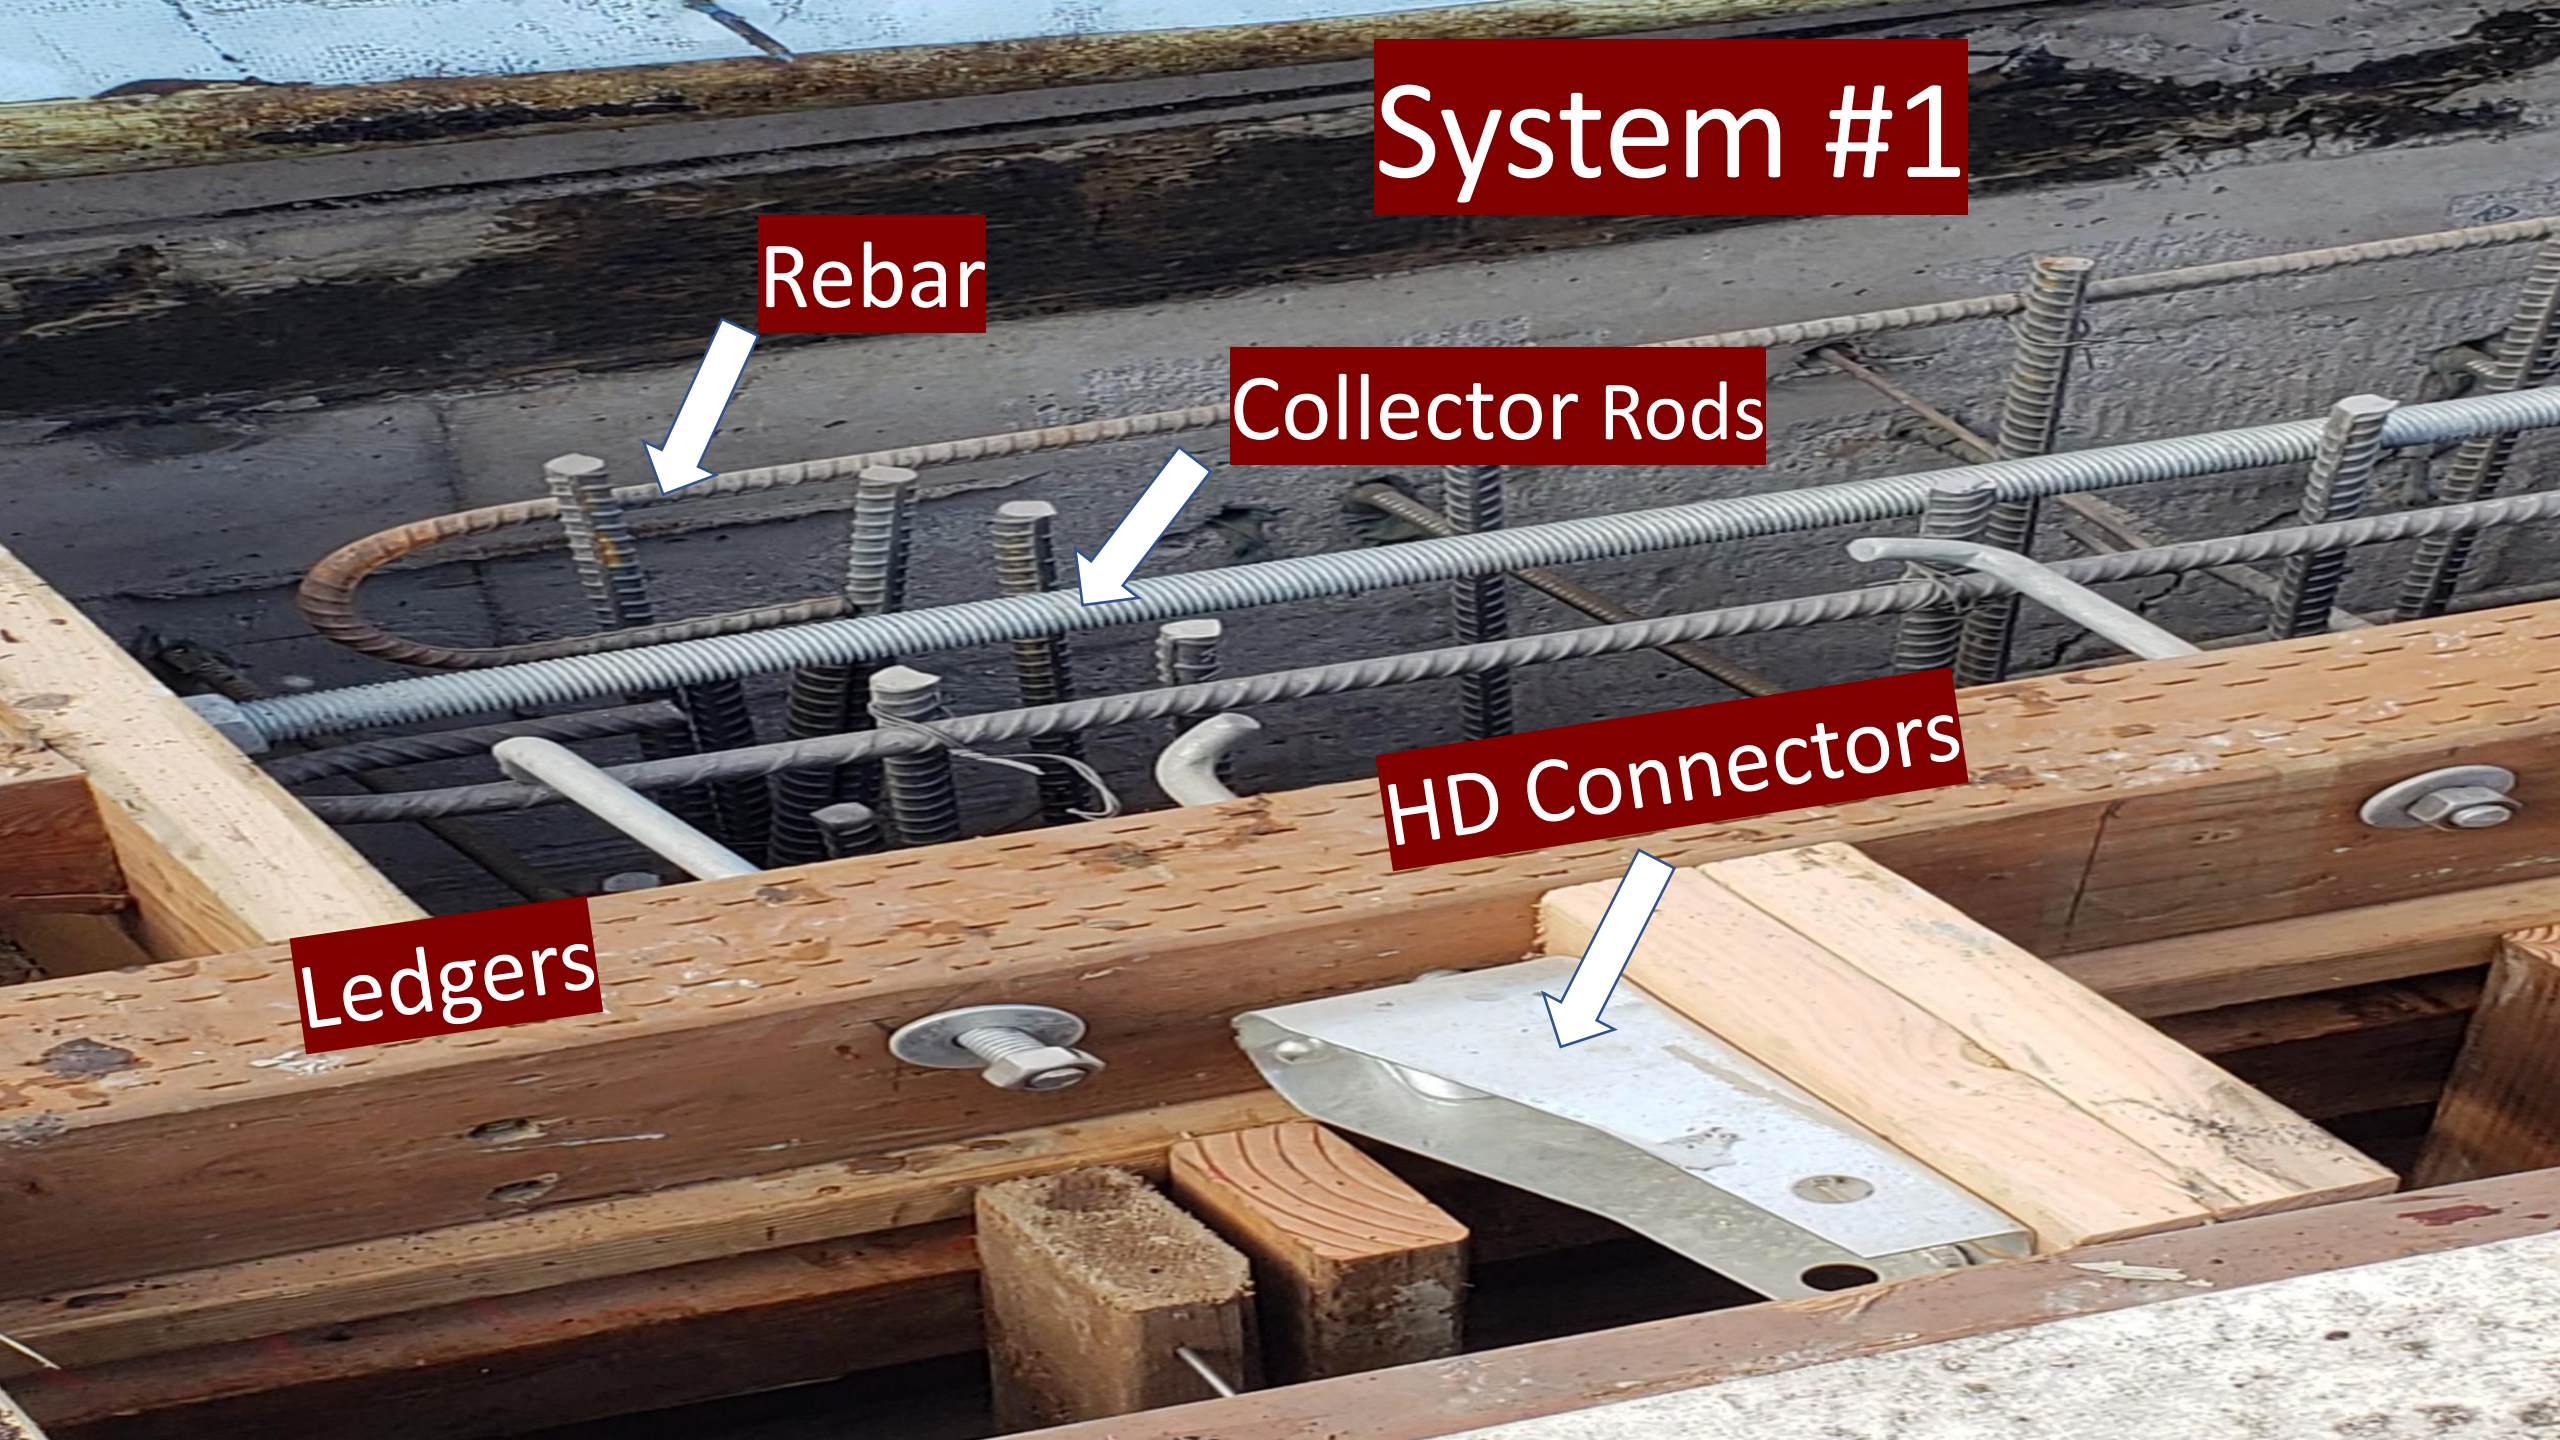
# System #1

X- Bracing

Rebar

Collector Rods

HD Connectors

Ledgers

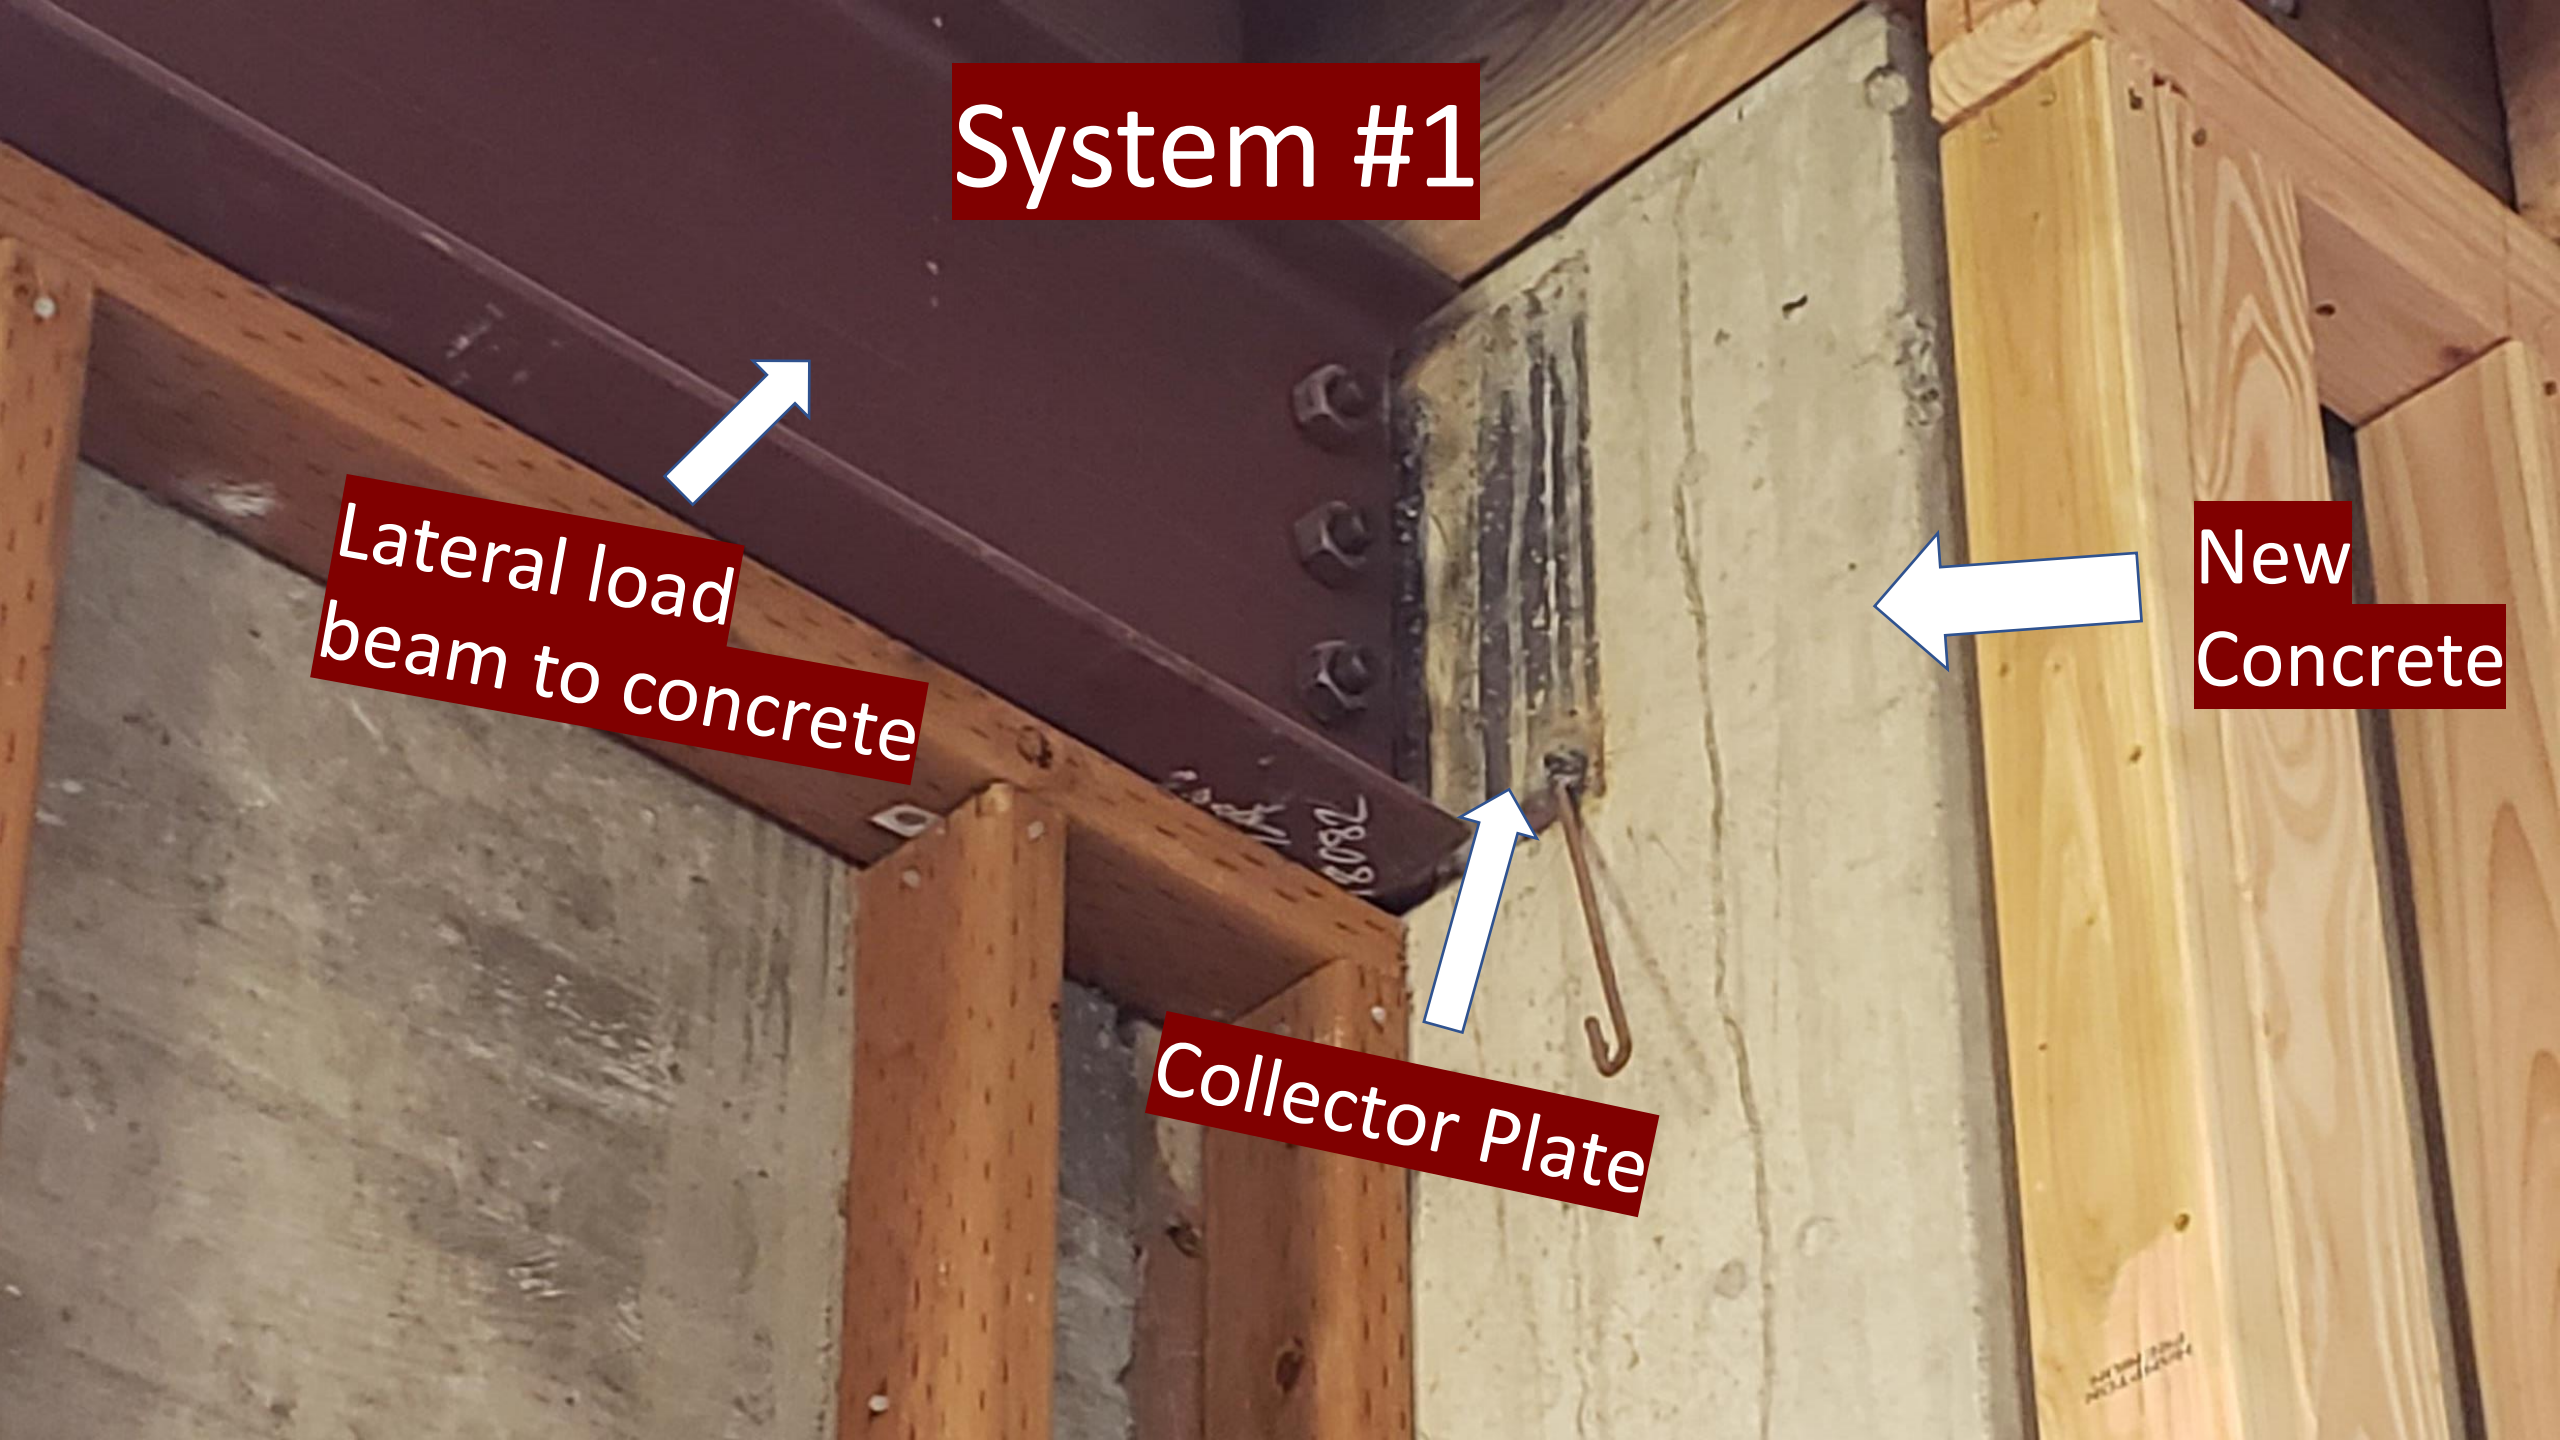
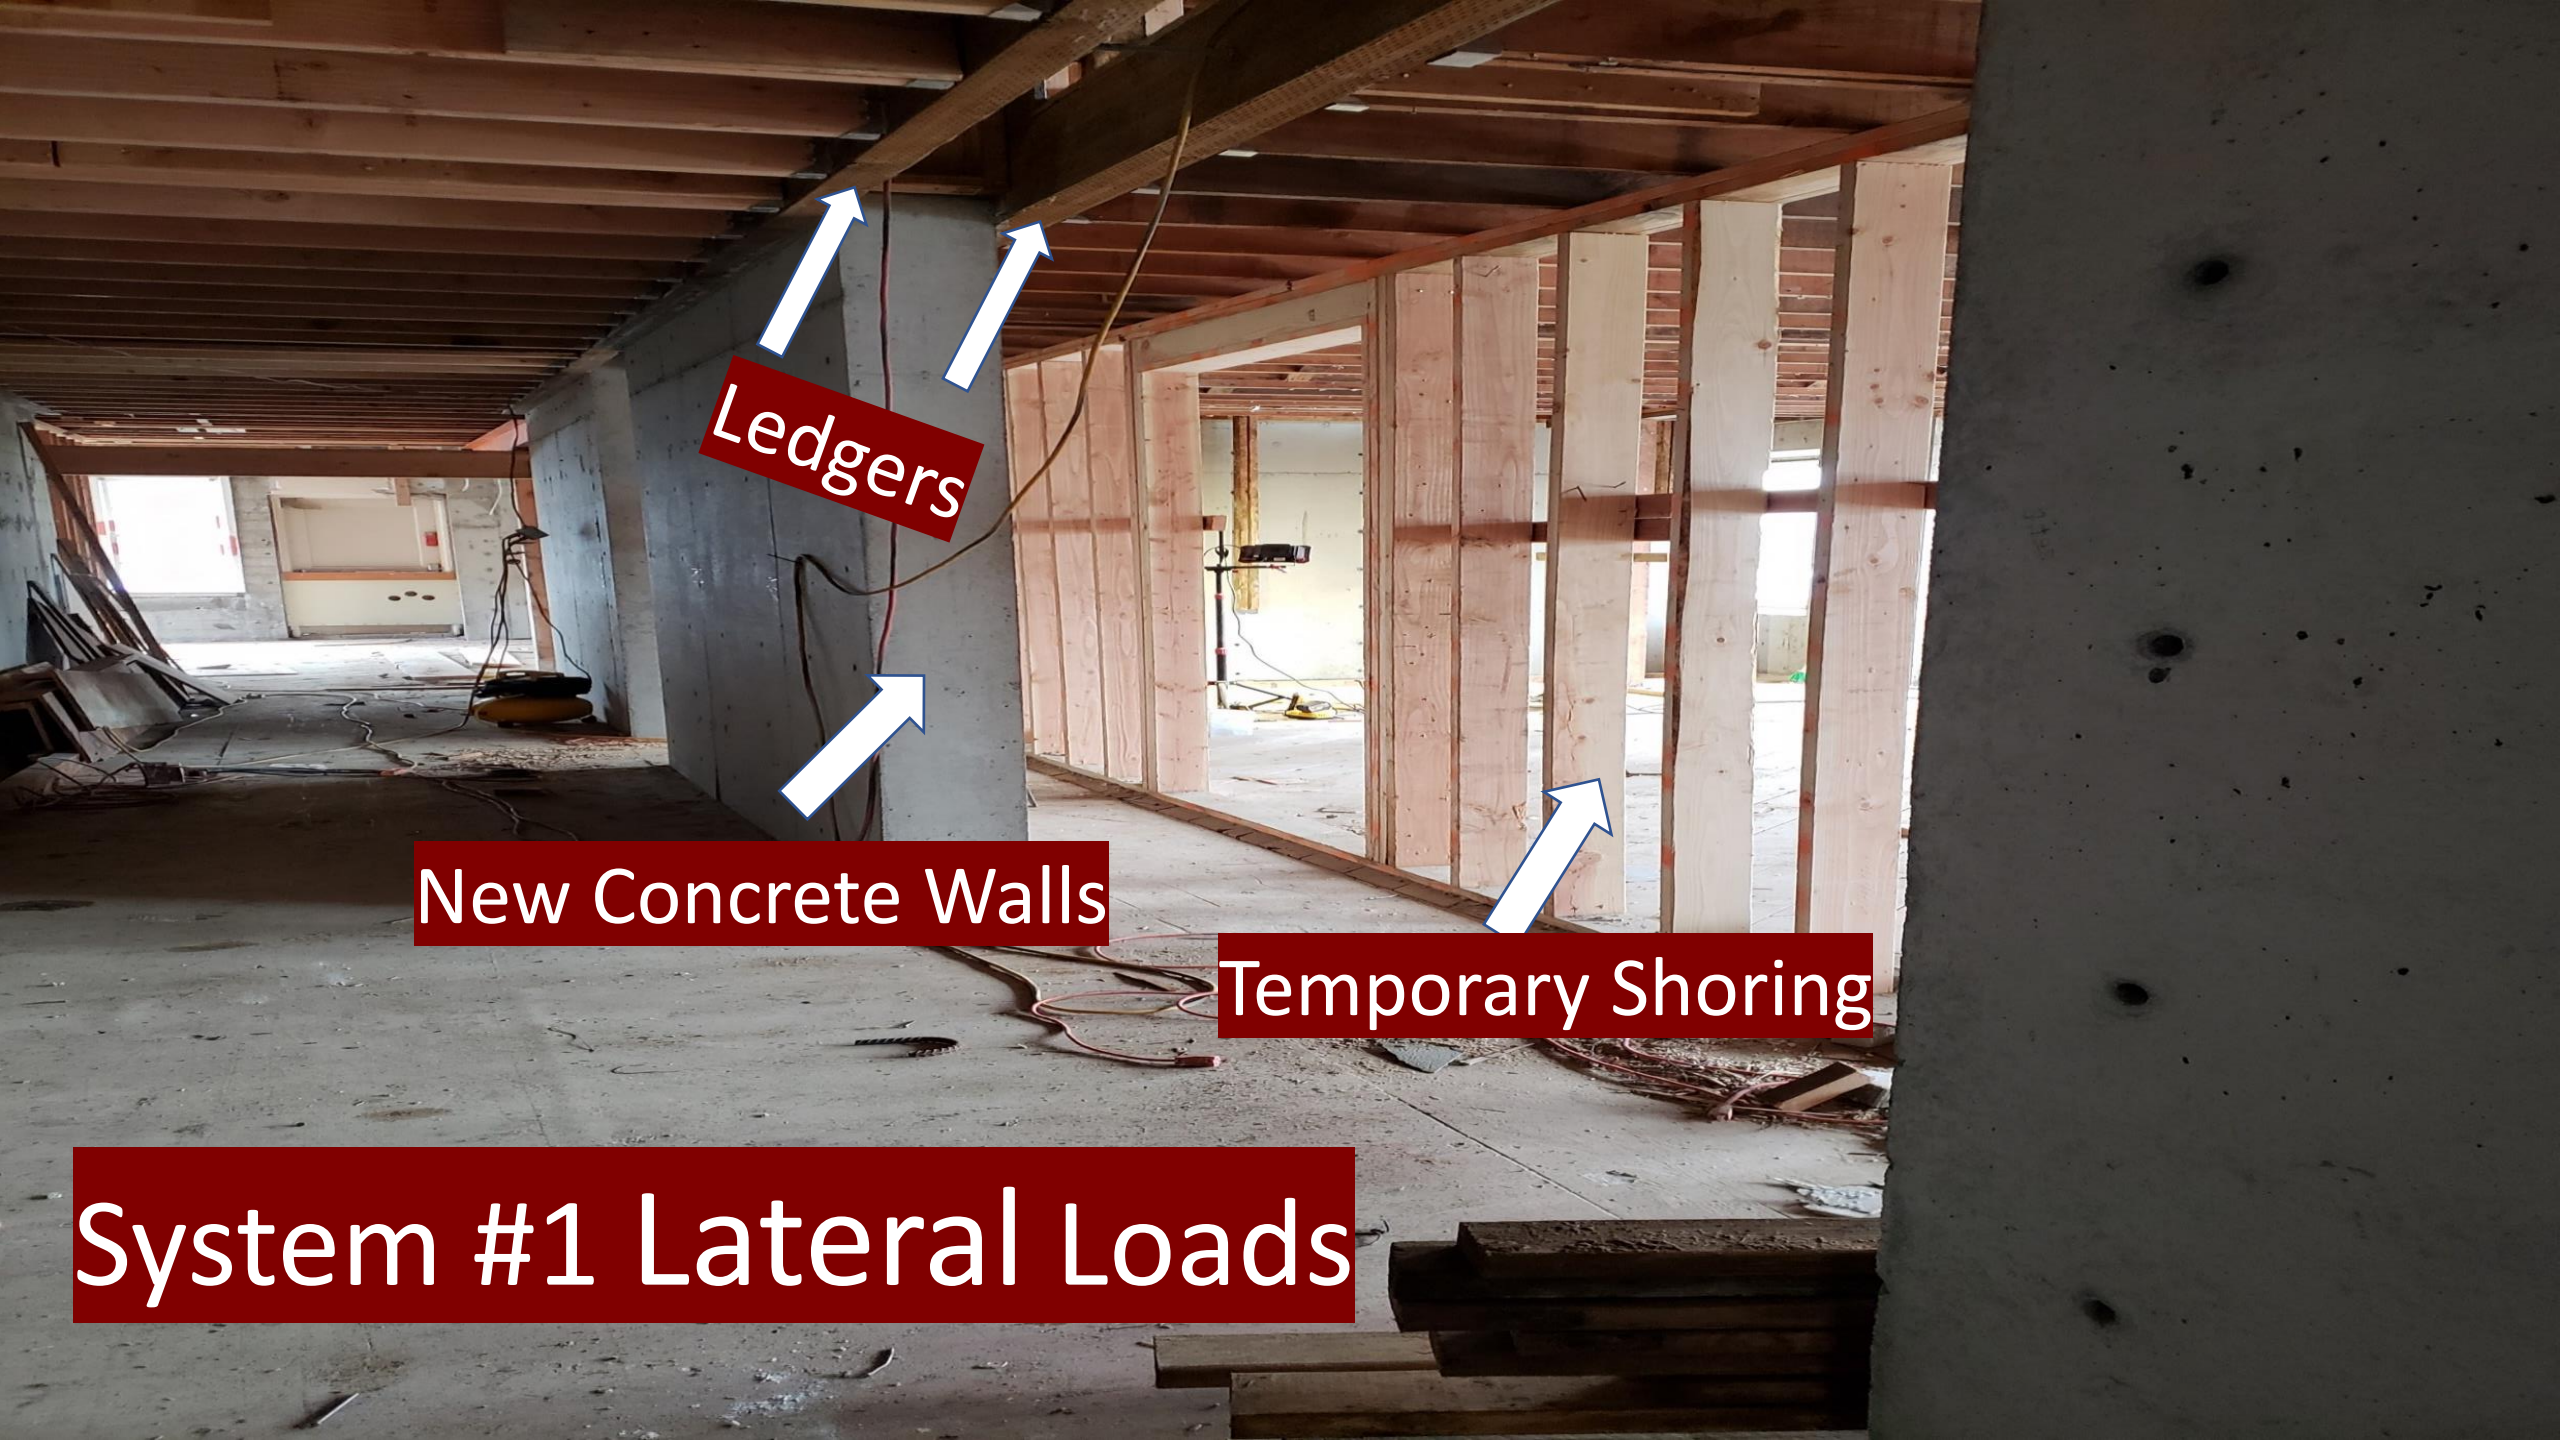
# System #1

Lateral load  
beam to concrete

New  
Concrete

Collector Plate

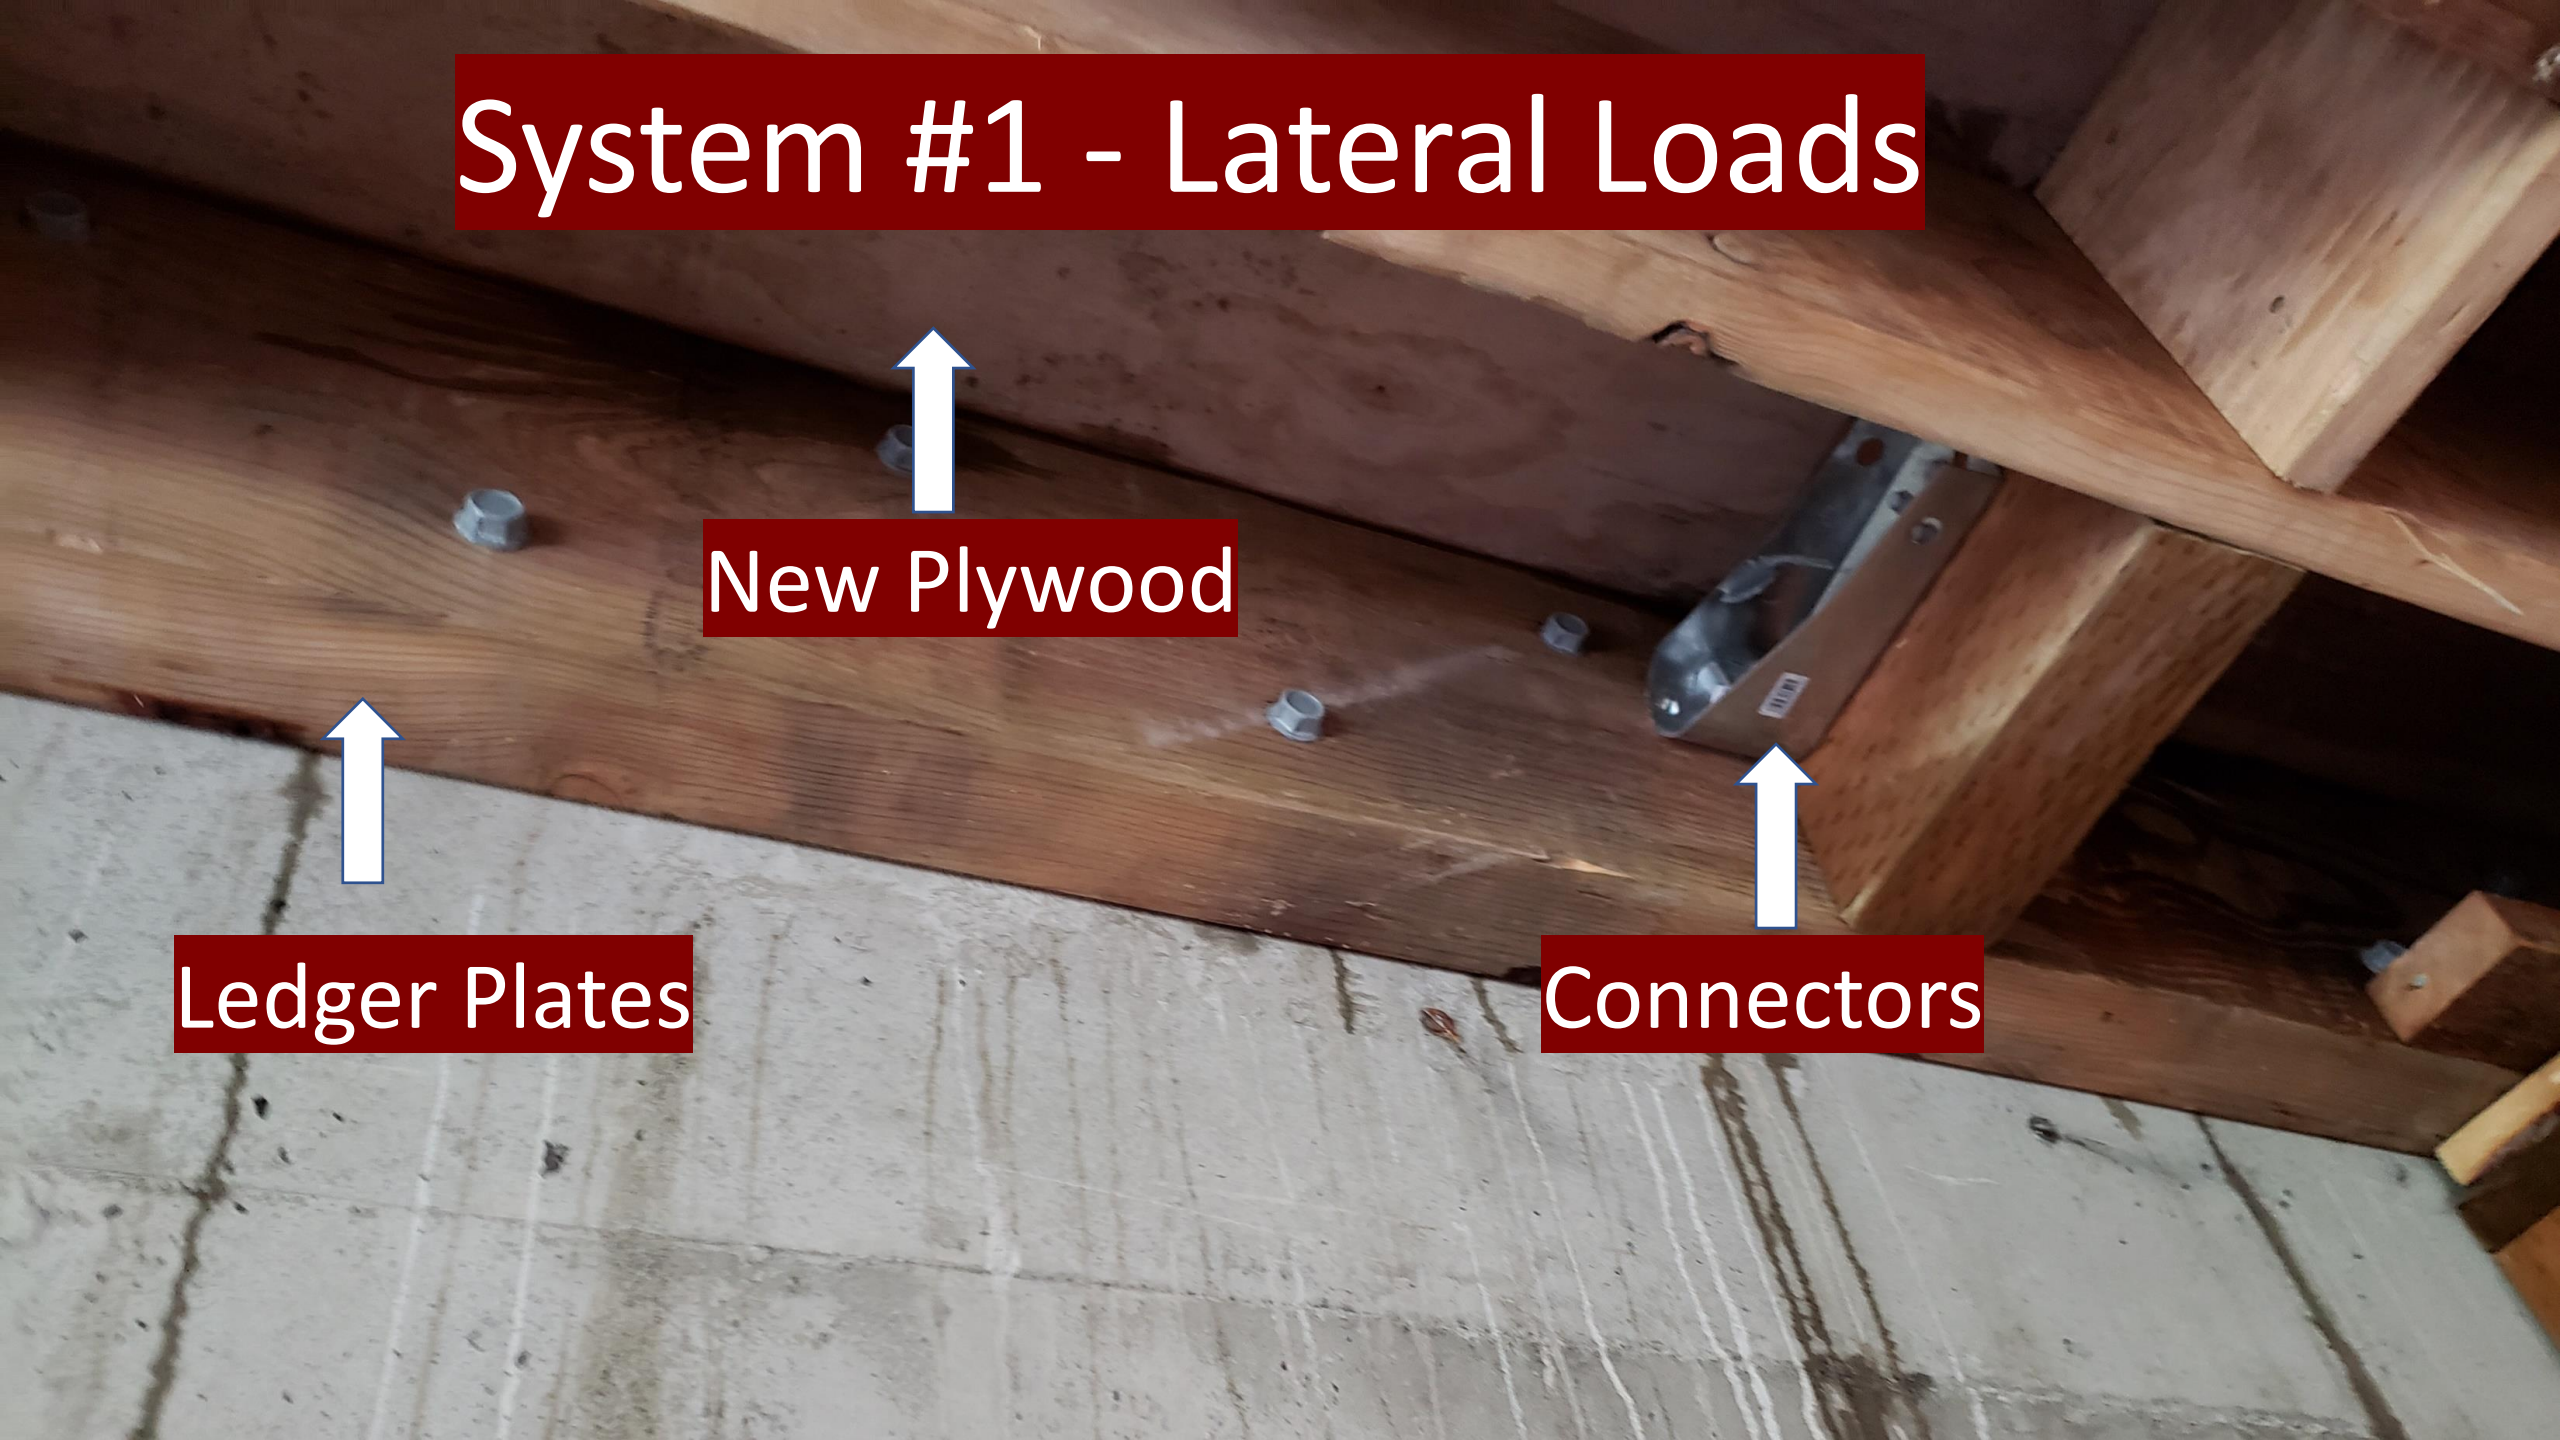
# System #1 - Lateral Loads

Ledgers

New Concrete Walls

Temporary Shoring

New Plywood

Ledger Plates

Connectors

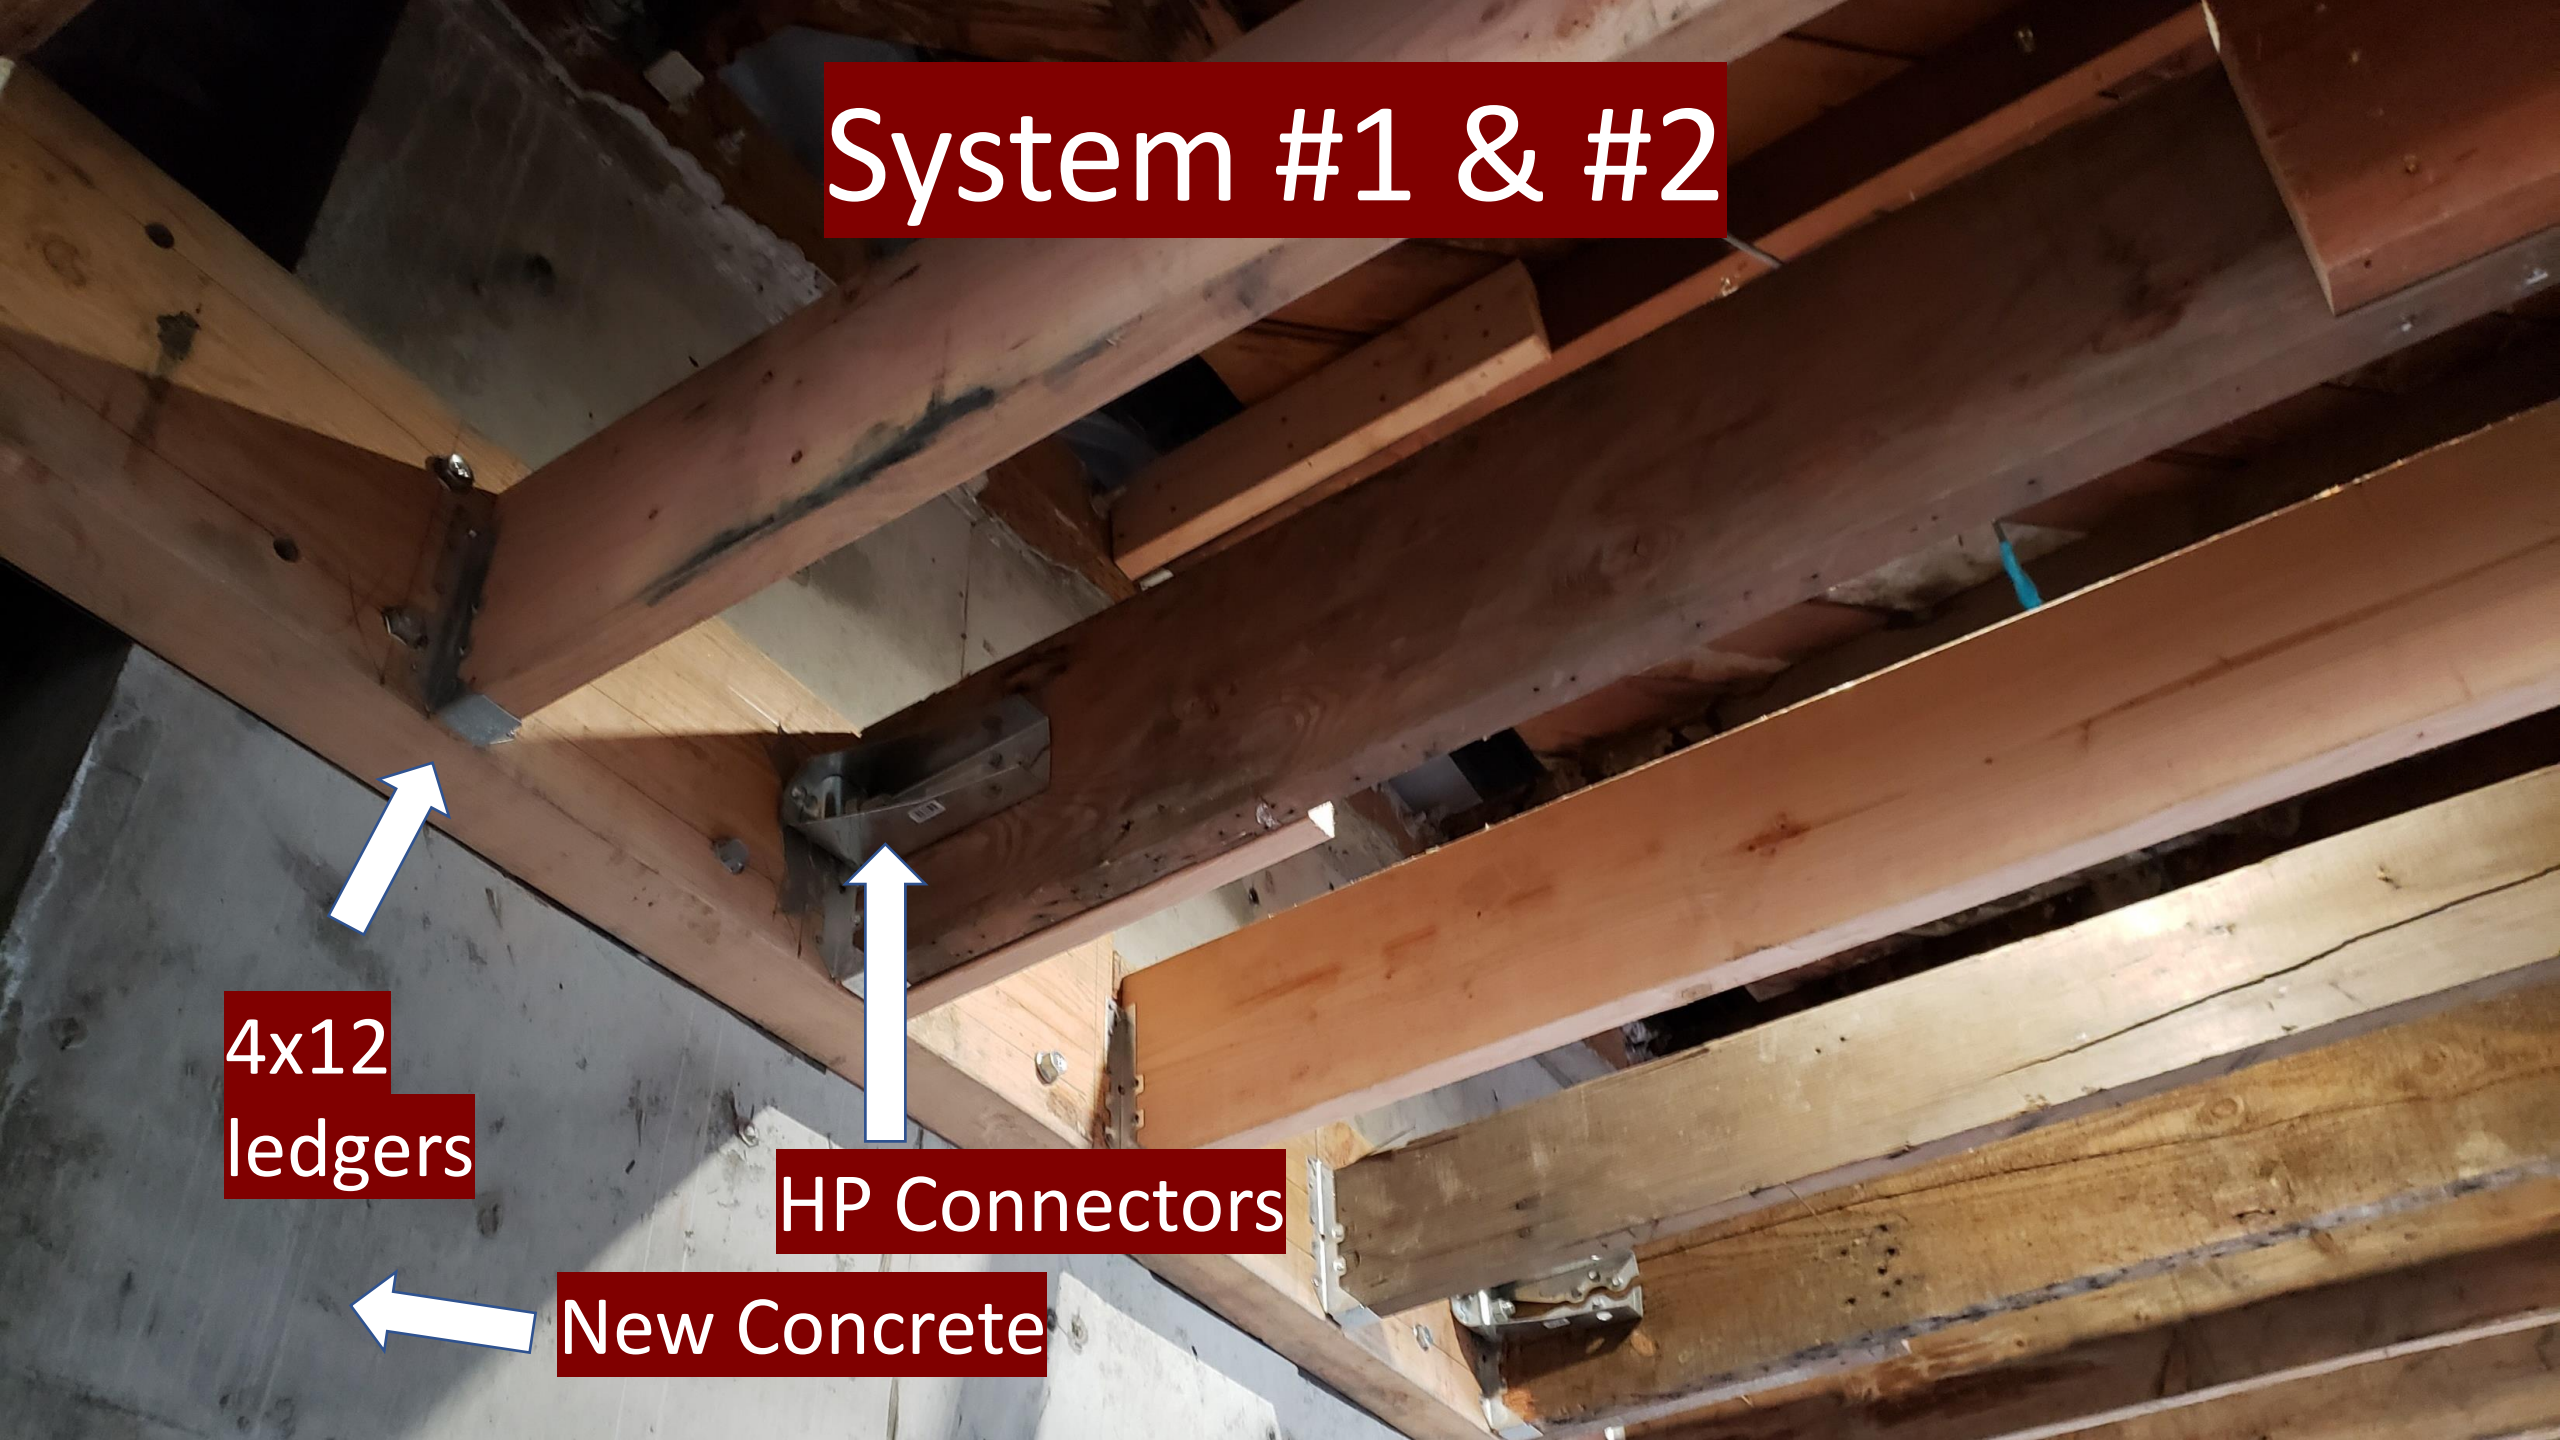
# System #1 & #2

4x12  
ledgers

HP Connectors

New Concrete
