Welcome  
2019 Spring  
Apartment  
Report Panelist  
Rudy Munzel

**Apartment Report**

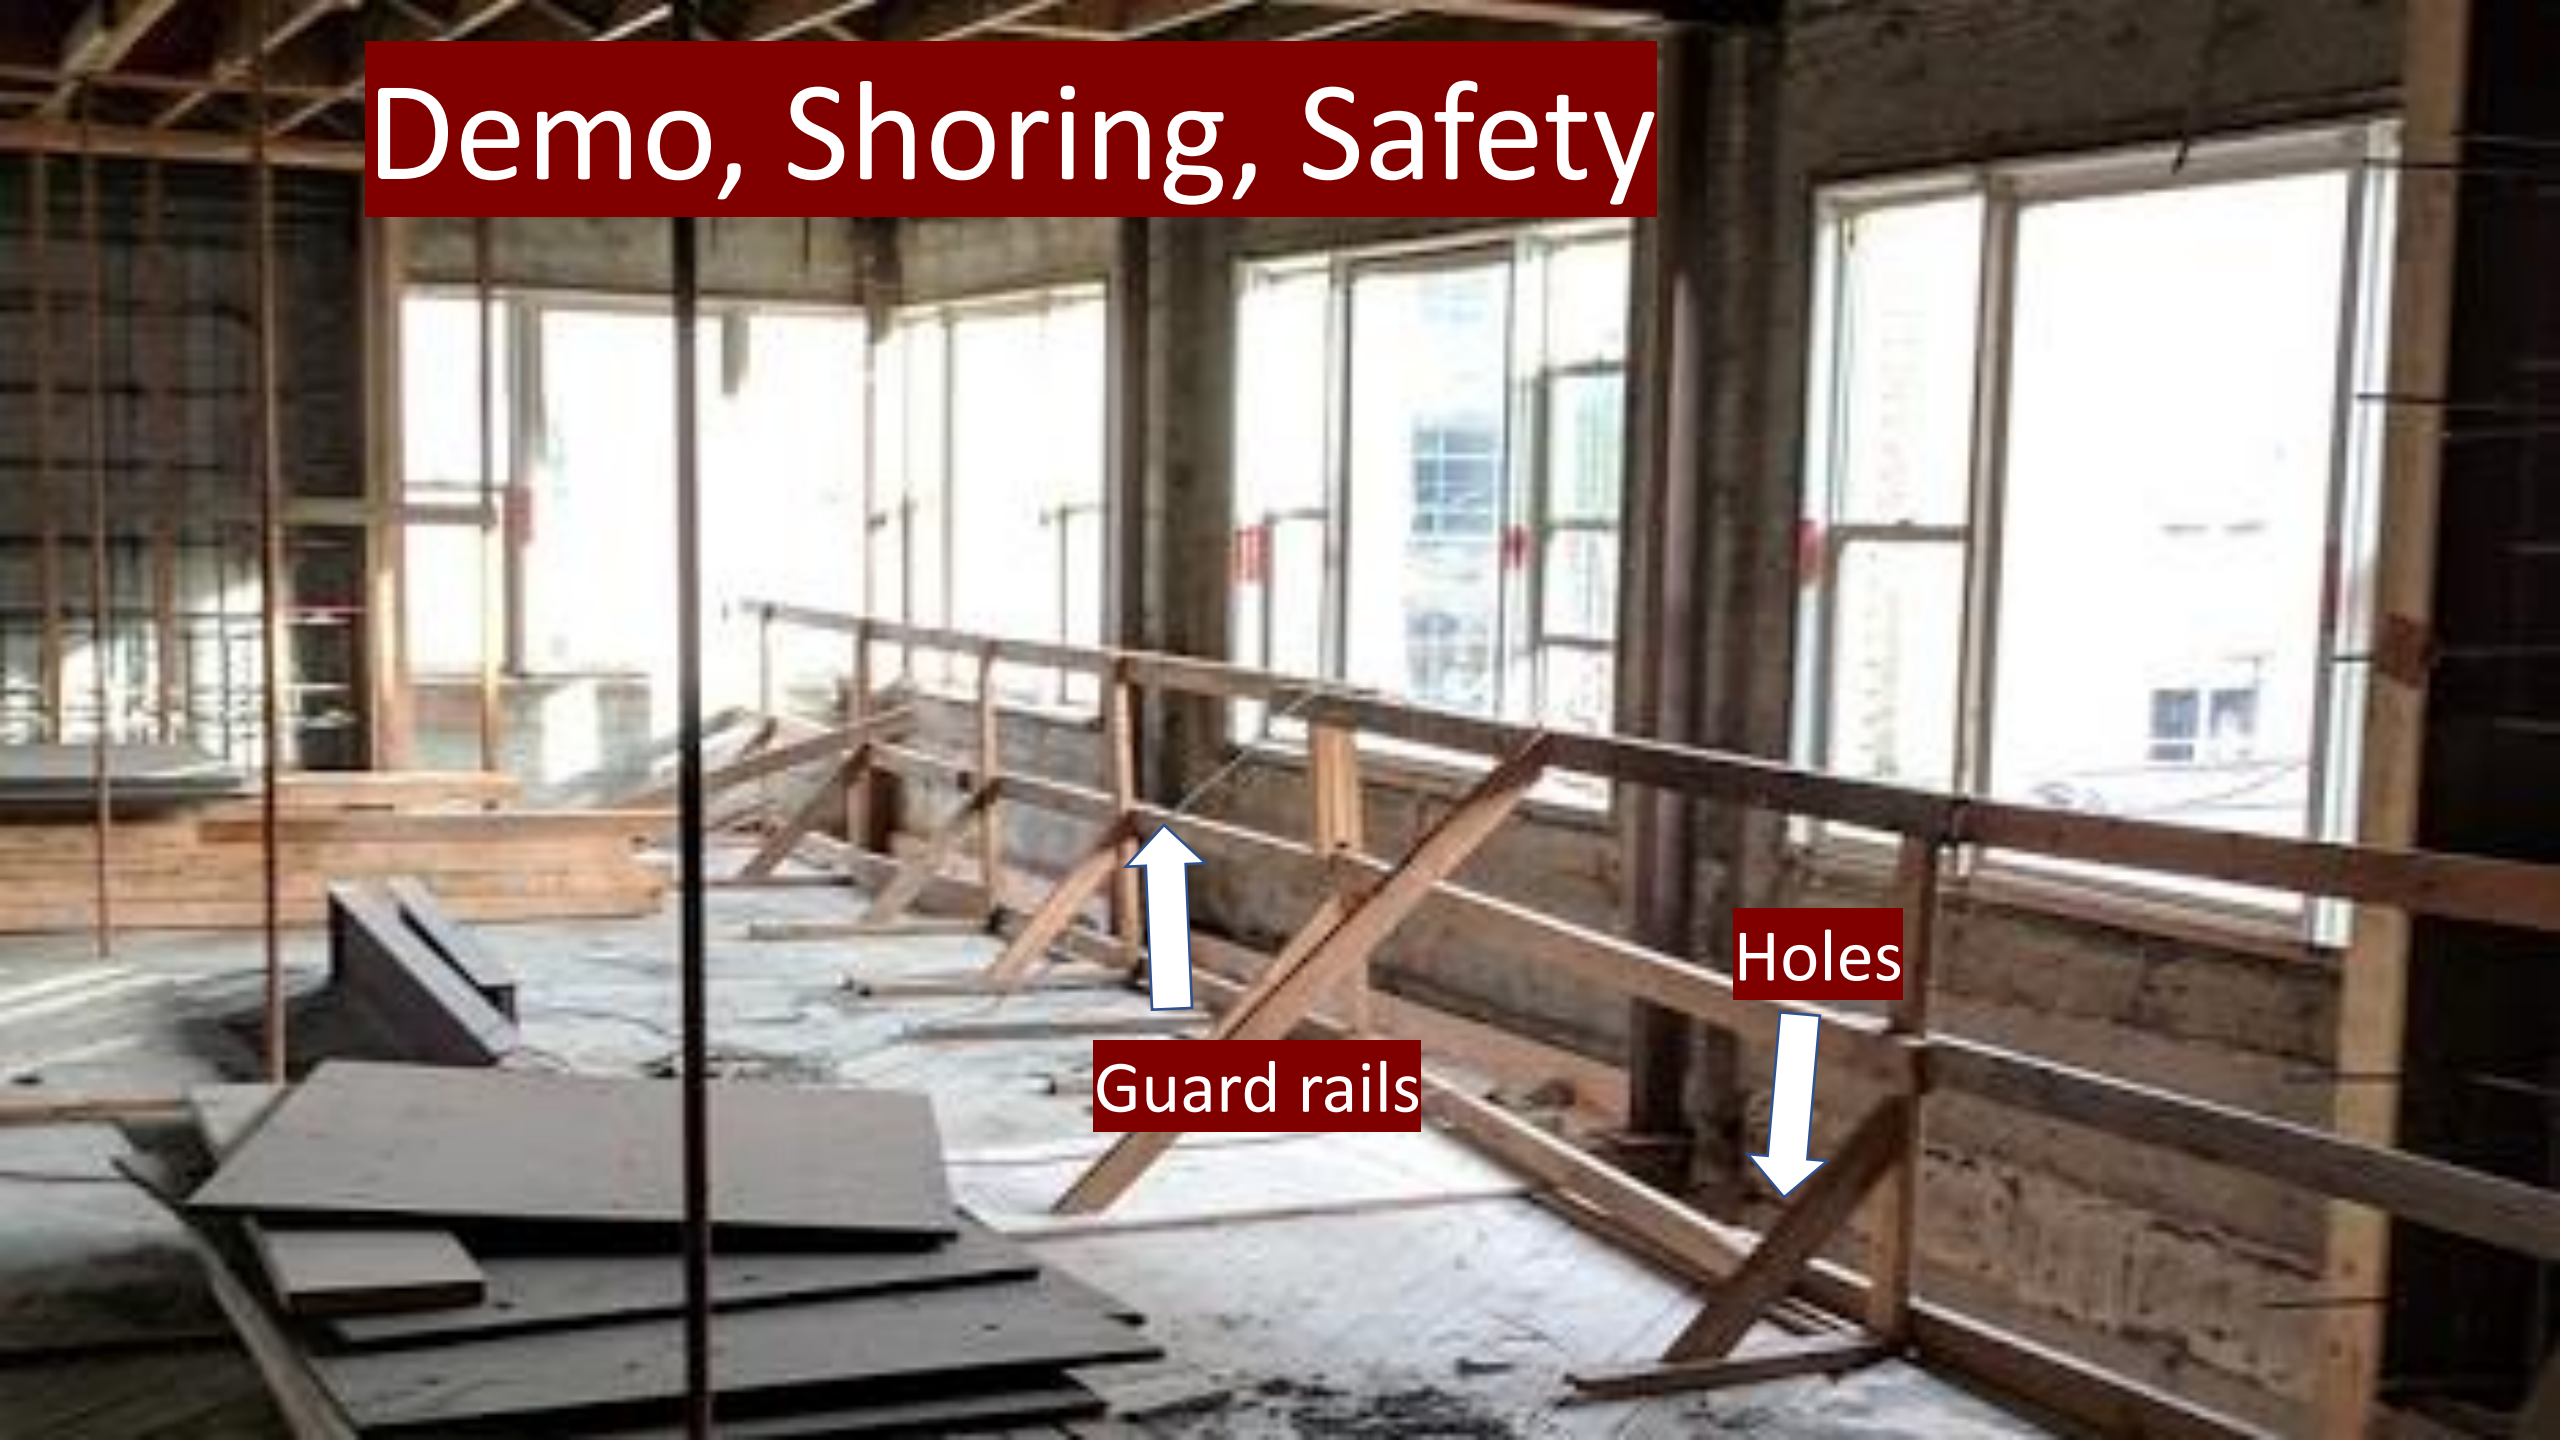
# Demo, Shoring, Safety

Guard rails

Holes

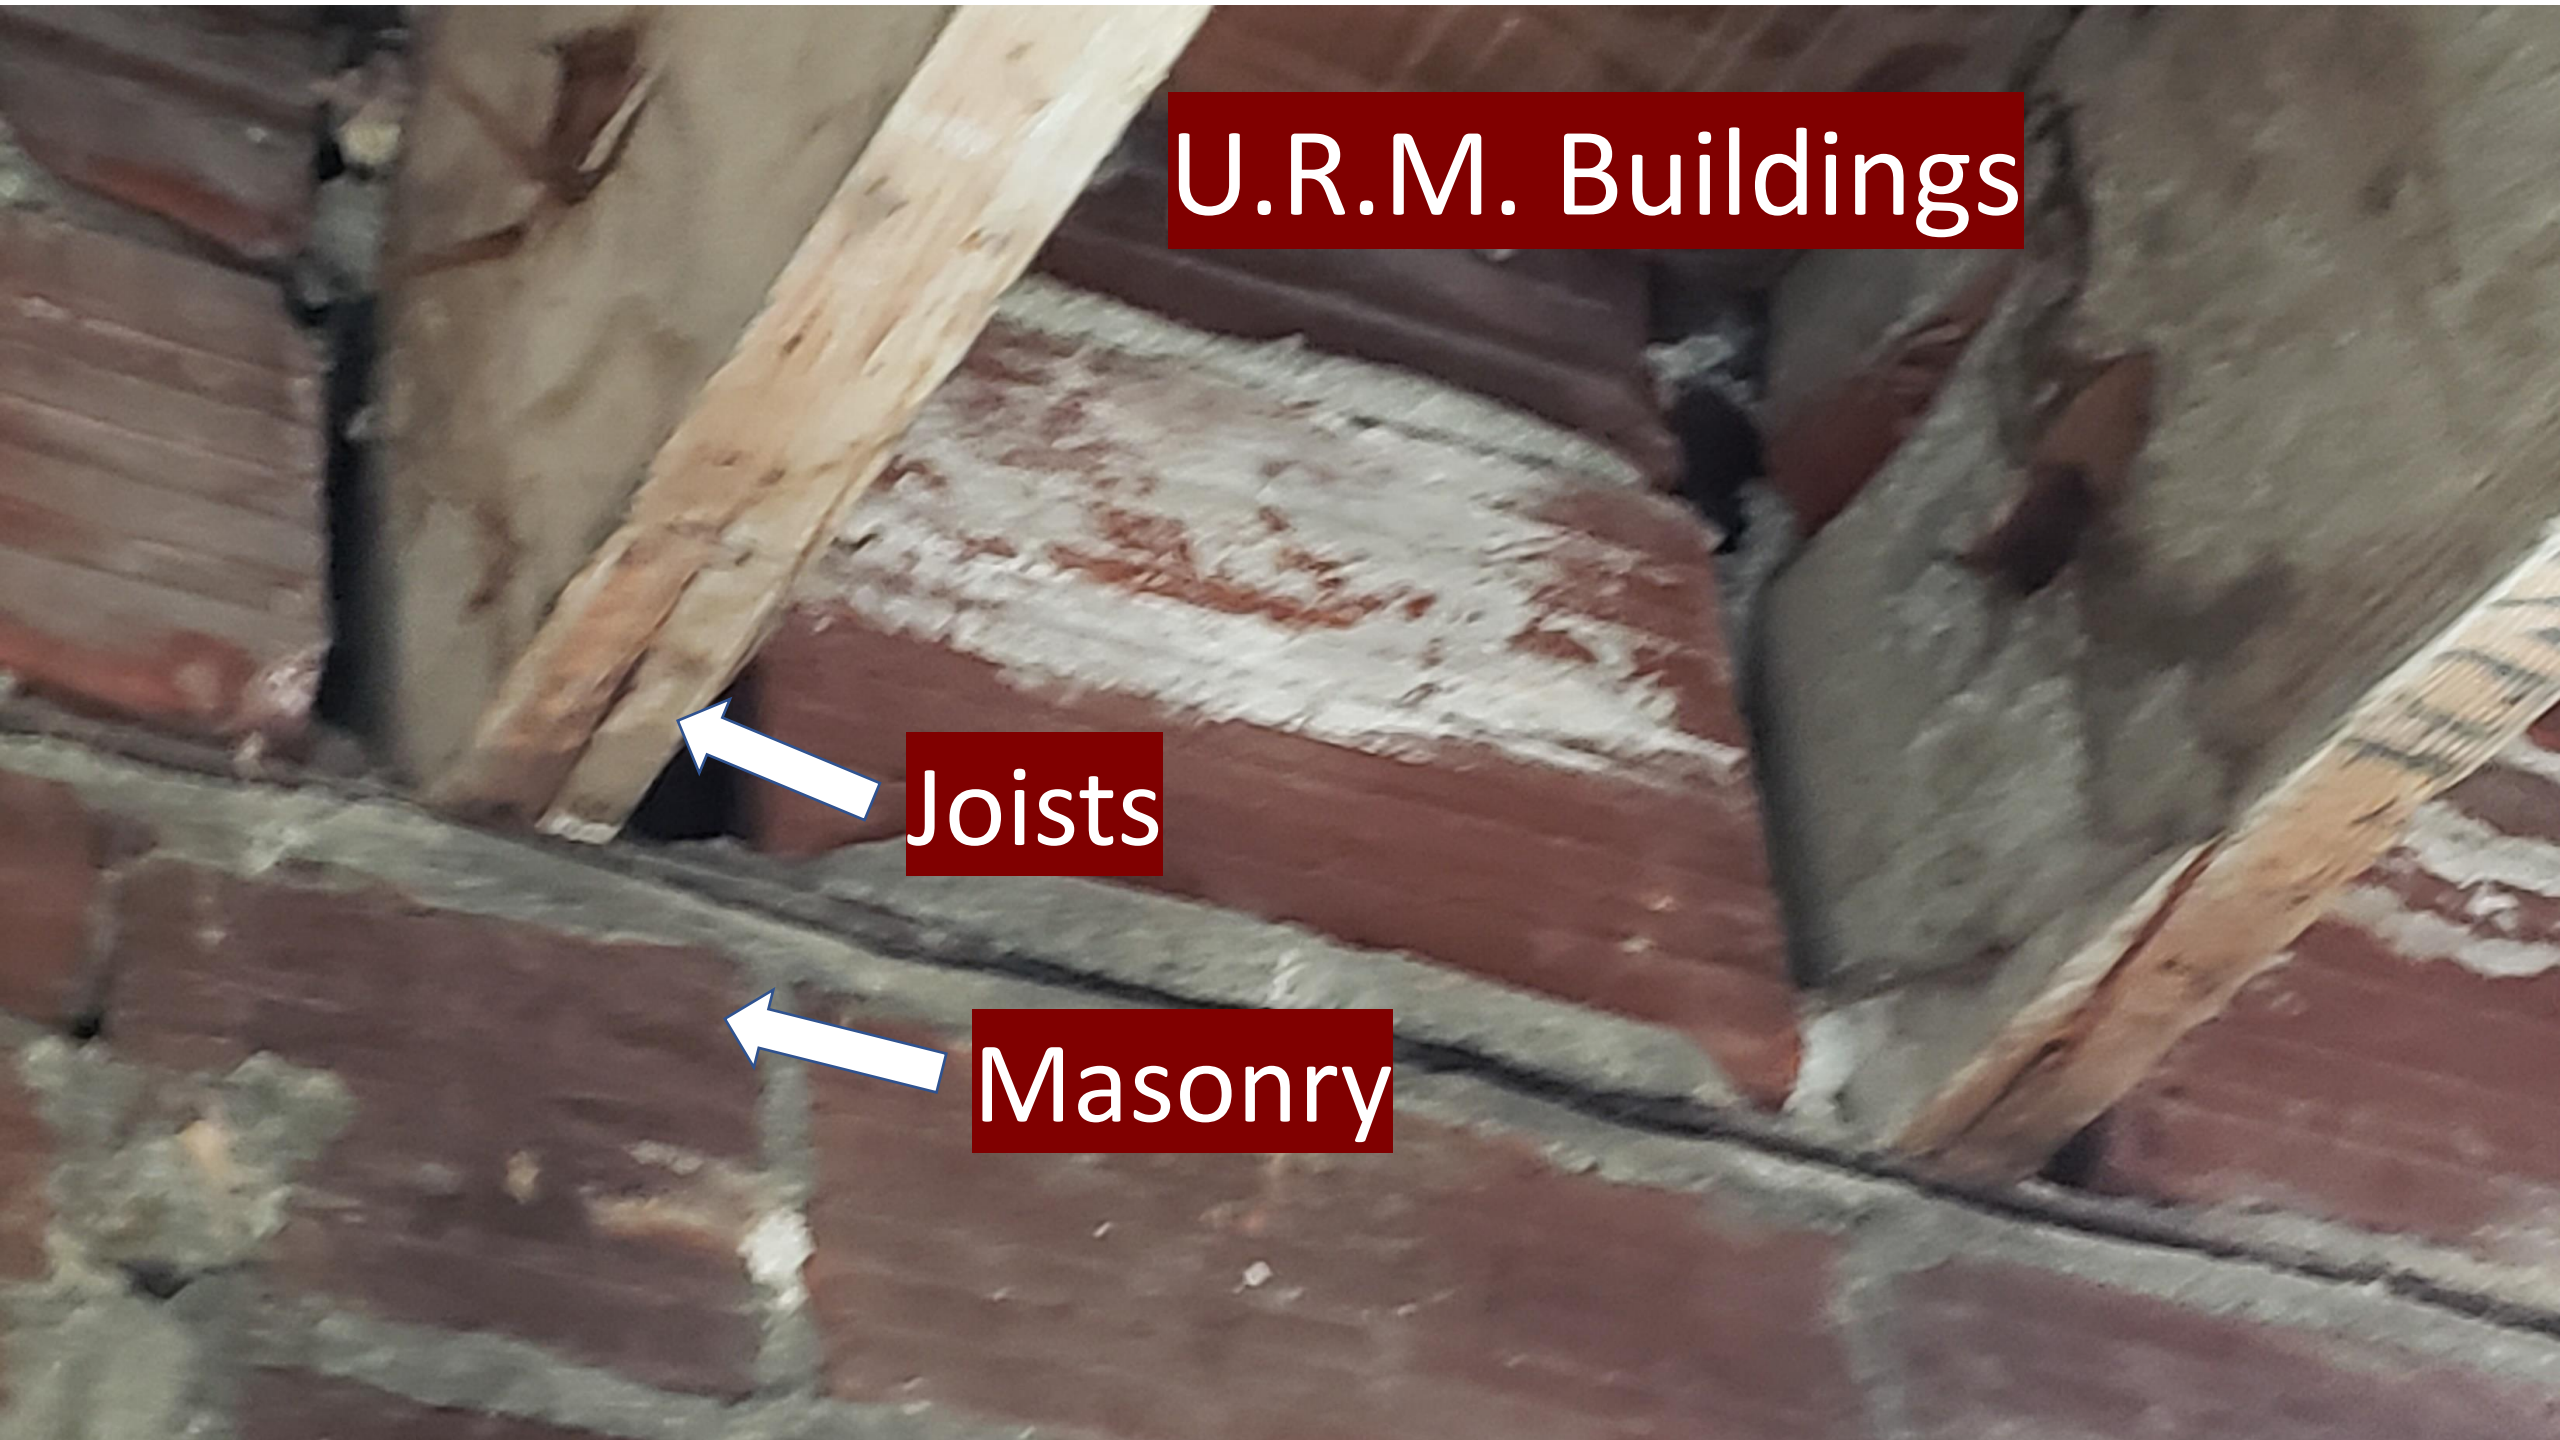
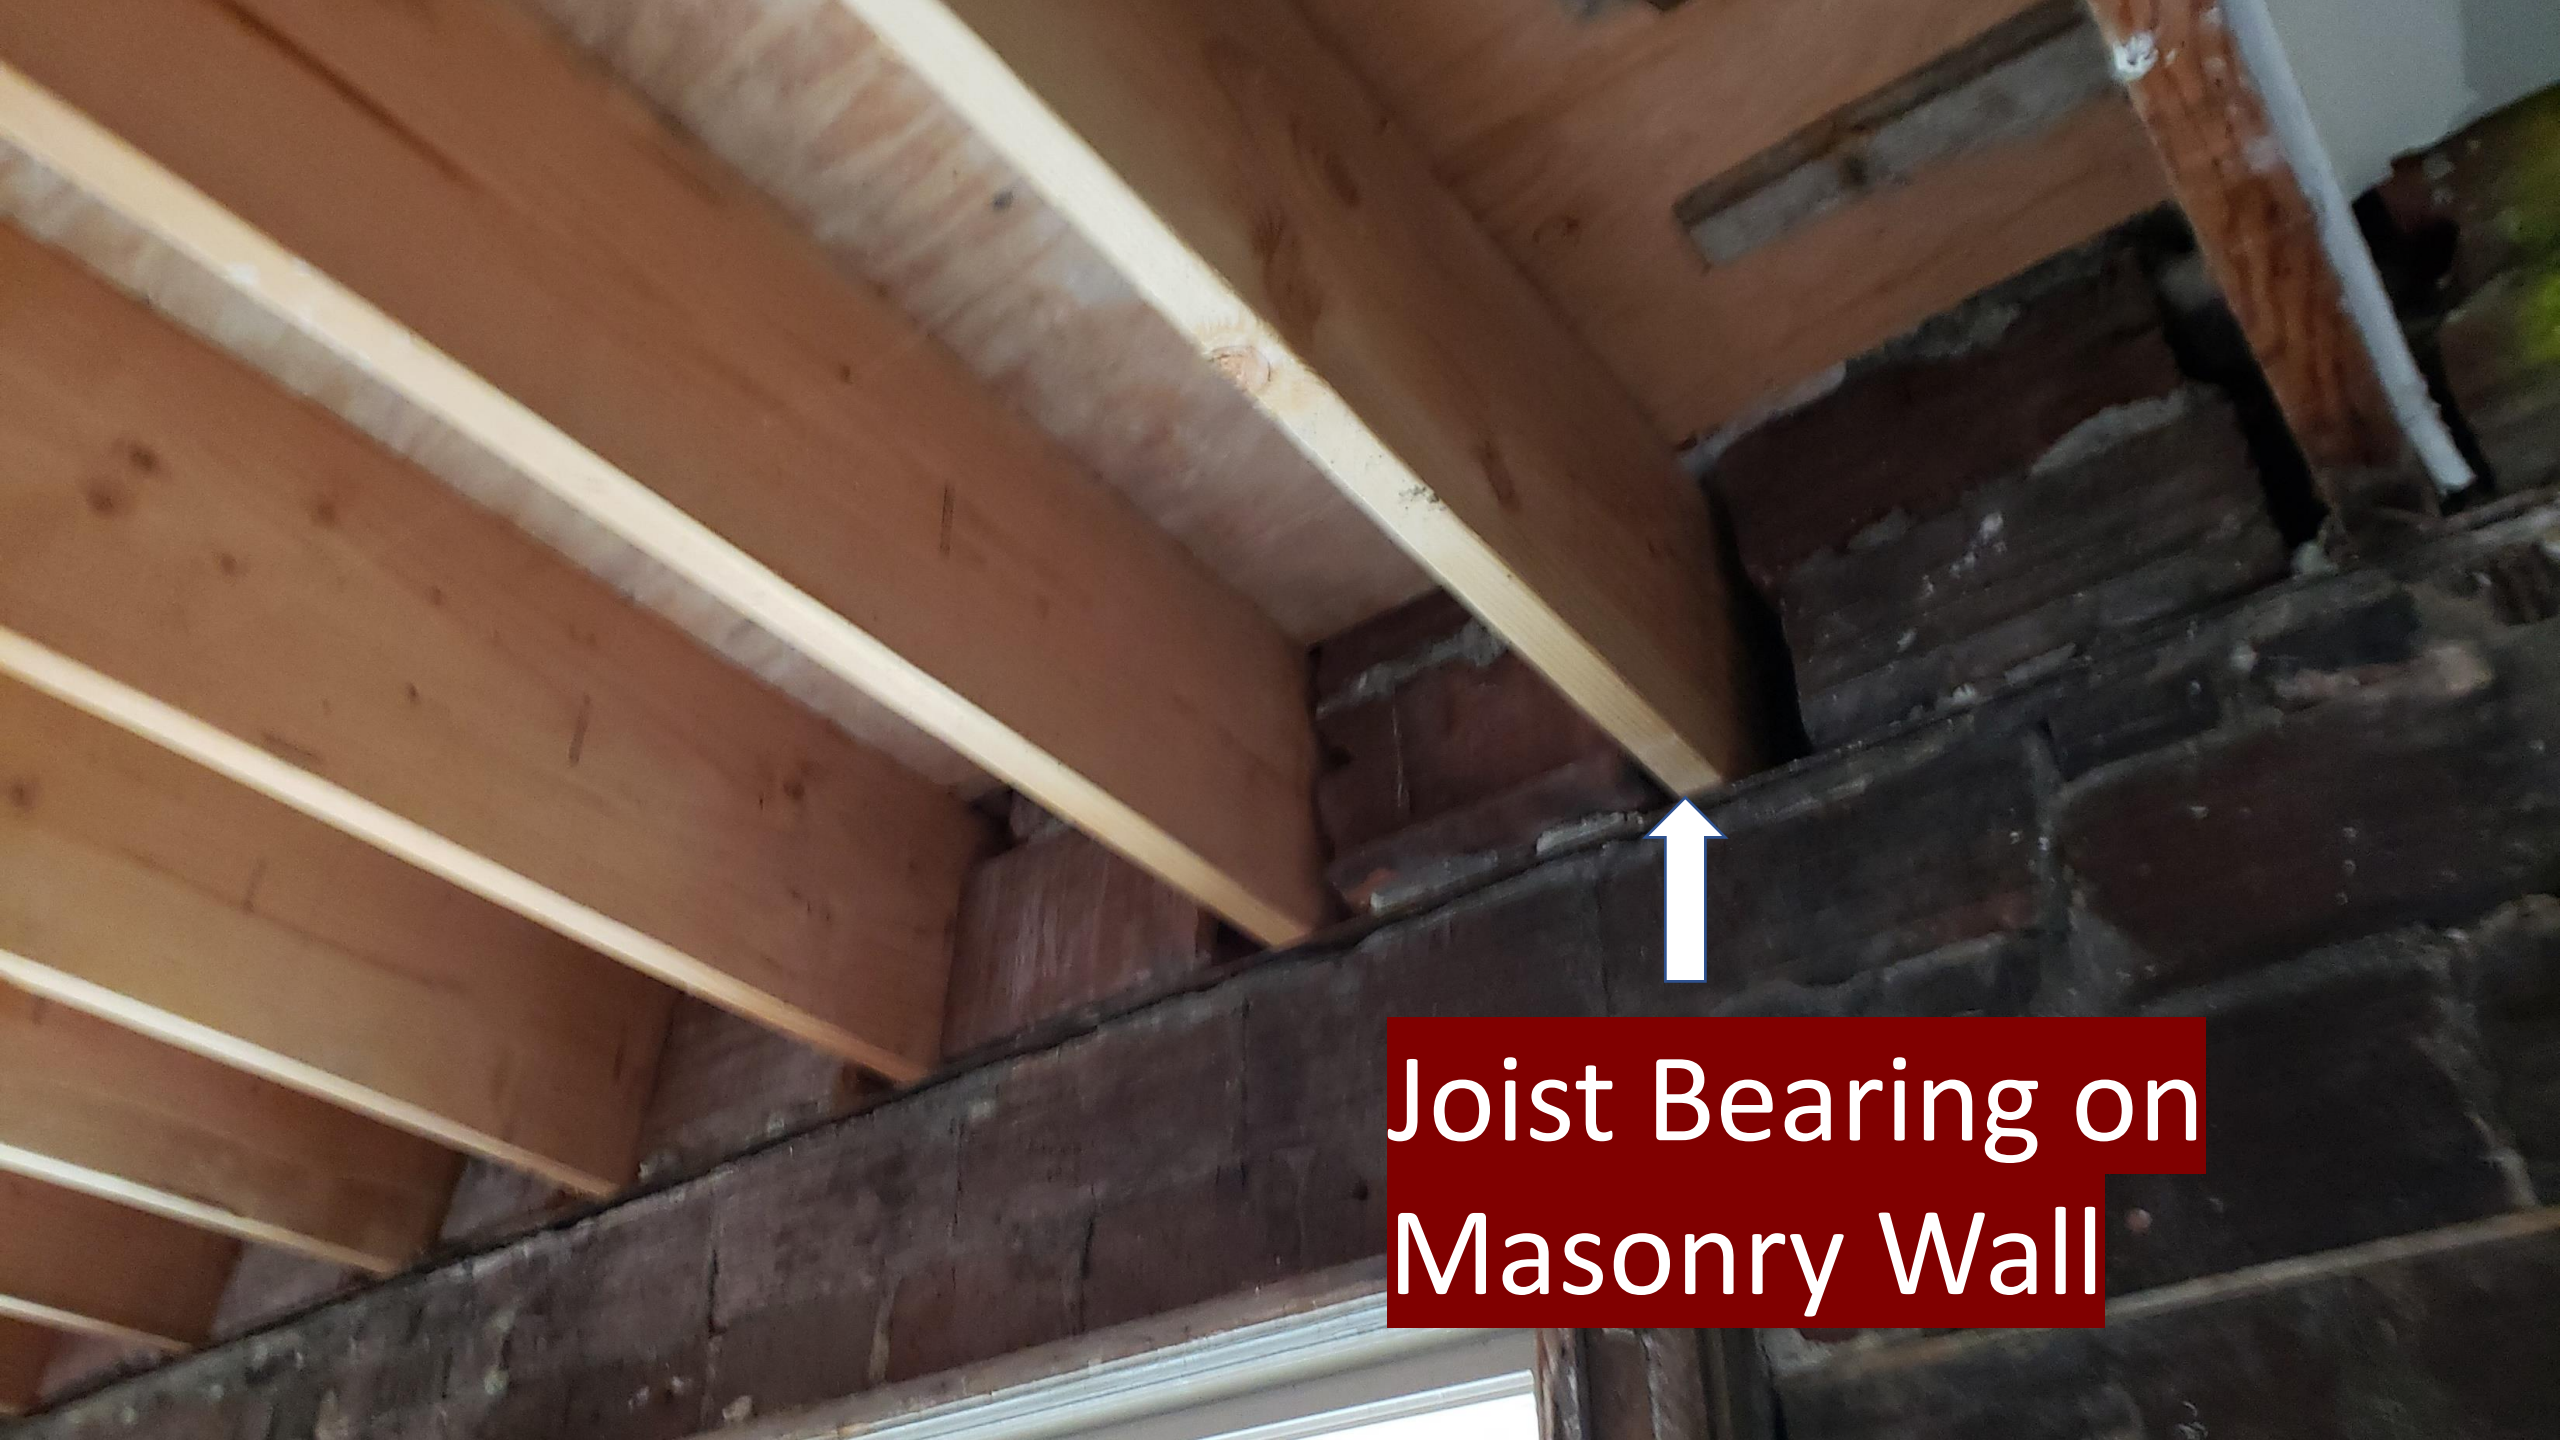
# U.R.M. Buildings

Joists

Masonry

Joist Bearing on  
Masonry Wall

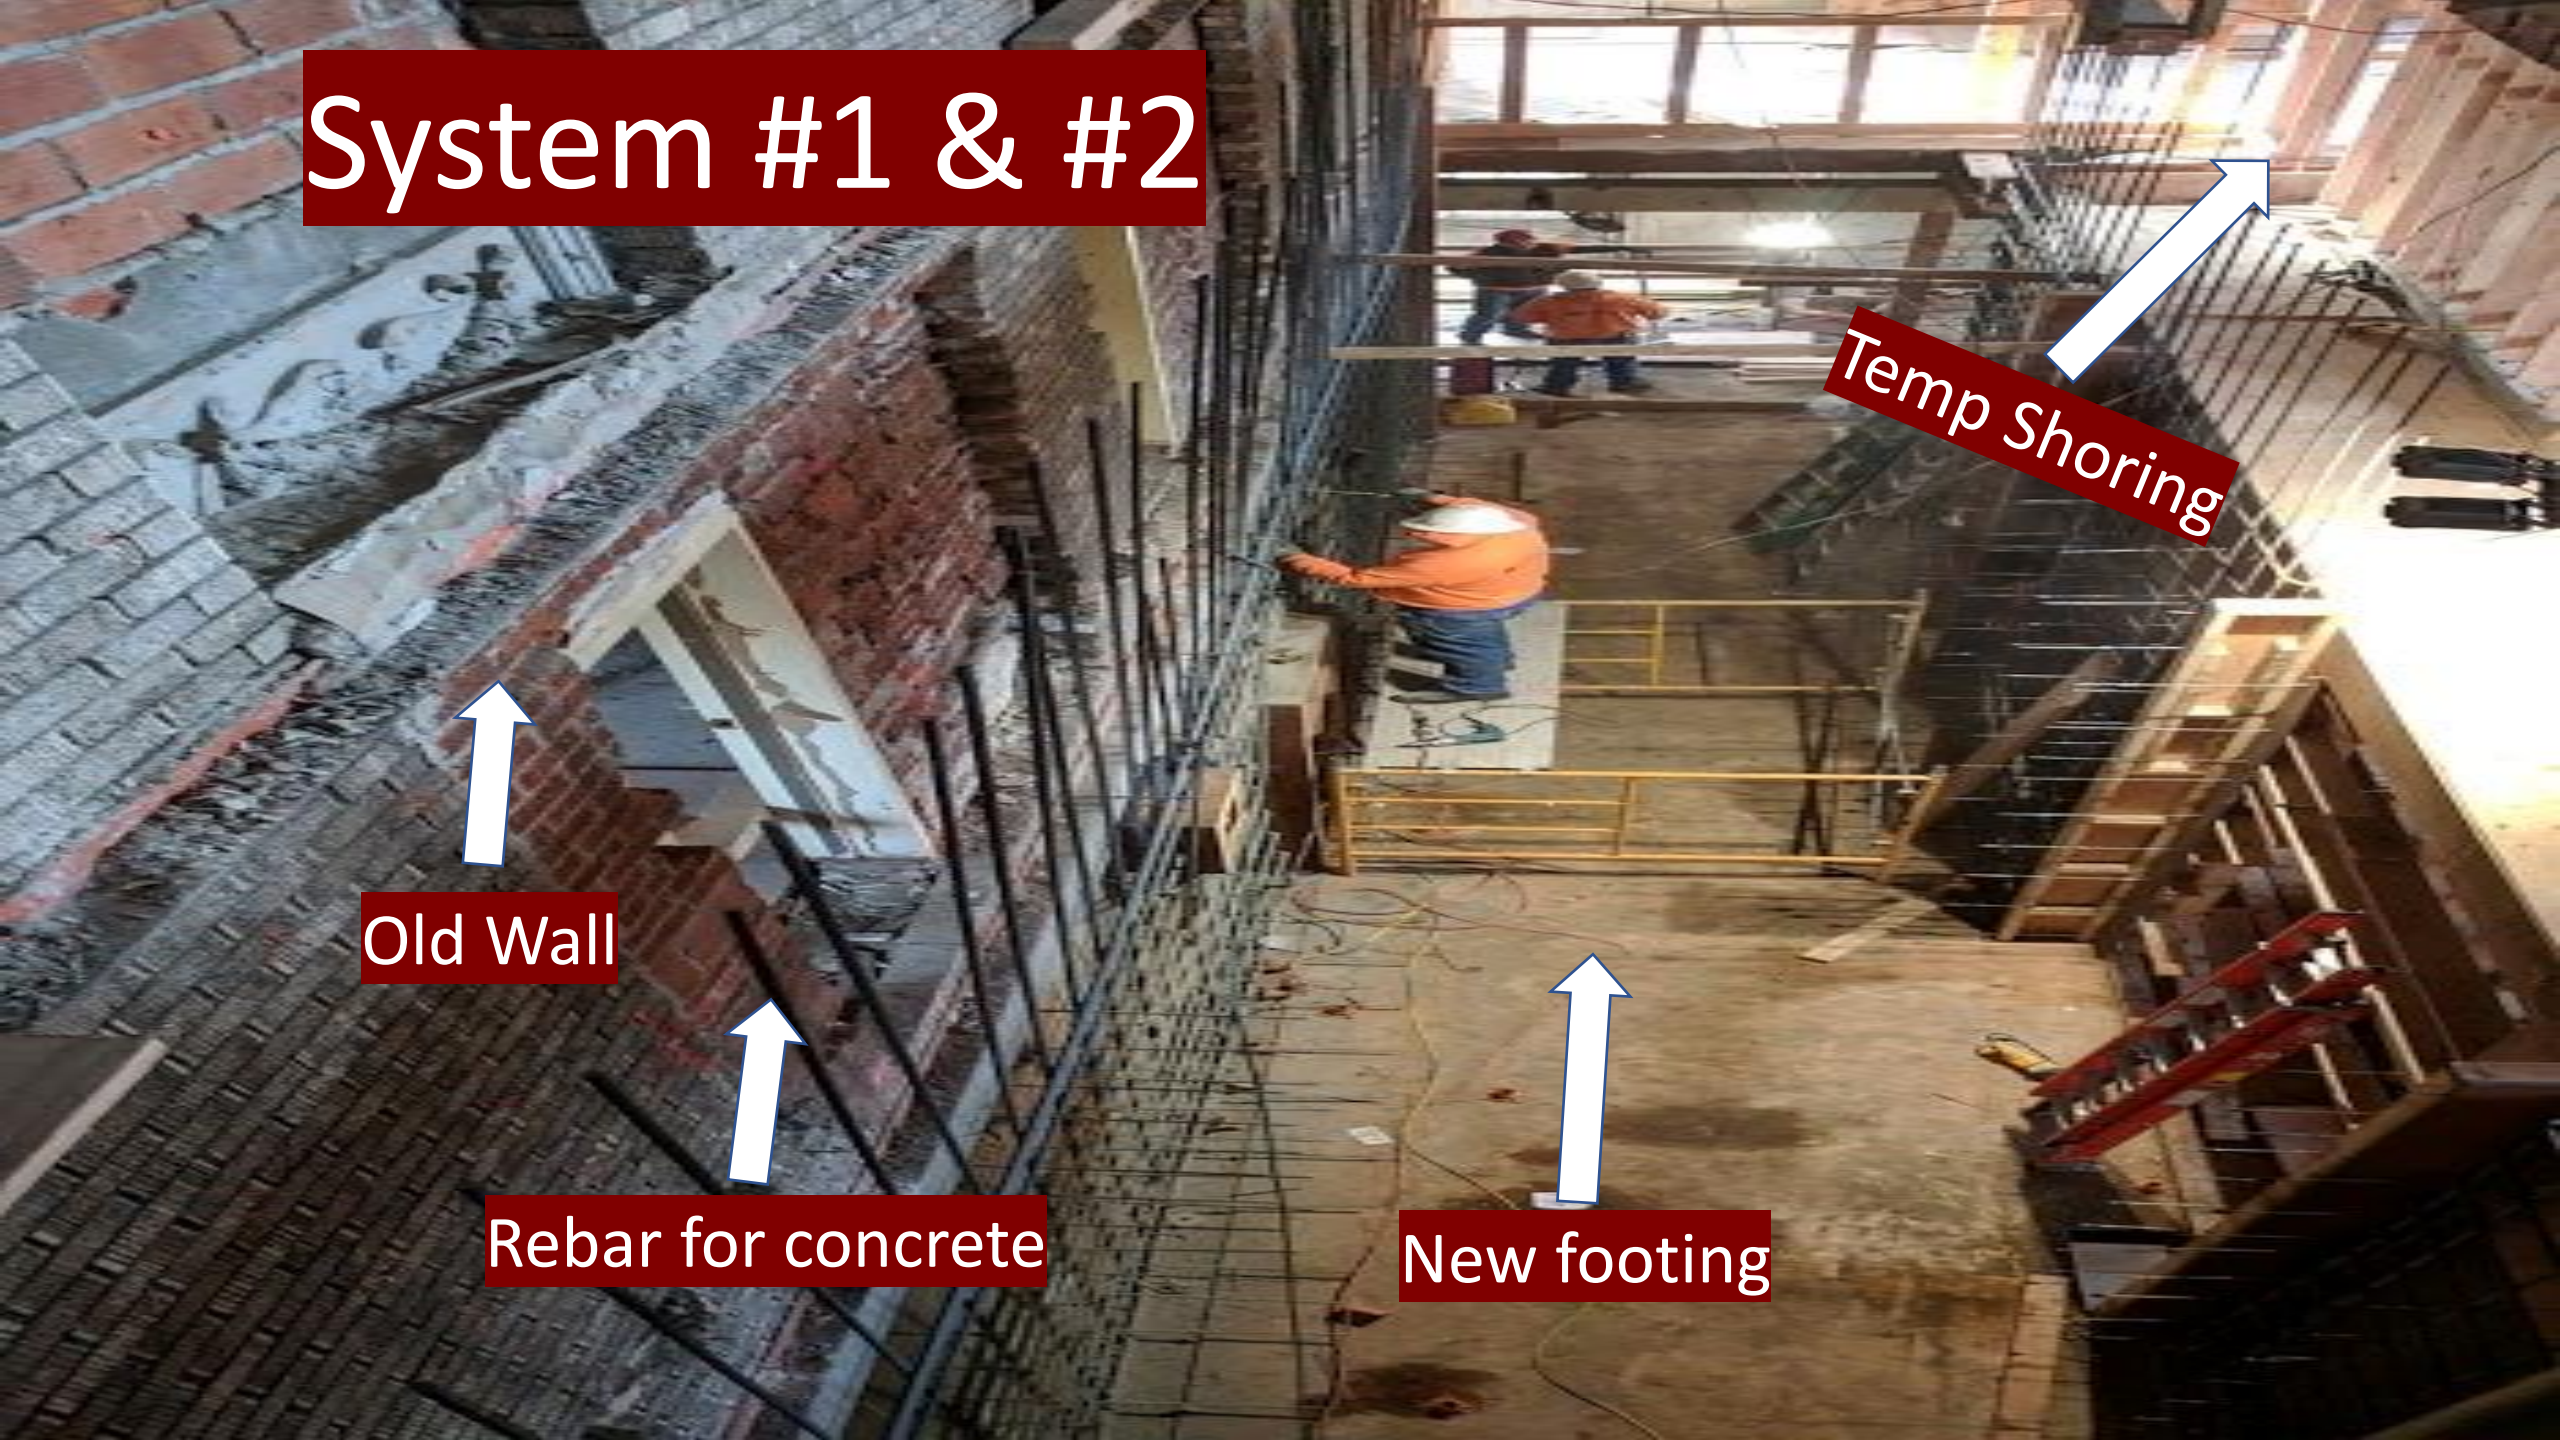
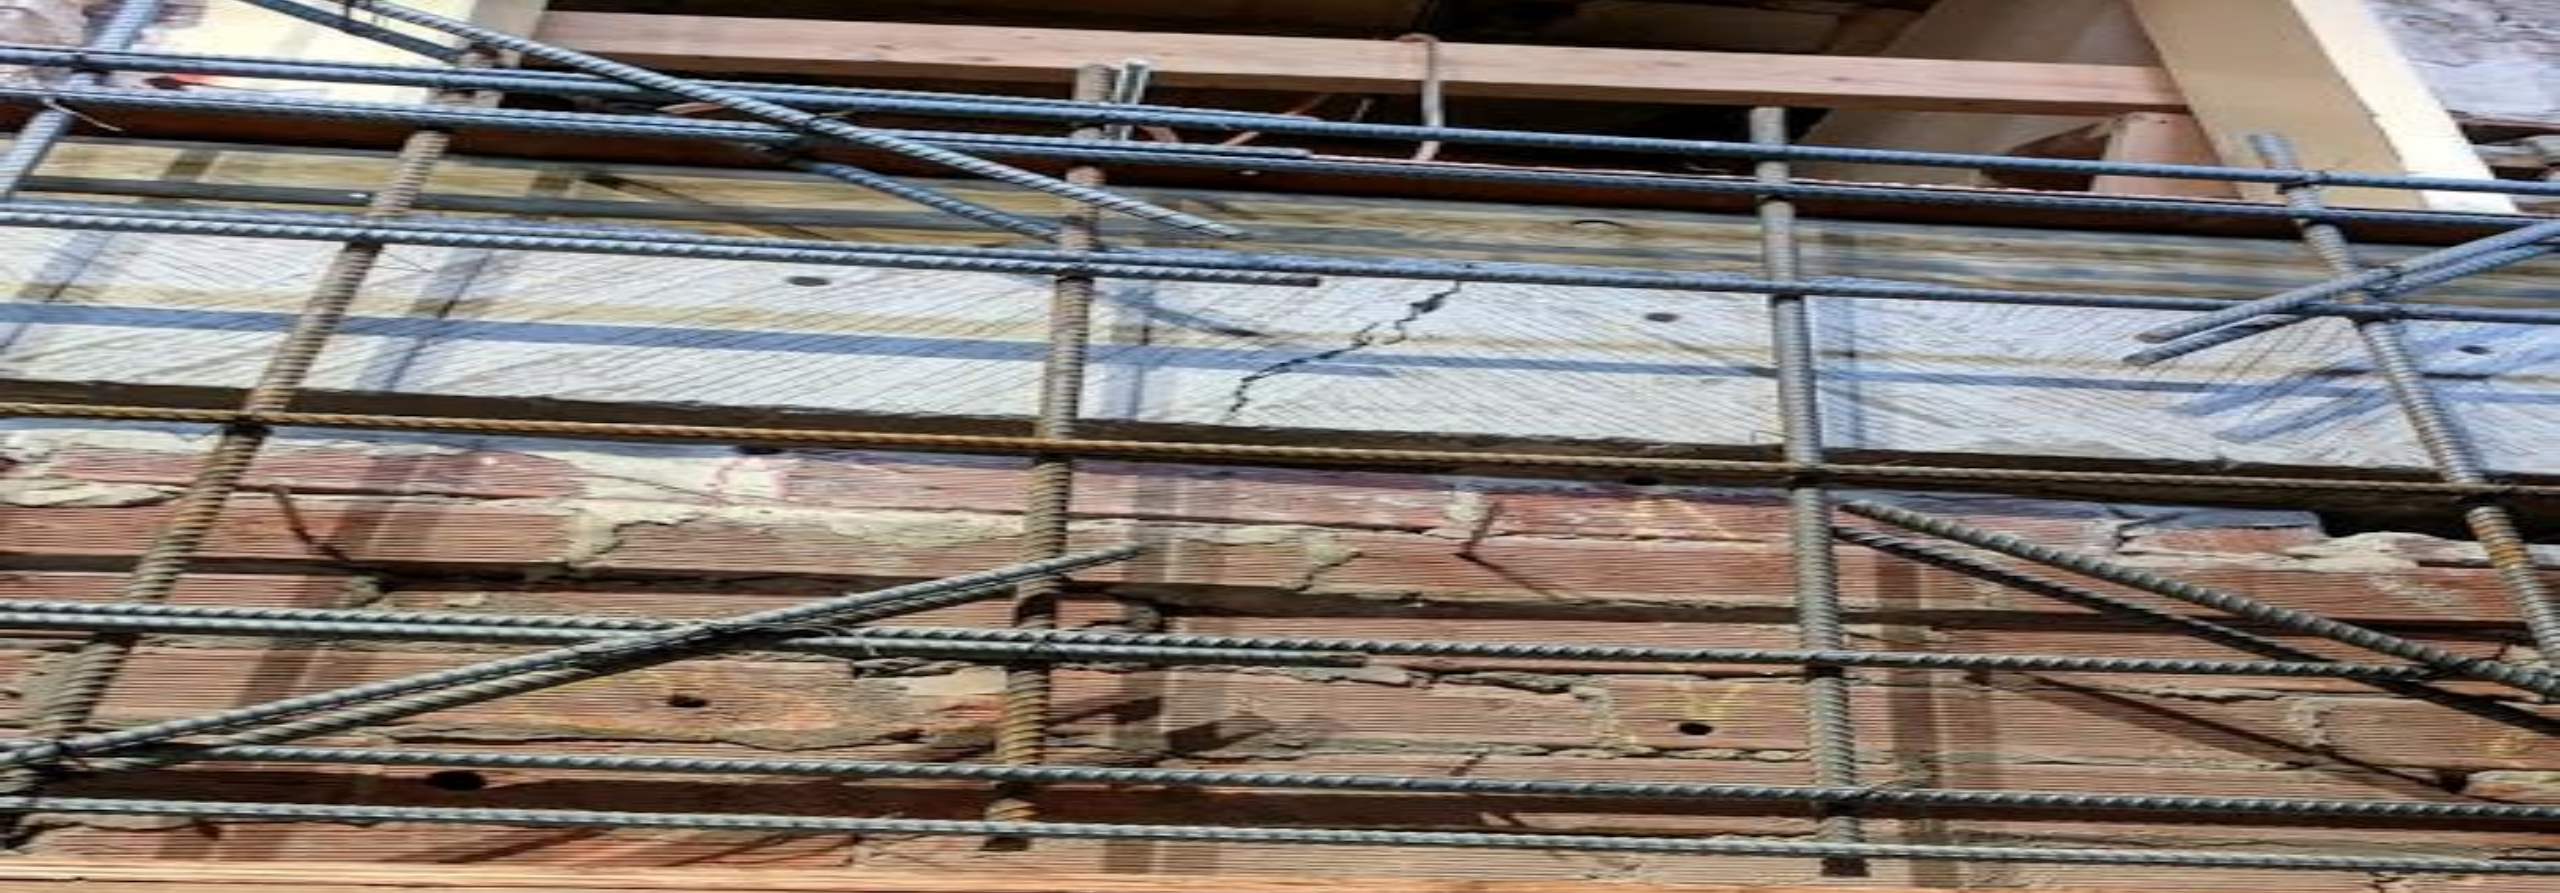
# System #1 & #2

Old Wall

Rebar for concrete

New footing

Temp Shoring

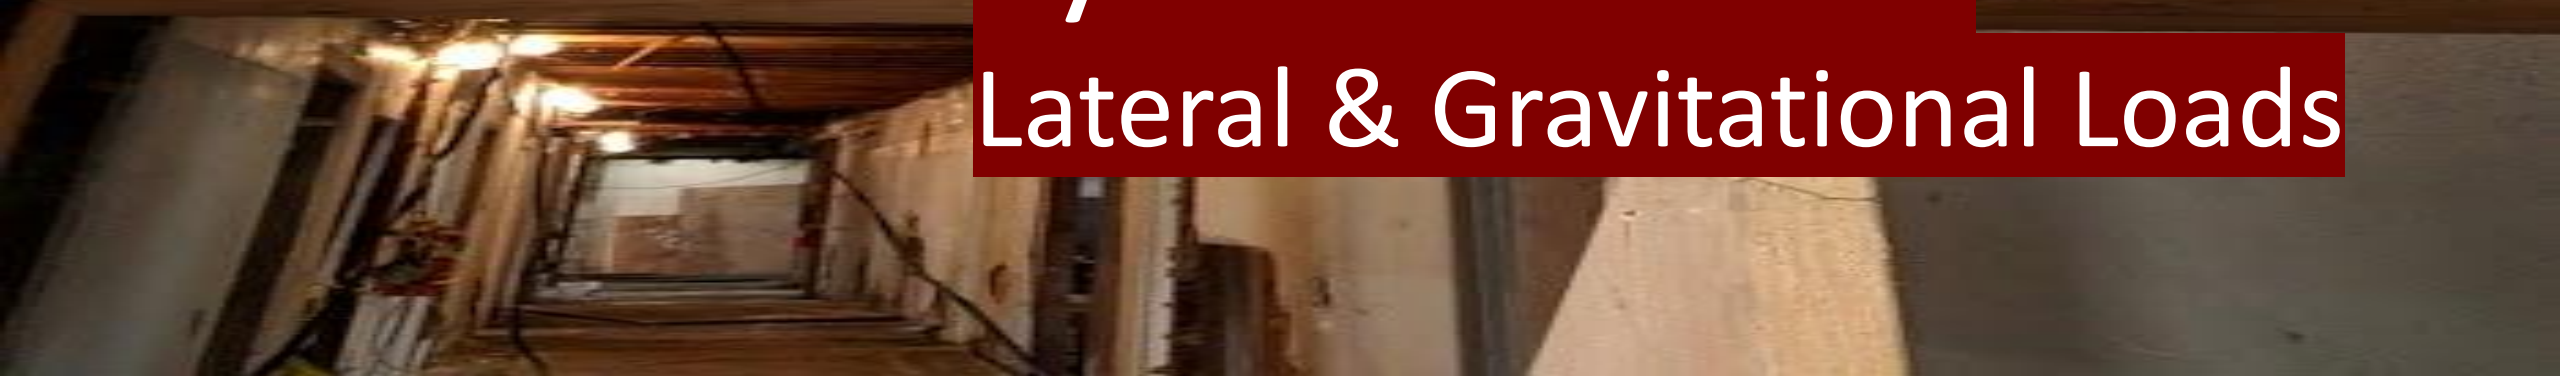
System #1 & #2

Lateral & Gravitational Loads

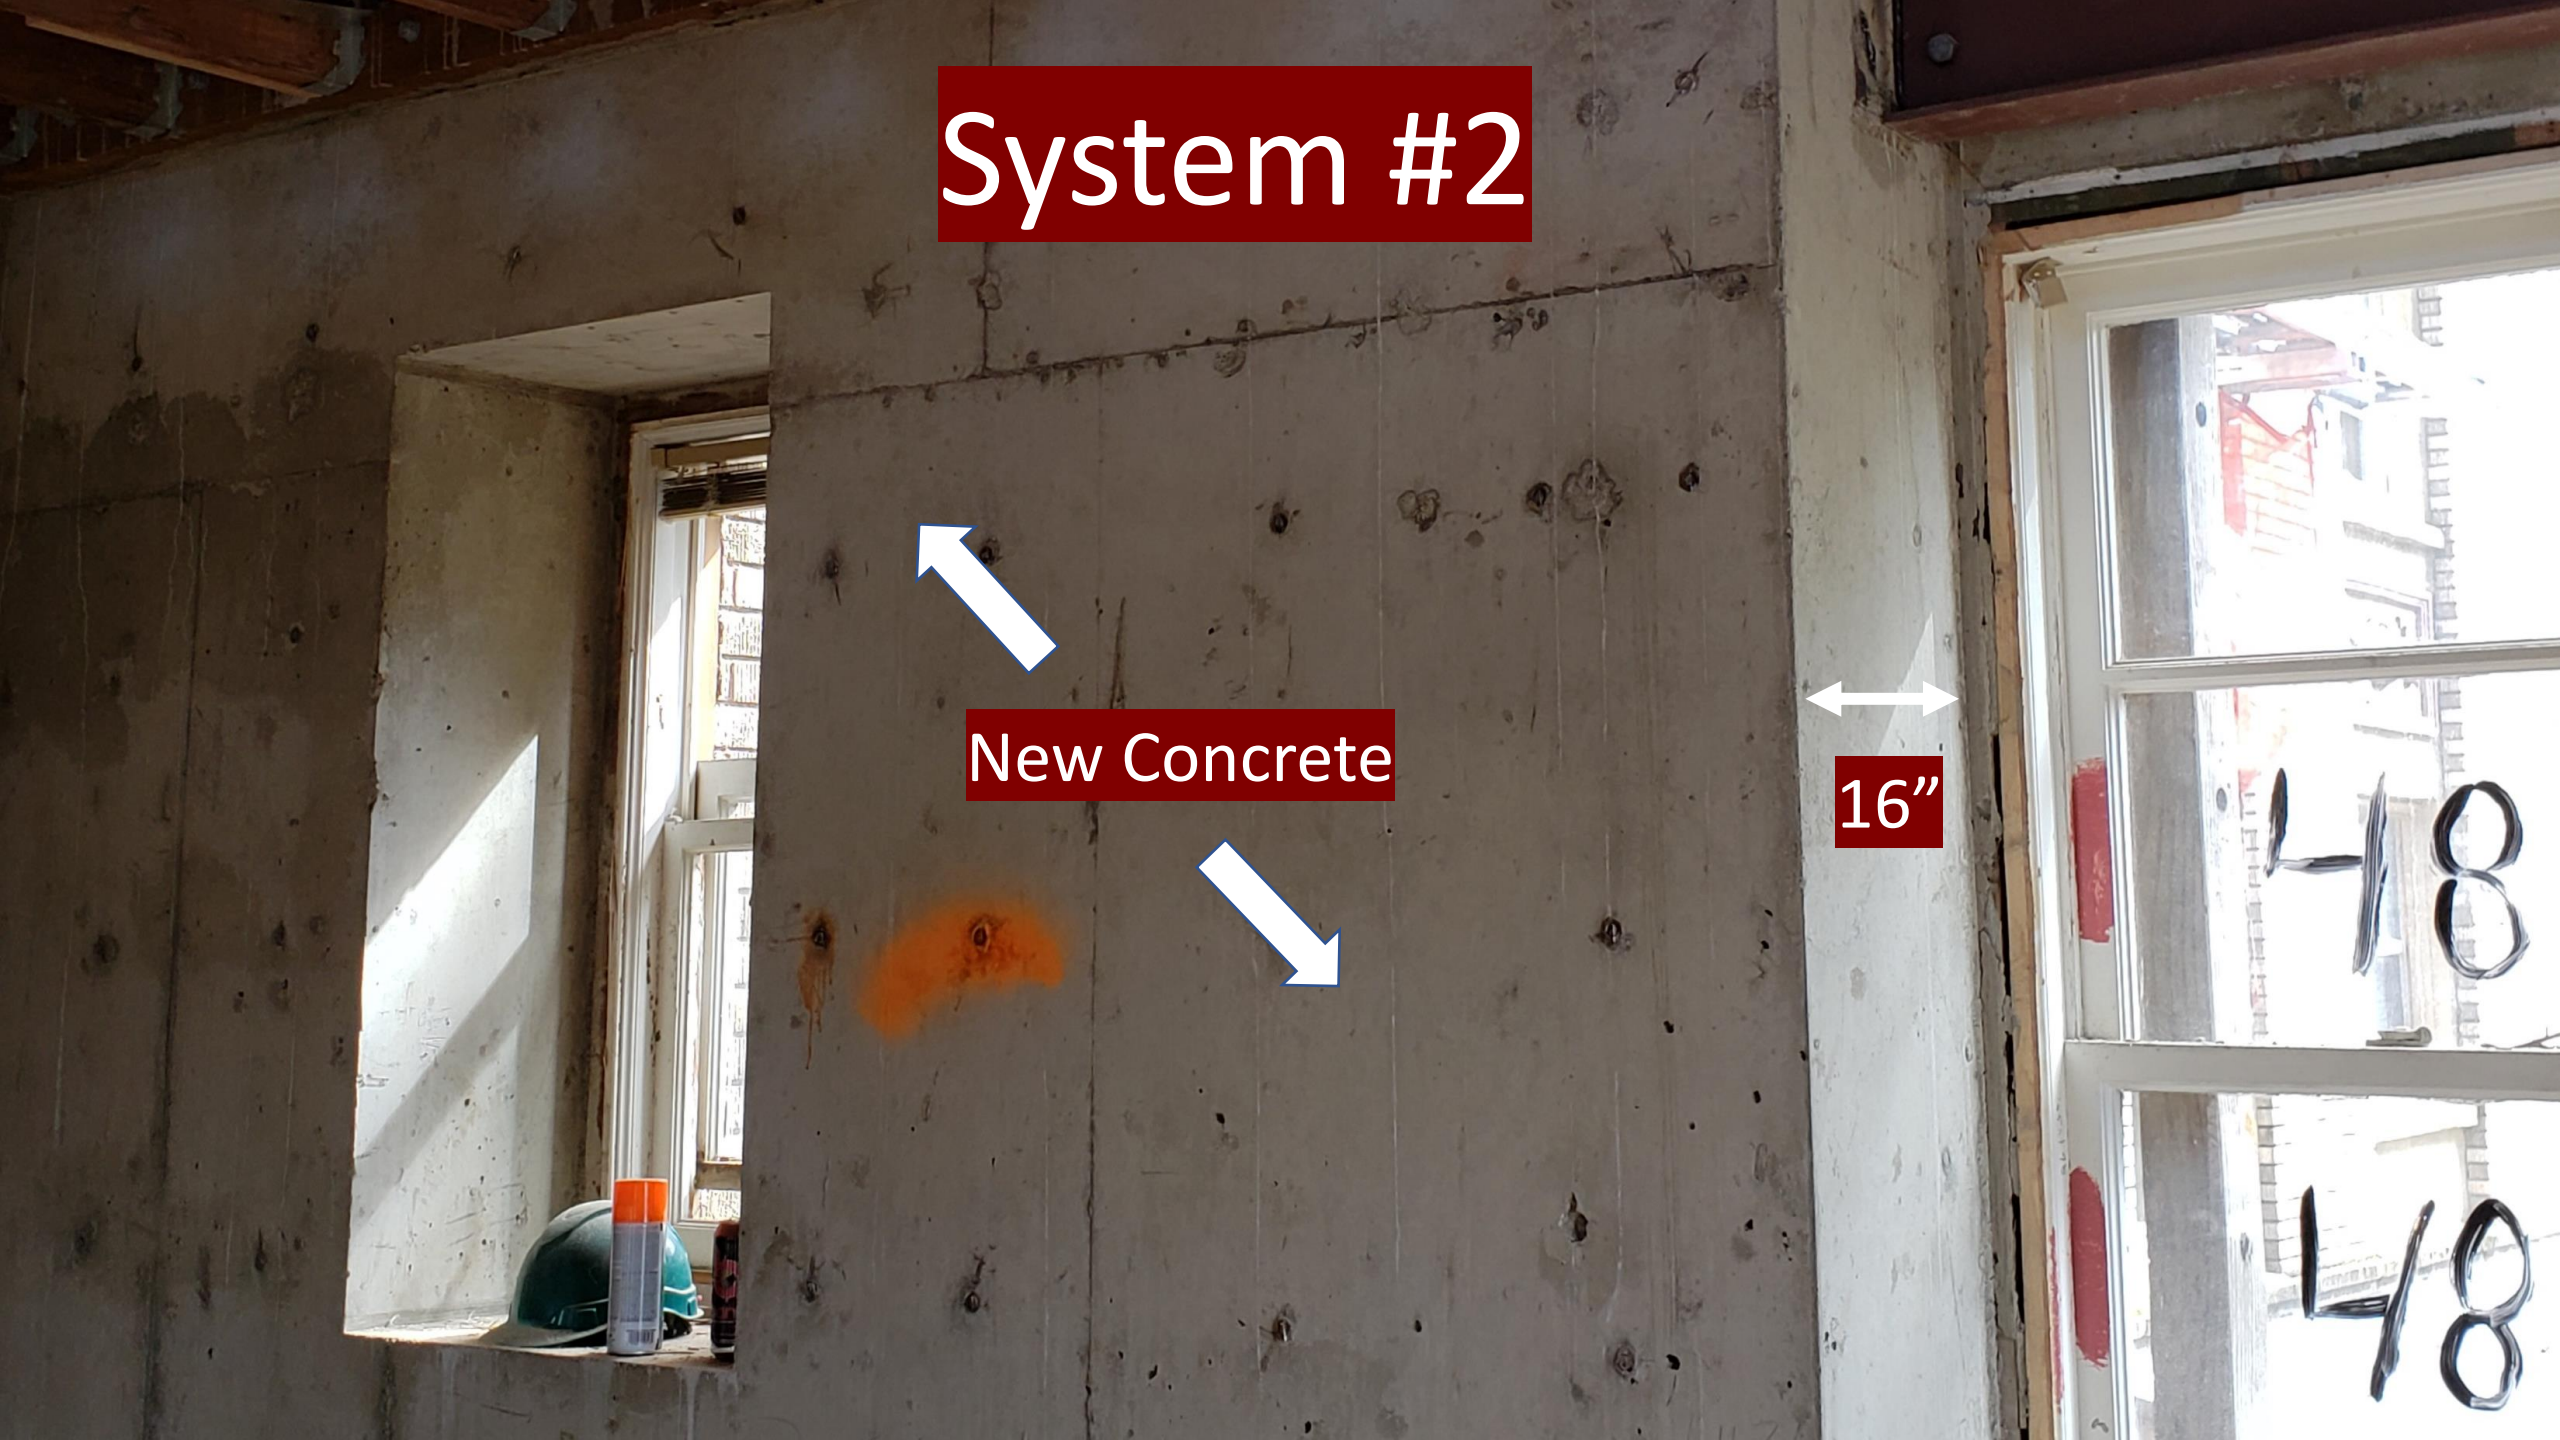
# System #2

New Concrete

16"
