Welcome  
2019 Spring  
Apartment  
Report Panelist  
Rudy Munzel

**Apartment Report**

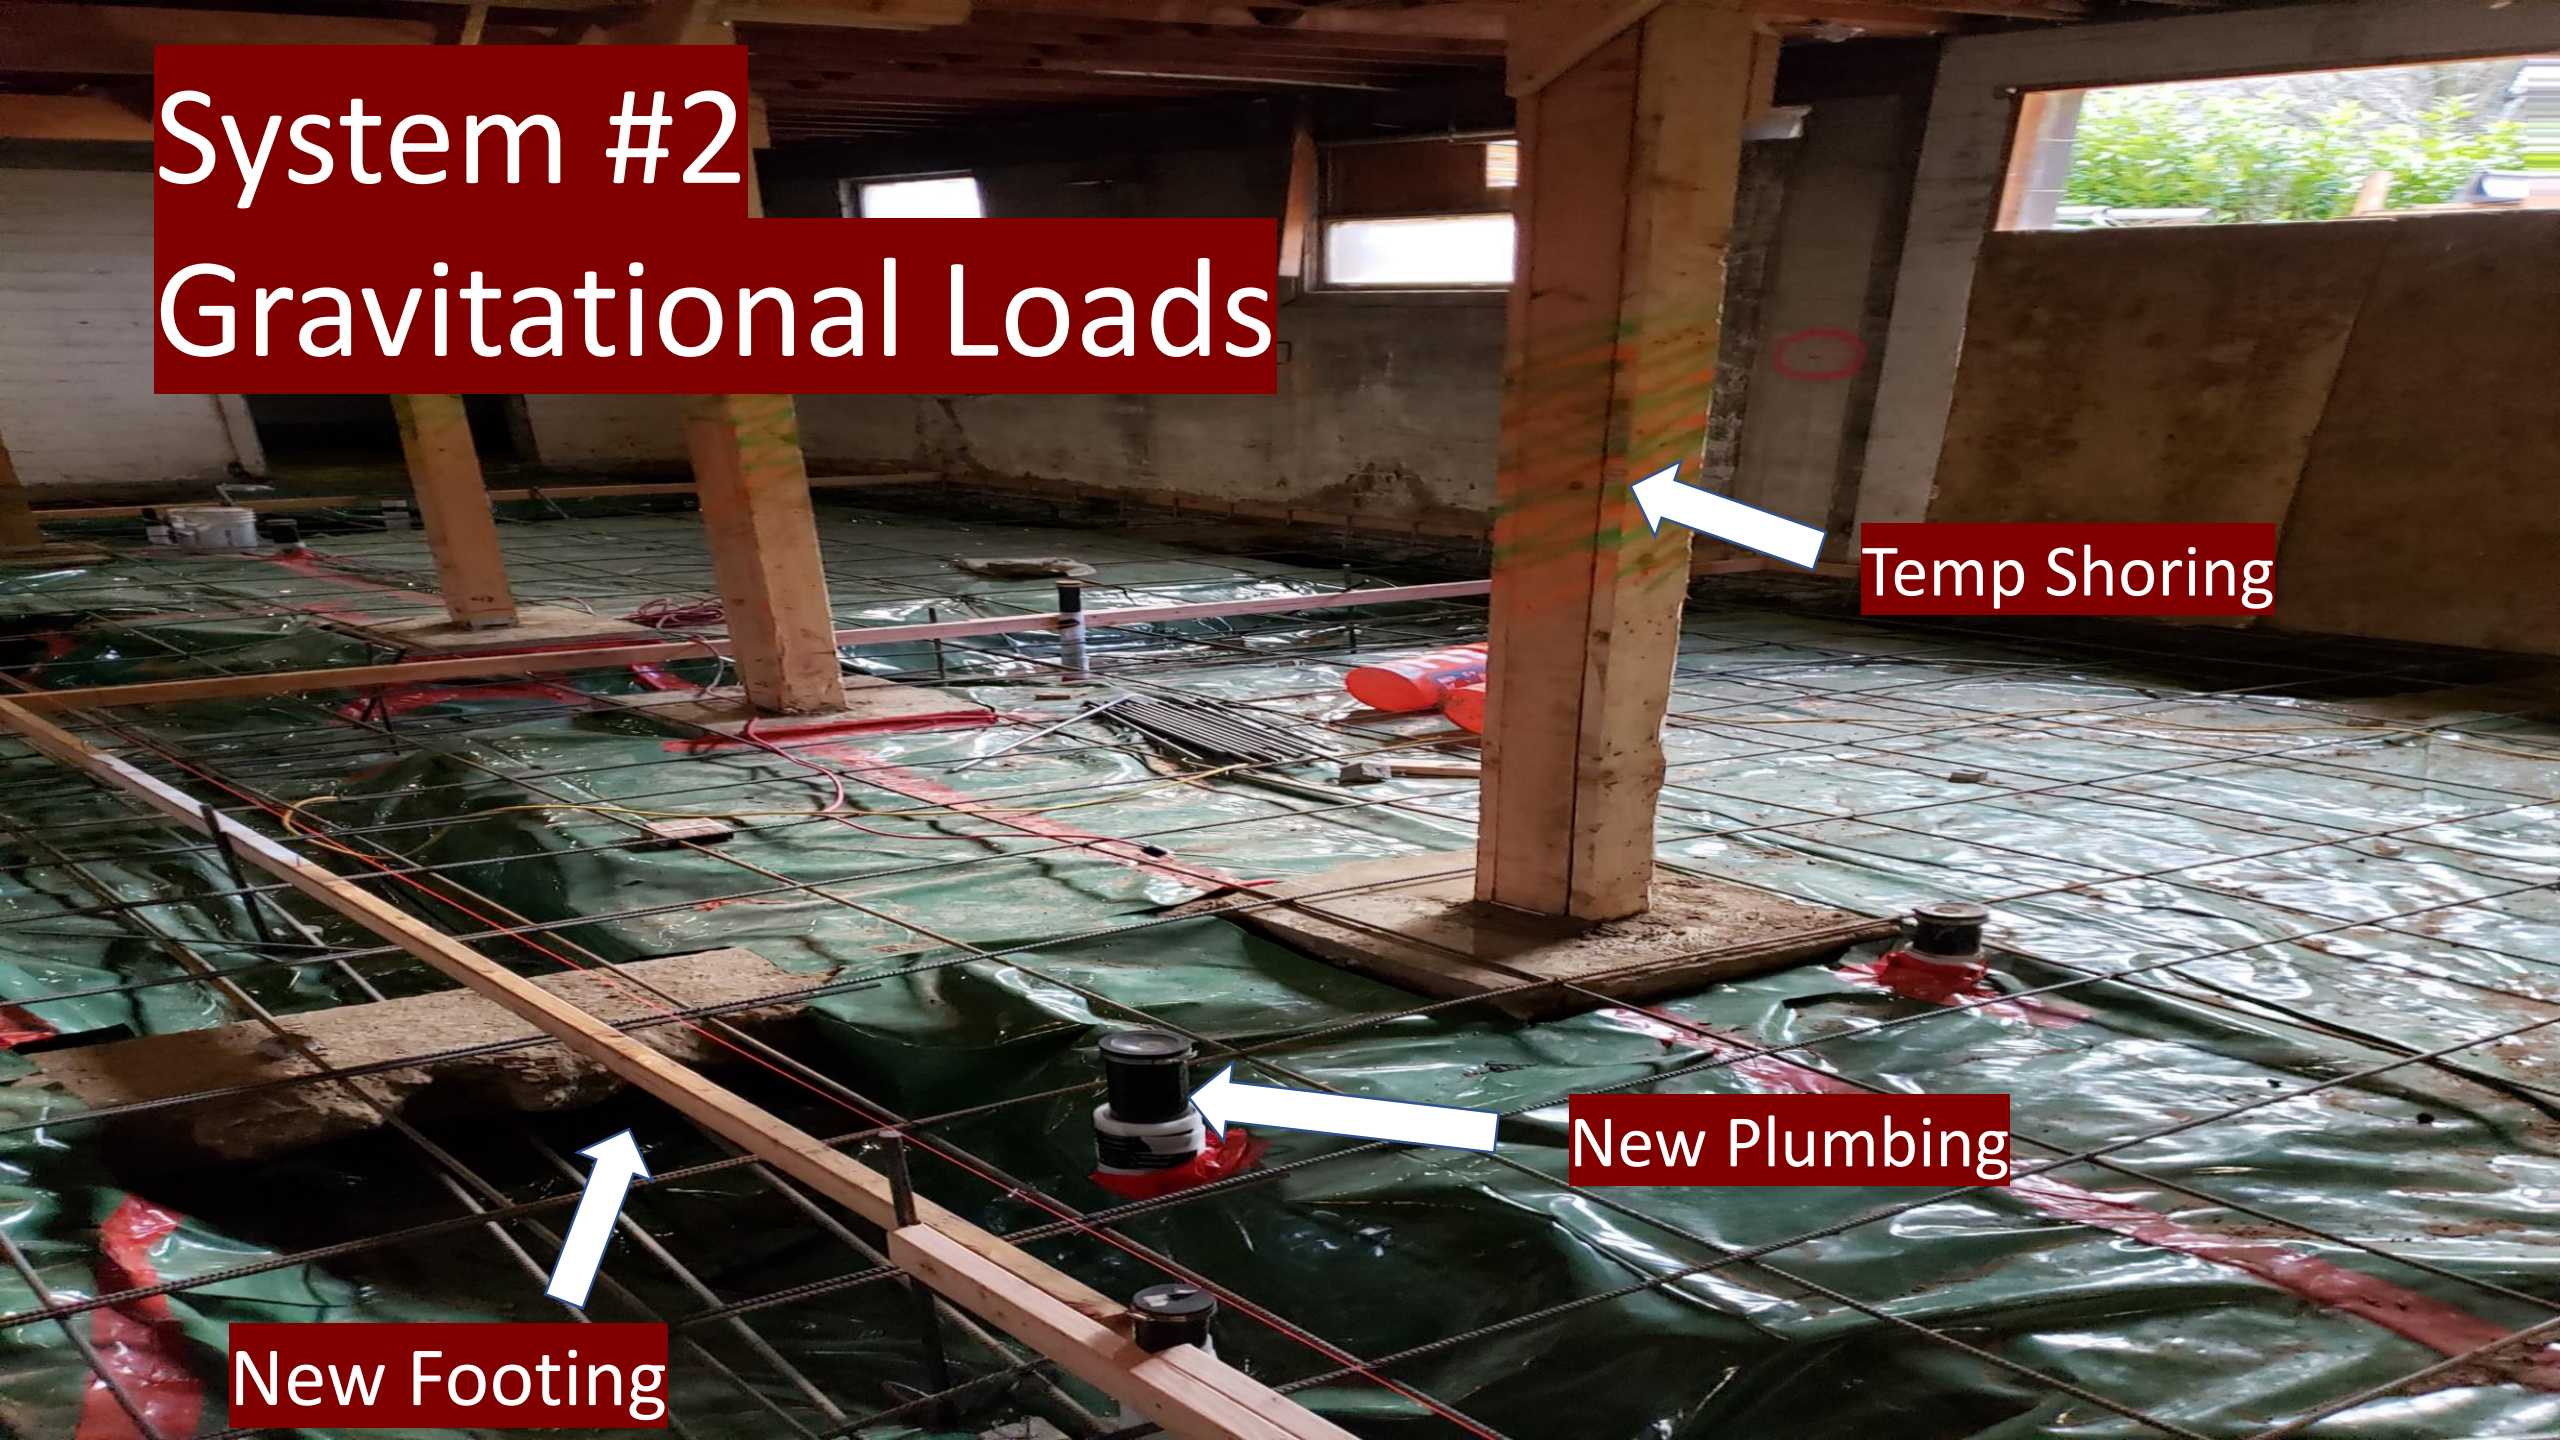
# System #2 Gravitational Loads

Temp Shoring

New Plumbing

New Footing

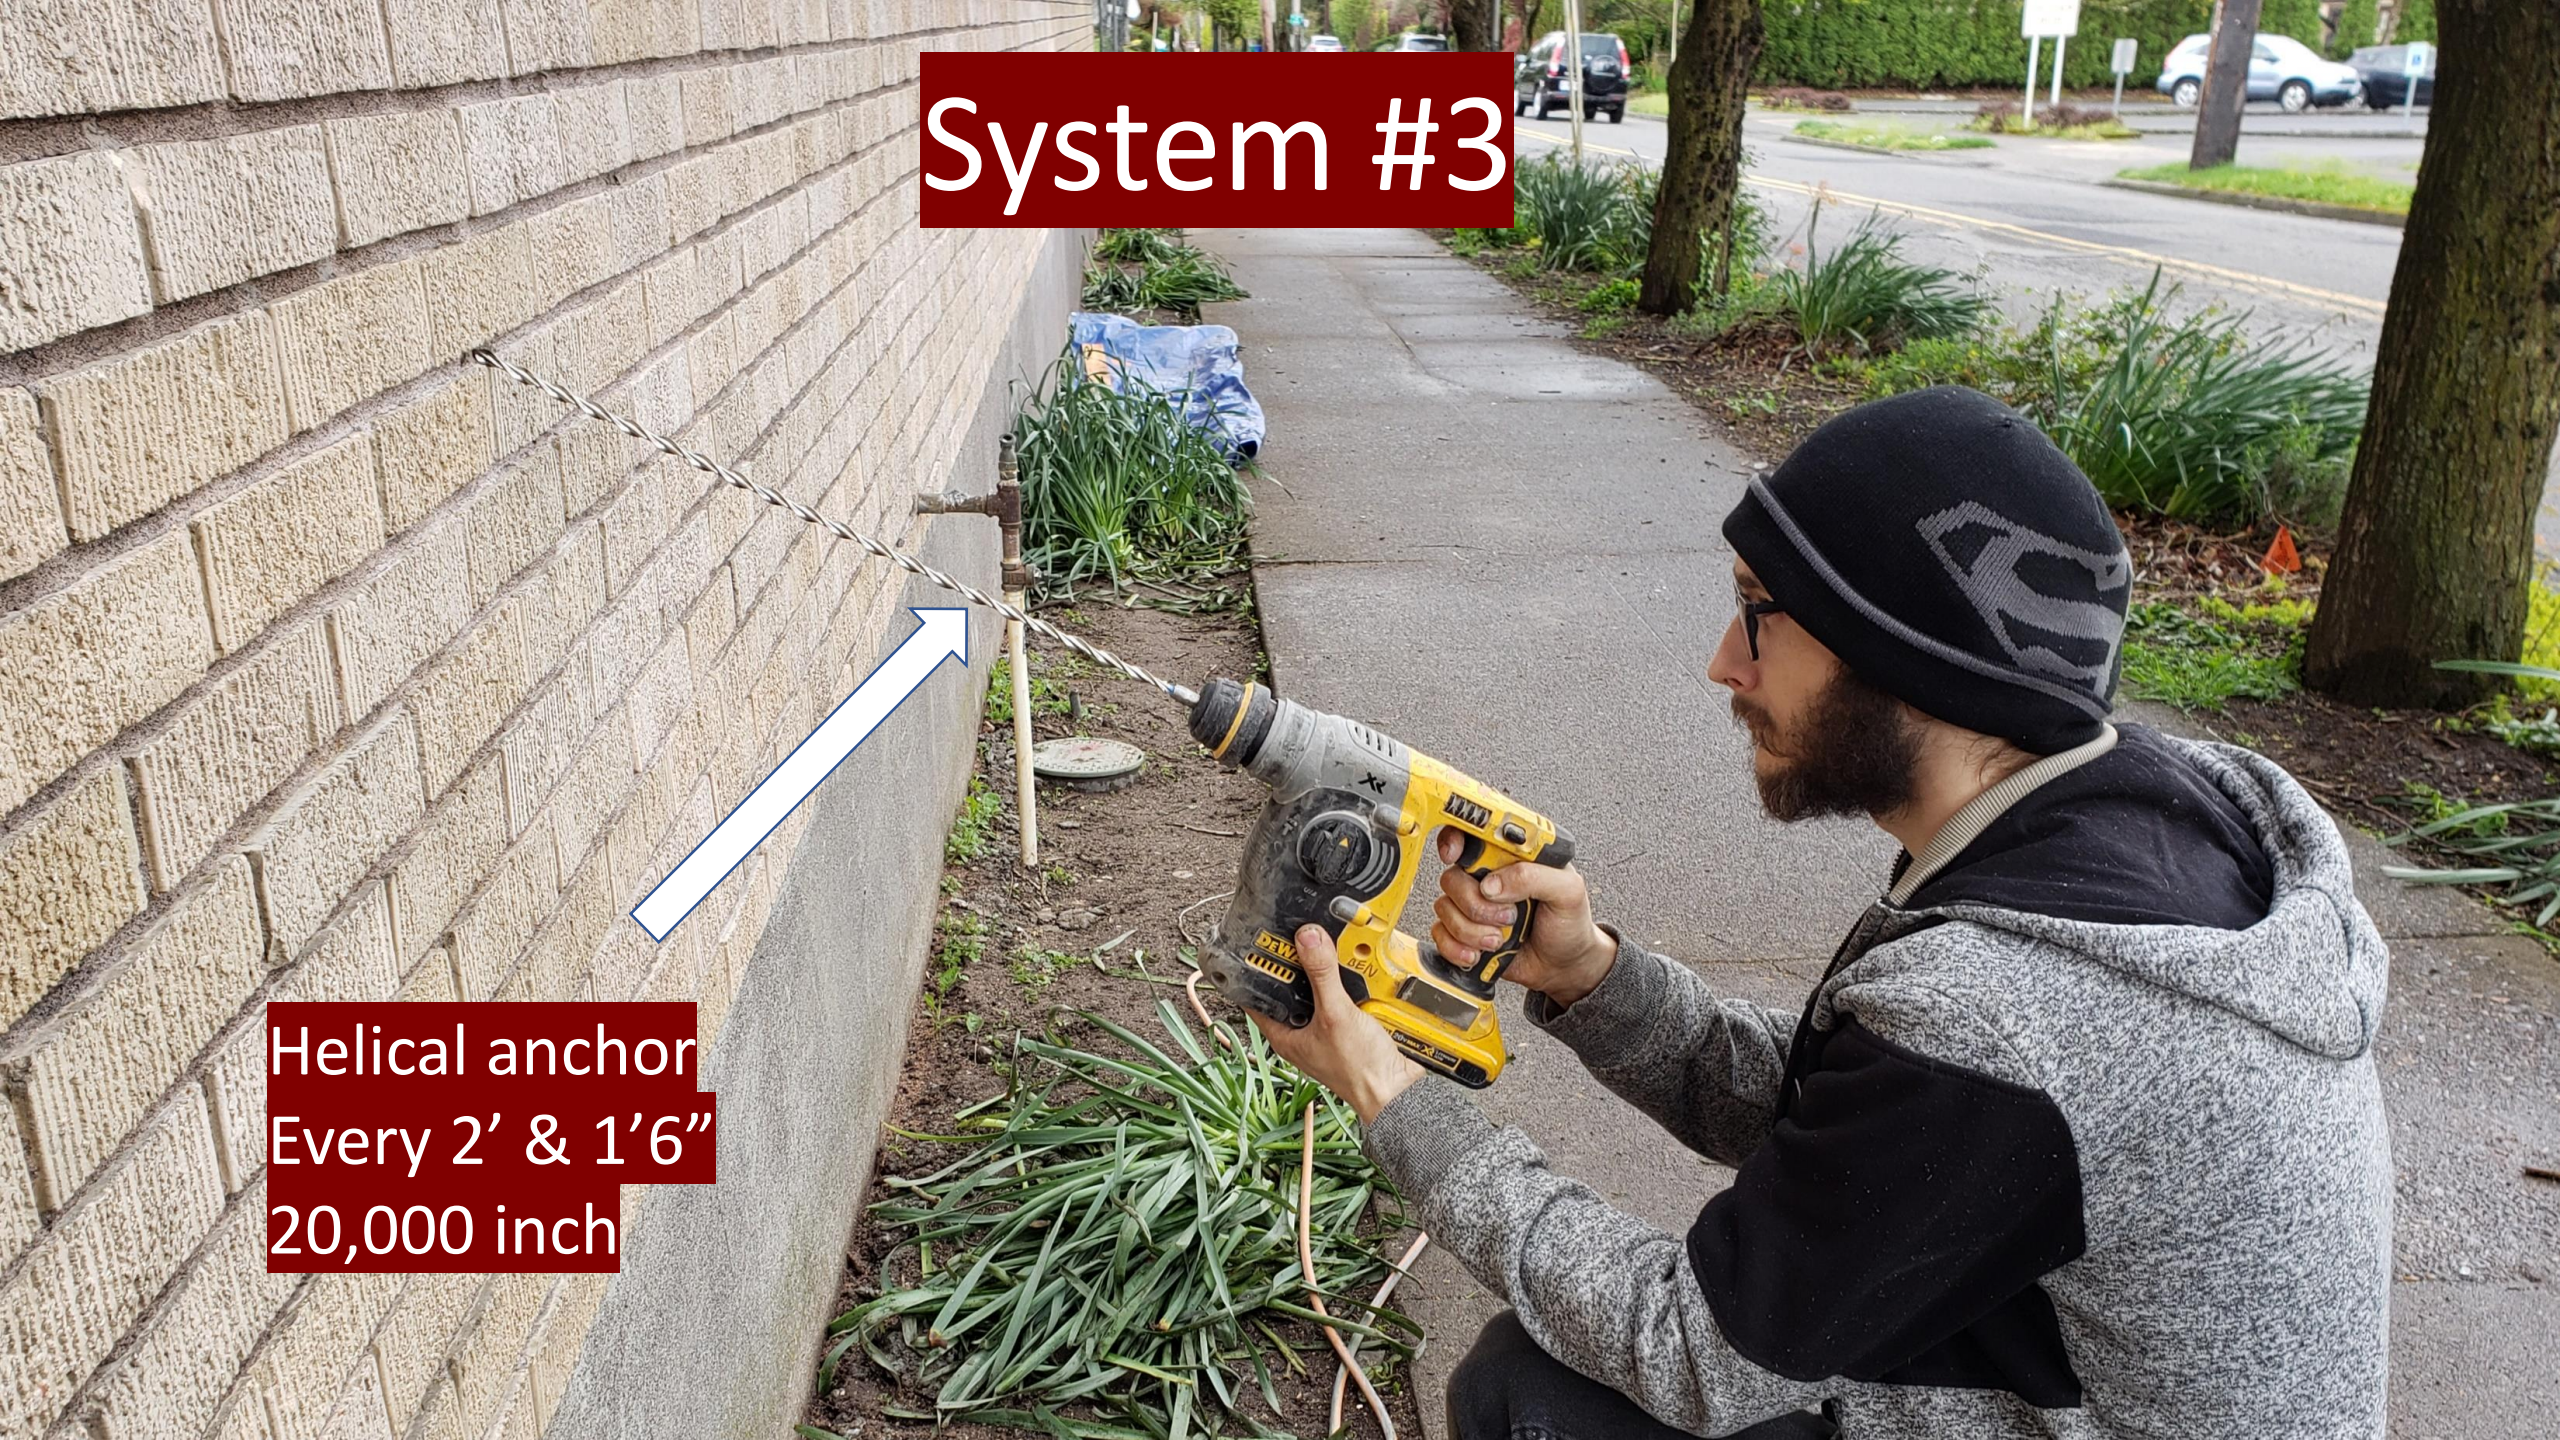
# System #3

Helical anchor  
Every 2' & 1'6"  
20,000 inch

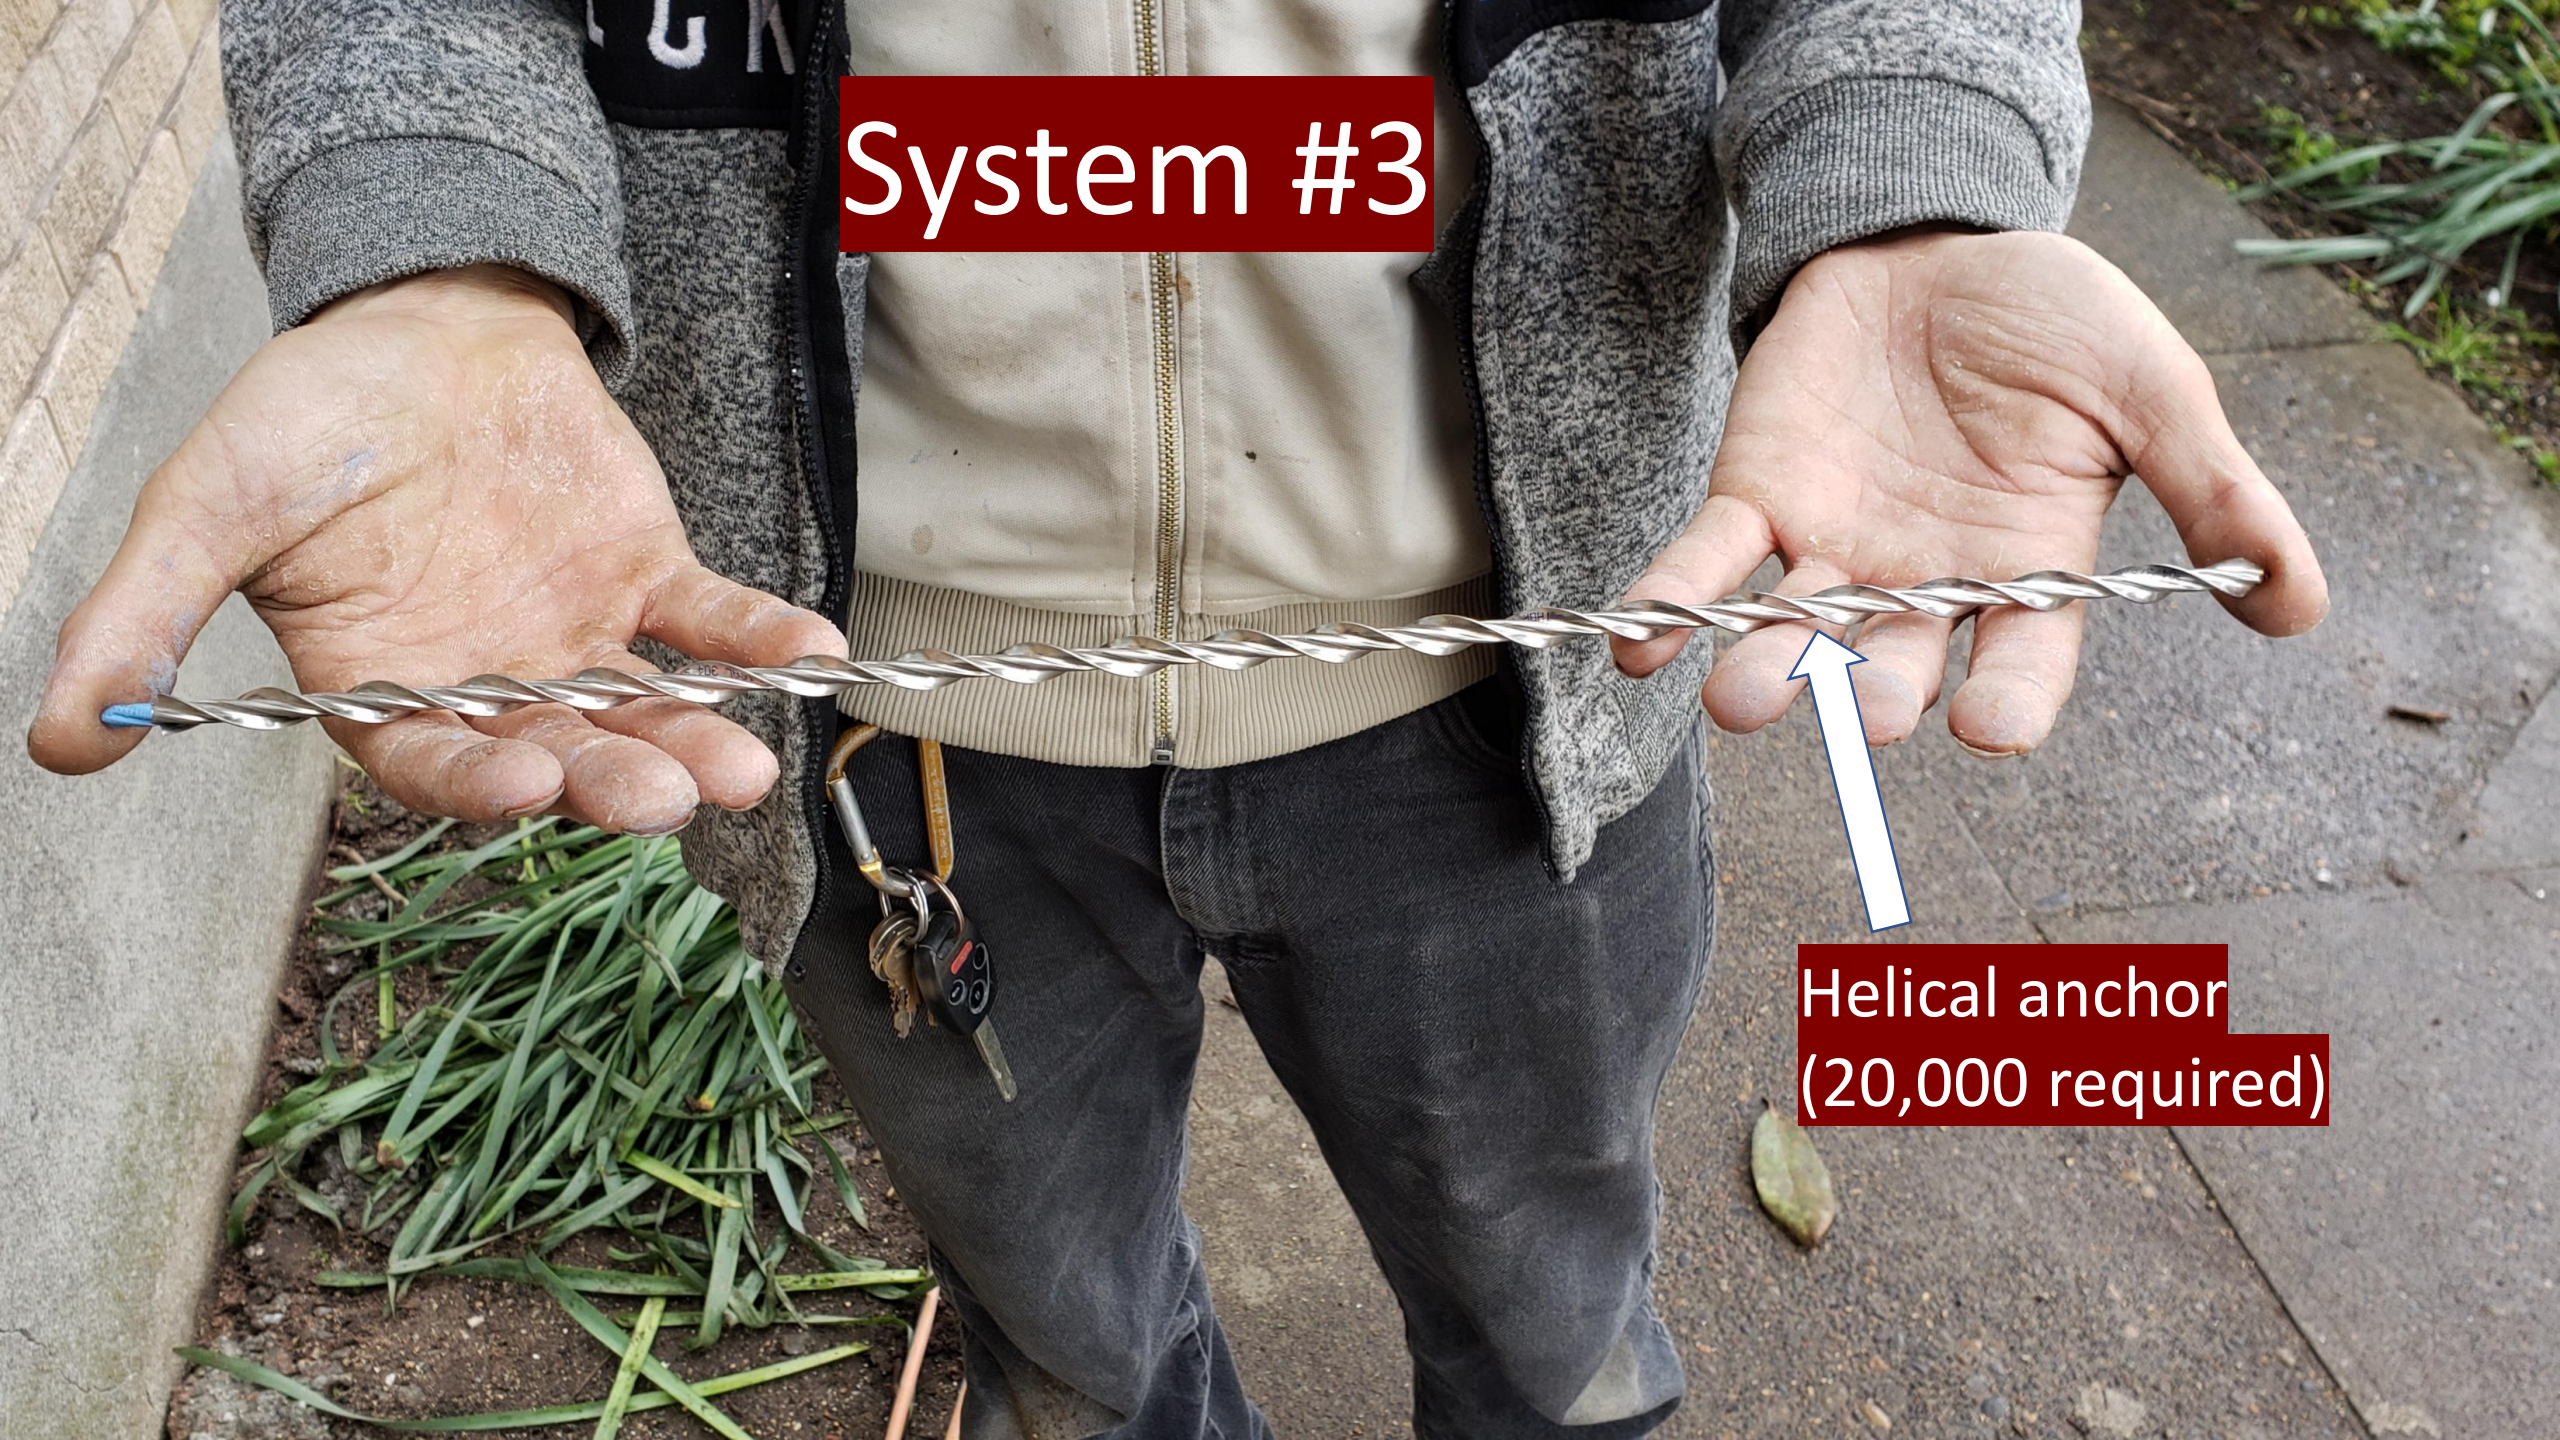
# System #3

Helical anchor  
(20,000 required)
