# 2026 NARI RotY Awards

**CATEGORY:** Residential Interior Over \$500,000  
**PROJECT:** Contemporary Minnetonka Remodel

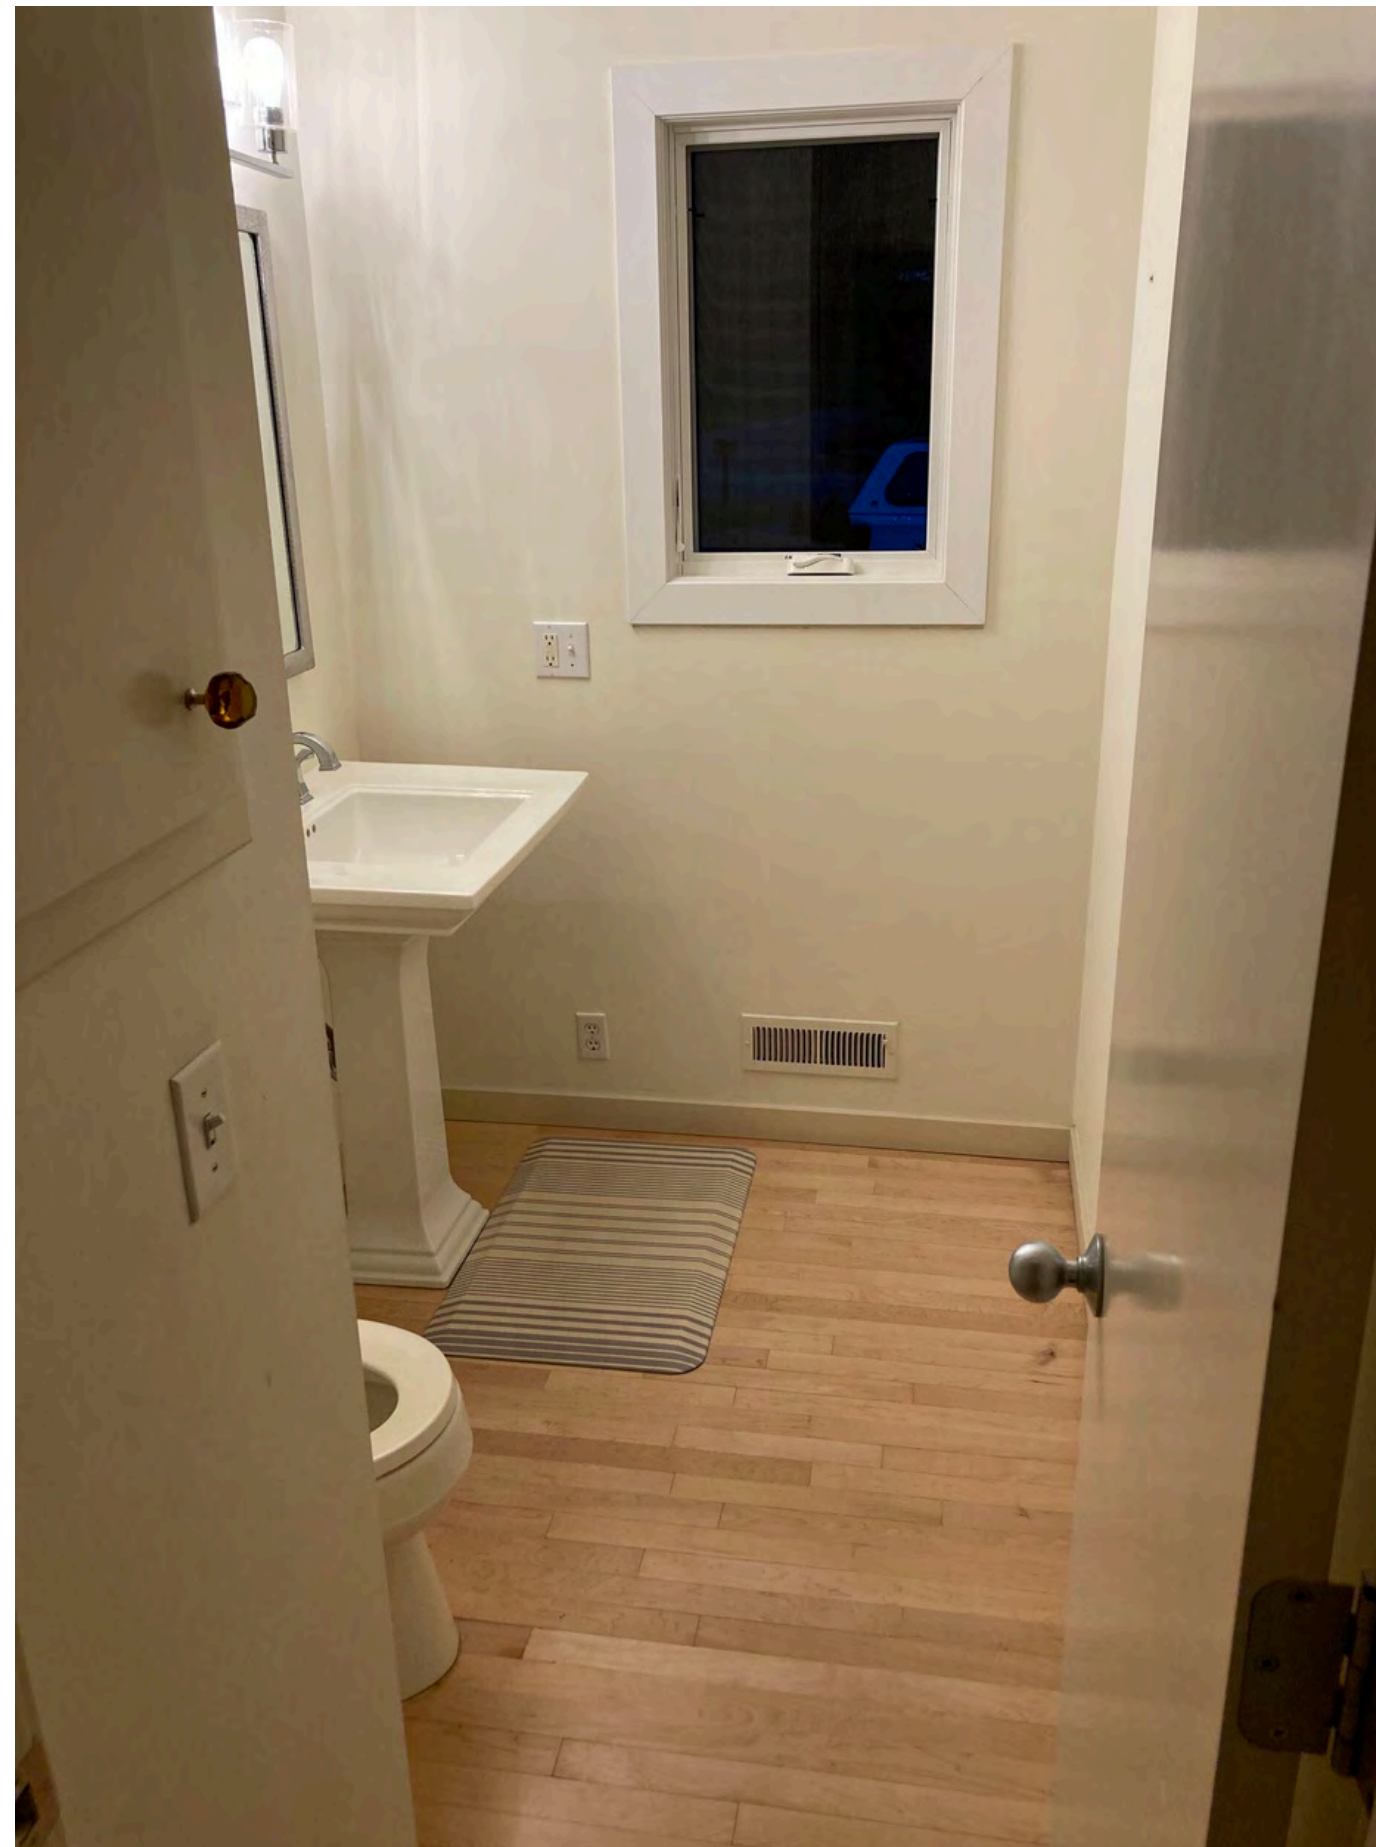
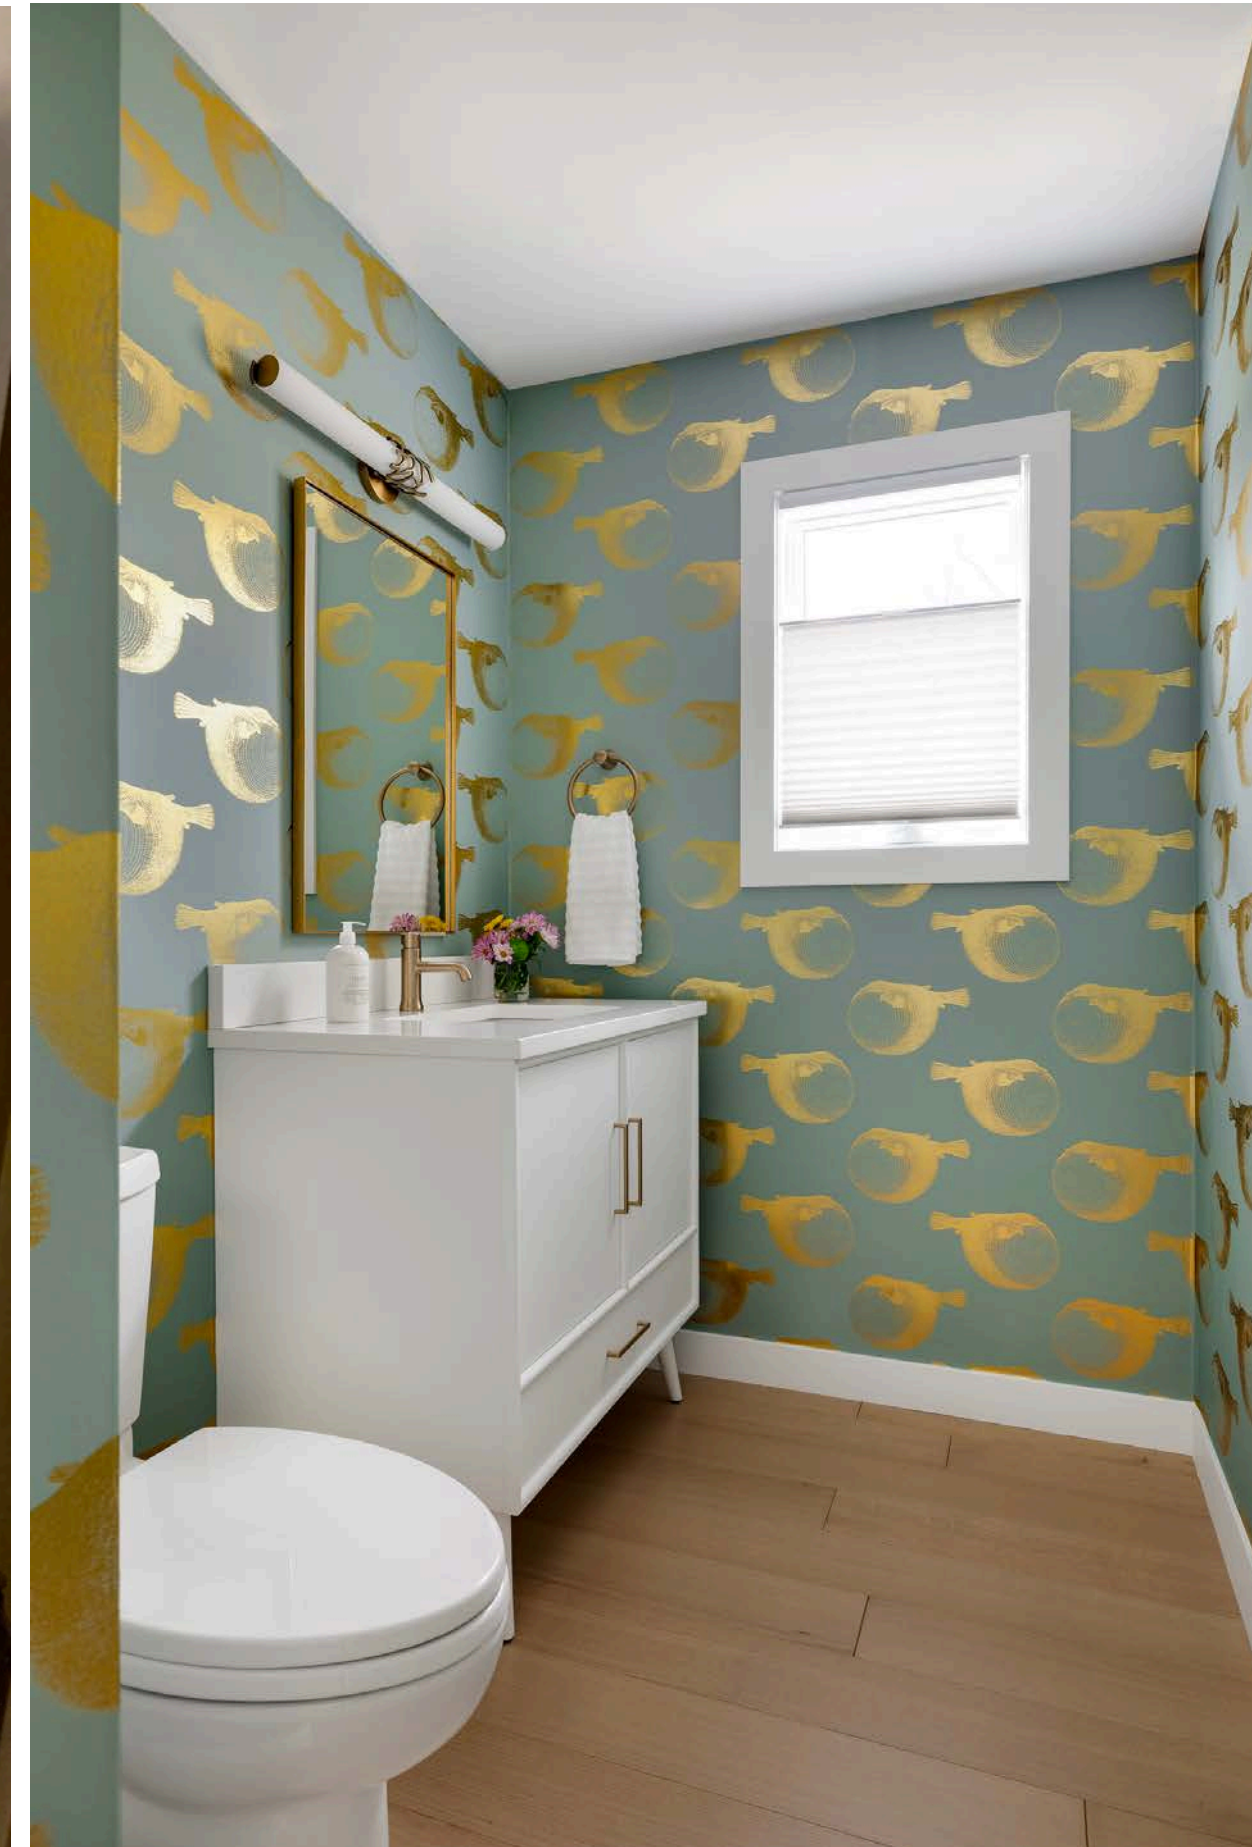
# POWDER BATH - BEFORE & AFTER

- Clients wanted to give the powder bathroom an updated and modernized look. They felt like it didn't represent their style preferences and lacked interest.
- Removal of popcorn ceiling was a must.

- **Aesthetic changes**
  - Mr. Blow in Goldfinger wallpaper from Abnormals Anonymous.
  - Same 6" White Oak flooring as the rest of the main level.
  - New updated plumbing features:
    - Novak 36" Freestanding Mahogany Vanity, light fixture, and mirror.
  - Removal of popcorn ceiling.
- **Innovation**
  - Client allowed the opportunity to get creative with this space. Collaboration between all parties gave the powder bathroom a fresh look that perfectly fit the clients' design preferences, while staying functional.

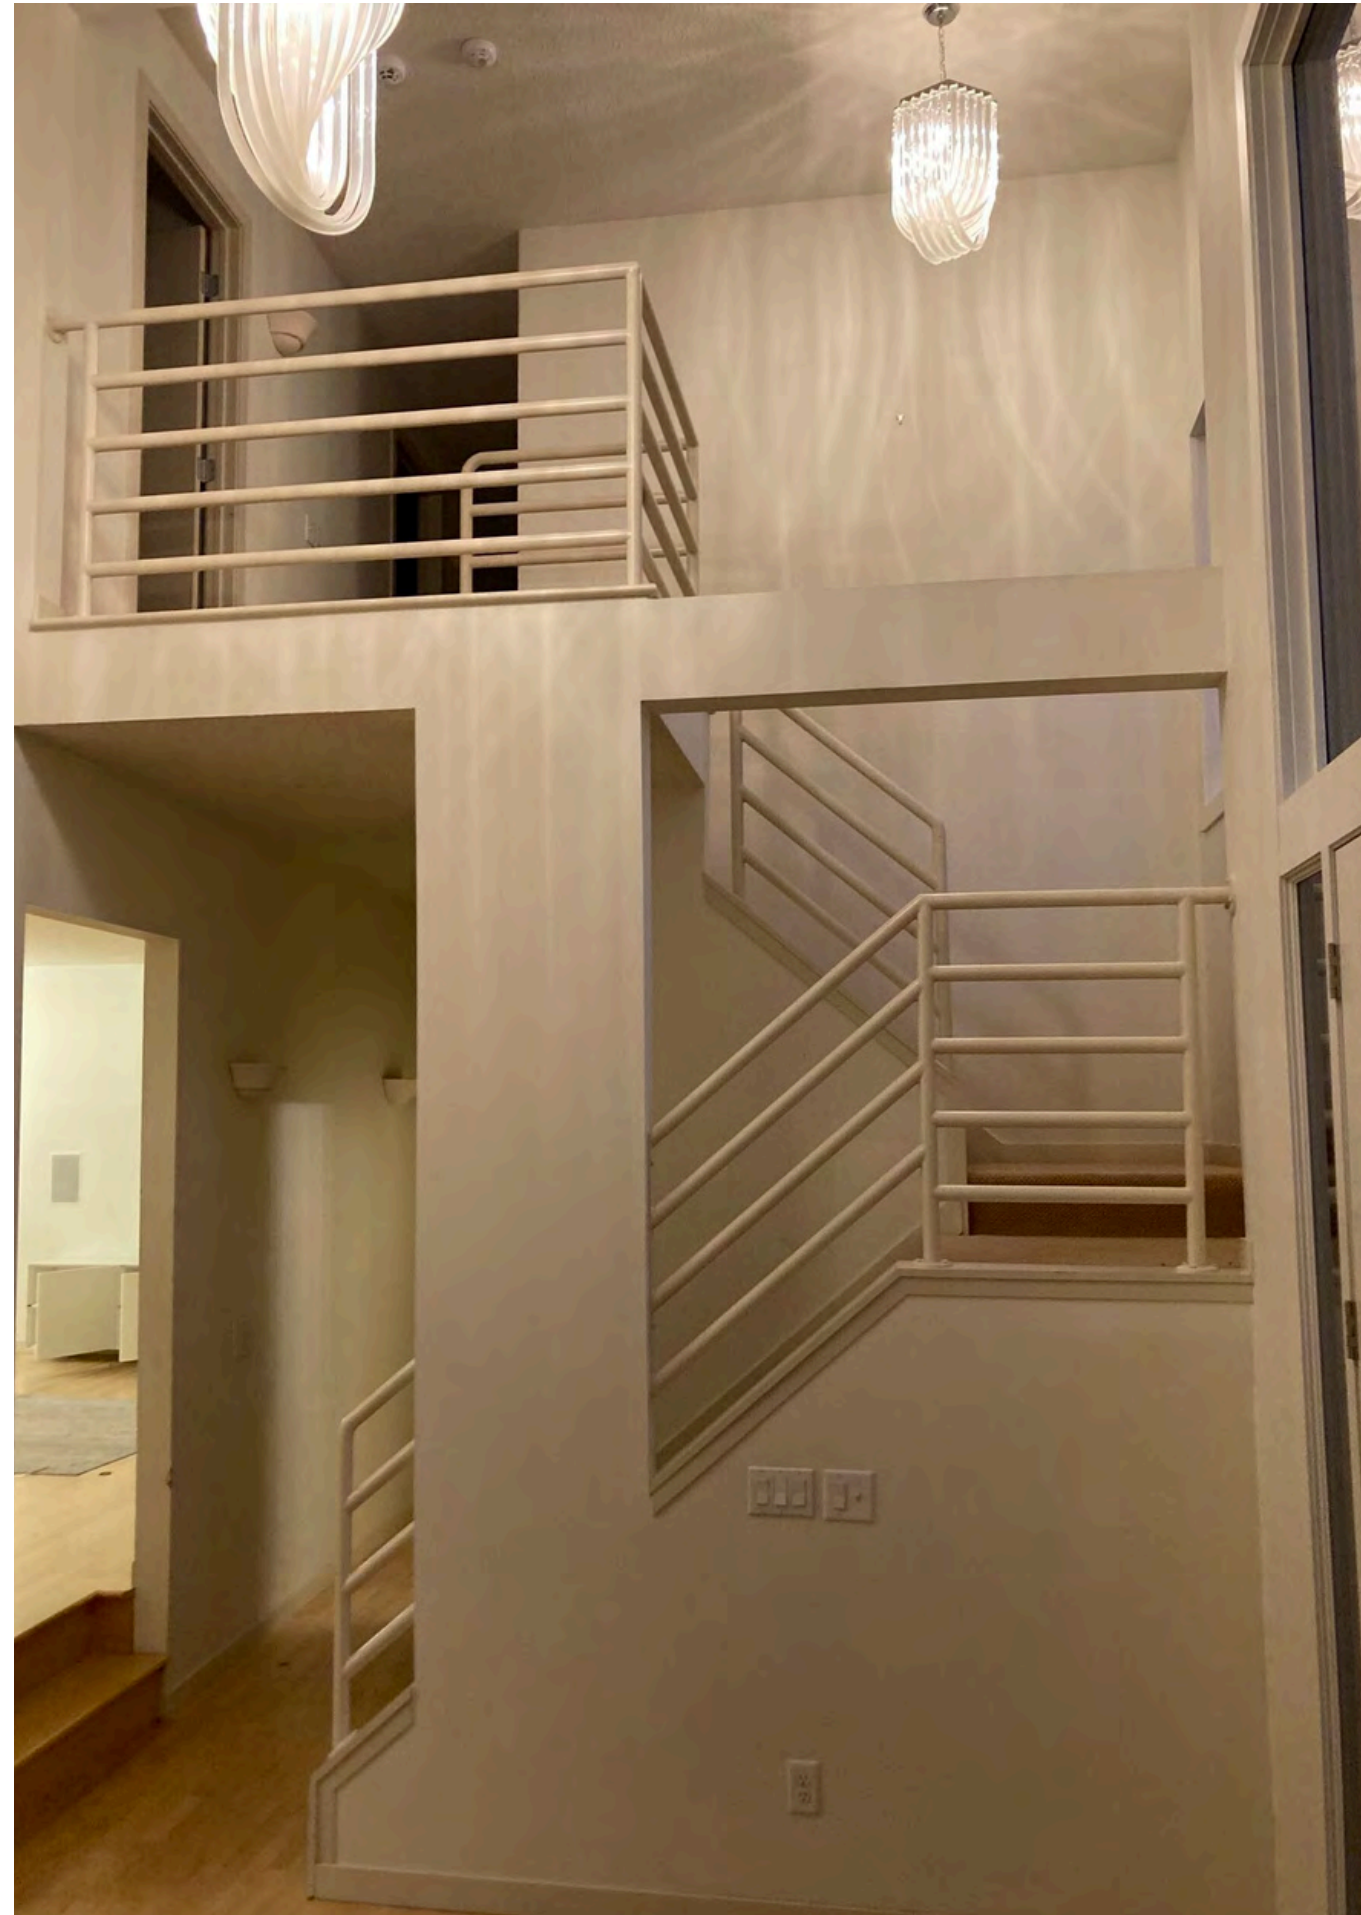
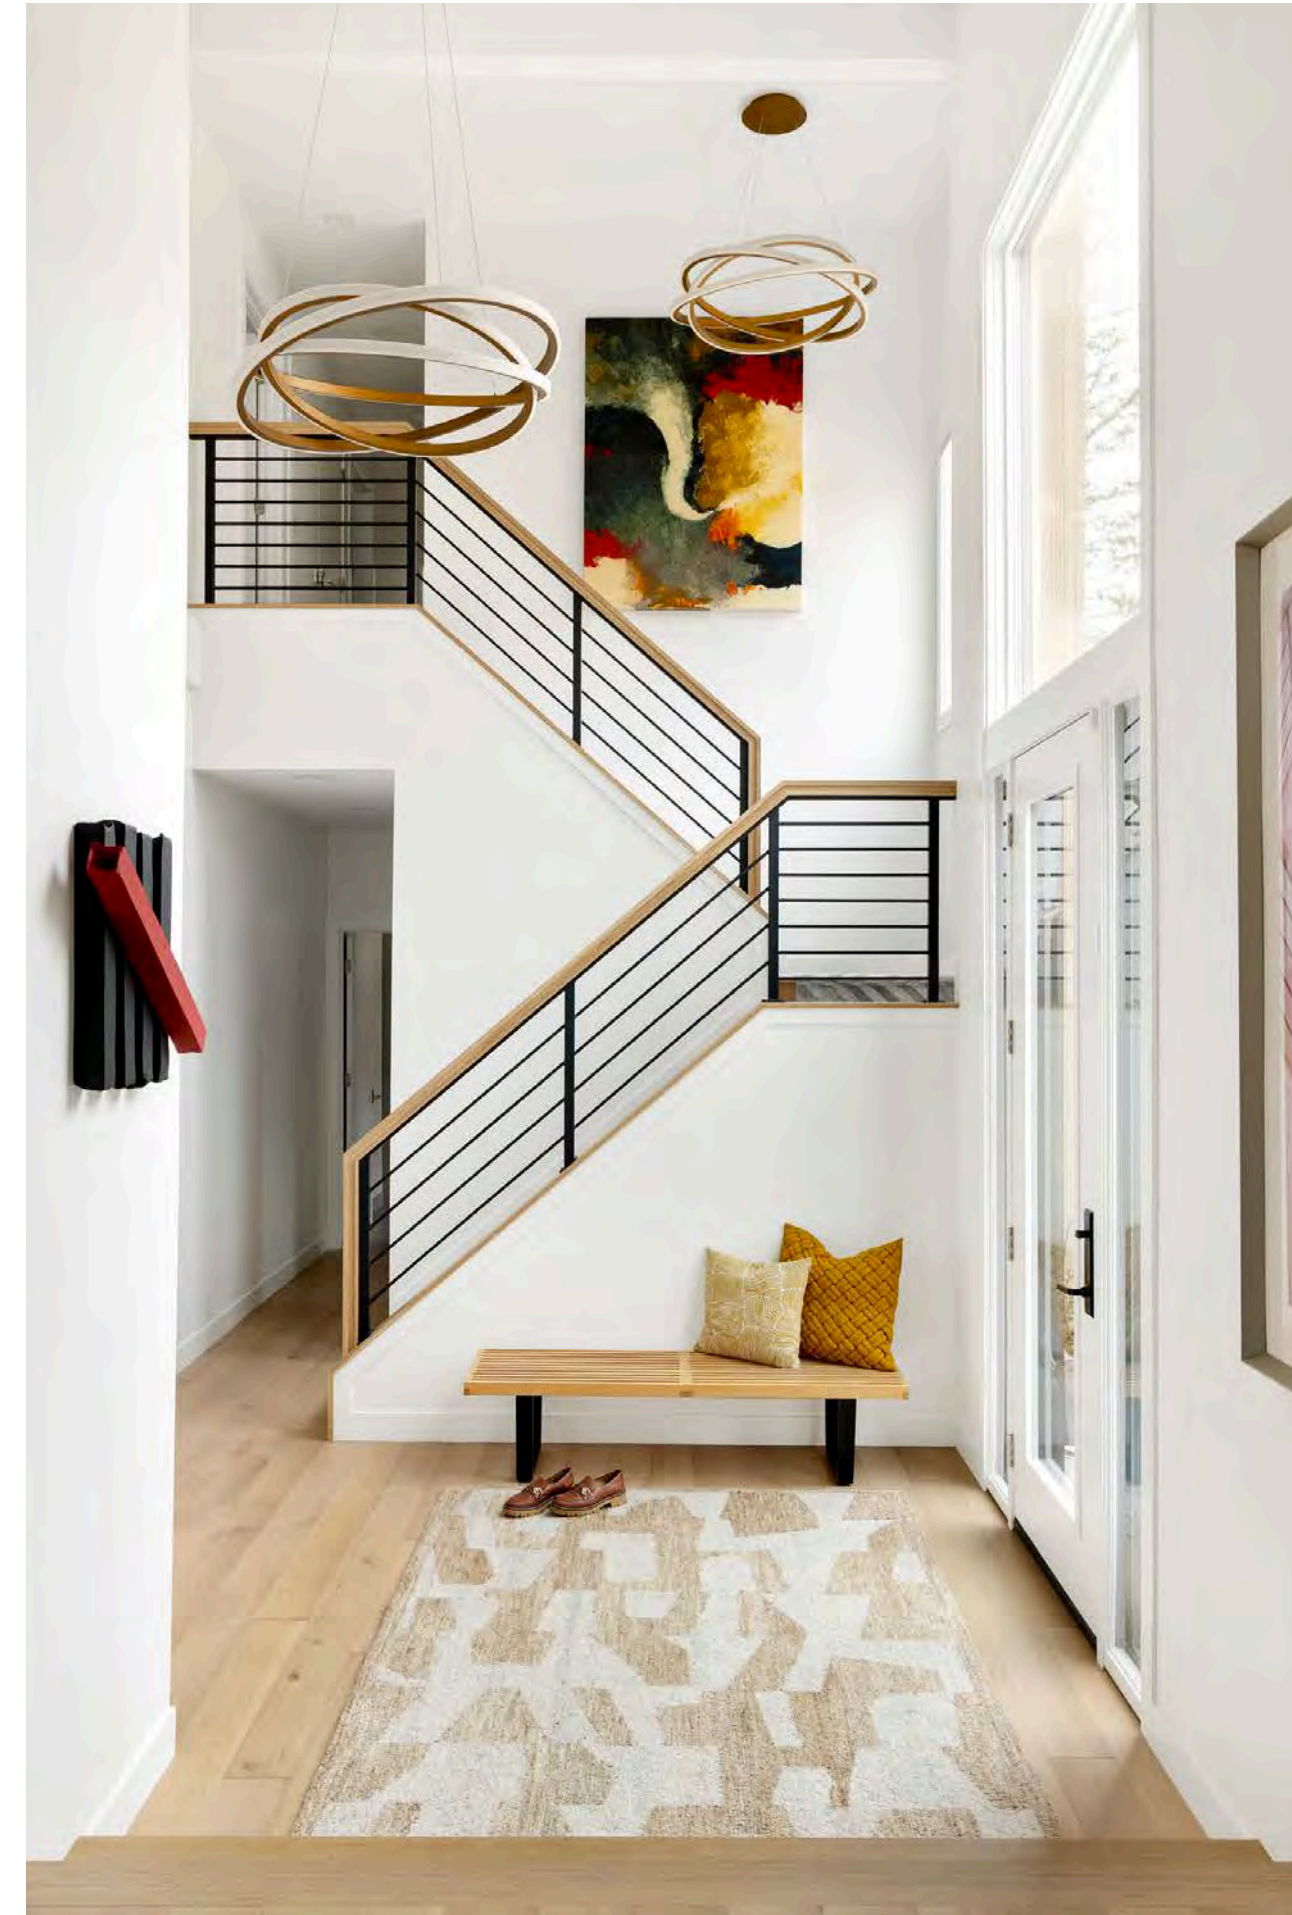
# STAIRWELL - BEFORE & AFTER

- Previous stairwell did not match clients' design preferences.
- Large gaps in railing became dangerous with the introduction of children.
- Unused landing at the top of the stairway required the use of large, unattractive support beams.

- **Aesthetic changes**
  - Removal of landing and support beams allowed for major design upgrades which helped create an impressionable entryway.
  - Rift White Oak on stairs stained to match flooring.
  - Added carpet runner.
  - Railing bracket: Heavy duty round aluminum handrail bracket in matte black.
- **Functionality**
  - Added carpet runner helps prevent kids from slipping and falling.
  - New railing has less space between brackets, reducing the risk of injury or accidents with the young children.
  - Removal of landing allowed for the space to truly open up to the rest of the house.

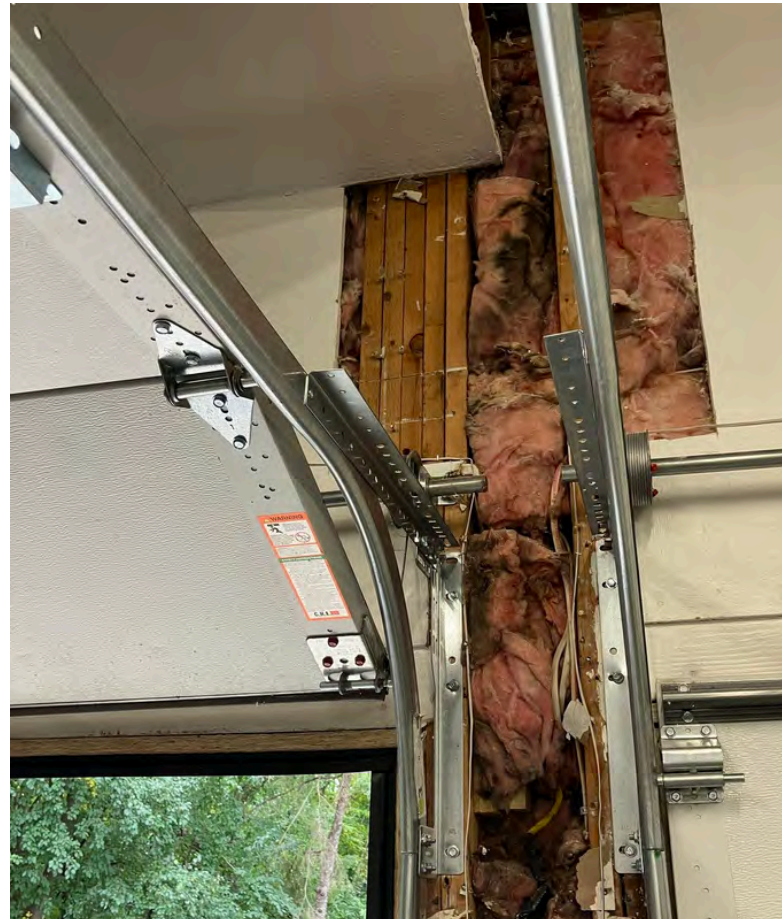
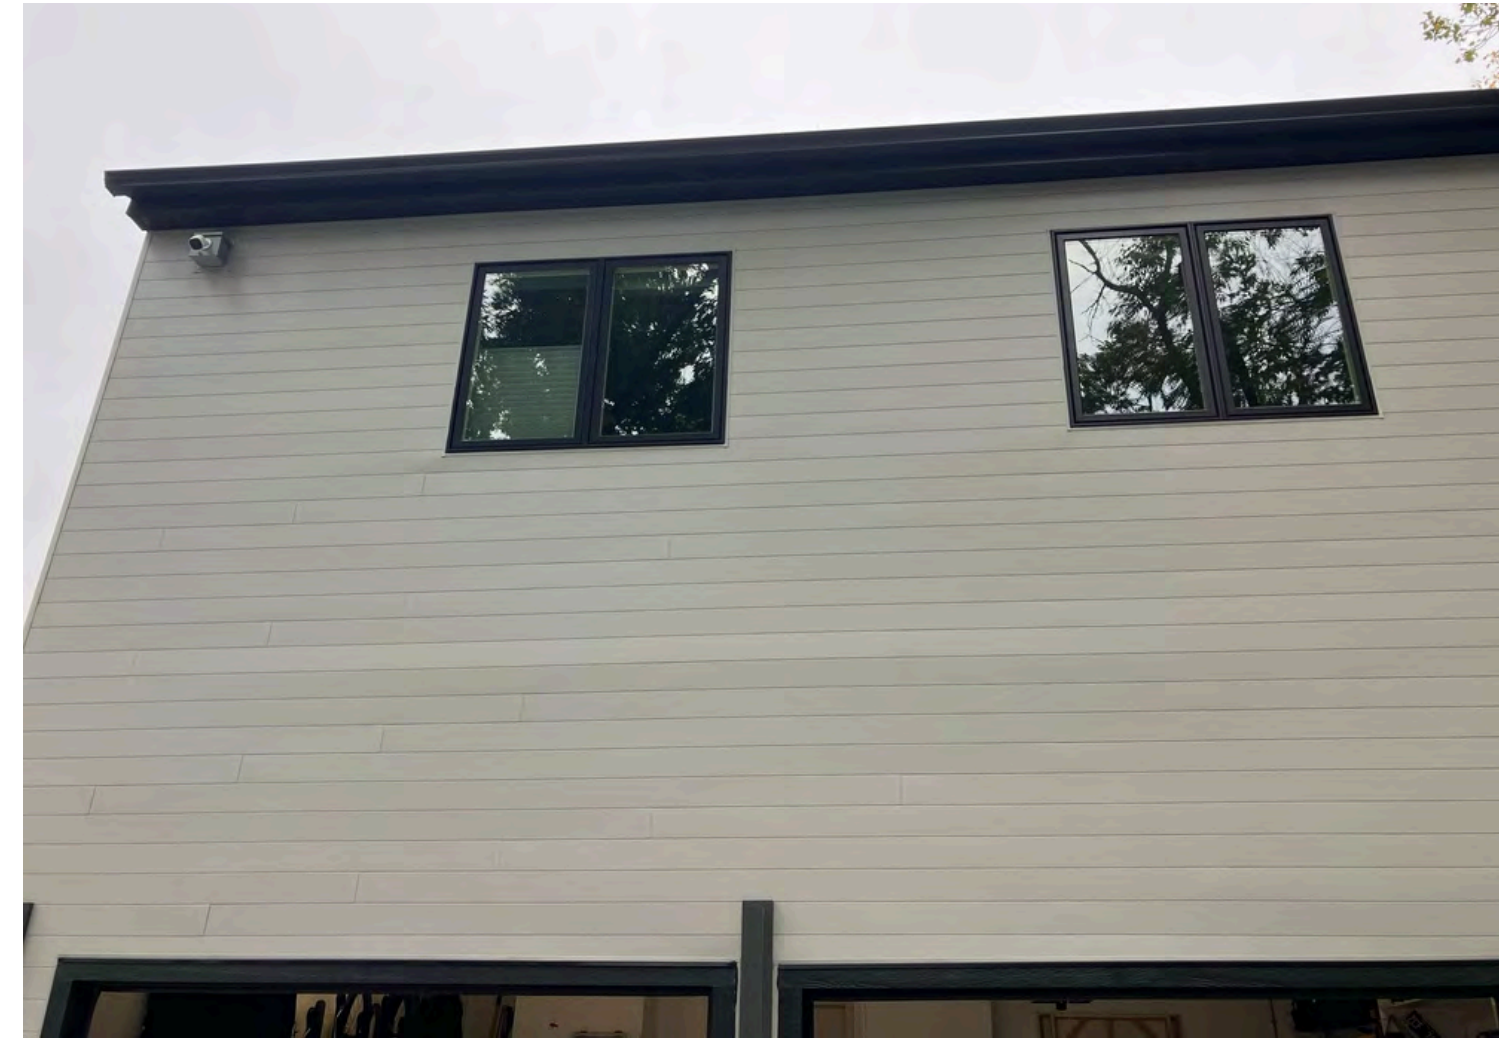
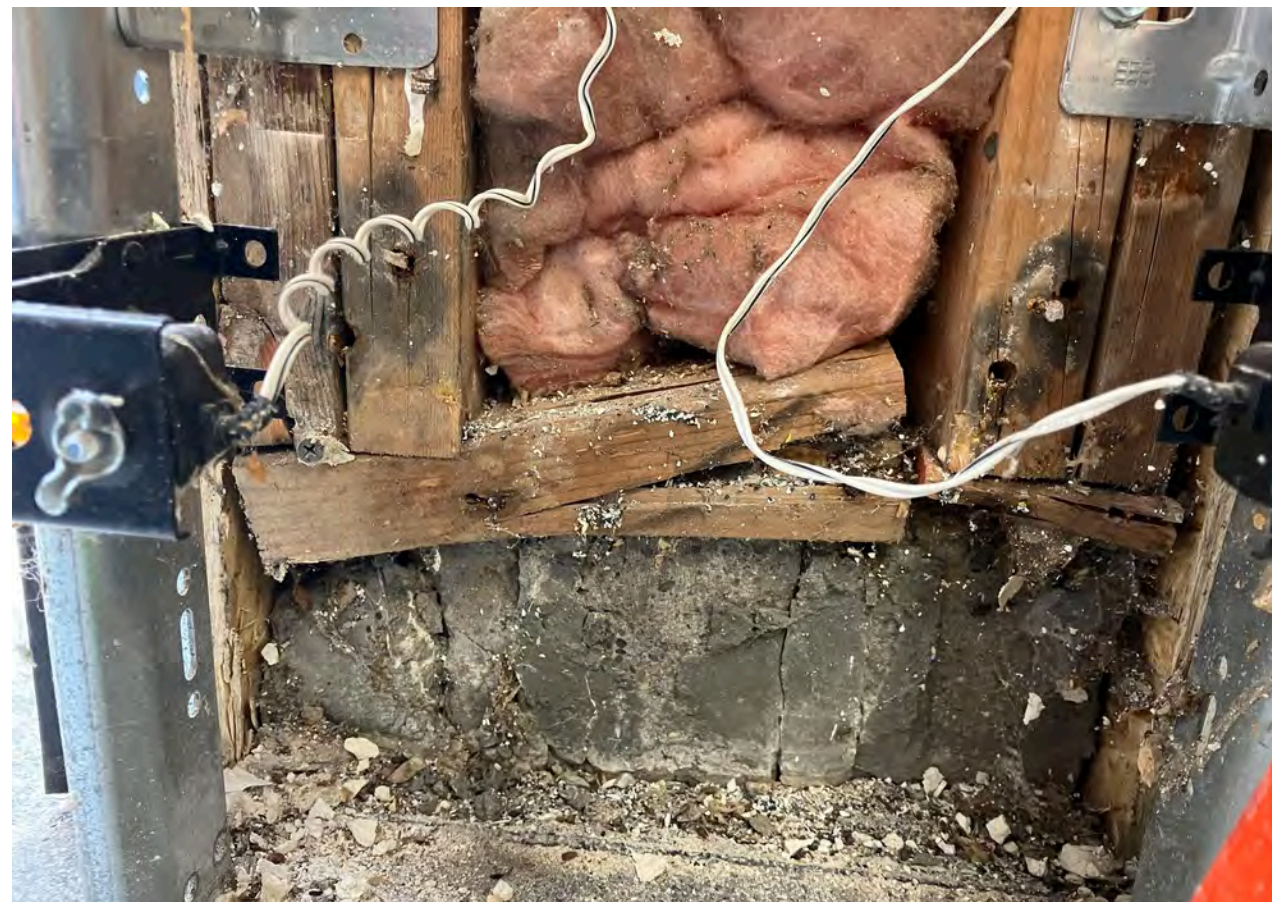
# UNFORESEEN STRUCTURAL BEAM CHALLENGE - THE ISSUE

- When we first walked through the house, one of our team members noticed a significant downward slope in the primary bedroom.
  - *See top right image for sloping*
- This prompted him to analyze the space below (garage) for structural cracks and issues.
- From the investigation, our team discovered the posts supporting the structural beam were bearing weight on the garage door and sliding off the cracked foundation below.
  - *Two left images*

- Our team member illustrated the existing beam dimensions and sent the illustration to the structural engineer.
  - *Bottom right image*
- The structural engineer responded with two clear messages:
  - Everyone working in the primary bedroom and garage need to get out as soon as possible since the floor could collapse.
  - The structural beam was "3x critical undersized".
- Issues with the structural beam, supporting beams, and cracked foundation all contributed to the significant downward slope initially felt in the primary bedroom.

- Our team immediately put up temporary shoring to support the structure.
  - *Two left photos*
- A correct size beam was promptly ordered.
- In the meantime, team properly sealed off areas to ensure safety and keep the cold winter weather out of the rest of the house.
- The new beam was installed and the appropriate reinforcements were made to ensure the upper level was safe for many years to come.

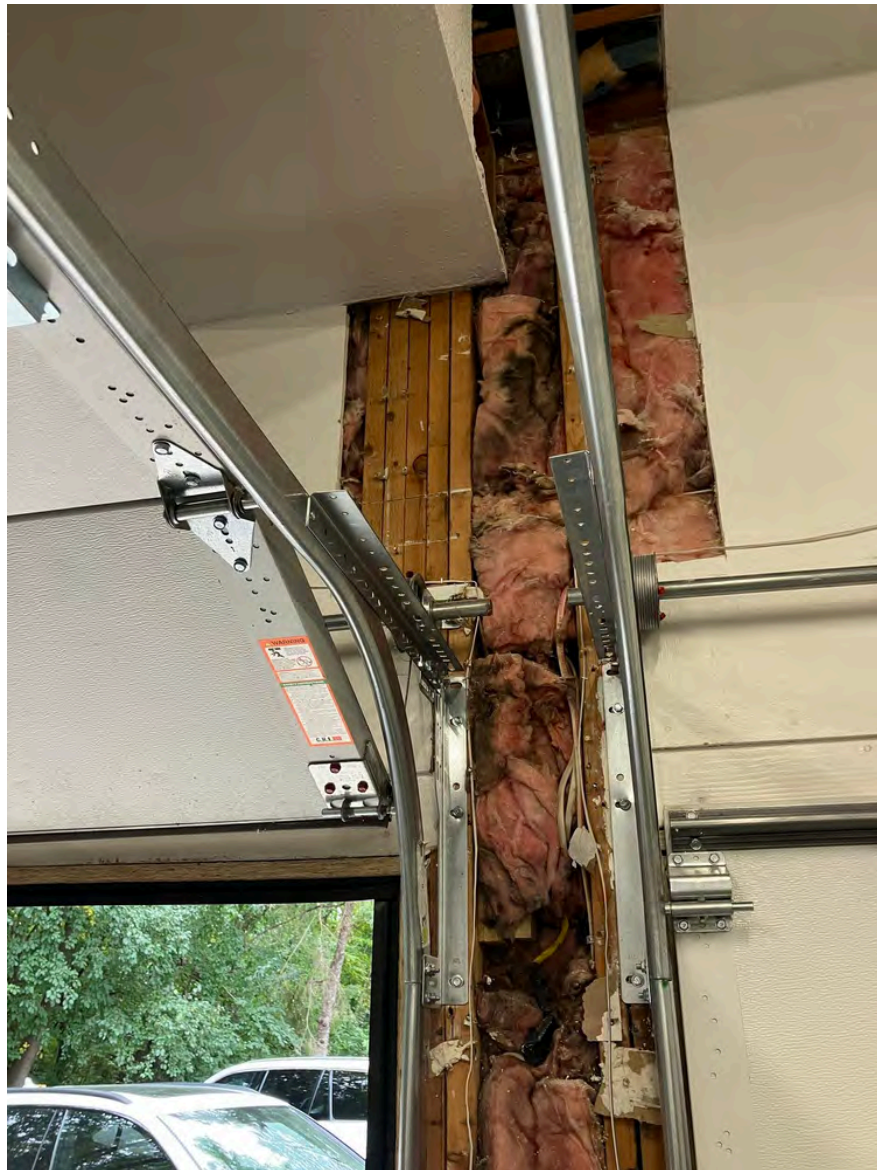
Old support configuration over garage.

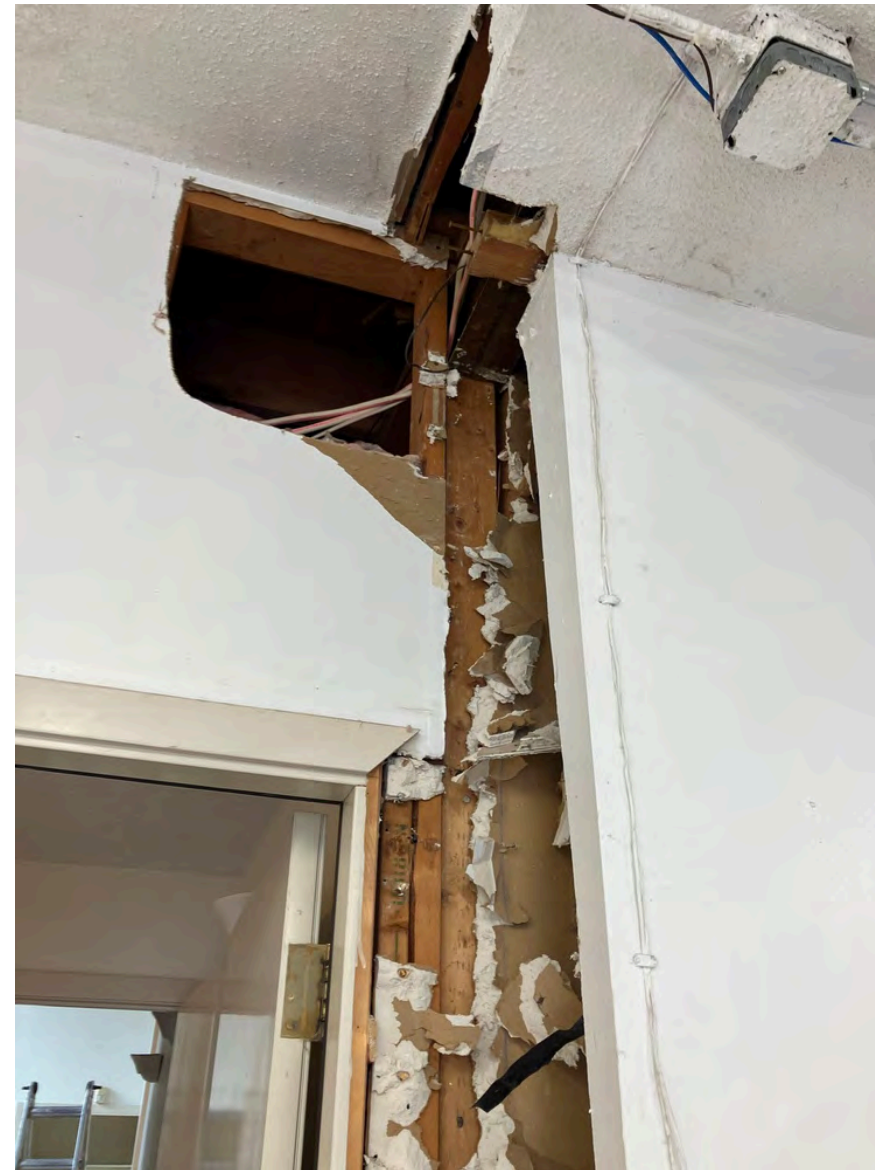
Old support configuration leading into mudroom.

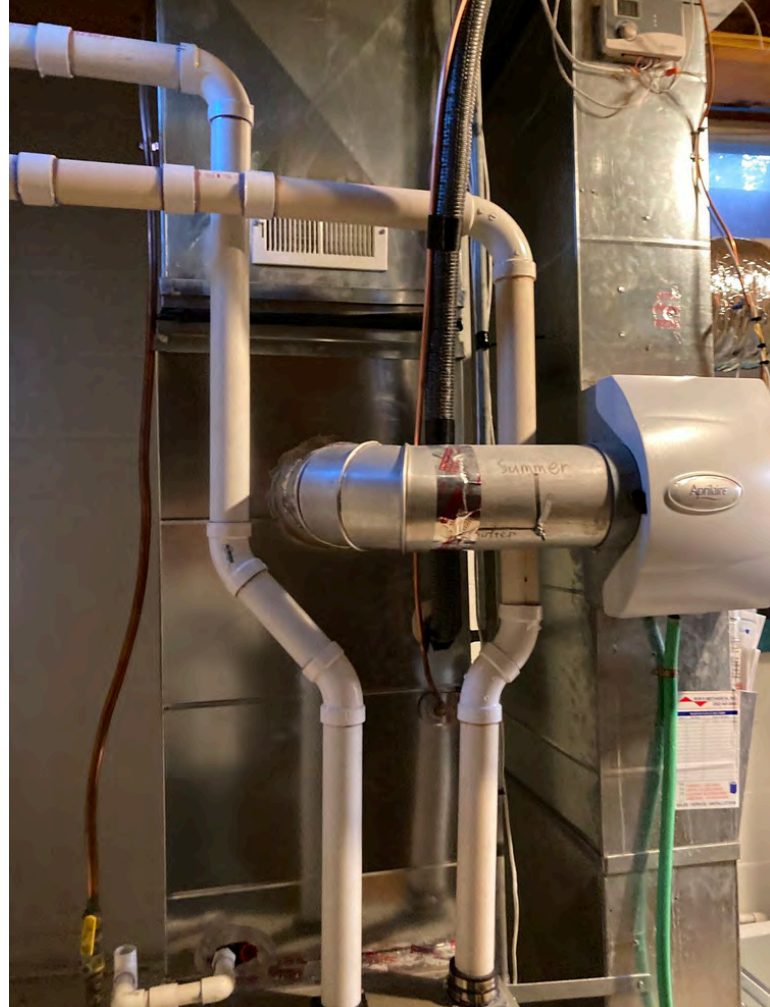
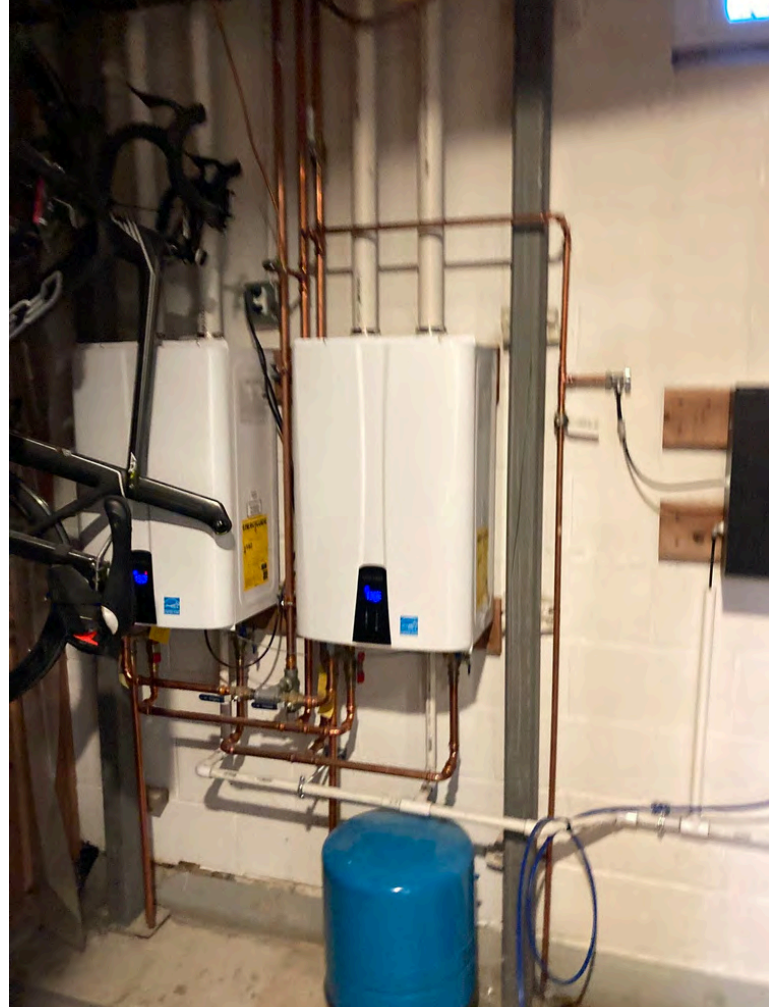
## Outdated mechanicals

- The home's existing HVAC system was outdated, undersized, and unable to properly heat and cool the residence.

- We upgraded all mechanical systems and installed additional HVAC units. By zoning the systems, we achieved consistent and efficient heating and cooling throughout the home.

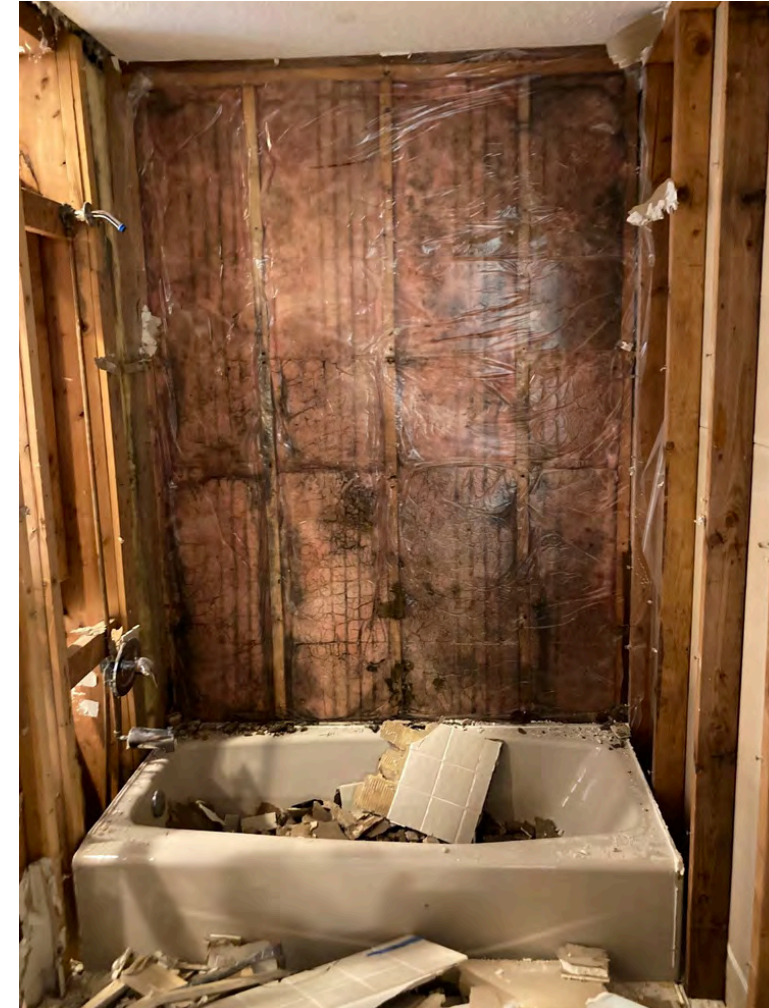
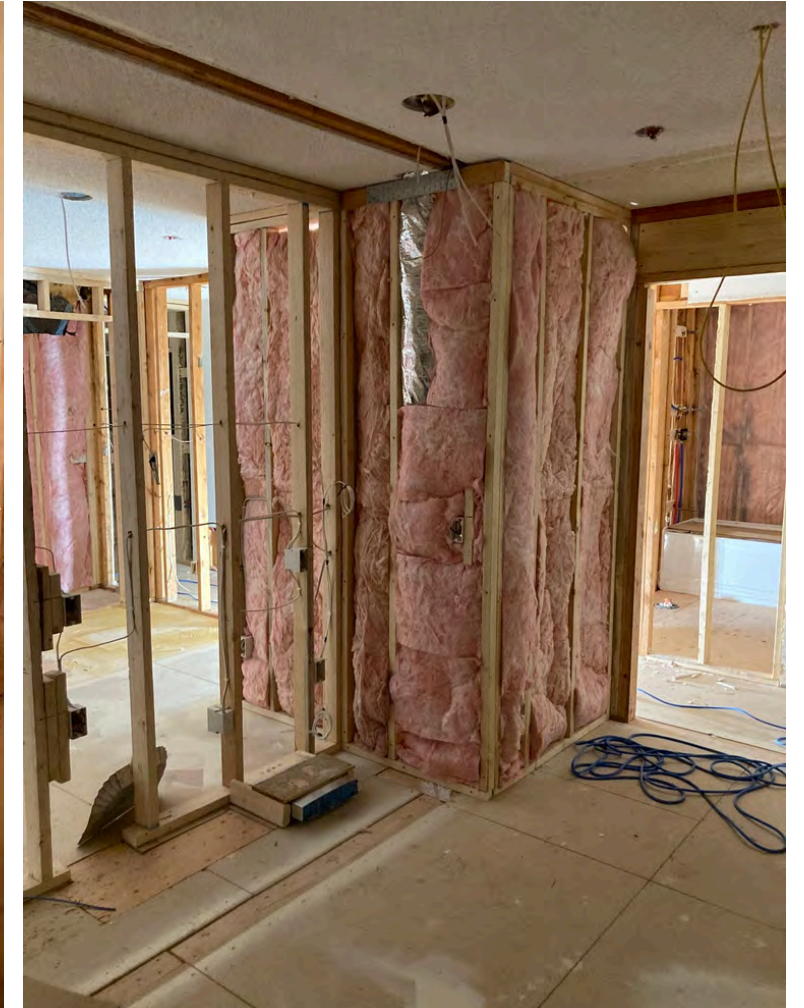
## Insufficient insulation

- During construction, we uncovered insulation that was outdated and highly ineffective, compounding the HVAC challenges and contributing to energy loss.

- We replaced the existing insulation with spray-foam, significantly improving the home's efficiency, comfort, and long-term performance.
