# NARI Minnesota 2026 RotY

## Category: Residential Interior \$100,000 to \$250,000

The team reconfigured the main floor of this 1931 Tudor Revival to combine Scandinavian-inspired design with improved function. The renovation addressed limited kitchen workspace and storage, insufficient gathering space and inefficient circulation on the main level.

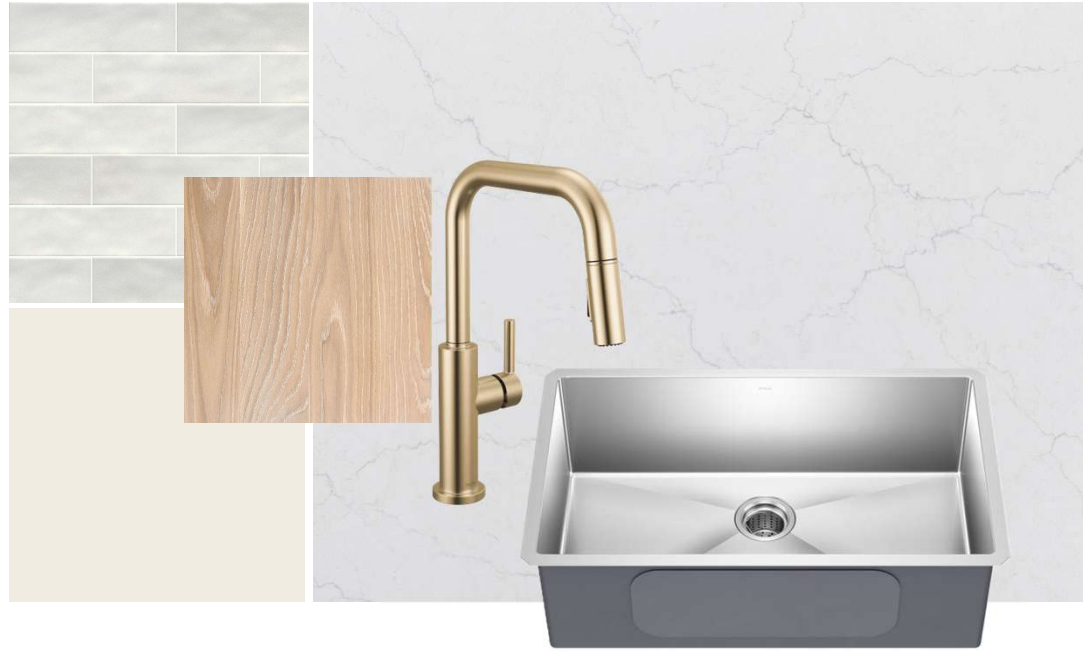
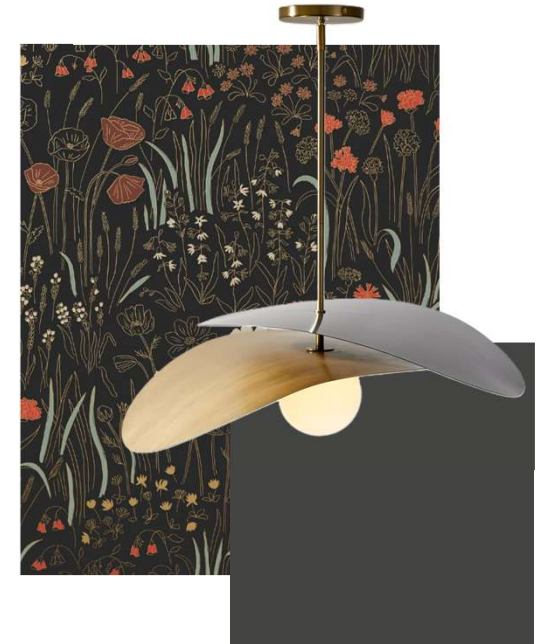
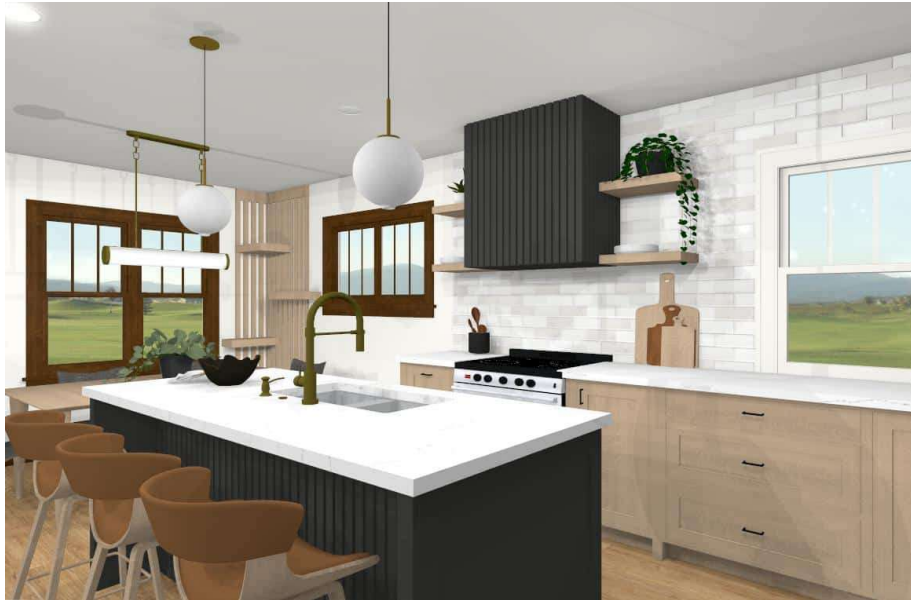
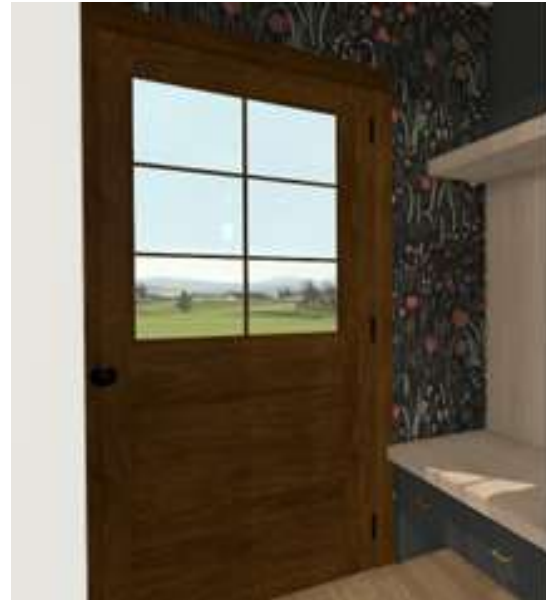
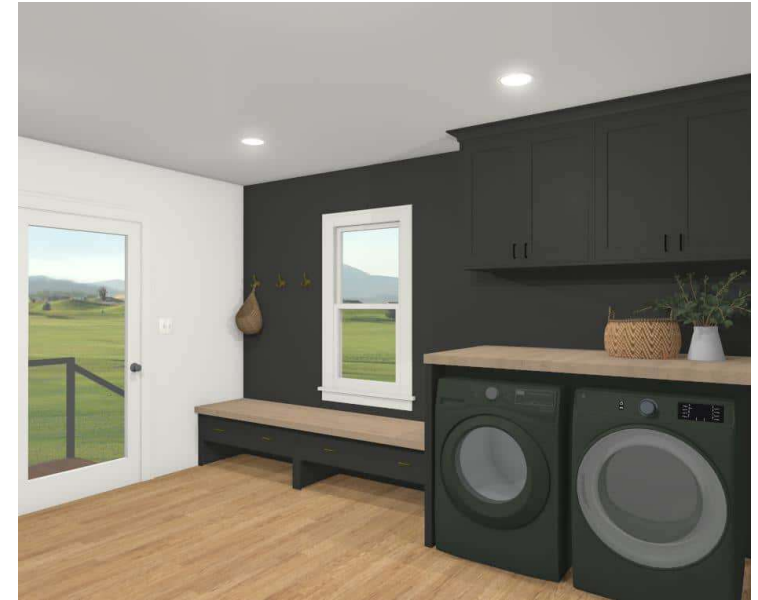
# 3D RENDERINGS & DESIGN DEVELOPMENT

A Scandinavian-inspired palette provides the architectural language for this remodel.

The clients came in with a clear direction: Scandinavian-inspired architecture. Part of the designer's job was creating a newly informed palette that could live comfortably inside a 95-year-old Tudor Revival without competing with its existing character. The result emphasizes warm white walls, natural white oak, and carefully placed dark cabinetry that enriches rather than overwhelms the home's original character.

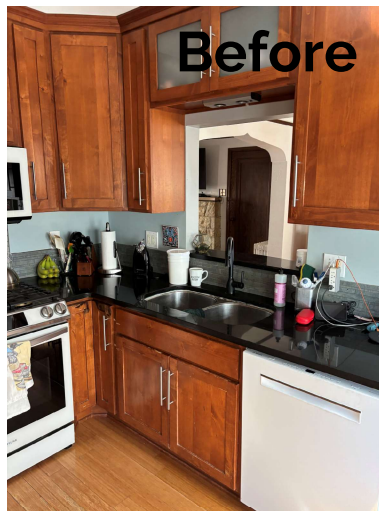
One of the biggest motivators for the remodel was the connection among the kitchen, dining room, and living room, now envisioned as a single interconnected space.

- The team worked with an engineer to specify a new LVL beam spanning the length of the dining room and kitchen to completely open that space to the living room beyond. Eating, enjoying a good show, sitting by the fireplace, cooking, entertaining: all of those things can now happen together in one open floor plan.
- With the walls gone, we could provide a spacious kitchen island with expansive prep space and offering a secondary dining zone for the family and for future get-togethers.
- By taking out a single window near the range, we could further adjust the kitchen layout, improve storage, and find the best placement for our clients' appliances. Likewise, with fewer interior walls, daylighting would not be a concern.

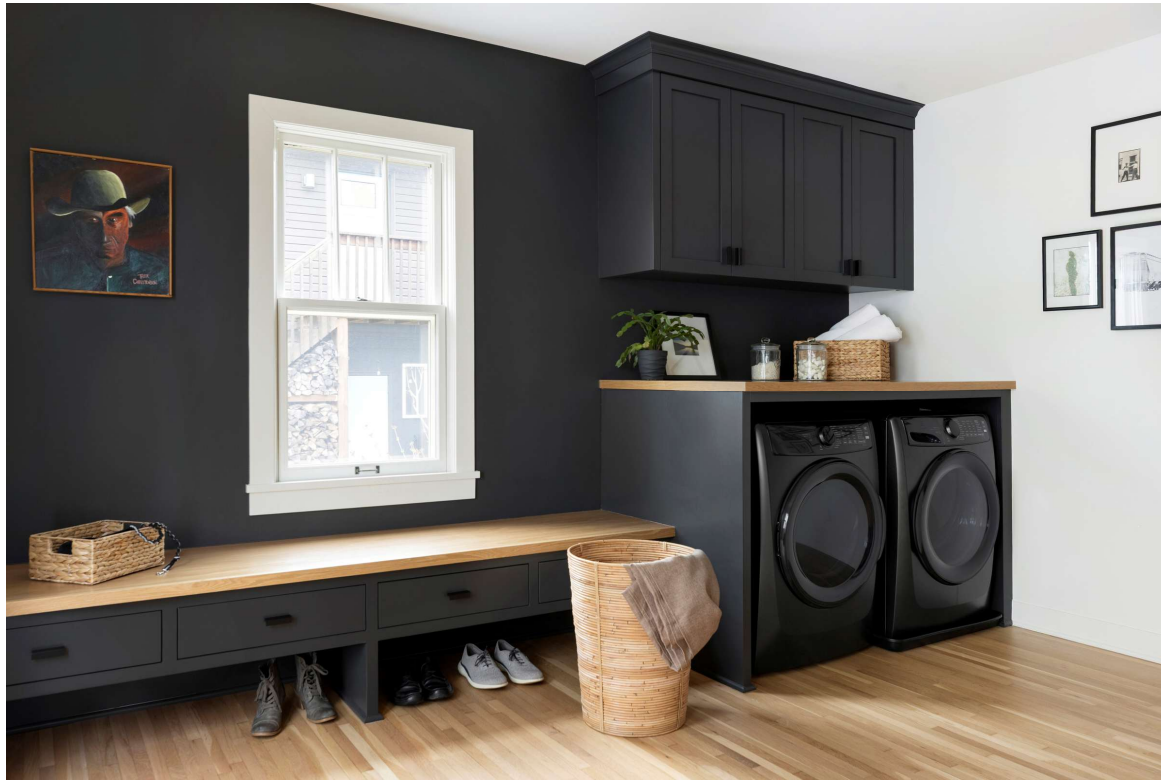
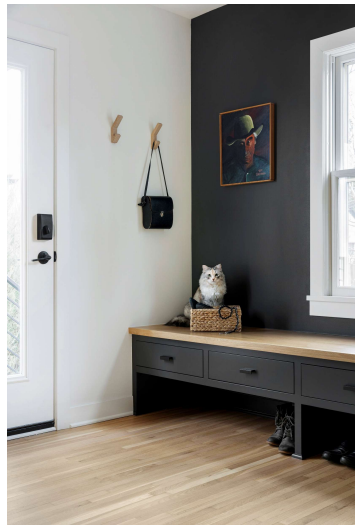
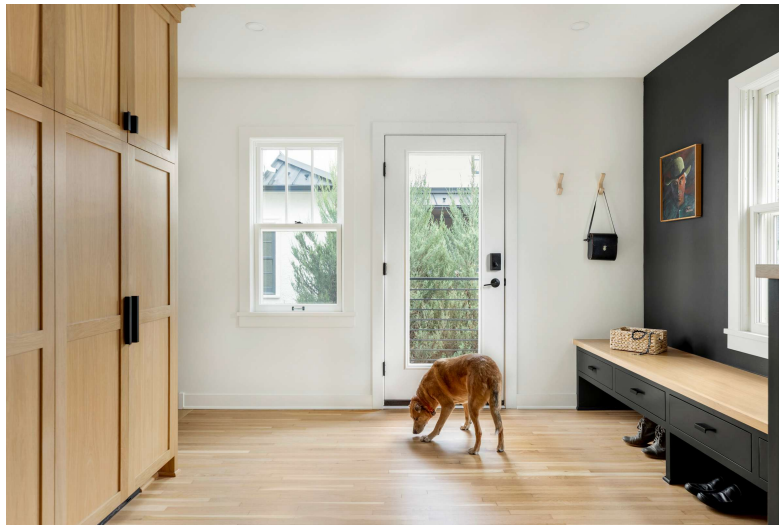
## Mudroom and Laundry

- We removed the passageway from the stairs to the kitchen, which completely changed how we could adjust the kitchen layout beyond, from more cabinetry to improved circulation throughout the home.
- We positioned a larger entry door further toward the backyard, closer to their garage. Partnered with an added patio and adjustments to the interior stair, the frustratingly tight entry sequence will be fully resolved.
- We've added new laundry equipment, multiple storage cabinets, and an entry bench.

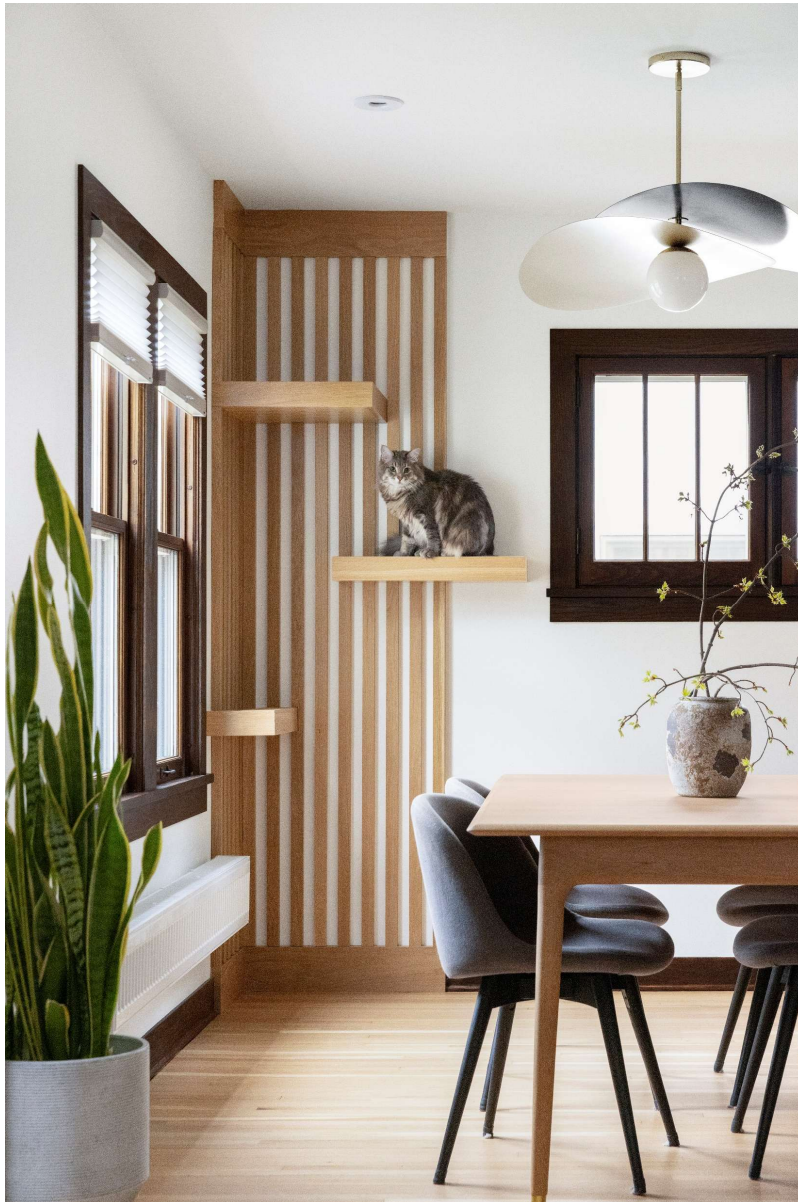
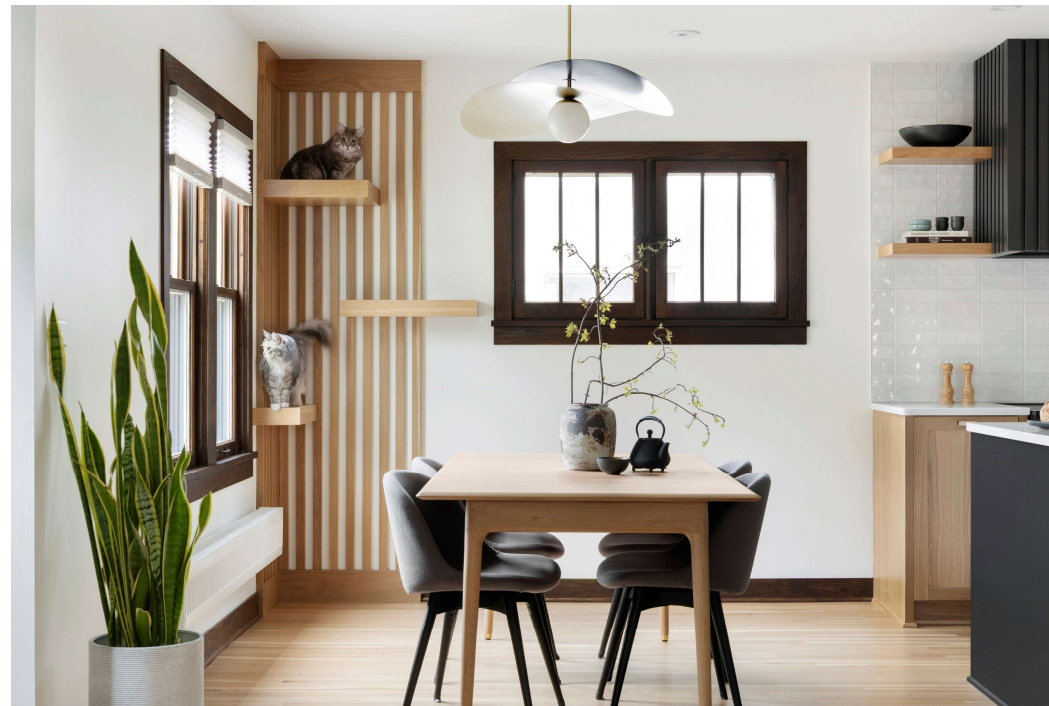
Our clients presented a unique and delightful challenge: seamlessly integrating their love for their two large cats into a newly remodeled, open-concept kitchen and dining area without sacrificing the home's sophisticated aesthetic. The solution was a striking, custom-designed slat wall that serves a dual purpose as both a modern architectural focal point and a dedicated feline lounging space positioned adjacent to two large windows, so they'd be just as happy with the new space as everyone else.

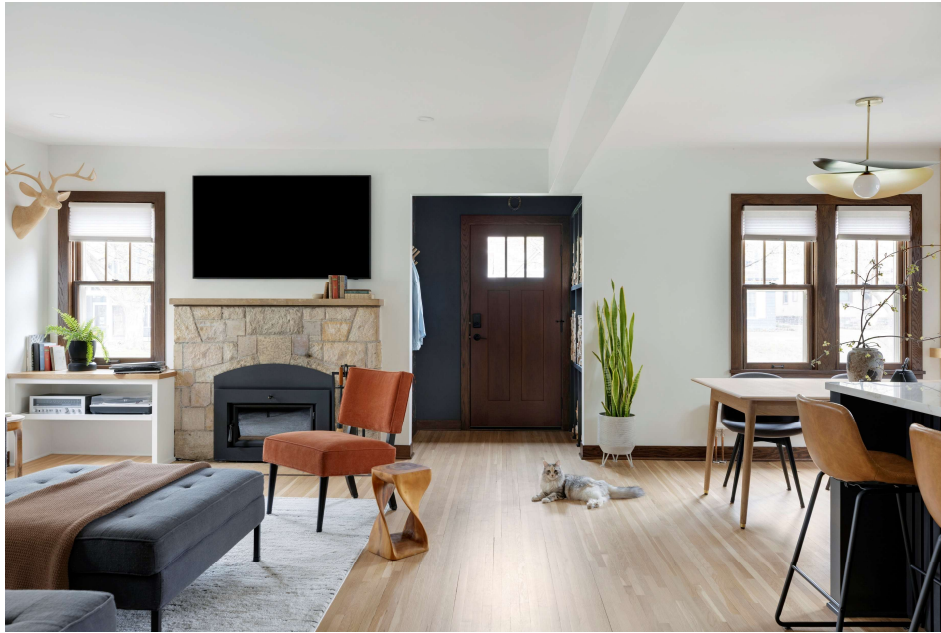
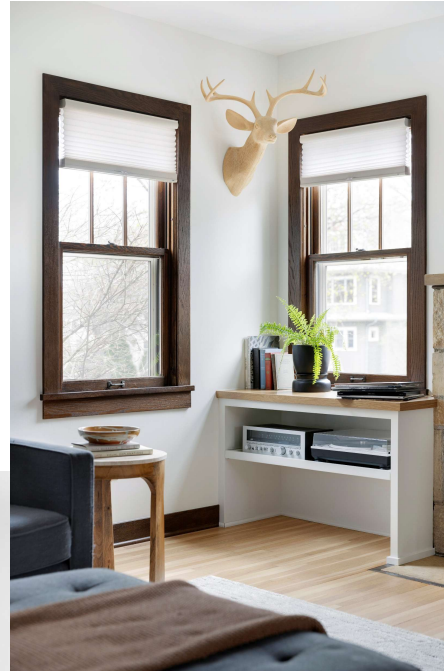
- The record collection had grown into a shared family hobby. A custom pull-out record station built into the cabinetry near the fireplace keeps it protected from the cats while still easily accessible.
- A large aerial print of Minneapolis has been waiting for the right wall for years. In the new plan, it anchors the back wall of the living room, opposite the fireplace, with downlighting planned right above it.

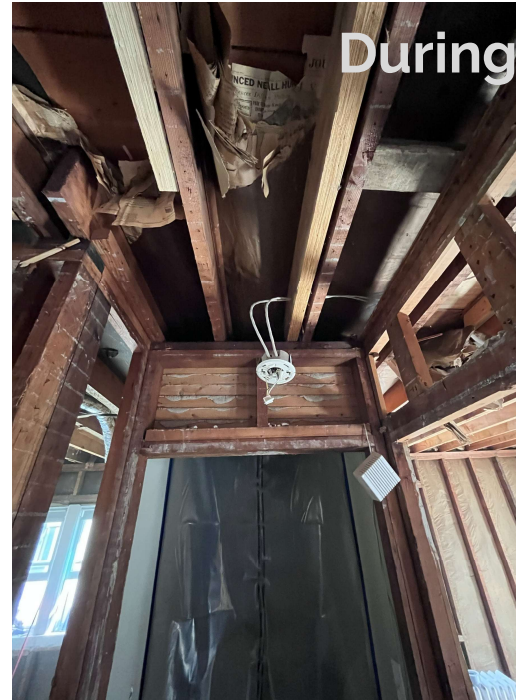
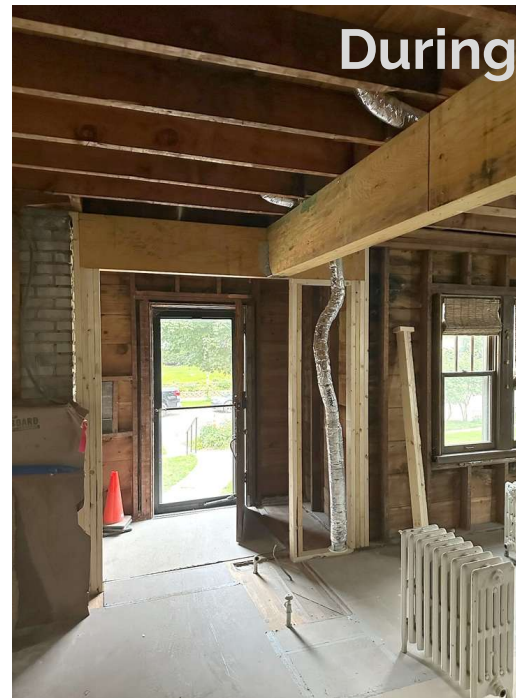
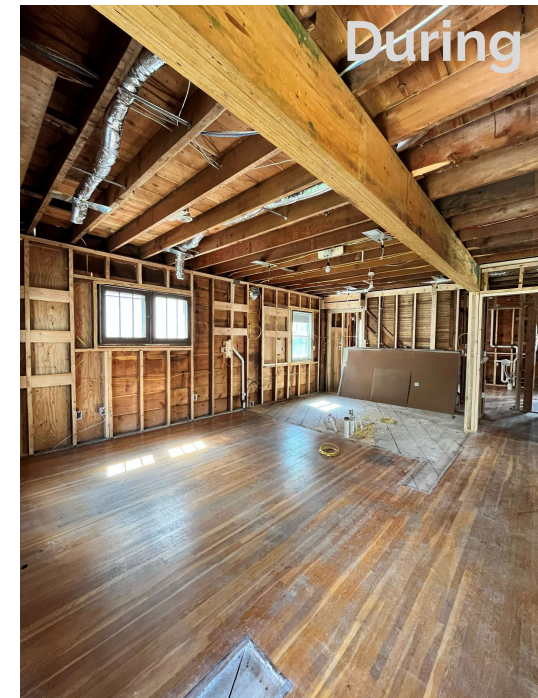
# PROJECT CHALLENGES

- The renovation began with a comprehensive energy audit, which uncovered several performance issues that informed the scope of the project. Insufficient insulation, aging building materials, and poor overall energy efficiency contributed to cold winters, stuffy summers, and inconsistent comfort throughout the home. These findings guided a series of upgrades aimed at improving durability, efficiency, and indoor comfort.

- As construction progressed, additional deficiencies were uncovered. Water intrusion through the stucco exterior had caused localized damage to the sheathing, and a deteriorated rim joist near a former dryer vent required replacement. Elevated radon levels detected in the basement also led to the installation of a radon mitigation system, enhancing the home's health and safety.

- To address both comfort and long-term performance, the main floor was fully gutted to the studs, allowing for the replacement of outdated 95-year-old electrical systems and the installation of spray-foam insulation throughout. The project also included an upgraded heating and cooling system with improved ventilation to better regulate temperatures year-round. To preserve the home's original character, the existing white oak floors were refinished and seamlessly patched where needed, blending new materials with the historic fabric of the house.
