# Right at Home

A 1913 Kitchen Reimagined

Residential Kitchen | \$50,000–\$100,000

# A vintage kitchen, thoughtfully reclaimed

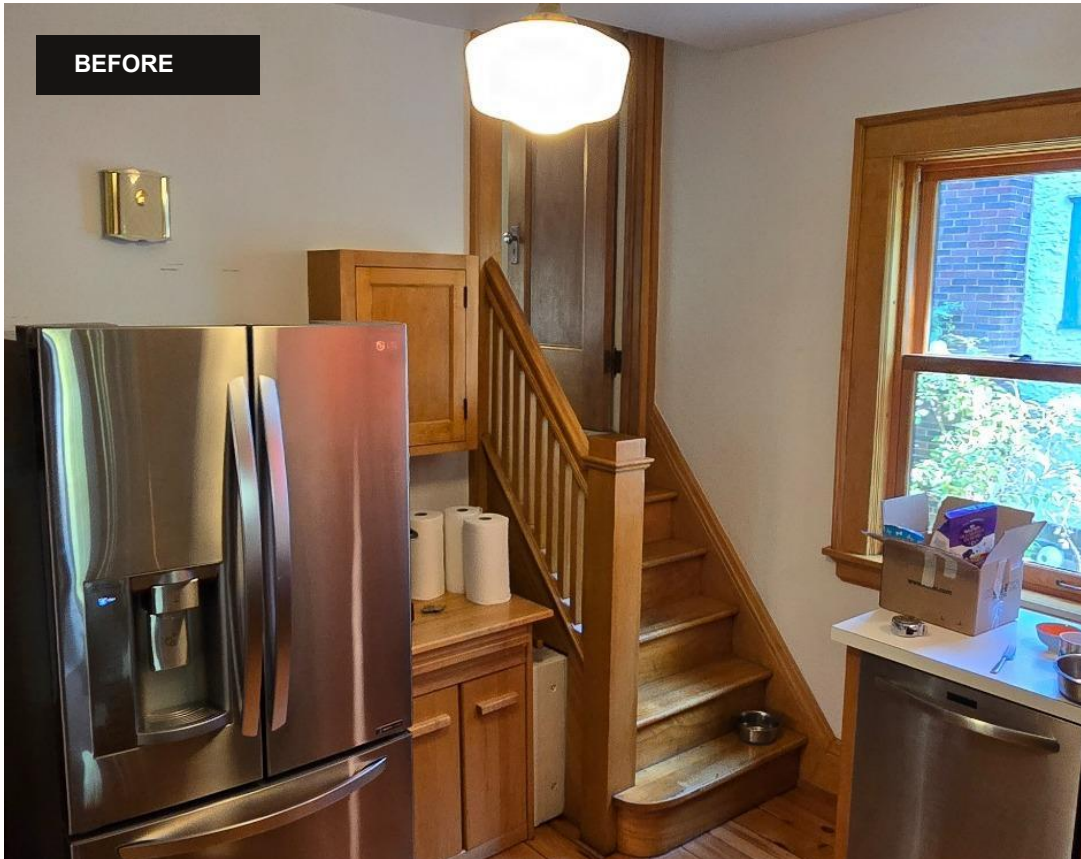
The steep stairs and radiator made the end of the kitchen less usable.

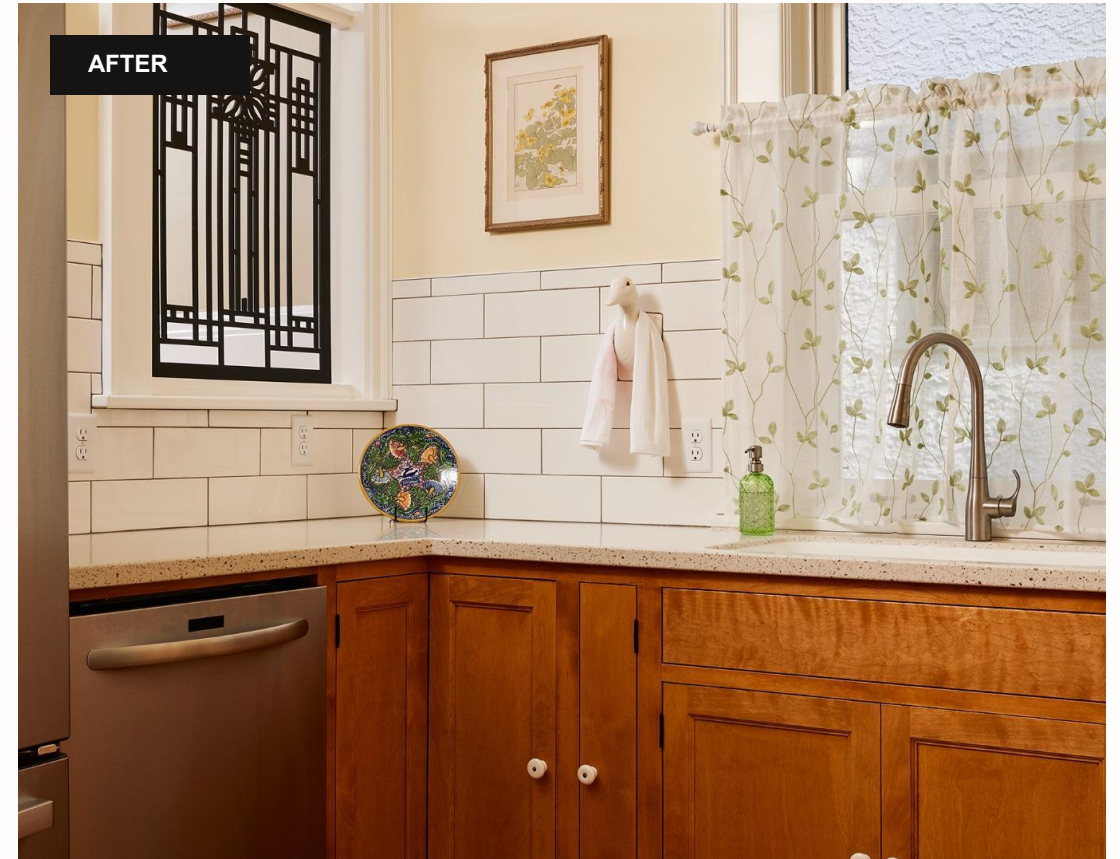
The reclaimed footprint now supports storage, counter space and the dishwasher.

The opening above remains, preserving daylight and connection to the front foyer.

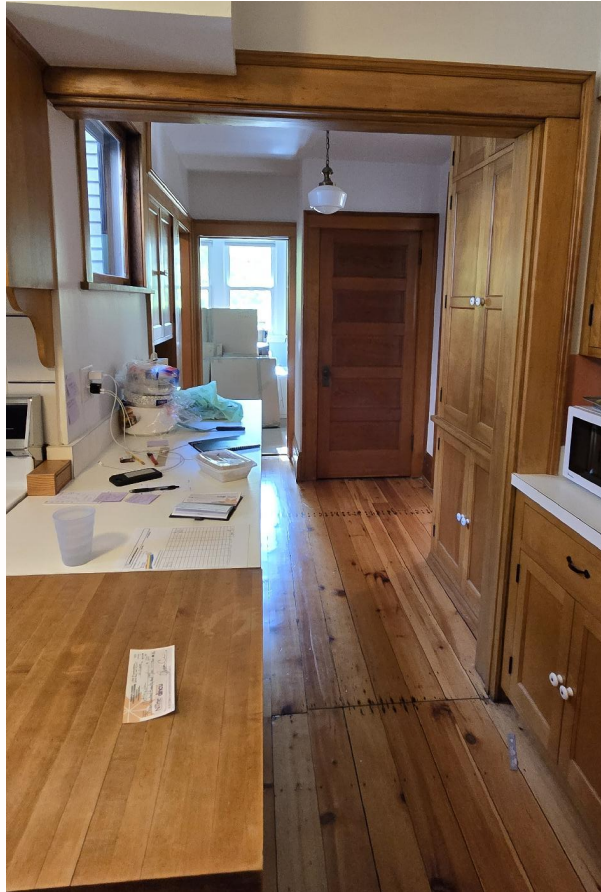
**BEFORE**

**A heavy header announced the boundary of the old addition.**

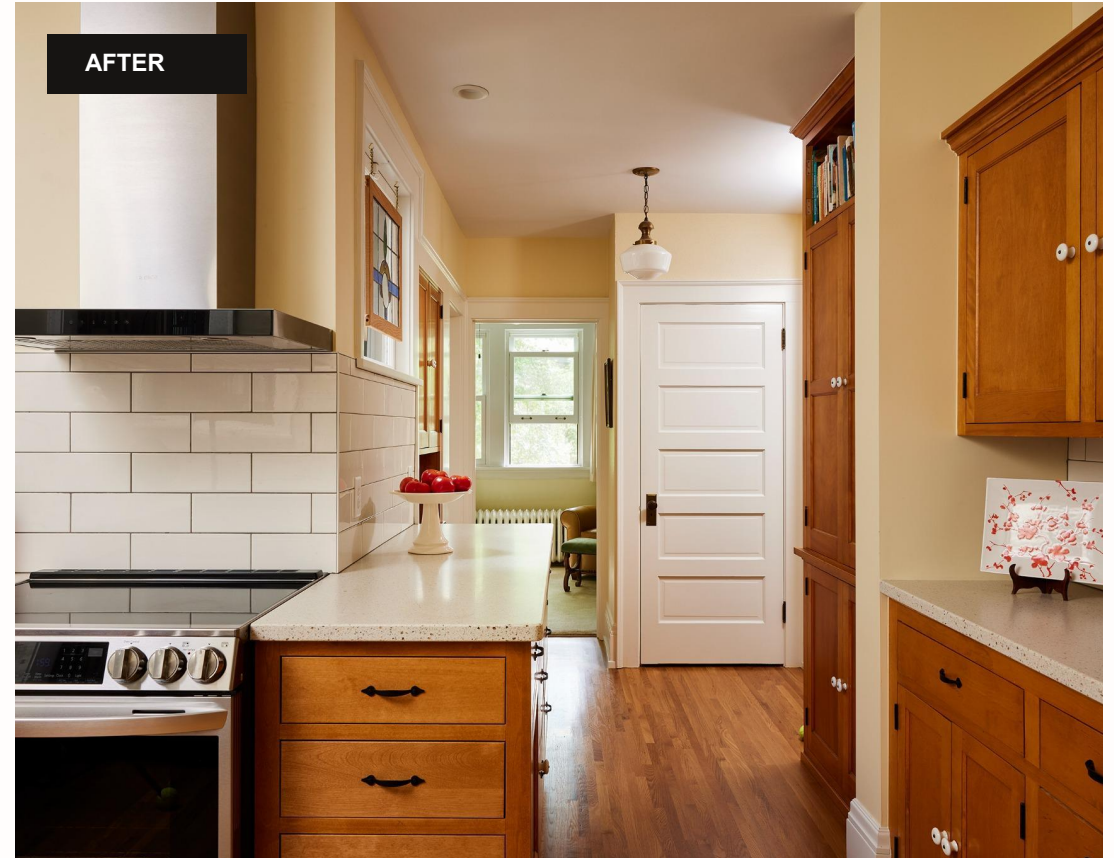
**AFTER**

**A continuous ceiling and oak floor create a long, open sightline.**

Painted trim now connects the kitchen visually with the rest of the house.

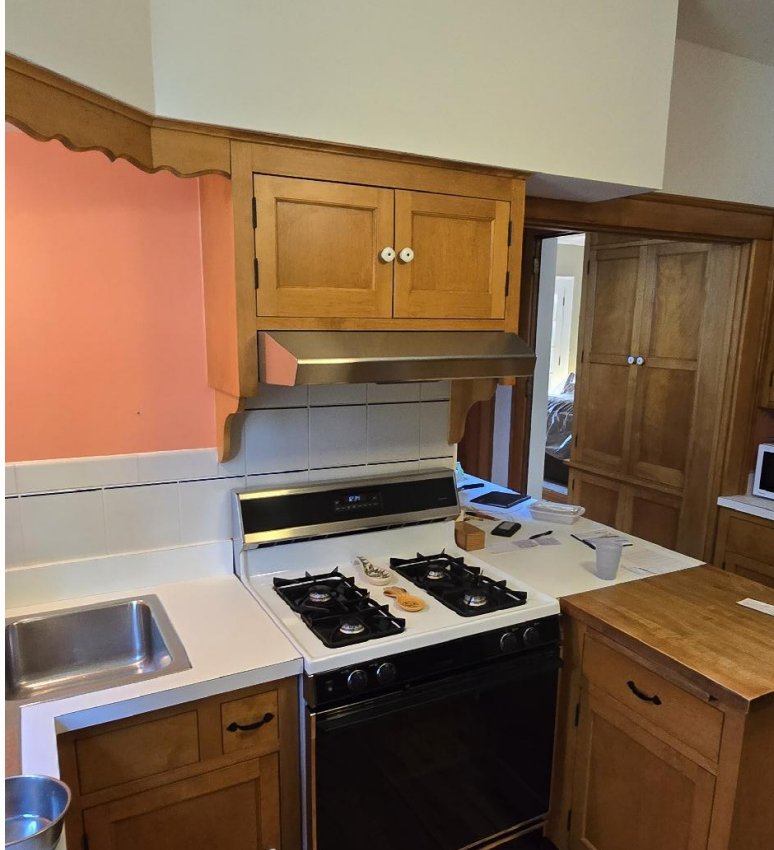
BEFORE

The range was boxed in by a soffit, scalloped trim and limited landing space.

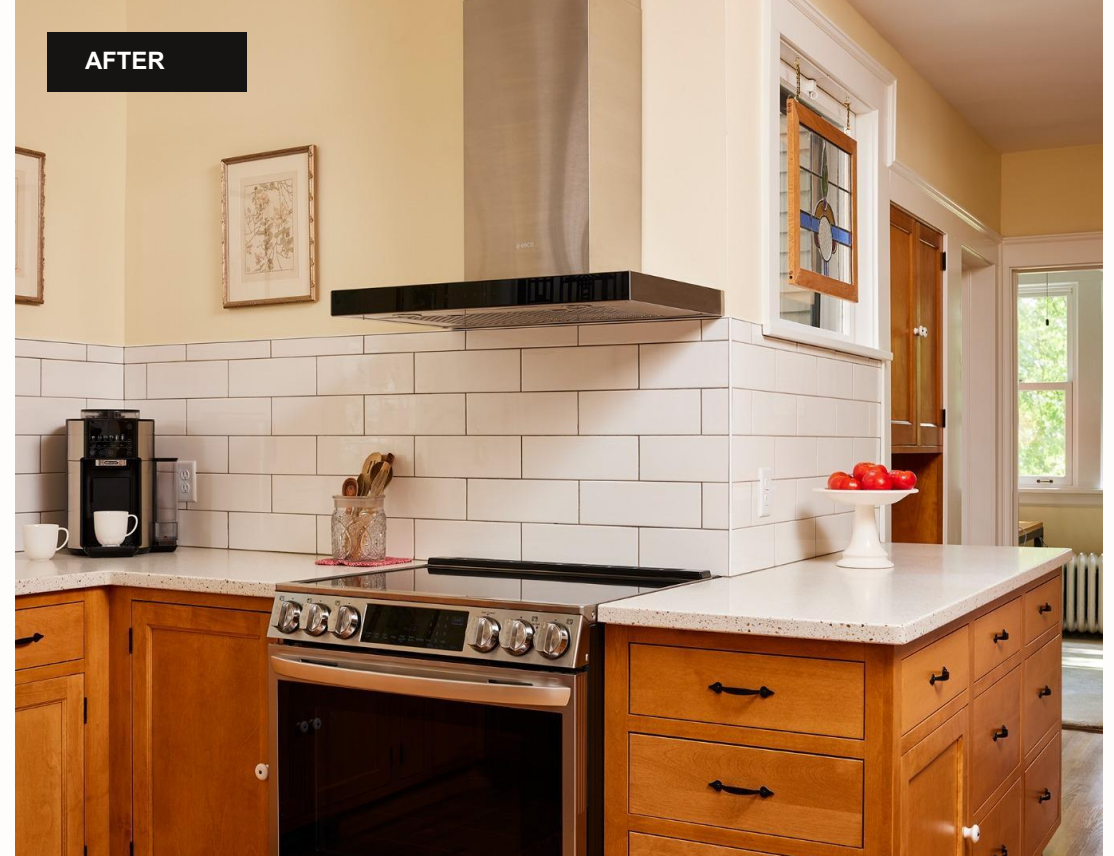
AFTER

A proper hood, deep drawers and expanded counters improve daily work.

The new arrangement supports cooking without the peninsula obstructing circulation.

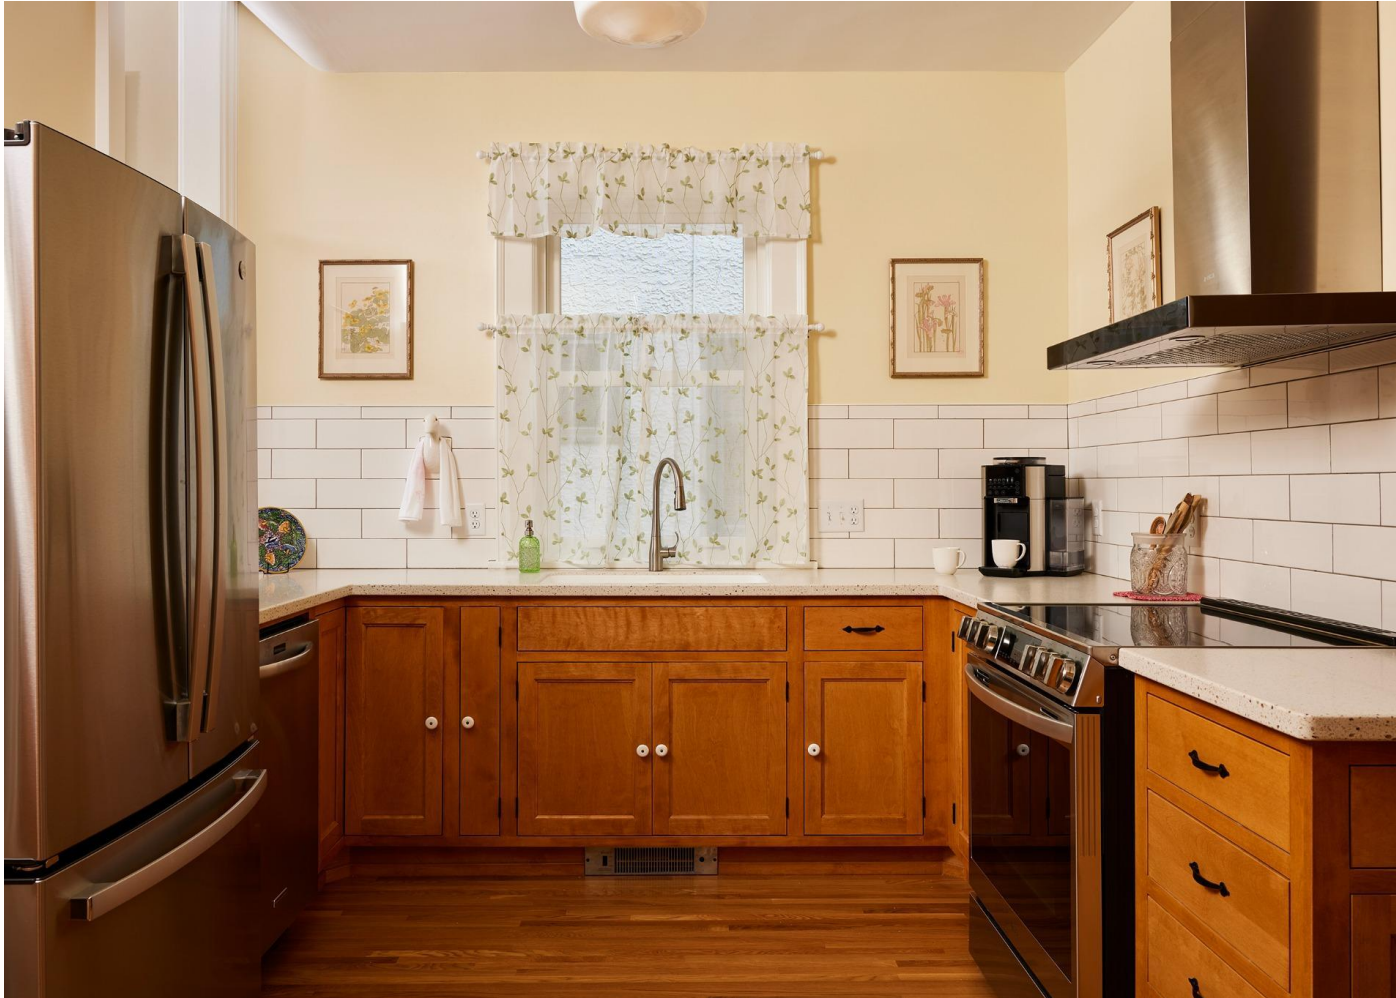
# AESTHETICS | Old and new read as one room

The design restores balance while respecting the home's 1913 character.

- **Rhythm and continuity**  
Inset doors, porcelain knobs, dark pulls and warm maple repeat across retained and new custom cabinetry.
- **Balance and focal point**  
The centered sink and balanced cabinetry create symmetry around the window.
- **Color and contrast**  
Speckled cream Corian countertop, tile and painted trim brighten the room against the maple and black accents.
- **Openness**  
Removed soffits and limited upper cabinets leave visual space for light and artwork.

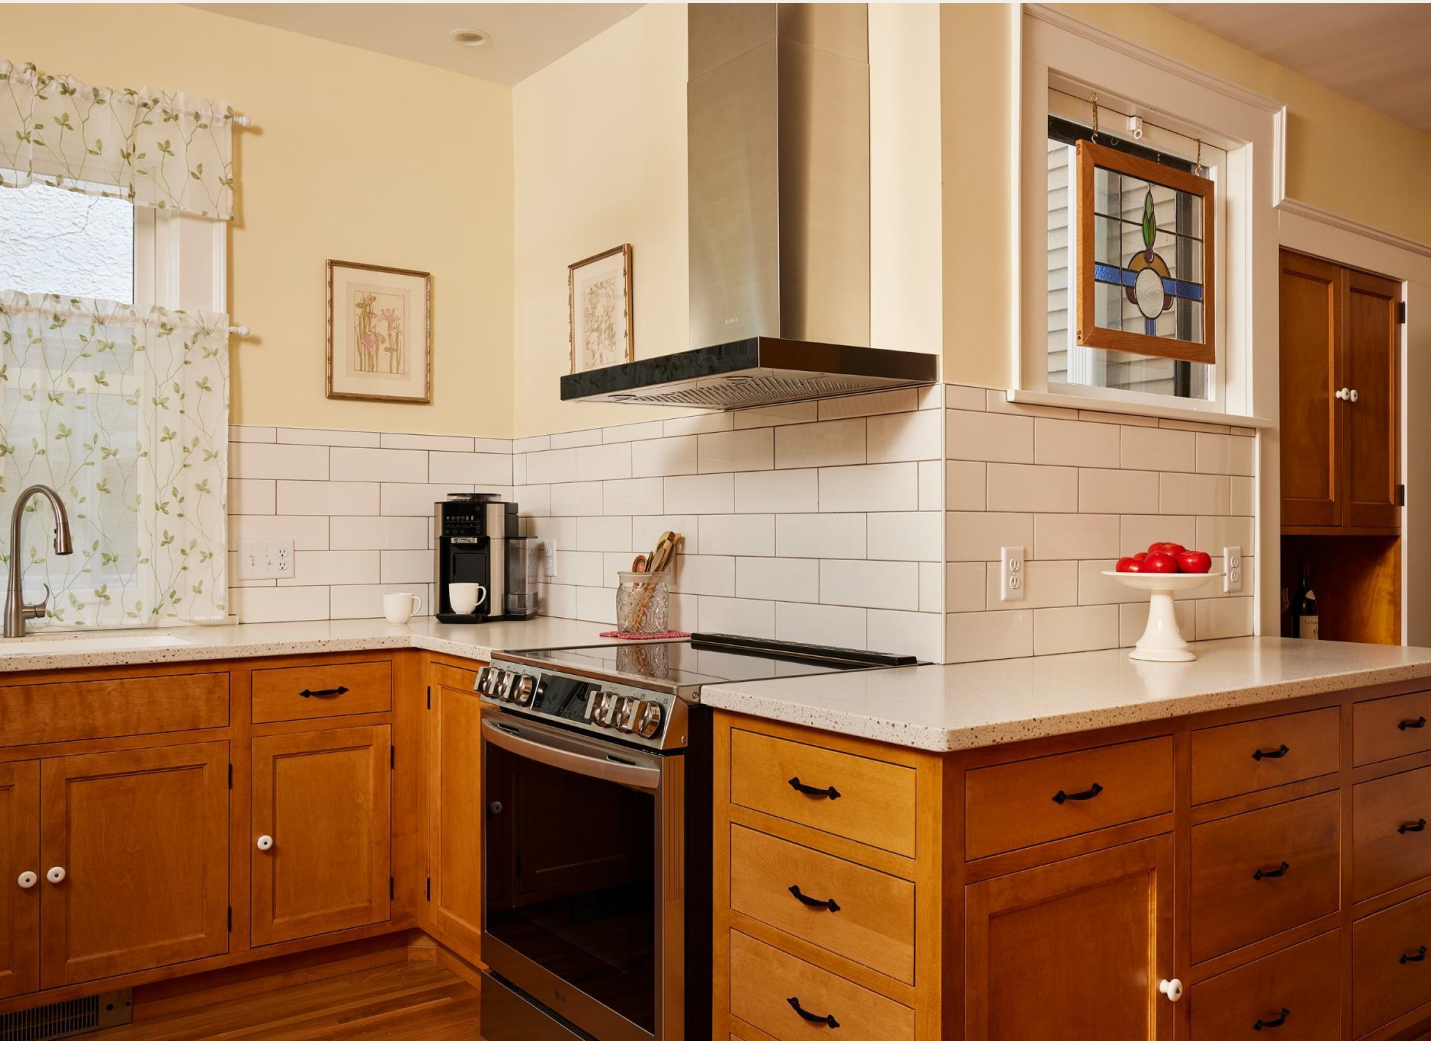
# FUNCTIONALITY | Reclaimed space works harder

The existing footprint now supports efficient cooking, storage and circulation.

- **Replaced corner sink**  
Awkward geometry and ergonomic issues were solved by creating space for a standard sink.
- **More work surface**  
Removing the stairs and peninsula created considerably more continuous counter.
- **More storage**  
New base cabinets, full-extension drawers, and creative pantry inserts add capacity without crowding the walls.
- **Clearer traffic flow**  
The open ceiling line and continuous floor connect both ends of the kitchen.
- **Improved ventilation**  
A properly sized hood supports the new range that actually vents outside.
- **Durable materials**  
Low-maintenance Corian countertops integrates seamlessly with the Corian sink.

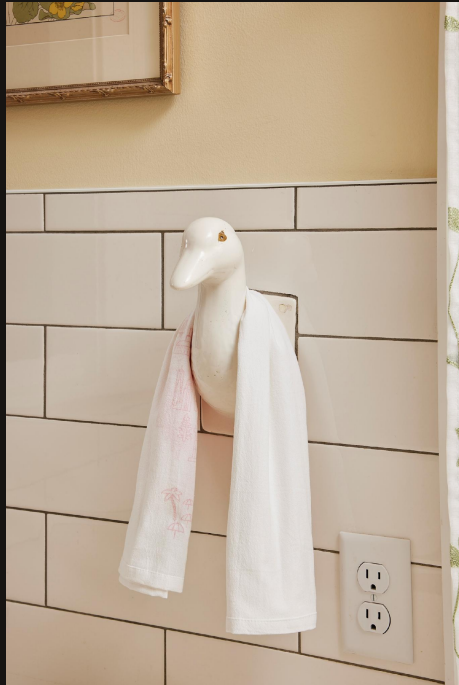
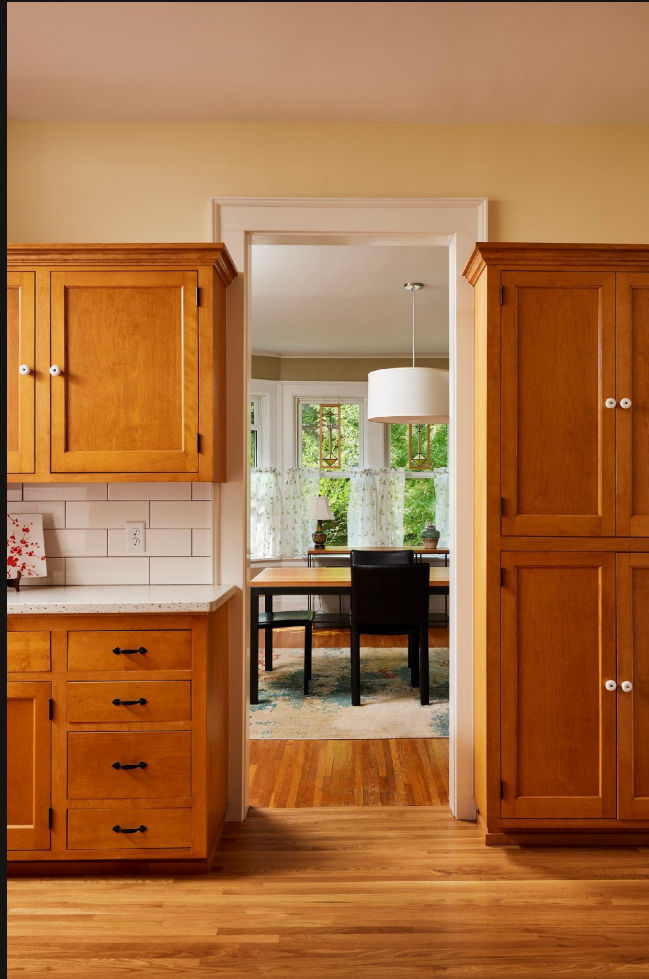
# CRAFTSMANSHIP | Details make the integration subtle

Custom work bridges a 1913 home and a new kitchen.

- **Cabinetry**

Custom-built pieces match the existing profiles, proportions and stain color.

- **Molding**

New crown molding replaces soffits and wraps precisely into the door casing.

- **Flooring**

Extensive shimming created a level plane before new oak was installed, stained to match and finished.

- **Tile**

The backsplash was laid cleanly around a family heirloom used as a towel holder.

- **Metalwork**

A locally fabricated guard translates original stained-glass geometry into steel, matching the 1913 era glass with a new functional gate.

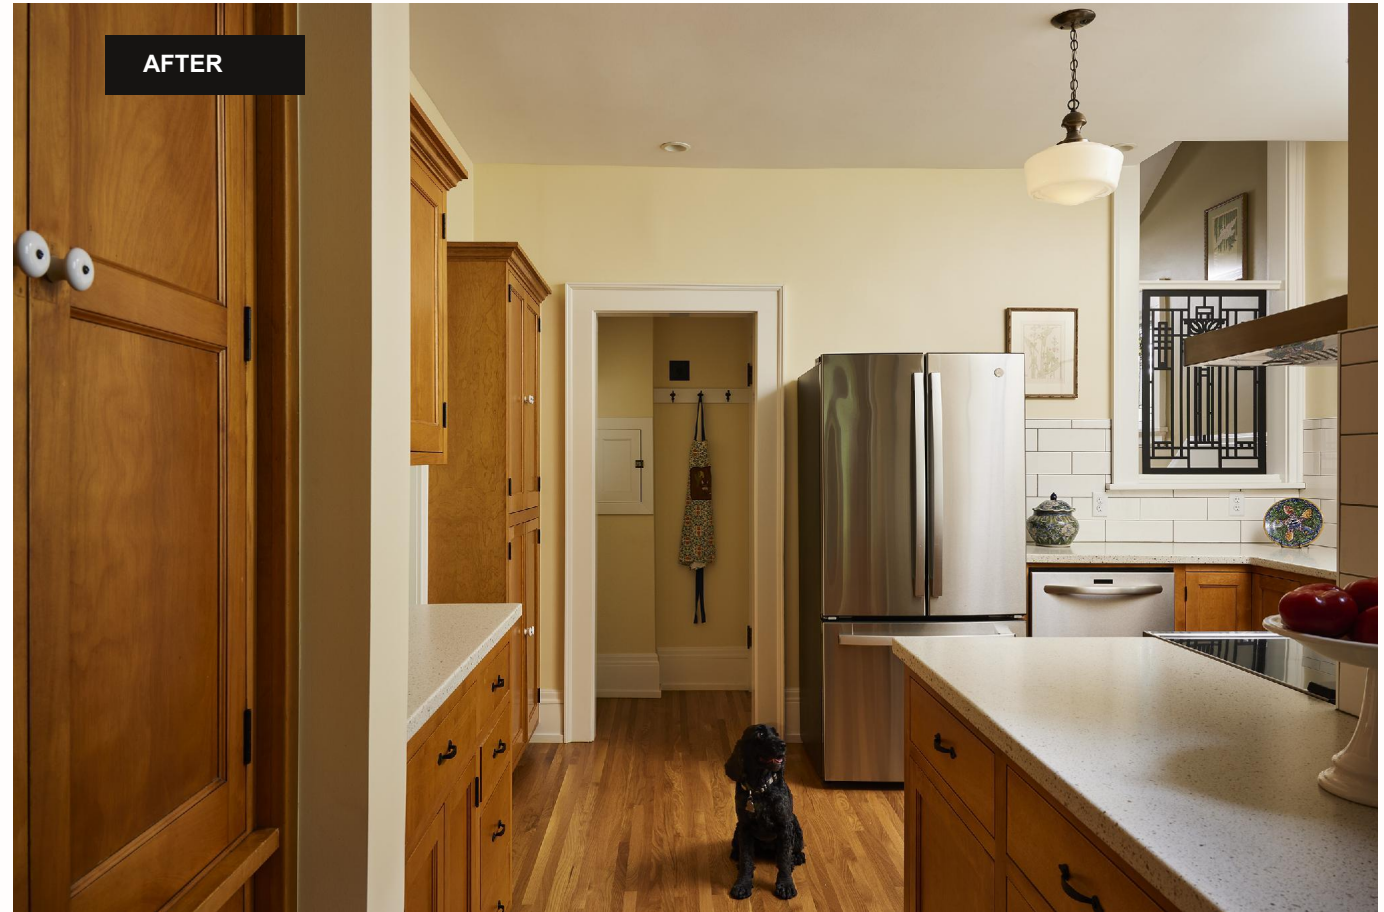
The rear portion was added roughly a century ago. Once the old flooring, soffits and header were removed, extensive shimming was required to bring the irregular structure into plane. New oak flooring was installed and custom stained to blend with the home.

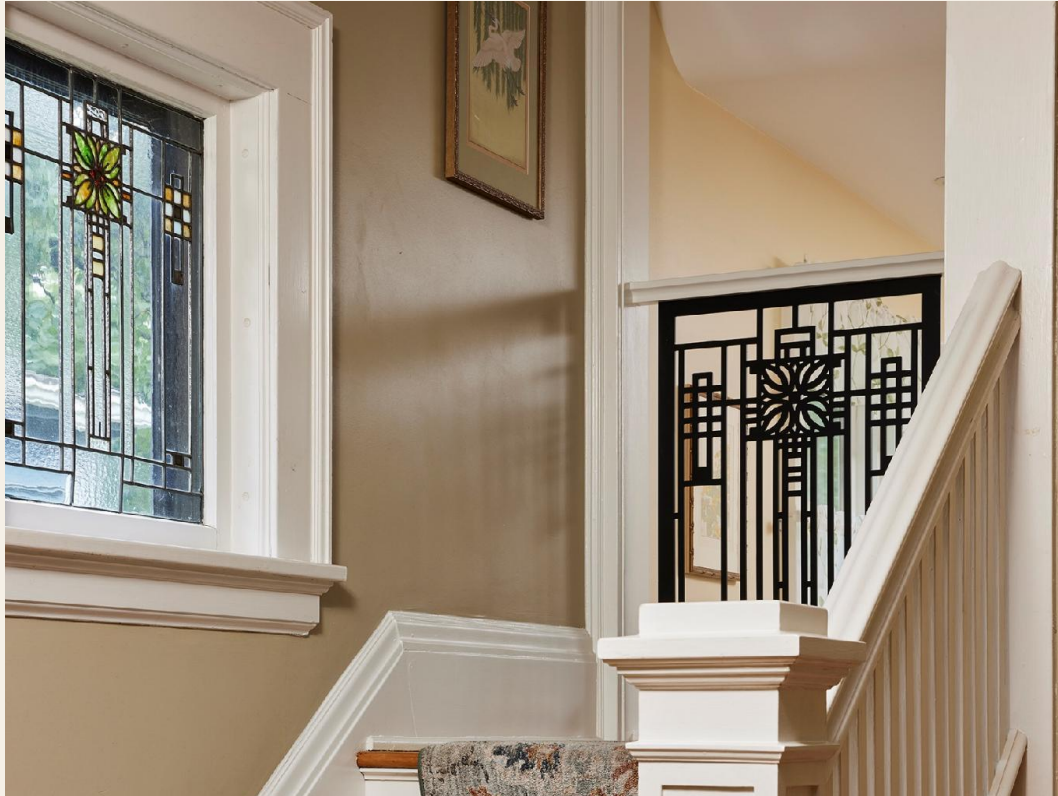
The unused stair was removed from the kitchen, while the upper opening remained to share light with the front foyer. A local metalworker created a custom guard whose floral form and rectilinear border echo the original 1913 stained-glass window.

The custom steel guard keeps the light-sharing opening while protecting the former stair edge.

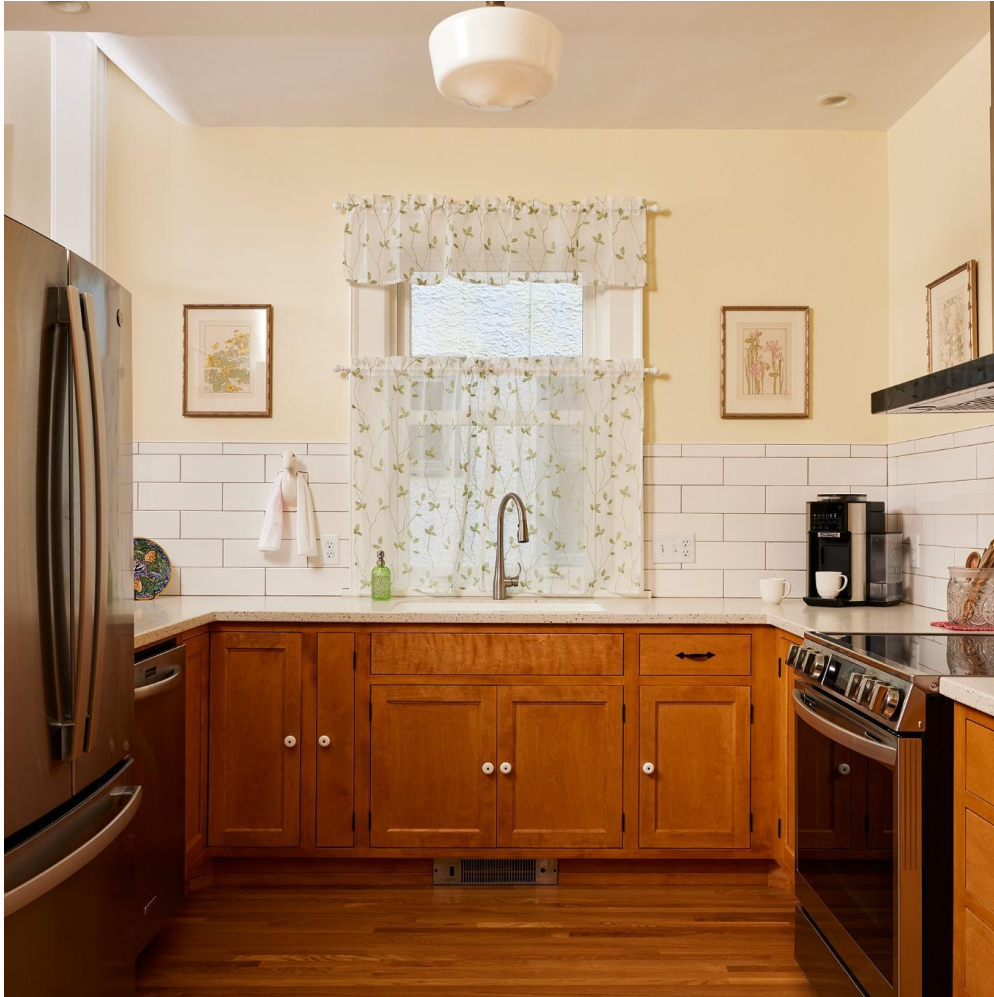
- **Toe-kick hydronic radiant heat**

A power-assisted heater beneath the sink replaces the radiator displaced by stair removal.

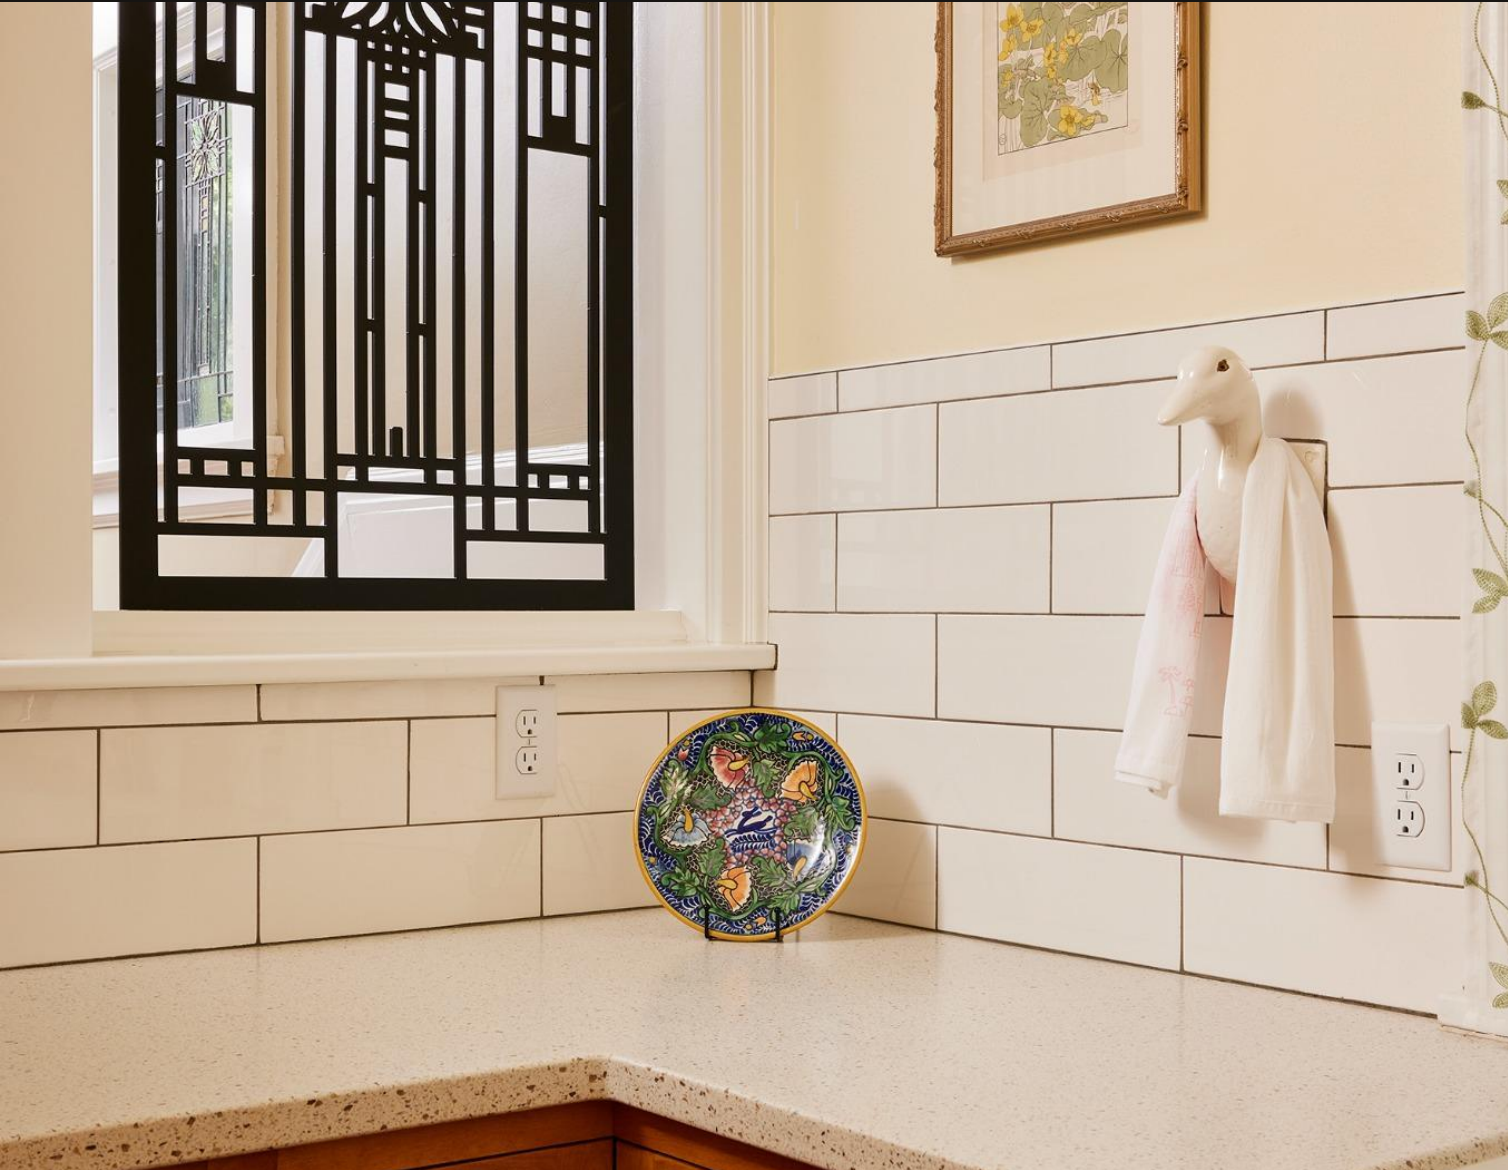
The ceramic duck was carefully incorporated into the subway-tile backsplash and now serves as a hand-towel holder. The surrounding tile layout accommodates the object cleanly while giving a personal artifact a useful role.
