ADJUSTABLE-BLADE TURBINE RUNNER TECHNOLOGY: WATER FILLED HUBS NWAHA TECHNICAL FORUM

Cole Sergi, PE USACE

Calvin Carr PNNL

01 May 2025

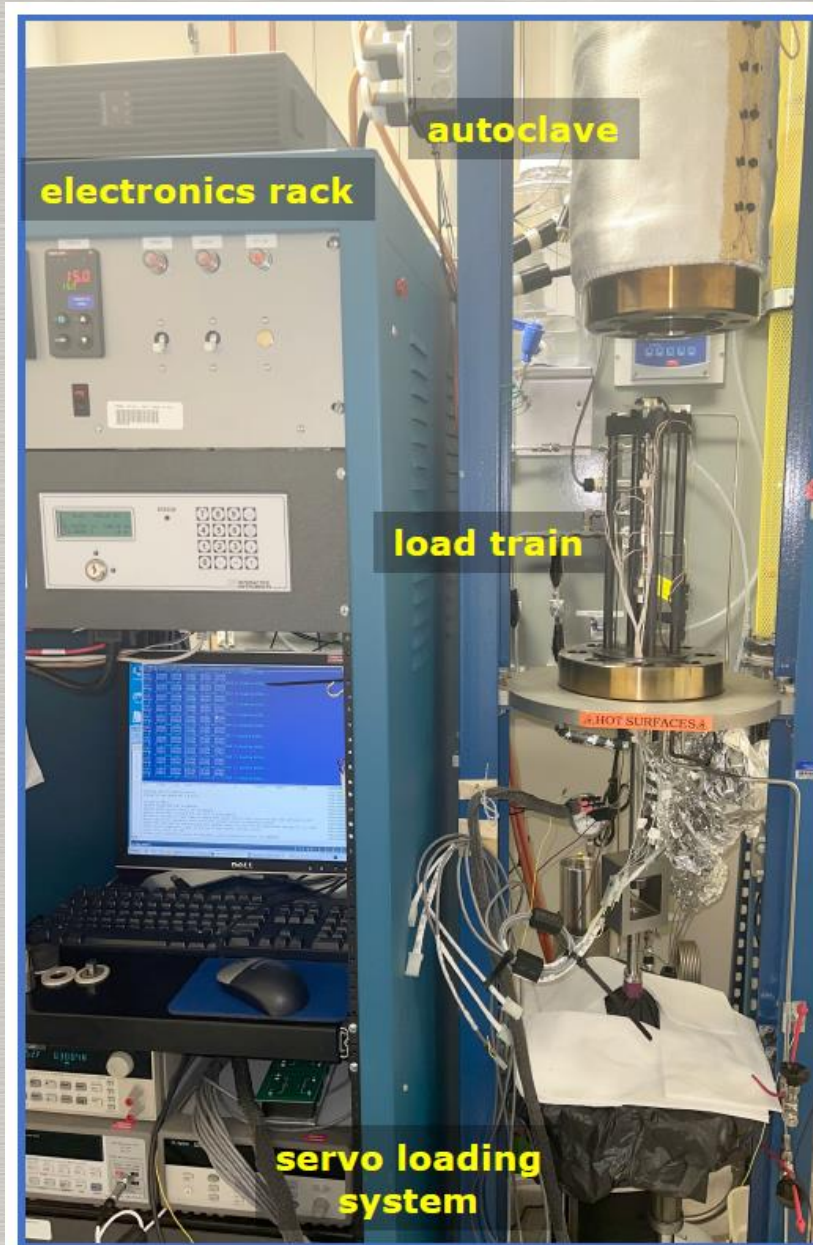
CORROSION INDUCED FATIGUE

The removal of oil exposes highly stressed, critical Kaplan components to a corrosive environment.

Testing was completed that accelerated the impacts due to stainless steels exposed to water.

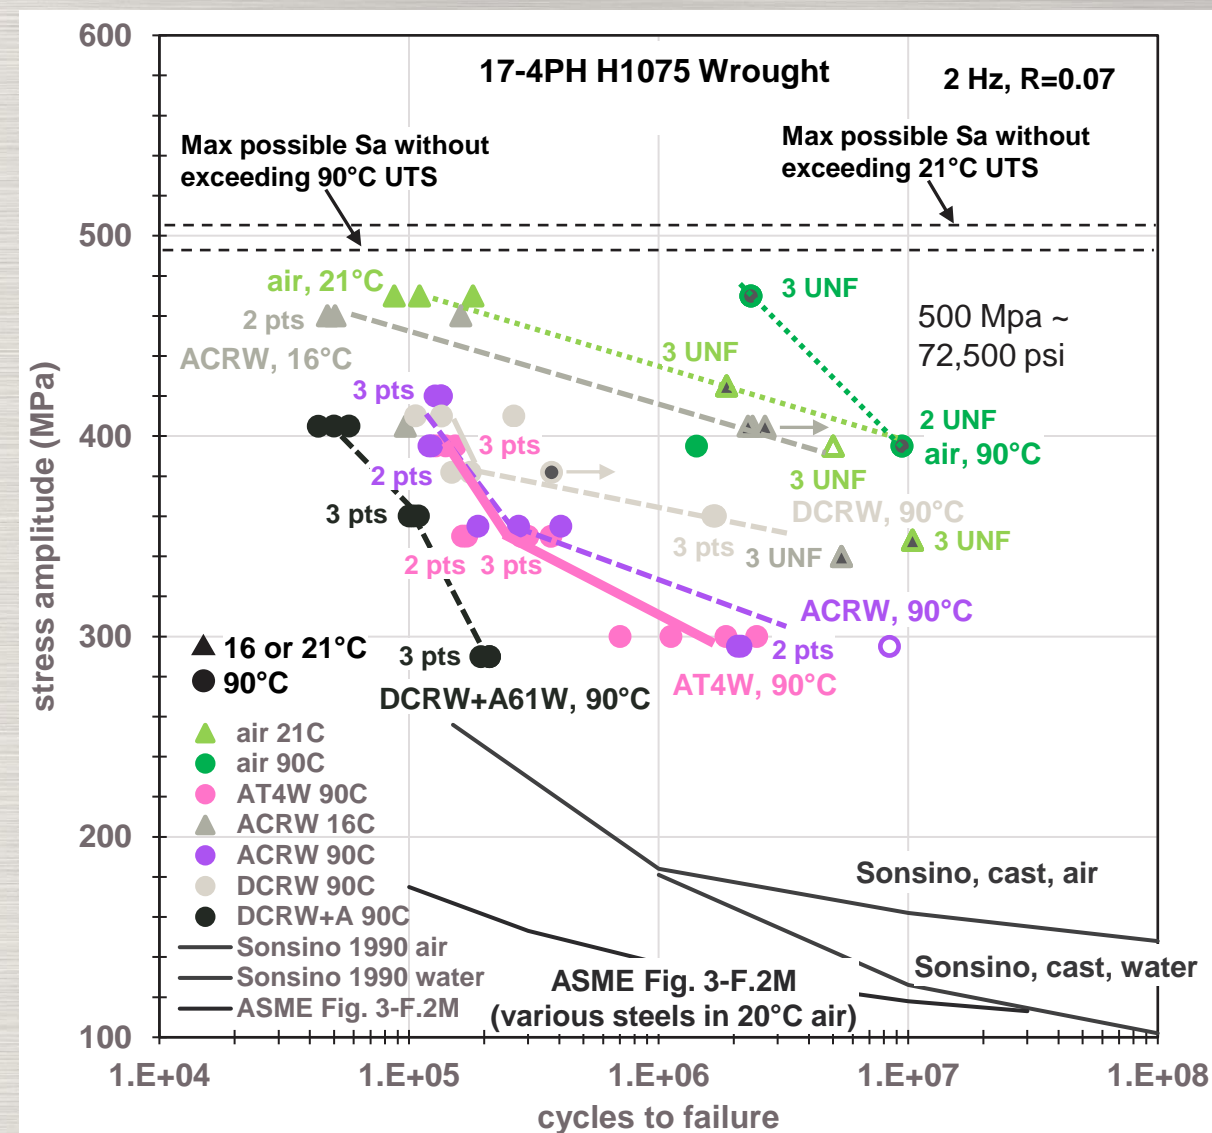
- When compared to data in air, there is life reduction for 17-4 in water at a similar stress amplitude.
- When compared to cool temperatures, there is life reduction for 17-4 at hot water temperatures (there is a corrosion acceleration)
- Rust inhibitor reduced life in the laboratory.

CONCLUSIONS FROM FATIGUE TESTING

- Fatigue testing and selection of 17-4 PH (wrought or forged) allows for more design flexibility for designs for Improved Fish Passage (**good news**)

- Testing identified little difference between Columbia River Water and ASTM Type 4 water. This indicates a blade seal failure does not require an immediate forced outage and can be done during a scheduled outage (**good news**)

- The addition of a rust inhibitor did not increase life. In fact, there is risk that it may have an adverse effect. Additionally, there was indication from one self-lubricating bushing manufacturer that rust inhibitors could negatively affect bushings. Rust inhibitor will not be included in any oil-free designs. This will reduce the O&M efforts associated with maintaining inhibitor quality and potential reporting requirements and reduce scope of bushing testing (**good news**)

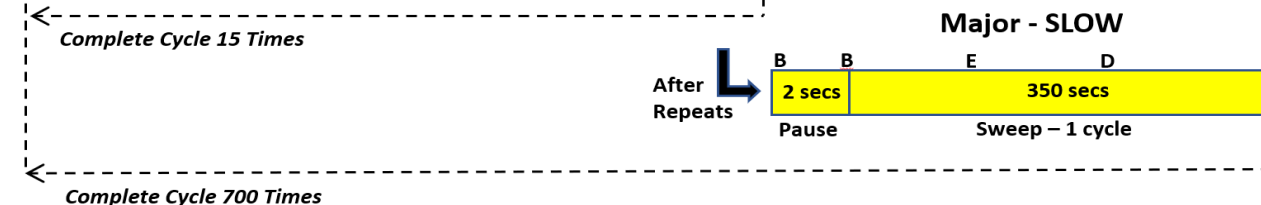
LOADING & MOVEMENT MAP

(Two Testing Phases per Bushing, Total Test Duration: Less than 30 days continuous 24/7)

Set & Creep Phase - Bushing Conditioning for Testing

Oscillation Cycles ($\pm 5.0^\circ$) Completed = 247

Friction & Wear Phase – Bushing Operational Testing

Minor Oscillation ($\pm 0.3^\circ$) Cycles Completed: 5,040,000

Major NORMAL Oscillation Cycles ($\pm 8.0^\circ$) Completed: 10,500

Major SLOW Oscillation Cycles ($\pm 8.0^\circ$) Completed: 700

- 20 Minor cycles: 8 secs
- 60 Minor cycles: 24 secs
- Minor cycle (8) repeats + Major-Normal cycle: 3 minutes, 36 secs
- Major-Normal cycle (15) repeats + Major-SLOW cycle: 54 minutes, 16 secs
- Total Test with 700 Major-Slow cycles: 641 hours, 26.7 days

Major - NORMAL

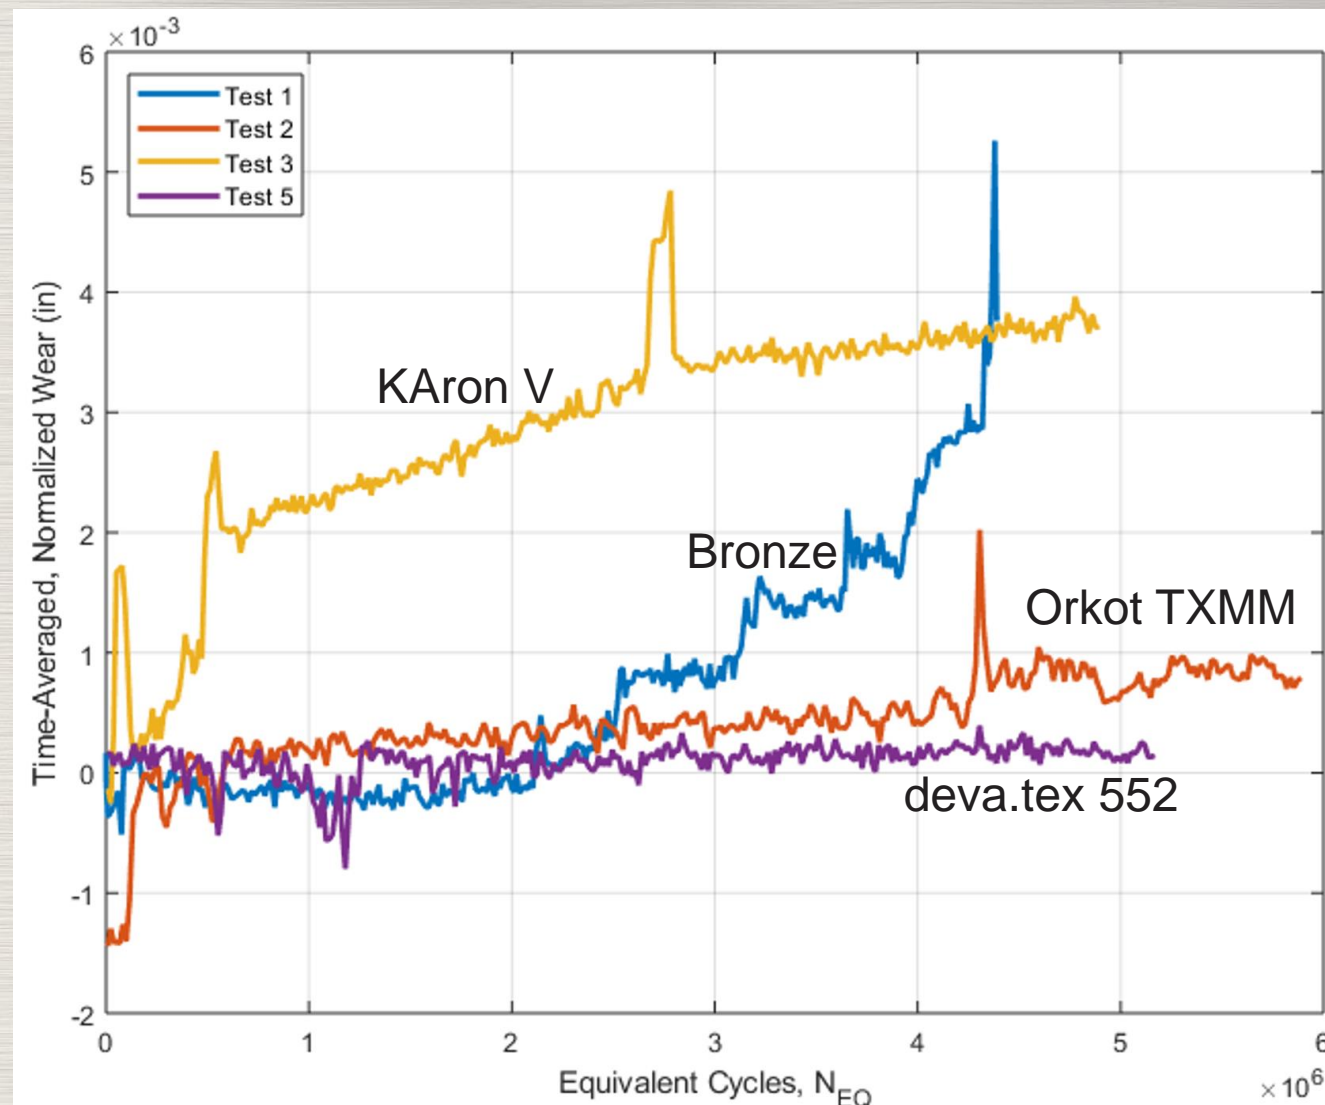
TYPICAL WEAR TRENDS FOR BRONZE & SLB

Wear

CONCLUSION: Bronze and SLBs both meet 50-year life conditions with maximum wear on the order of 0.005 inches.

- Bronze bushing wear increases with time
- Self-lubricated bushings (SLBs) wear levels off with time

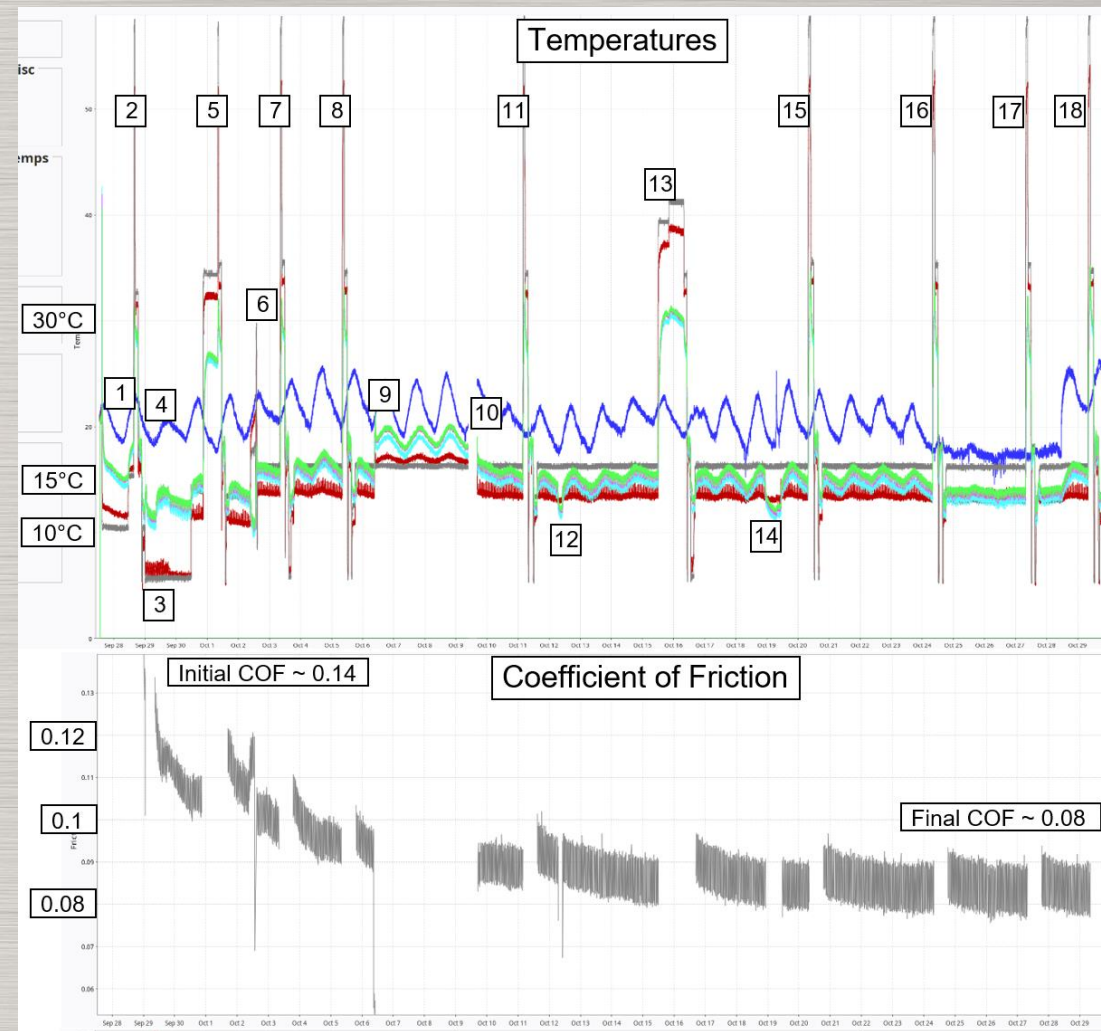
TEST EVENT CHART (TYPICAL) – TEST 5

TESTING KEY FEATURES:

- Direct comparison of all data over time.
- Test events can be seen in data.
 - Gaps for Matrix testing
 - Temperature manipulation from Matrix testing

Note: Test pauses or equipment excursions outside of normal parameters affects data.

- Increased temperatures decrease COF in SLBs
 - Actual temperatures will be in narrow operating range of 10 - 15°C so these effects will be minimized.
