Cushman #1 Rock Fall Mitigation

Dealing With the Aftermath

2025 NWA Technical Workshop

Seth Doull, PE Tacoma Power

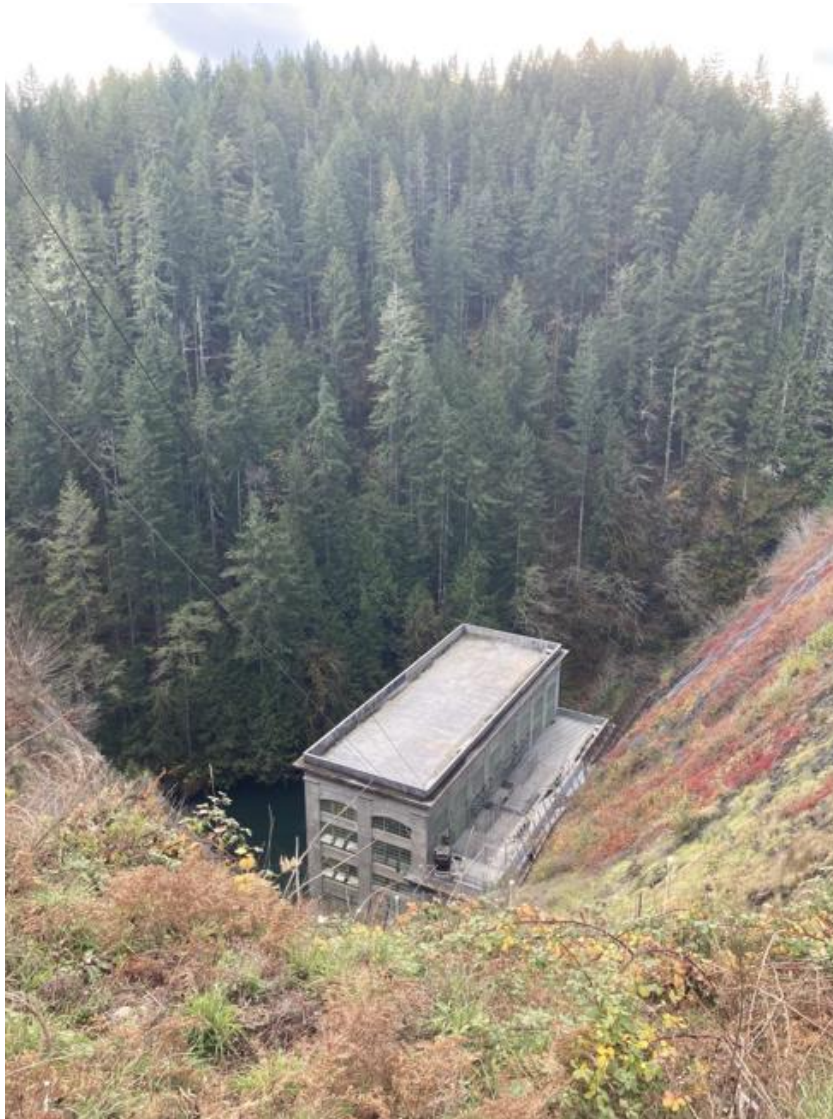
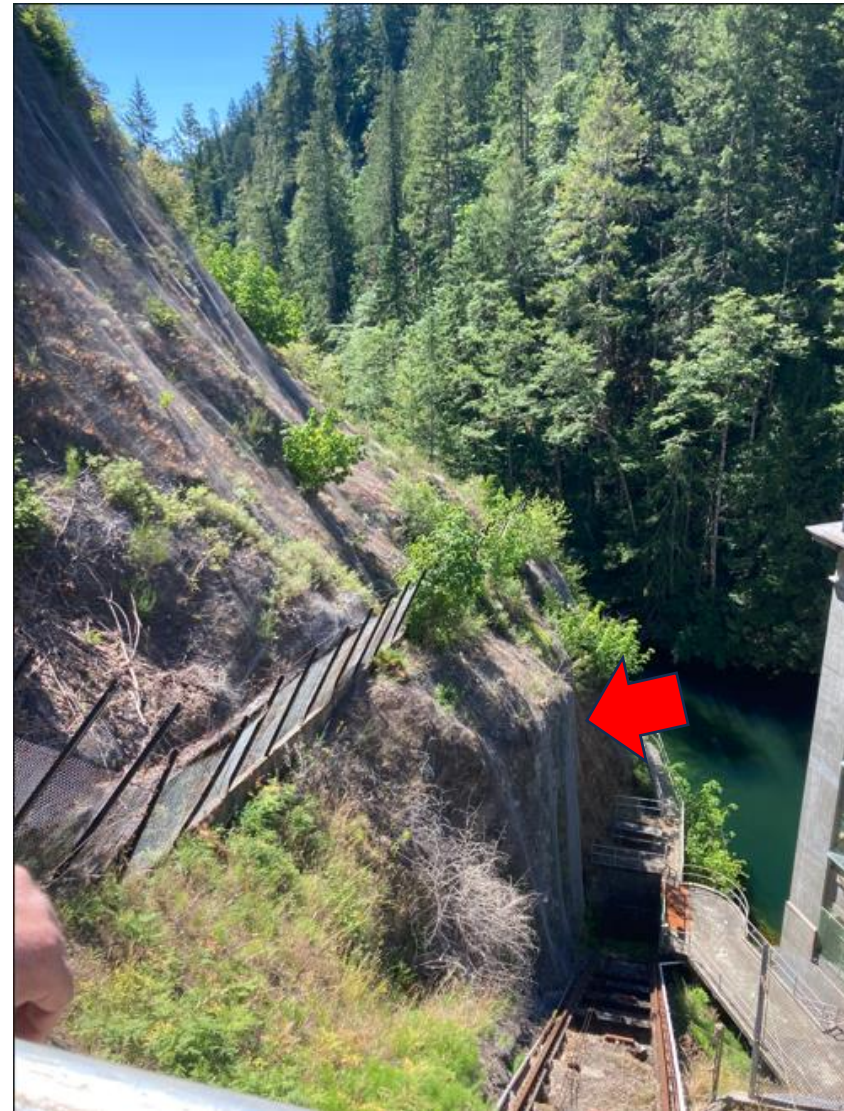
Cracking noticed by staff

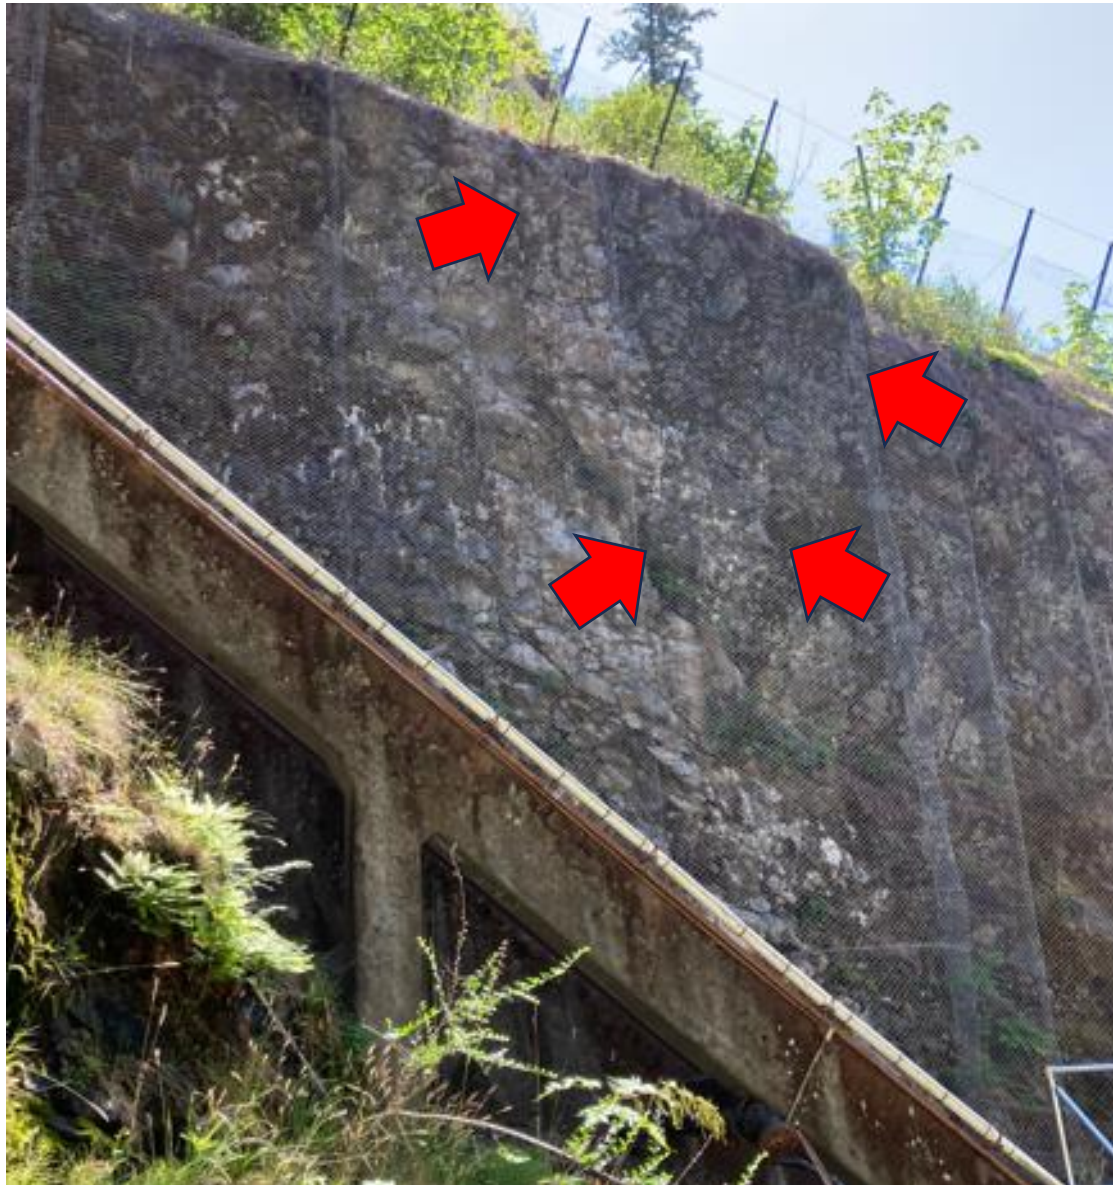
Converging cracks - The type you don't want to see

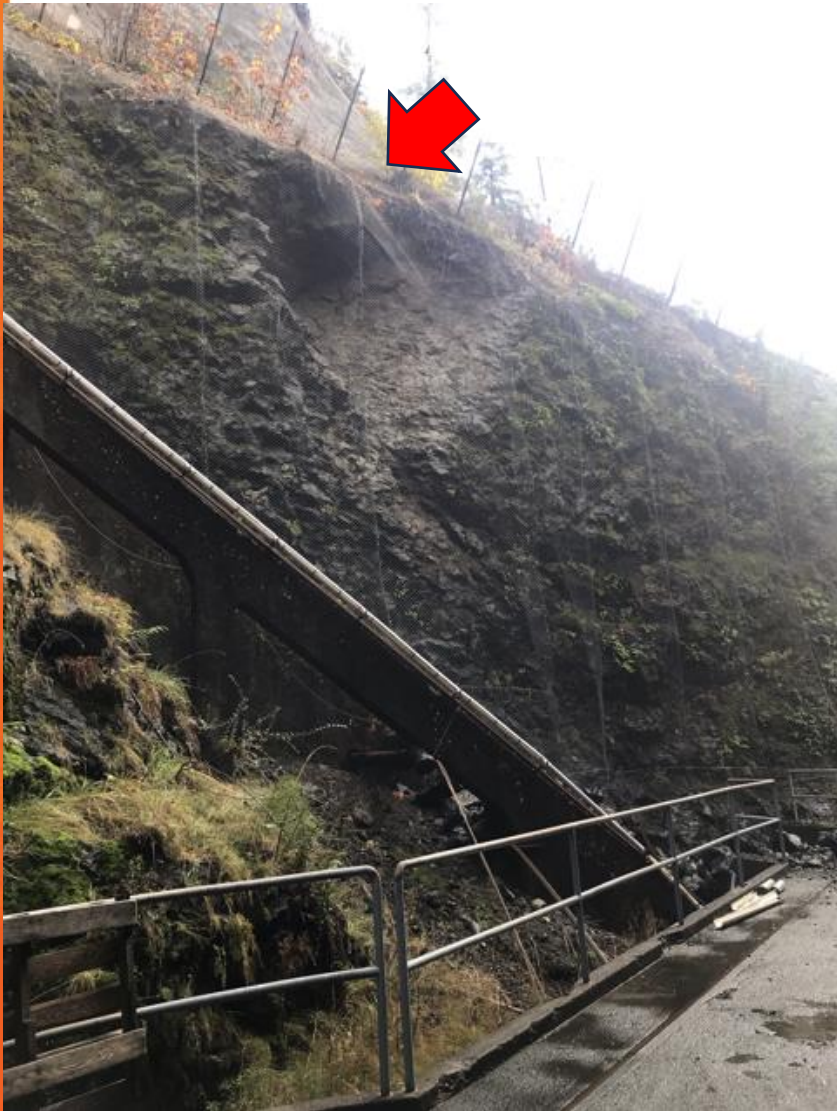
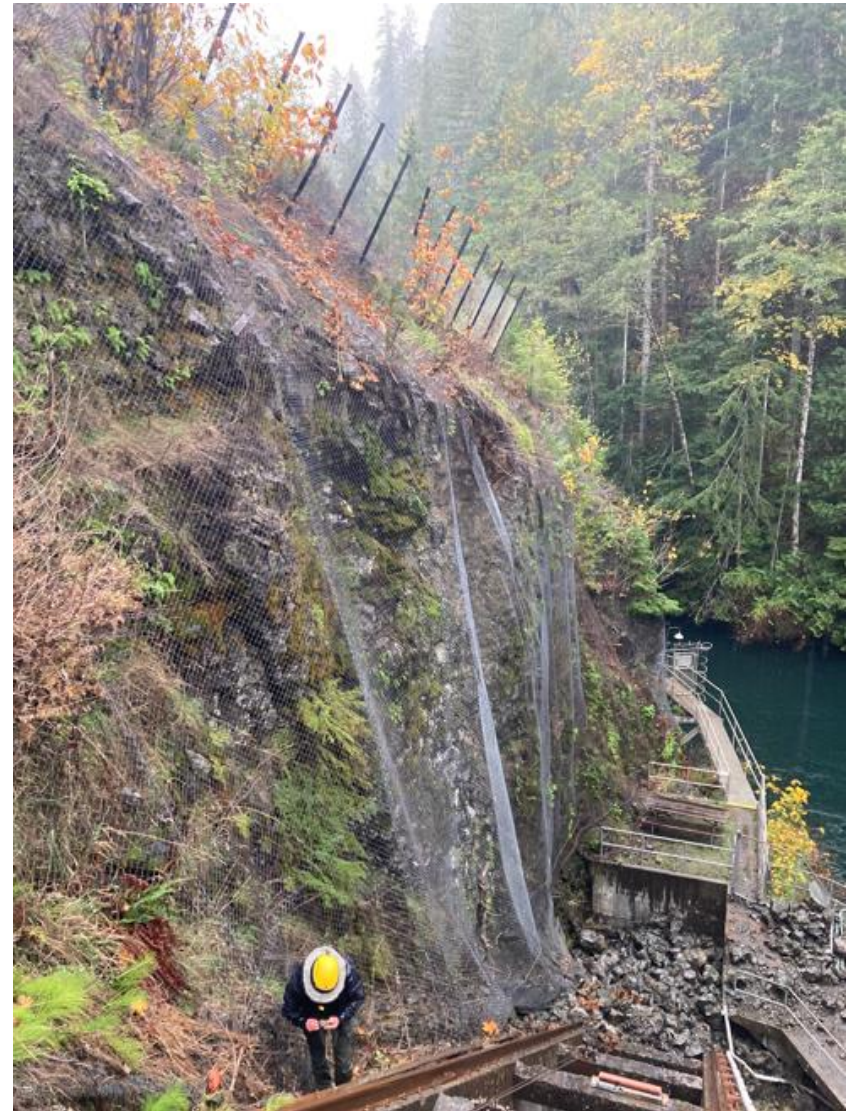
And made quite the mess

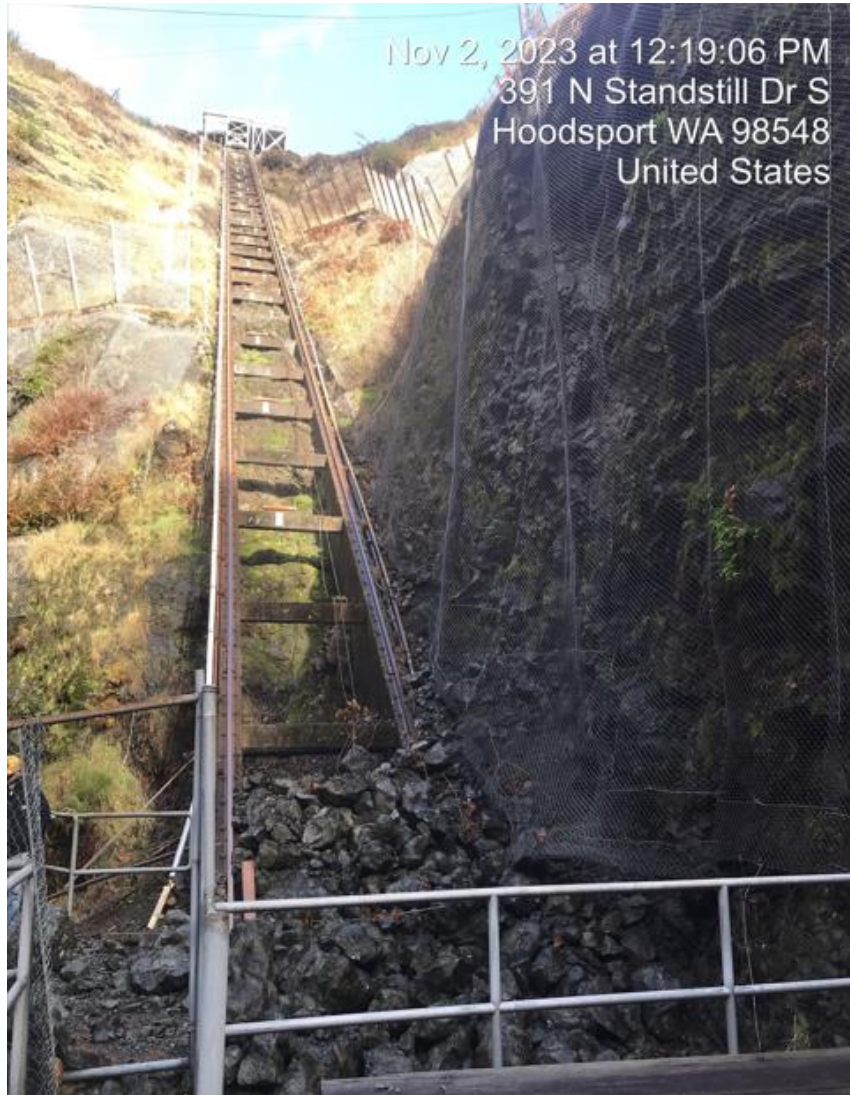
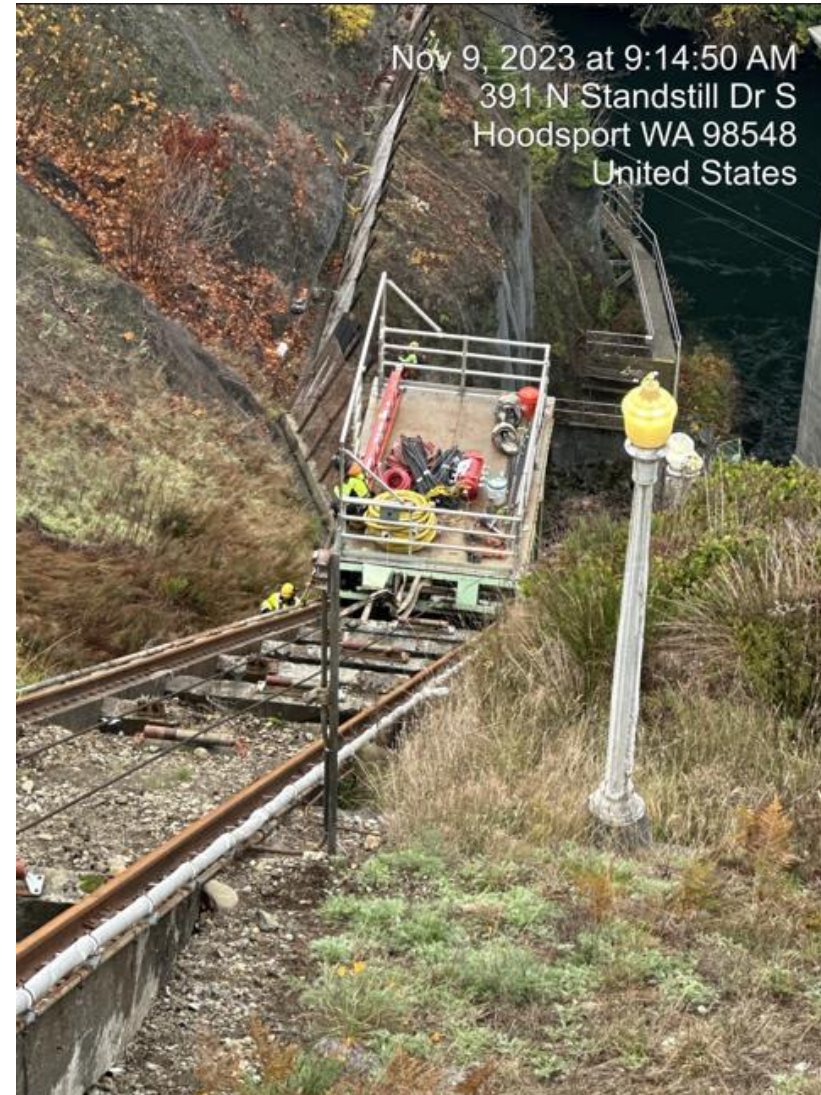
Evaluating stability of overhanging rock

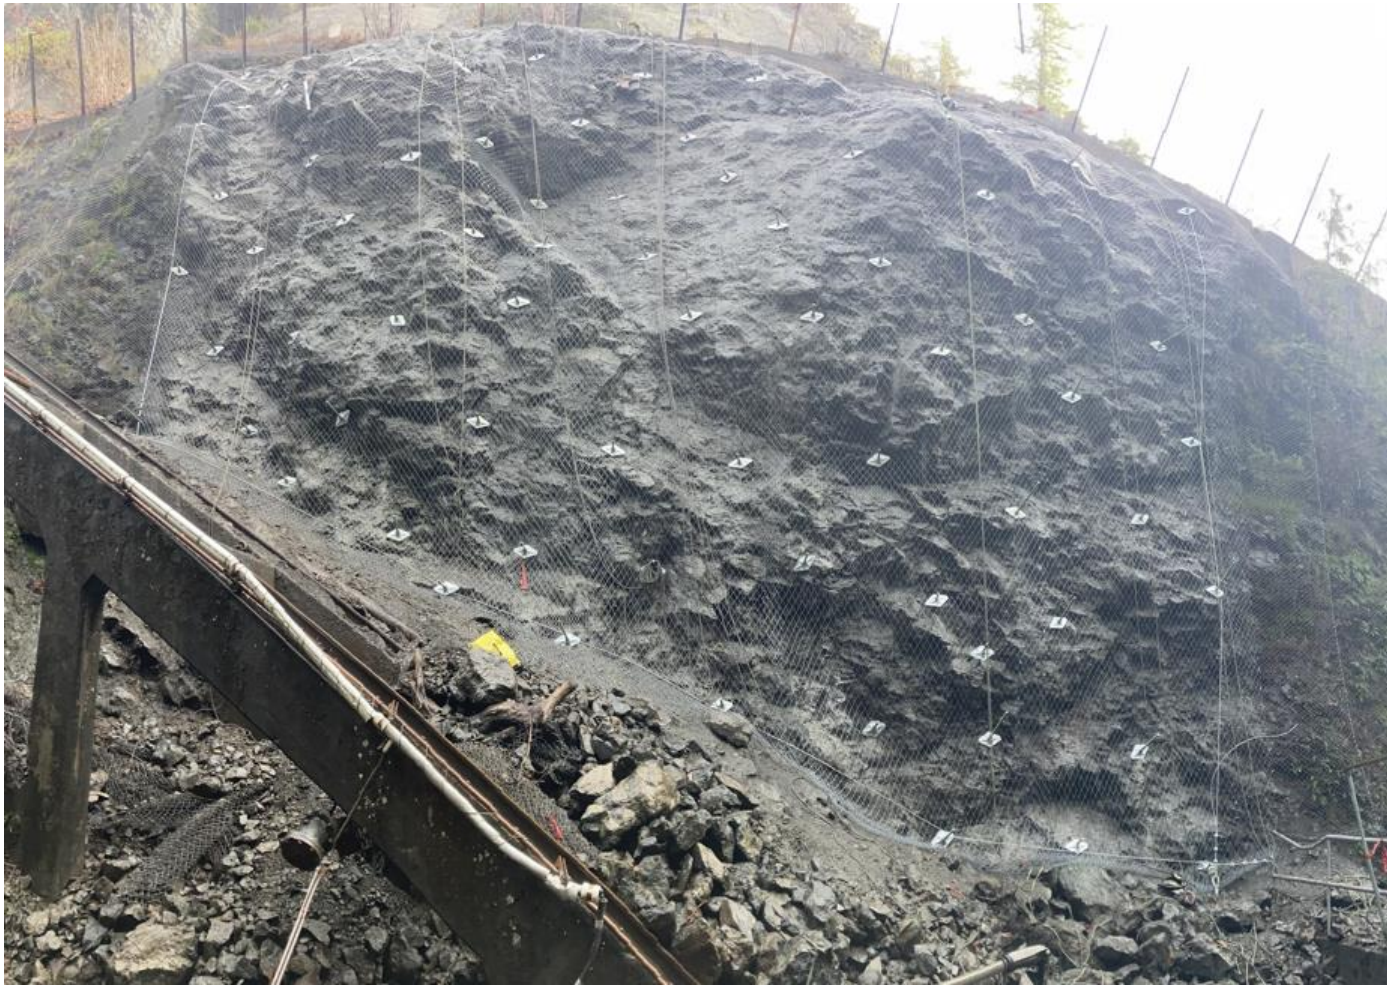
- How to remove all of the rock?
- About 100 yards or 250,000 lbs
