Seattle City Light Boundary Powerhouse

Thrust Bearing Failures
Presented by: Casey Holter

Thrust Bearing Failure Events

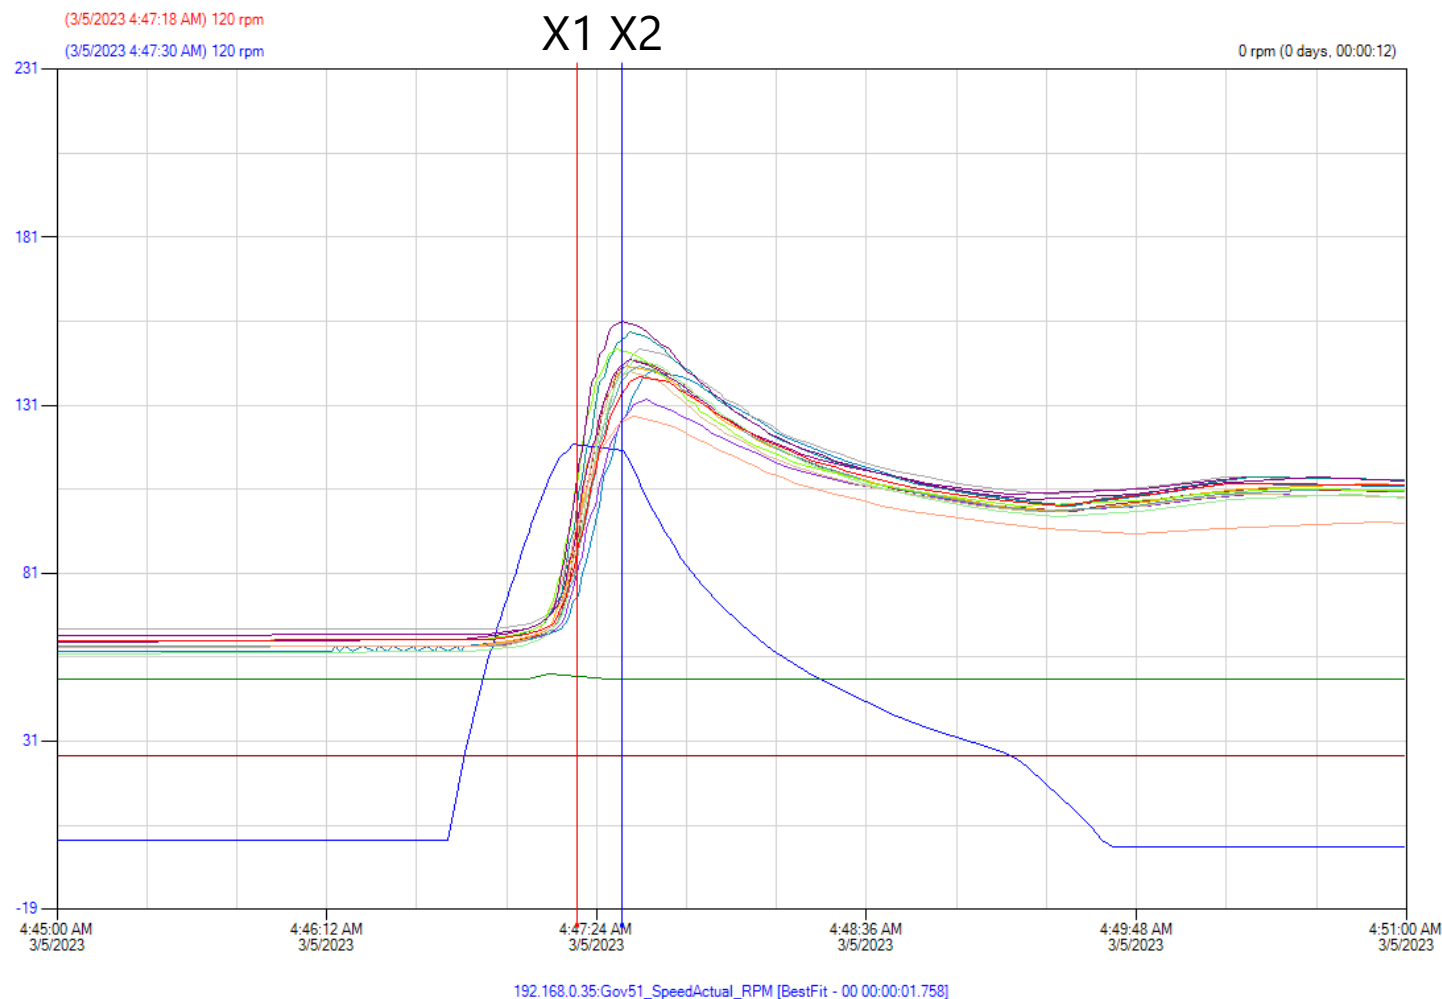
Thrust Bearing Temp. Trend During Startup [wipe]

Description	Number	Color	Units	Value at X1	Value at X2
Gov51 - SpeedActual RPM	1	Blue	rpm	120	120
Meter51_MW	2	Dark Red	MW	0	0
RTD_U51_GTB_OIL_1_PV	3	Dark Green	°C	31	30
RTD_U51_GTB_1_PV	4	Blue	°C	44	76
RTD_U51_GTB_2_PV	5	Dark Red	°C	52	85
RTD_U51_GTB_3_PV	6	Orange	°C	53	85
RTD_U51_GTB_4_PV	7	Purple	°C	46	76
RTD_U51_GTB_5_PV	8	Tan	°C	52	84
RTD_U51_GTB_6_PV	9	Grey	°C	48	83
RTD_U51_GTB_7_PV	10	Grey	°C	49	85
RTD_U51_GTB_8_PV	11	Purple	°C	54	86
RTD_U51_GTB_9_PV	12	Light Green	°C	50	84
RTD_U51_GTB_10_PV	13	Teal	°C	57	90
RTD_U51_GTB_11_PV	14	Orange	°C	56	76
RTD_U51_GTB_12_PV	15	Yellow	°C	63	89
RTD_U51_GTB_13_PV	16	Purple	°C	62	94
RTD_U51_GTB_14_PV	17	Red	°C	50	81

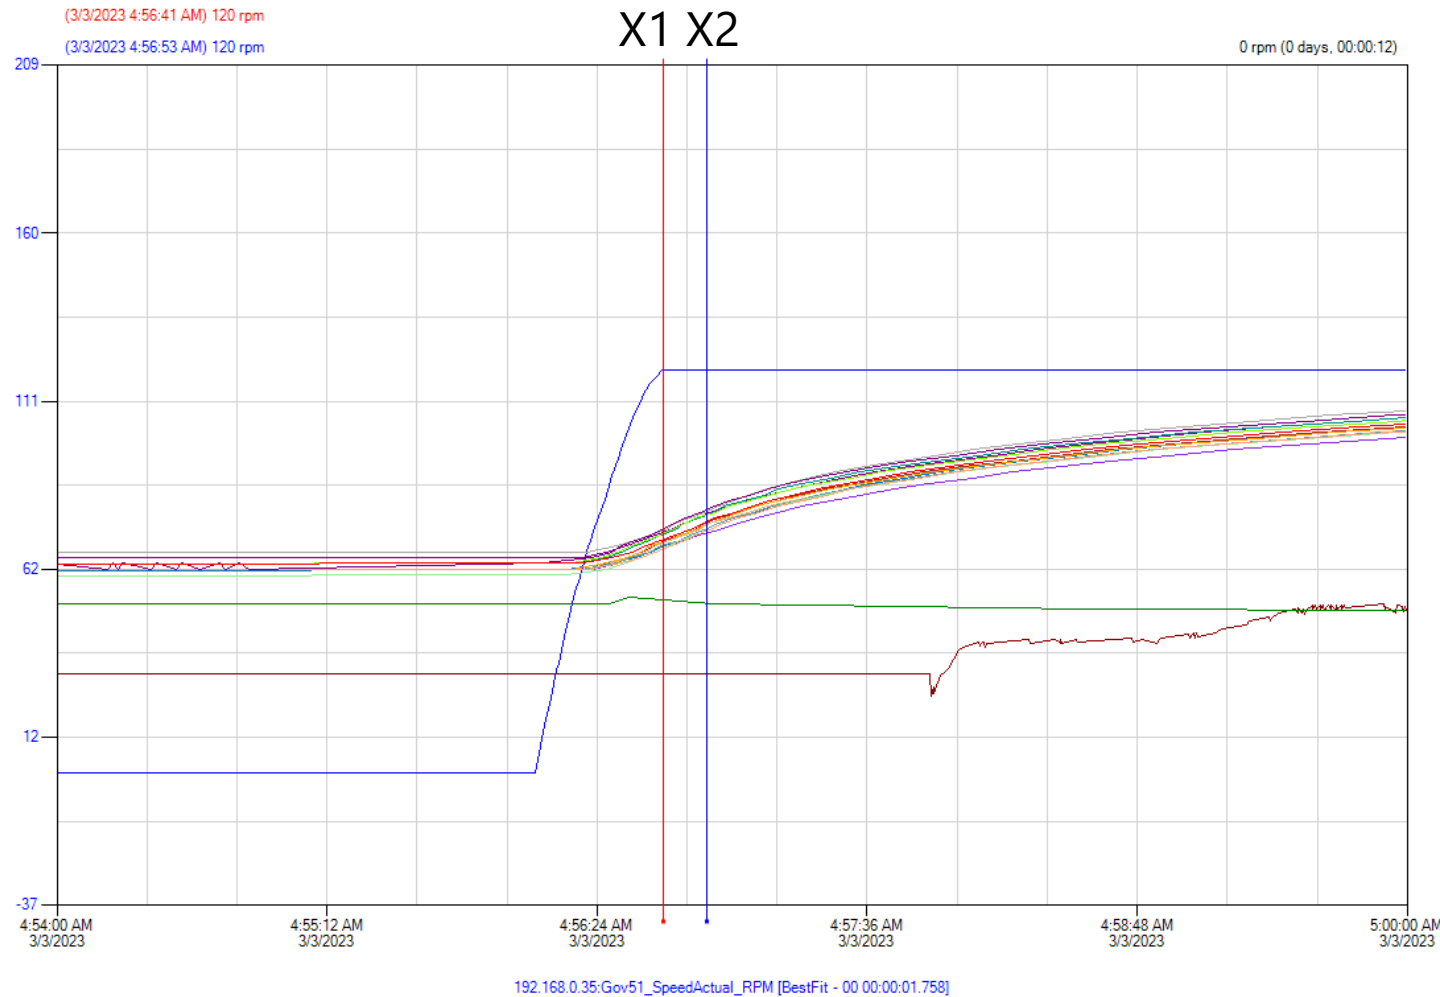
Thrust Bearing Temp. Trend During Startup [normal]

Description	Number	Color	Units	Value at X1	Value at X2
Gov51 - SpeedActual RPM	1	Blue	rpm	120	120
Meter51_MW	2	Dark Red	MW	5	5
RTD_U51_GTB_OIL_1_PV	3	Green	°C	32	32
RTD_U51_GTB_1_PV	4	Blue	°C	40	43
RTD_U51_GTB_2_PV	5	Dark Red	°C	41	45
RTD_U51_GTB_3_PV	6	Orange	°C	41	44
RTD_U51_GTB_4_PV	7	Purple	°C	40	43
RTD_U51_GTB_5_PV	8	Tan	°C	41	44
RTD_U51_GTB_6_PV	9	Grey	°C	41	44
RTD_U51_GTB_7_PV	10	Light Grey	°C	43	47
RTD_U51_GTB_8_PV	11	Purple	°C	43	46
RTD_U51_GTB_9_PV	12	Light Green	°C	40	43
RTD_U51_GTB_10_PV	13	Teal	°C	43	46
RTD_U51_GTB_11_PV	14	Orange	°C	40	43
RTD_U51_GTB_12_PV	15	Yellow	°C	43	46
RTD_U51_GTB_13_PV	16	Purple	°C	44	47
RTD_U51_GTB_14_PV	17	Red	°C	42	45

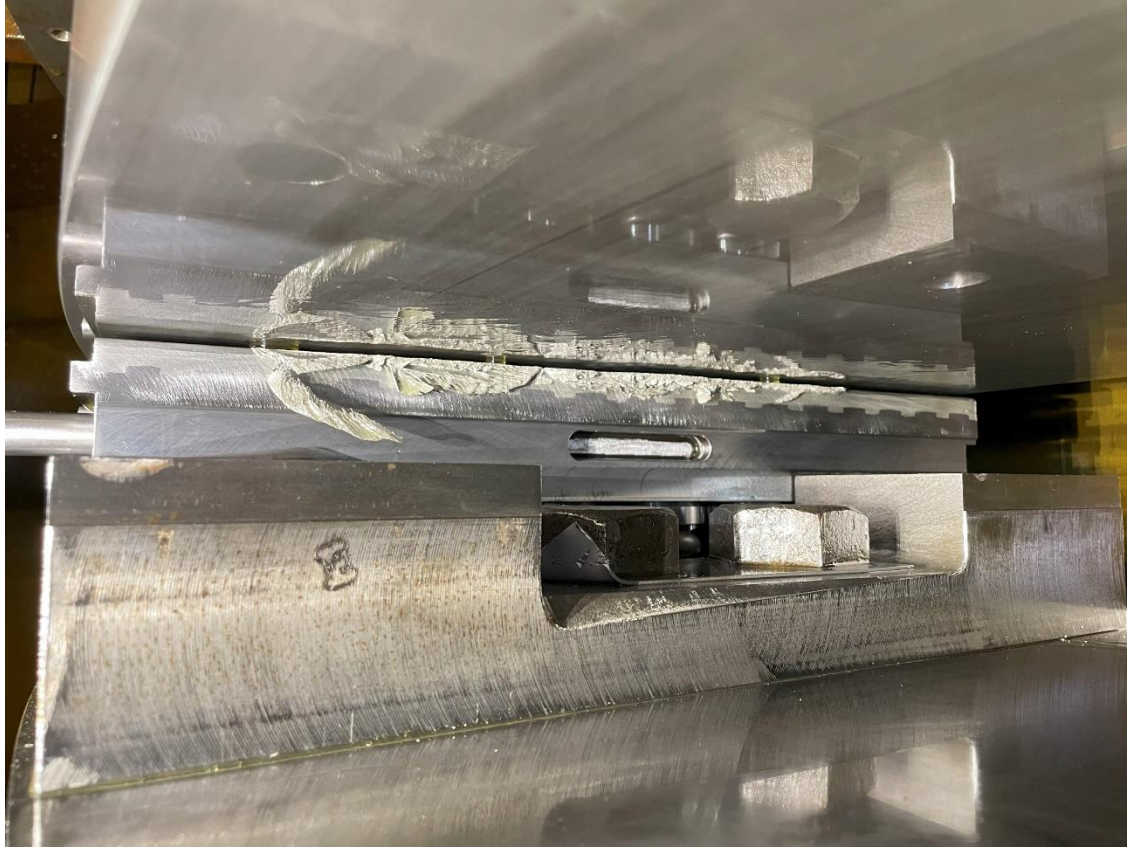
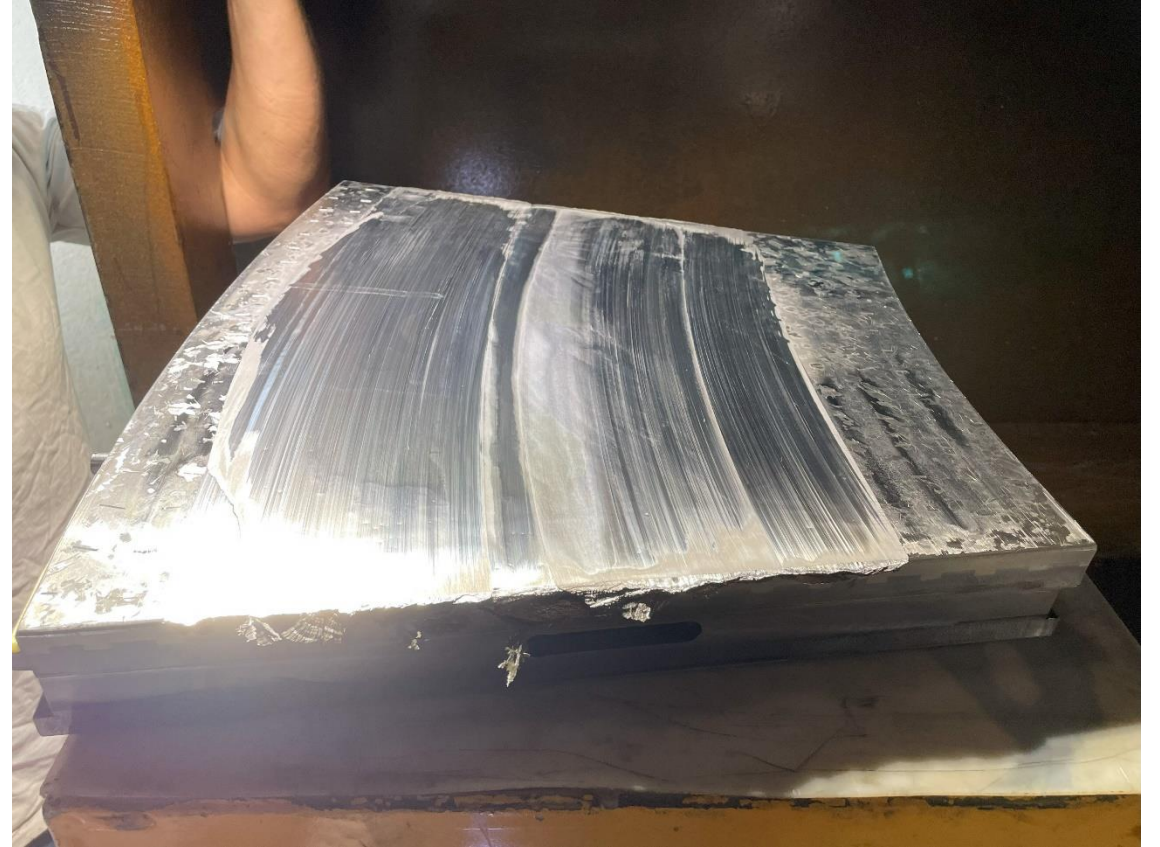
Thrust Bearing Wipe

- Rapid bearing shoe temperature rise upon startup, triggering unit shutdown
- U51 – 22 months in service following 2021 generator rehab
- U54 – 2 months in service following 2023 generator rehab
- Units taken out of service for inspection of thrust bearing
- Inspection confirms wiped thrust bearing(s)
- Surface of babbitt reaches melting temperature and is smeared across the surface of the shoe. Flakes of solidified babbitt scatter the oil pot.
- Babbitt is a white metal alloy consisting of mostly Tin, some Copper and Antimony. It can also contain Lead and Arsenic depending on the grade.

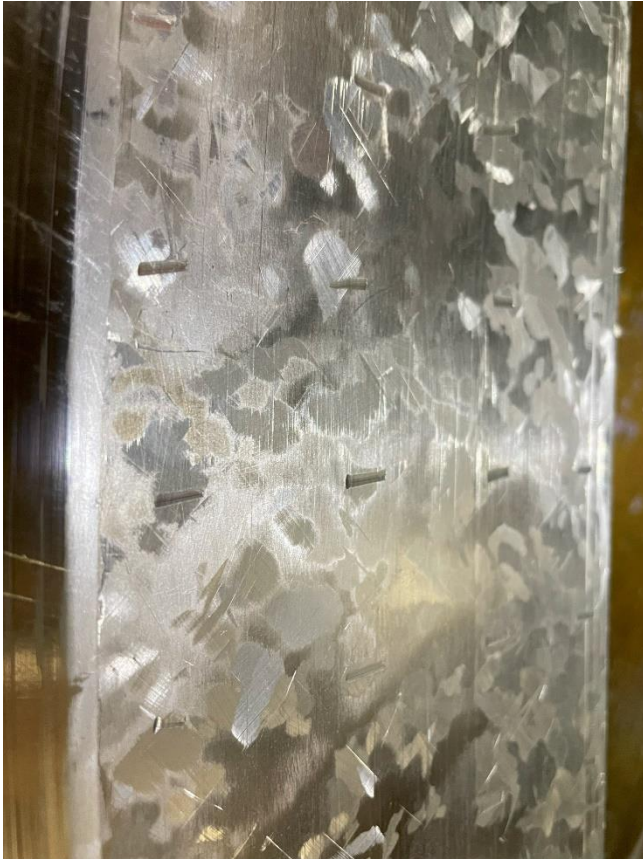
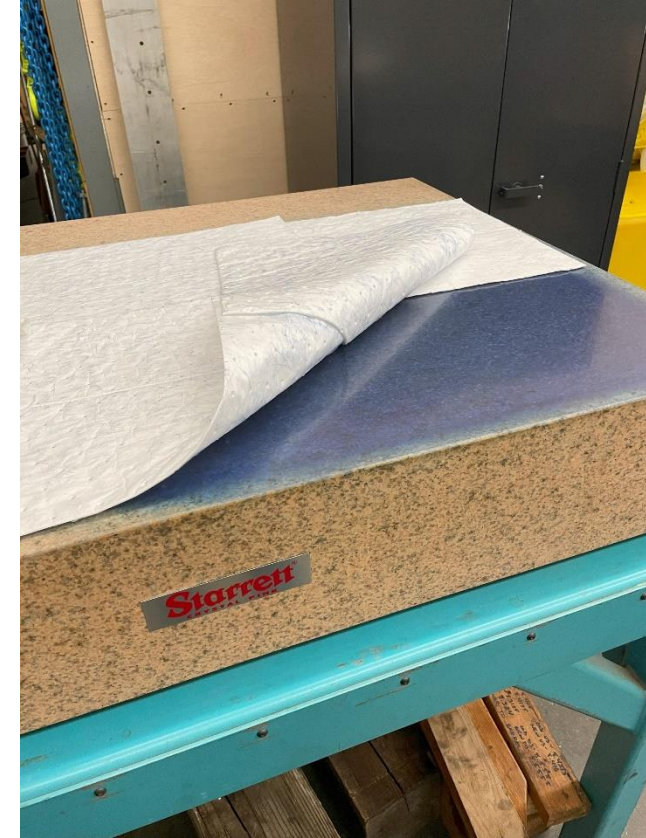
Babbitt Bearing Surface (scraping)

- Both U51 and U54 had conventional bearing scraping, as well as non-conventional scraping pattern

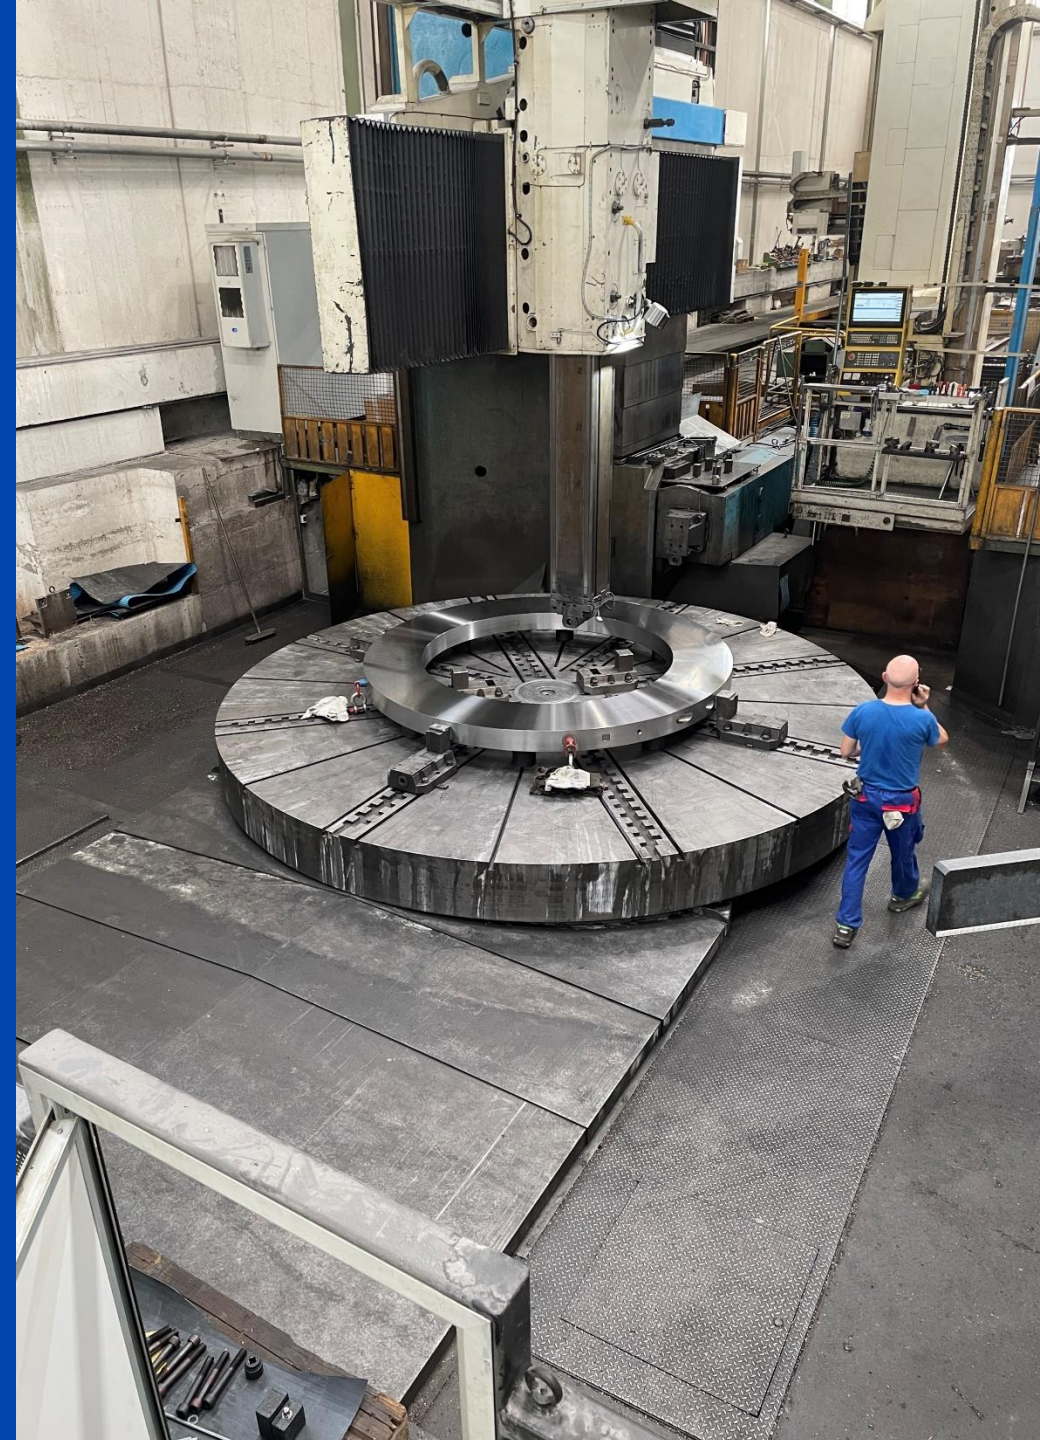
- Original spare thrust runner not acceptable
- Original cast thrust runner refurbishment found to be unfeasible due to thin hardened "chill layer"
- New thrust runners are of forged steel
- Repeat challenges with quality assurance issues with new runners, mainly shipping & handling damage, environmental exposure

- New Thrust Runners
 - Rotate / clock runner on shaft so thrust runner split lines do not align with old location on thrust block with localized fretting corrosion
- Add High Pressure Oil Injection System (High-Lift)
- Optimized Bearing Spring Bed Distribution
- Polymer Bearing (PEEK)
 - Repair Timeline: One spare thrust runner and one spare set of re-babbitted bearing pads on hand. Interim repair completed on U54 right away, including spring bed modification. U51 sat out of service for about one year waiting manufacture of new bearing pad, thrust runner and high-pressure oil lift pump skid.

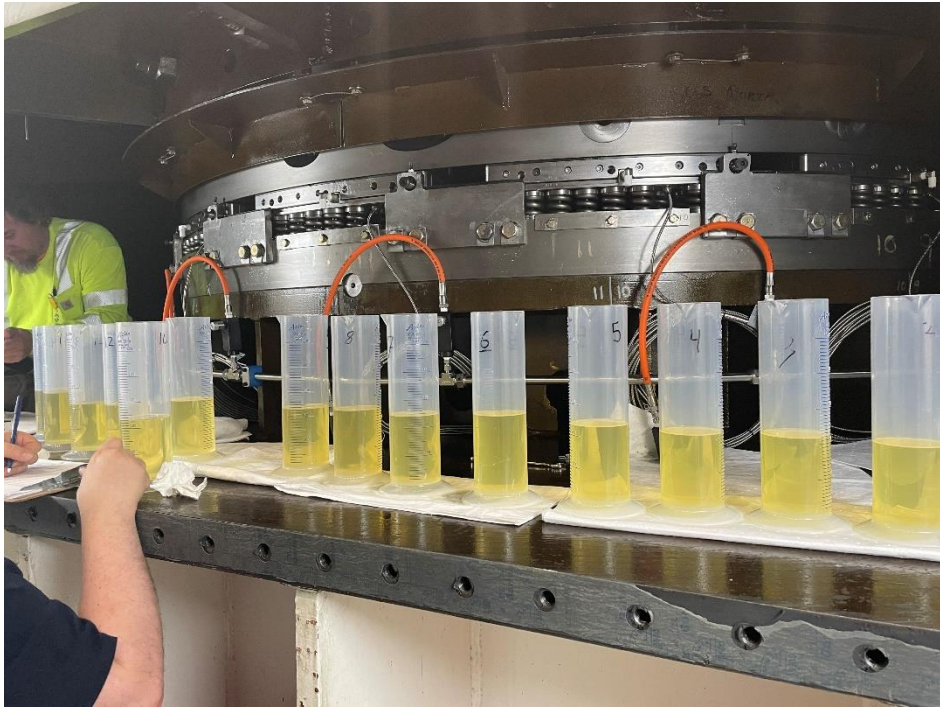
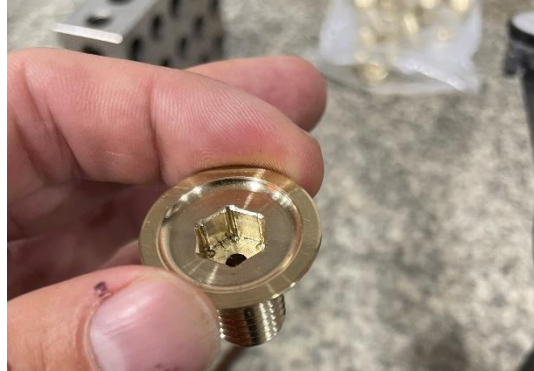
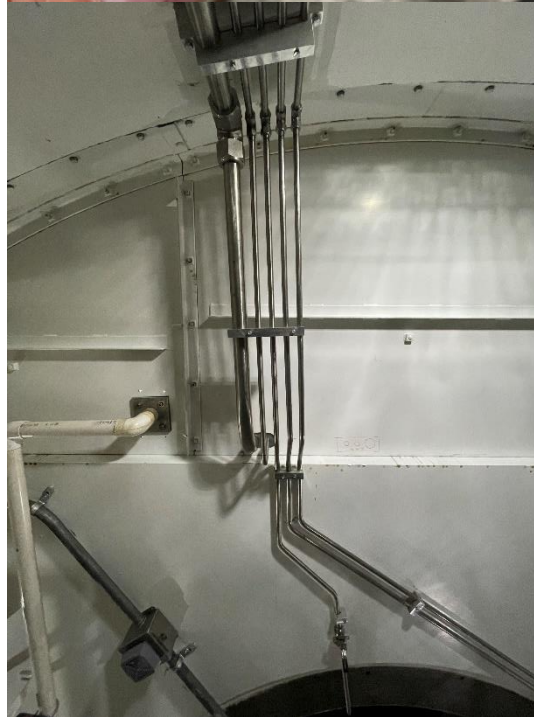
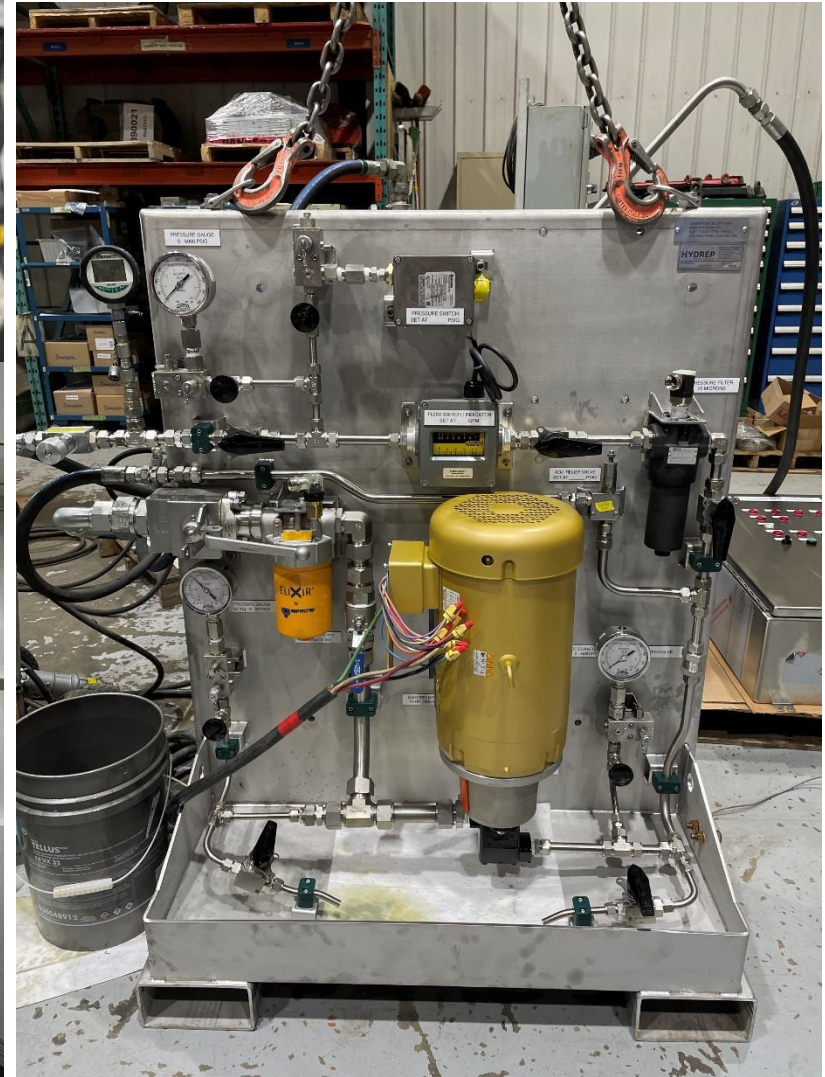
High-Pressure Oil Injection

- 2500 psi MAWP
- 10 HP Motor

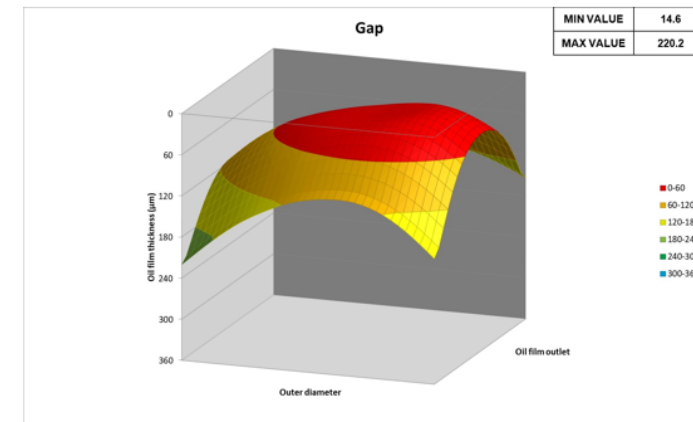
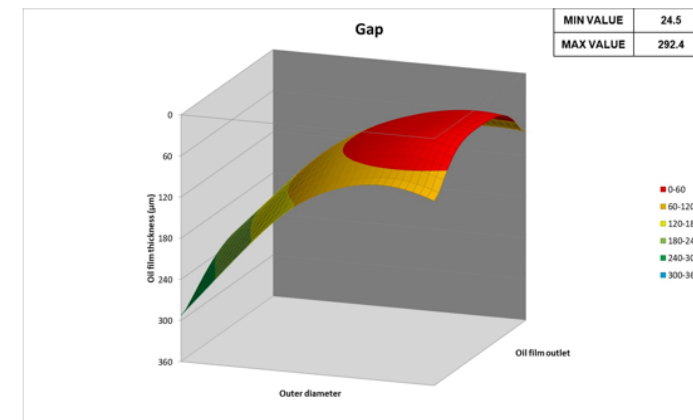
Oil film Gap

Main results

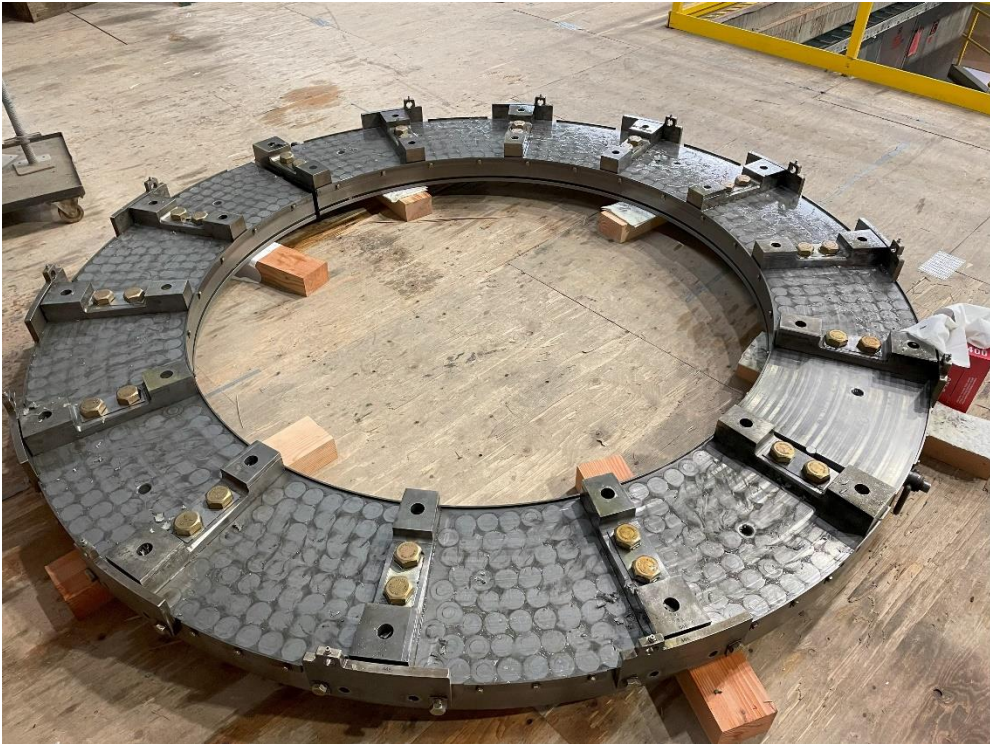
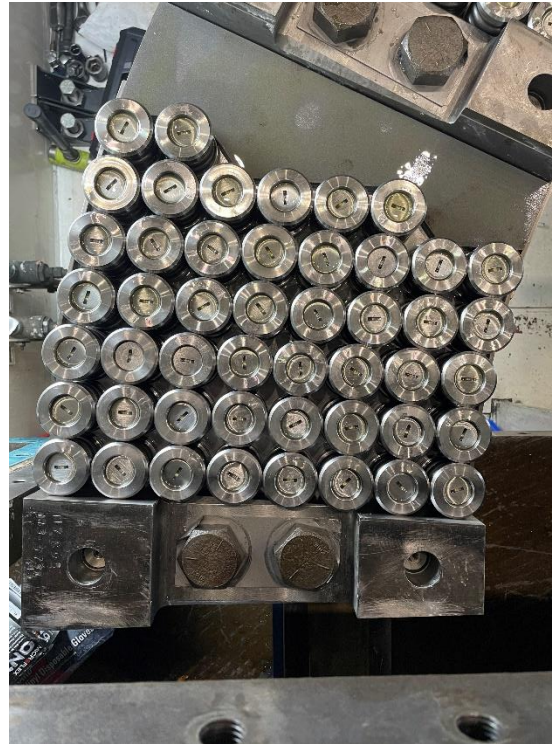
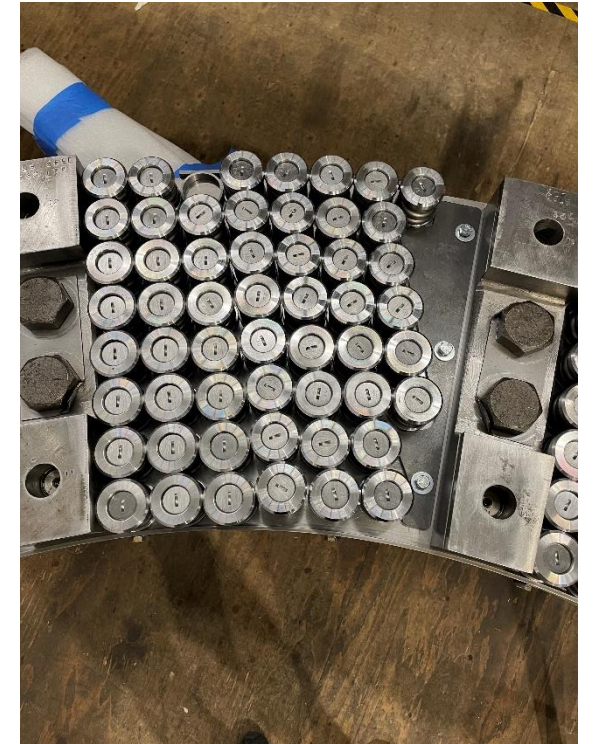
Optimized Spring Distribution (continued)

- Spring pattern can significantly affect the operating oil film thickness for spring supported thrust bearings
- G.E. self-equalizing thrust bearing membrane technology retrofit was not feasible due to constraints in elevation / overall height of bearing

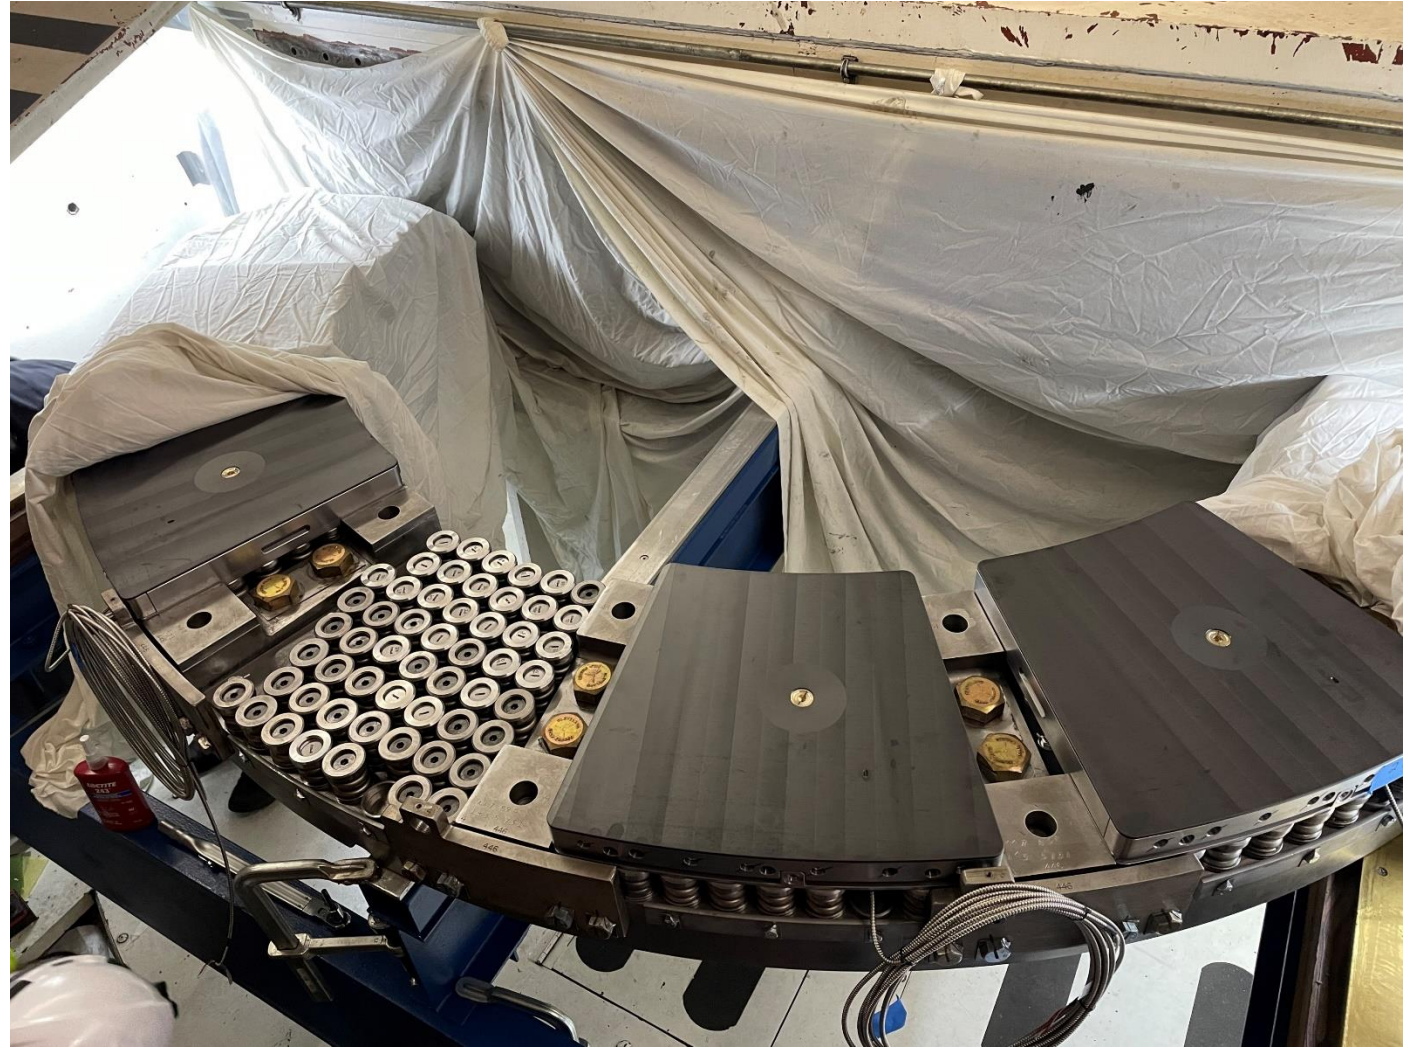
PEEK Bearing (Polyether ether ketone)

Victrex TDS 450FC30

Highly Loaded Bearing Proven at
Porjus Hydro Power Station in
Northern Sweden

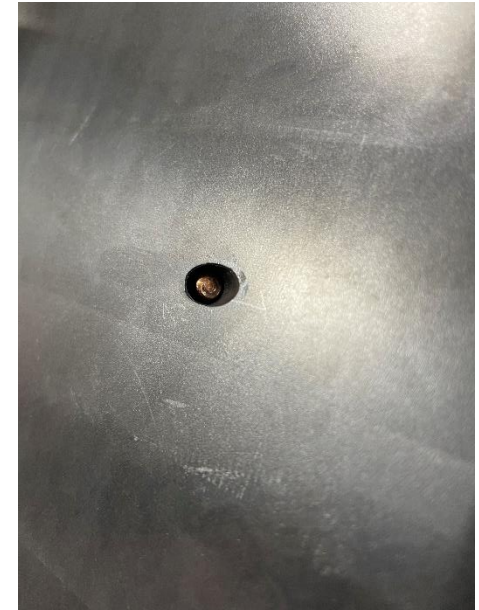
PEEK Bearing Benefits

- Increased Safety Margin Benefits Compared to Babbitt
 - Higher temperature operations
 - Higher specific loads and speeds → Shown to operate safely at specific pressures above 1450 psi (10 MPa)

- Reduced friction
 - Reduced thermal deformations (crowning) due to thermally insulating and elastic properties → more uniformly distributed hydrodynamic pressure profile reducing pressure peaks within oil film

- Lower wear rate by an order of magnitude
 - Proved to be more forgiving without a catastrophic failure mode
 - Increased allowable thrust runner surface finish → 32 μ in max. vs. 16 μ in max.

- Ease of replacement of PEEK insert
- Challenges
 - RTD installation with spring bed. RTD now measures oil film temperature vs. temperature of metal base. G.E. design on a new bearing would use thermocouples.

- Polymers do not give off elemental signature for oil analysis. Instead, rely on particle count and oil filter analysis for oil/bearing health indicator
