STRUCTURAL BUILDING COMPONENTS™

March 2014

Perfect Form

Long Span Trusses

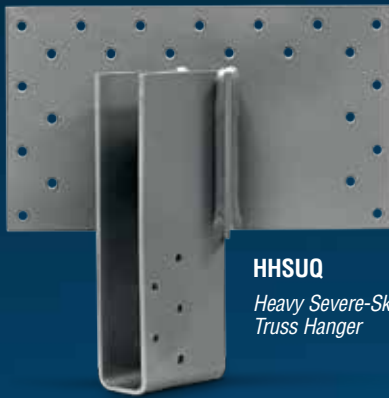
HHSUQ
*Heavy Severe-Skew
Truss Hanger*

You requested it. We delivered. Introducing three new high-capacity truss hangers that easily install with our Strong-Drive® SDS structural screws. Until recently, these types of welded hangers were custom orders, now they're part of our standard catalog offering. Engineered and tested to perform with multi-ply trusses, the HHSUQ, HTHGQ and HTHMQ are available in several options to fit your specific truss needs.

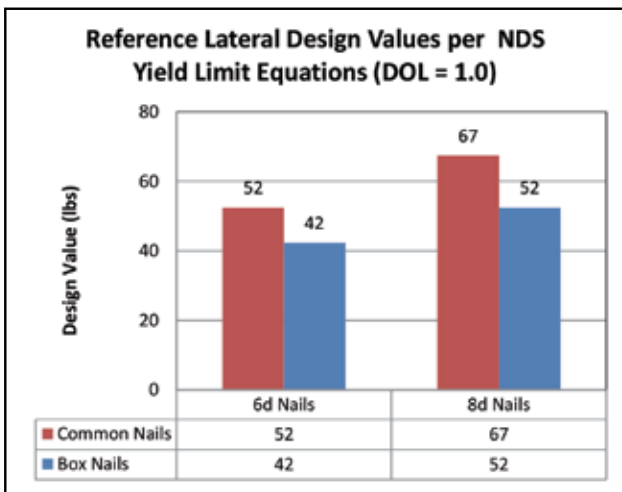
Figure 1. Comparison of 6d and 8d Box and Common Nails.
(Note: Calculations were performed in accordance with the yield limit equations in *NDS* Table 11.3.1A. Yield mode III_s controls.)

Using the *National Design Specification (NDS)* yield limit equations for dowel-type fasteners, the lateral load resistance for $7/16$ " OSB sheathing fastened to an SPF framing member drops by 19 percent and 22 percent when 6d and 8d galvanized box nails are used instead of 6d and 8d common nails, respectively.

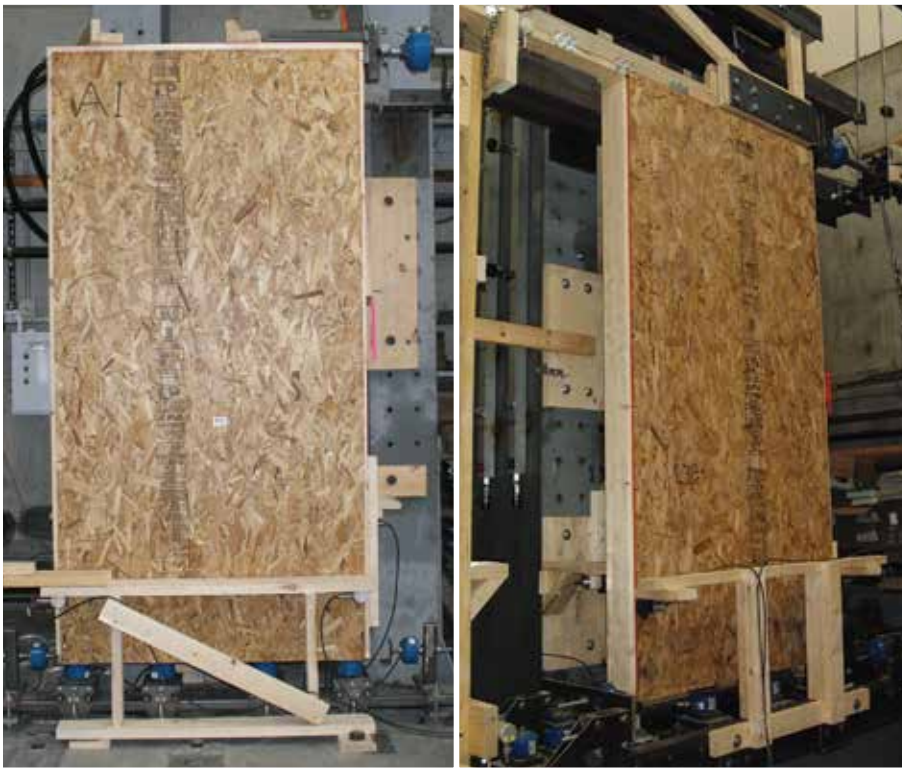
Figure 2. Single Panel Wall Testing: The results from these two single panel wall test setups were compared to ensure they produce similar results.

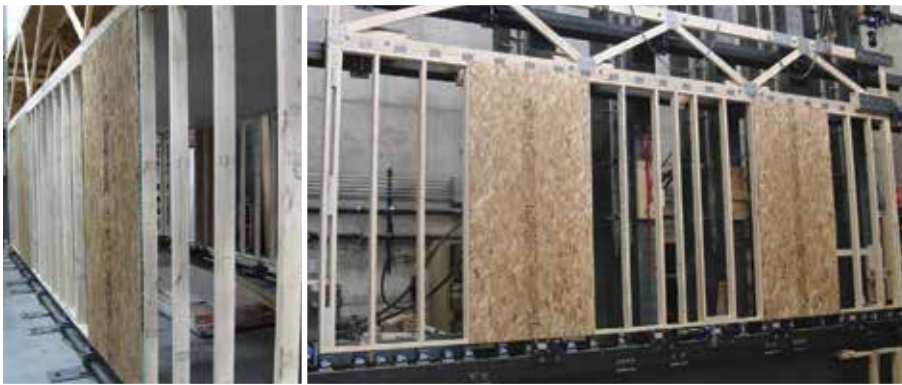
Figure 3. Isolated 4x8 Wall Testing: The results from the 12' x 30' building tests were compared to the new SBCRI lateral wall station with truss framing tests to ensure they produce similar results.

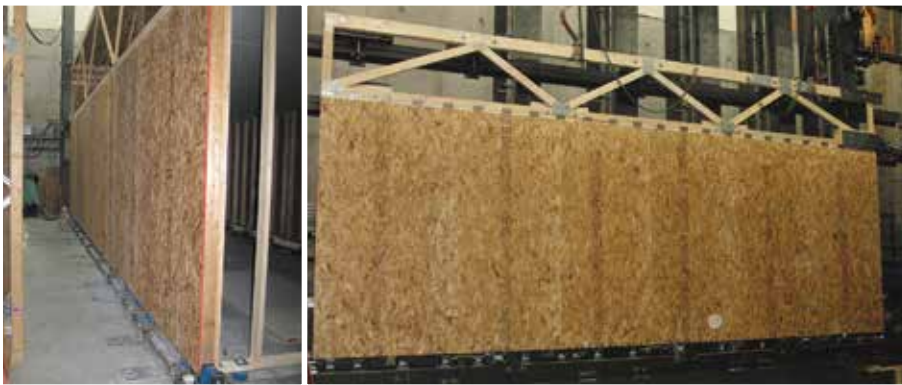
Figure 4. Fully Sheathed Wall Testing: The results from the 12' x 30' full building lateral wall with a full set of roof trusses test were compared to the lateral wall station with truss framing tests to ensure they produce similar results.

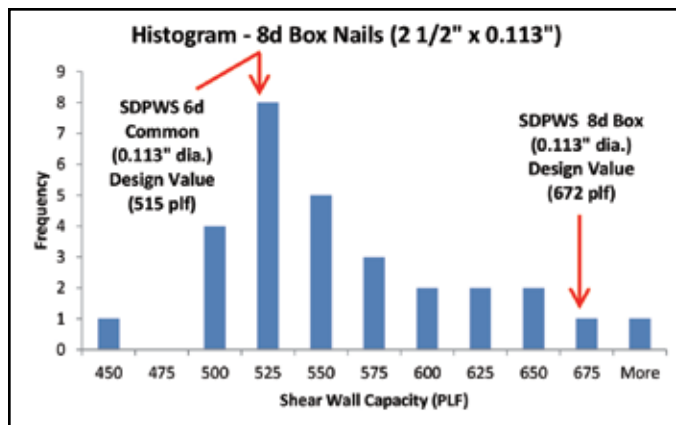
Figure 5. Histogram of Tested Shear Wall Capacity for 8d Box (2-3/8" x 0.113") Nails. (Per *SDPWS*, 3/8" WSP with SPF framing 16" o.c. has a design value of 515 plf for 6d common [2" x 0.113"] nails and 672 plf for 8d box [2-1/2" x 0.113"] nails.)

Of the 29 SBCRI shear wall tests with the 8d box (2-3/8" x 0.113") nails, only one test met the published *SDPWS* nominal unit shear capacity of 672 plf (see Figure 5).

However, as shown in Figure 5, the nominal unit shear capacity for the 8d galvanized box (2-3/8" x 0.113") nail has a median value between 500 and 525 plf, about 150 plf less than the design value given in *SDPWS*.

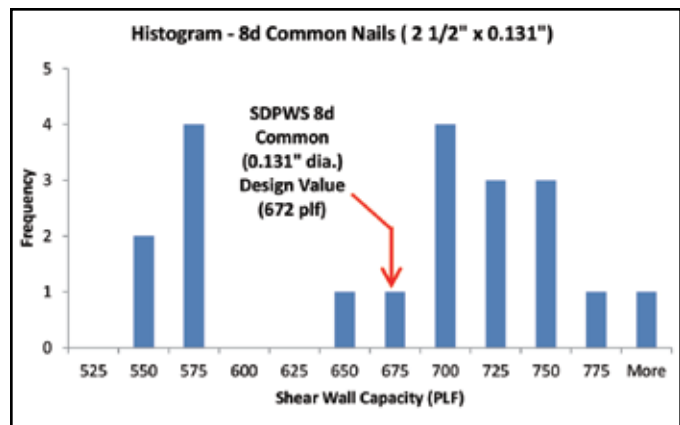
Figure 6. Histogram of Tested Shear Wall Tests for 8d Common (2-1/2" x 0.131") Nails. (Per *SDPWS*, 3/8" to 15/32" WSP with SPF framing 16" o.c. has a design value of 672 plf for 8d common [2-1/2" x 0.131"] nails.)

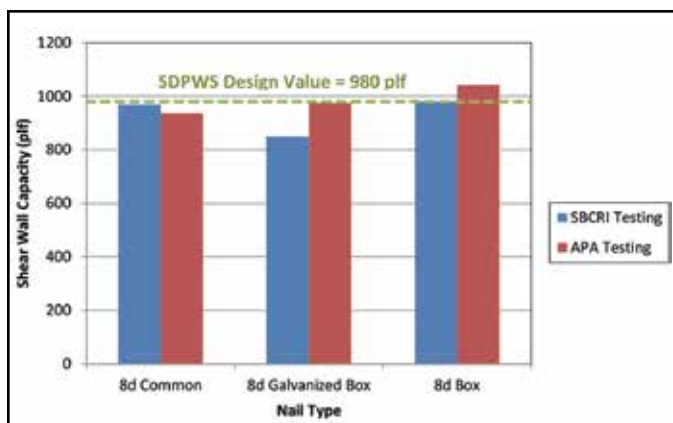
Figure 7. Bar Chart of Tested Shear Wall Capacity for 8d Common (2-1/2" x 0.131") and 8d Box (2-3/8" x 0.113") Nails. (Per *SDPWS*, 7/16" WSP with DF framing 24" o.c. or SPF framing 16" o.c. has a design value of 980 plf.)

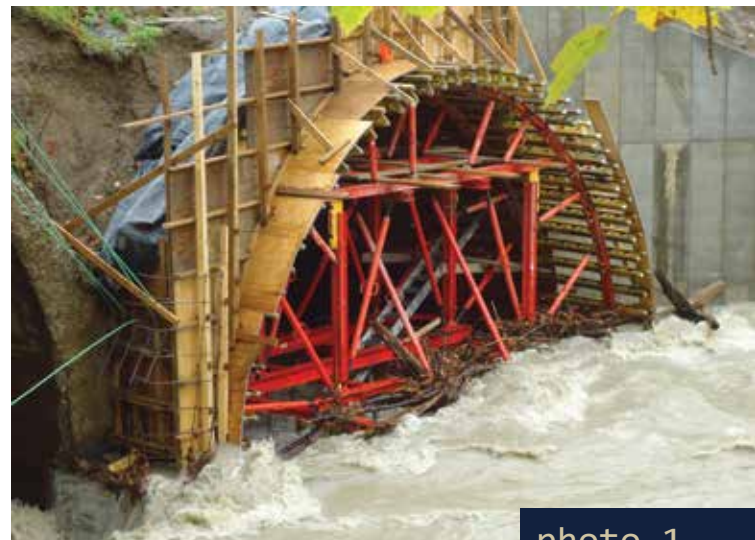
photo.1

1. Original formwork for the project was made out of heavy-gauge steel.
2. Torrential rain from Superstorm Sandy washed the steel form from the tunnel.

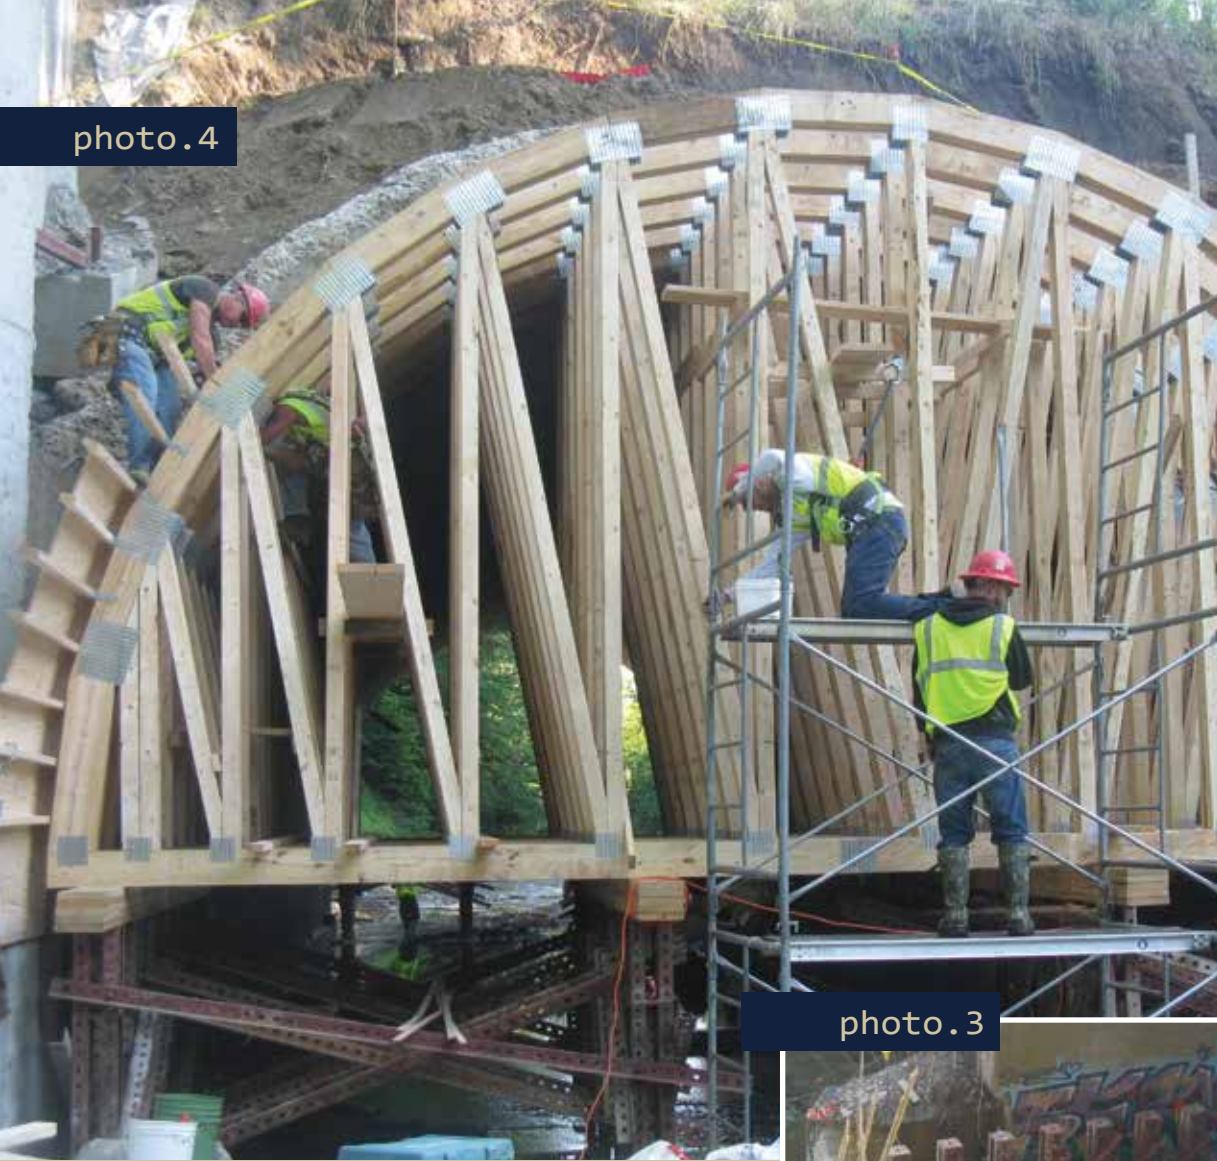
photo.5

3. A platform of steel jacks were an integral part of the installation
 4 & 5. The jacks provided four bearing locations for the truss assembly along their 28-foot length.

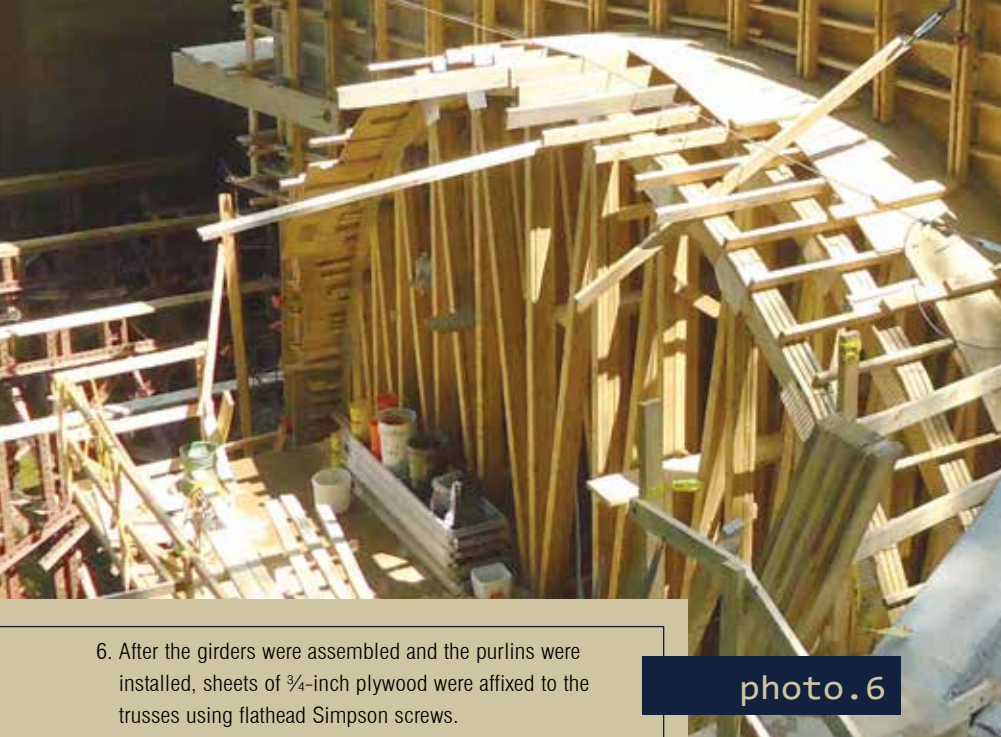
photo.6

6. After the girders were assembled and the purlins were installed, sheets of 3/4-inch plywood were affixed to the trusses using flathead Simpson screws.

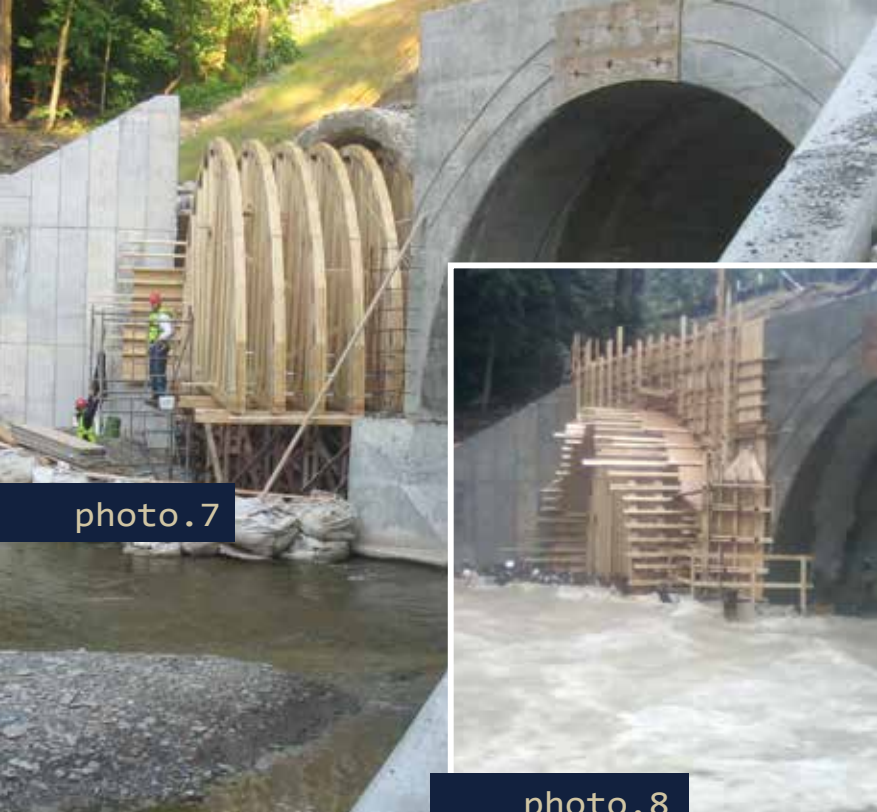
photo . 7

In fact, the most nerve-racking moments of the entire project had nothing to do with concrete, but with water. Normally, Walnut Creek is a pretty calm waterway (see Photo 7), but heavy rains came again, raising the water level and current strength, which threatened to wash the wood structure down the river, much as it had the steel structure earlier (see Photo 8). Fortunately, the form held and work was able to continue once the waters receded.

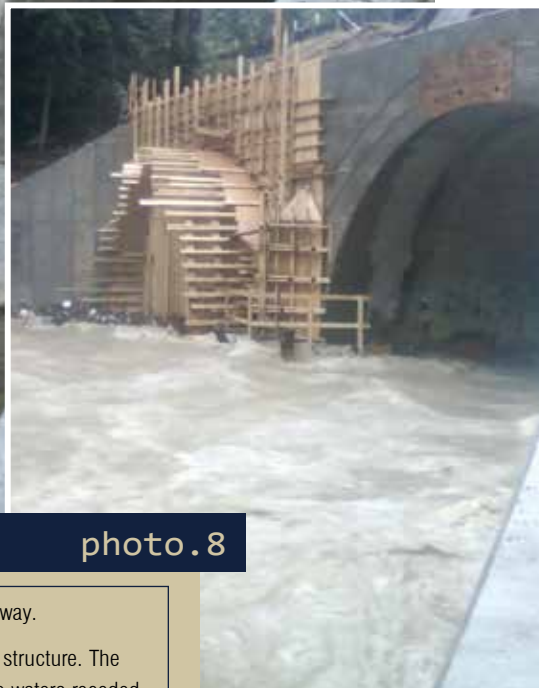
photo . 8

- 7. Walnut Creek is typically a calm waterway.
- 8. Heavy rains threatened the wood form structure. The form held and work continued after the waters receded.

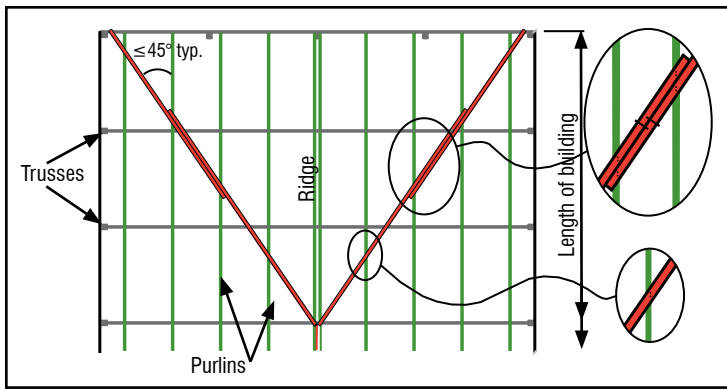
Figure 3. Top Chord Diagonal Bracing Using 2x4 Lumber (from Step 3 of B10)
