# Data and Methods for Estimating the Severity of Minor Impacts

Mark N. Bailey, Bing C. Wong, and Jonathan M. Lawrence  
Maclinnis Engineering Associates Ltd.

## ABSTRACT

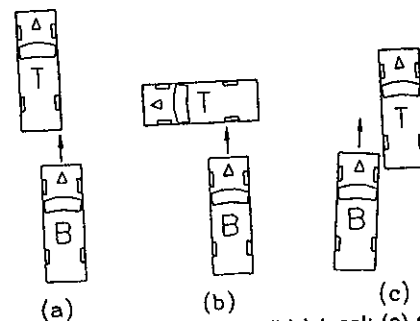
Figure 1. (a) rear and front-end; (b) lateral; (c) side-swipe  
For any of the four types of collisions, the usual question put to investigators is:  
*Are individuals who have experienced an apparently minor collision at risk of injury?*

Four types of "minor" collisions frequently occur. These are rear-end, front-end, lateral, and side-swipe, (Figure 1). Our previous work has concentrated on bumper properties and their relevance to "minor" rear-end impacts<sup>1,3</sup>. The term "minor" is used to describe impacts where tire forces and/or restitution effects cannot be ignored. It is not used to reference vehicle damage or occupant symptoms.

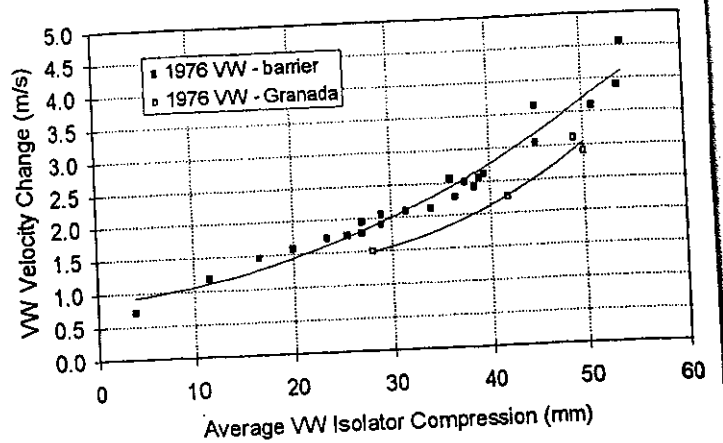
Figure 7. Average isolator compression, barrier and vehicle-to-vehicle impacts.

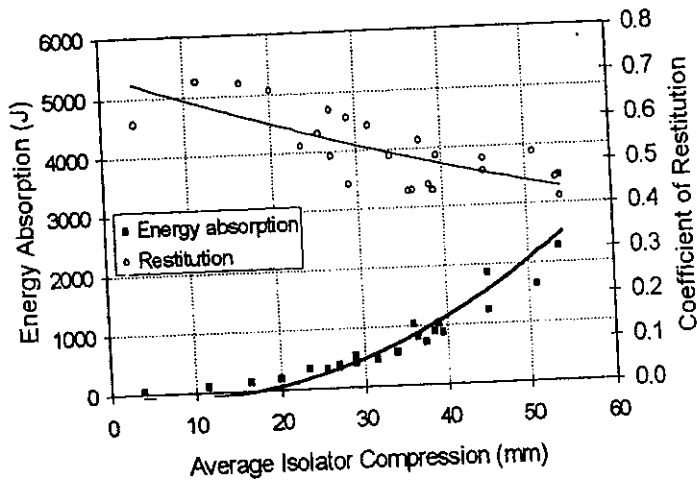
Figure 8. VW rear vehicle-to-barrier data.

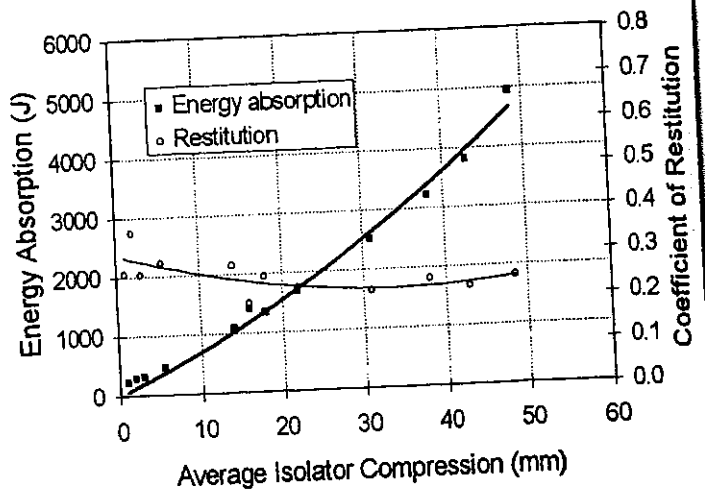
Figure 9. Granada front vehicle-to-barrier data.

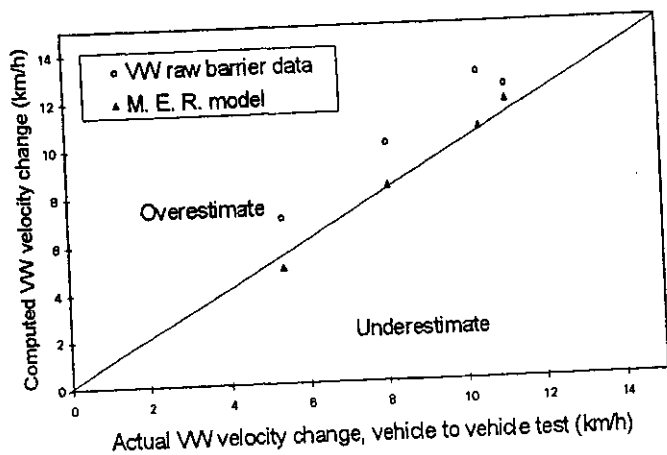
Figure 10. Actual and computed  $\Delta V$ , vehicle-to-vehicle impacts.

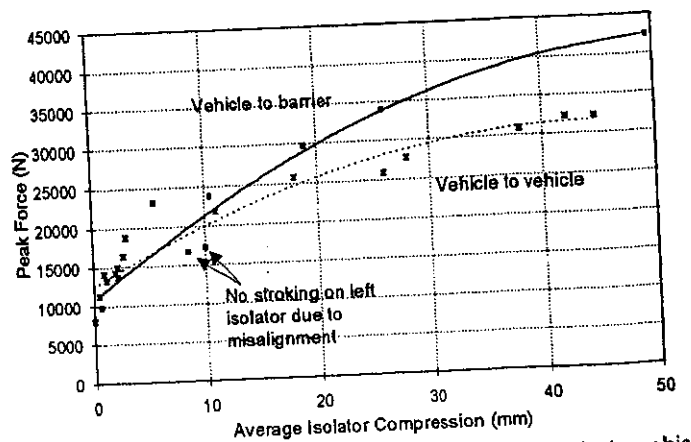
Figure 11. Escort front vehicle-to-barrier and vehicle-to-vehicle data.

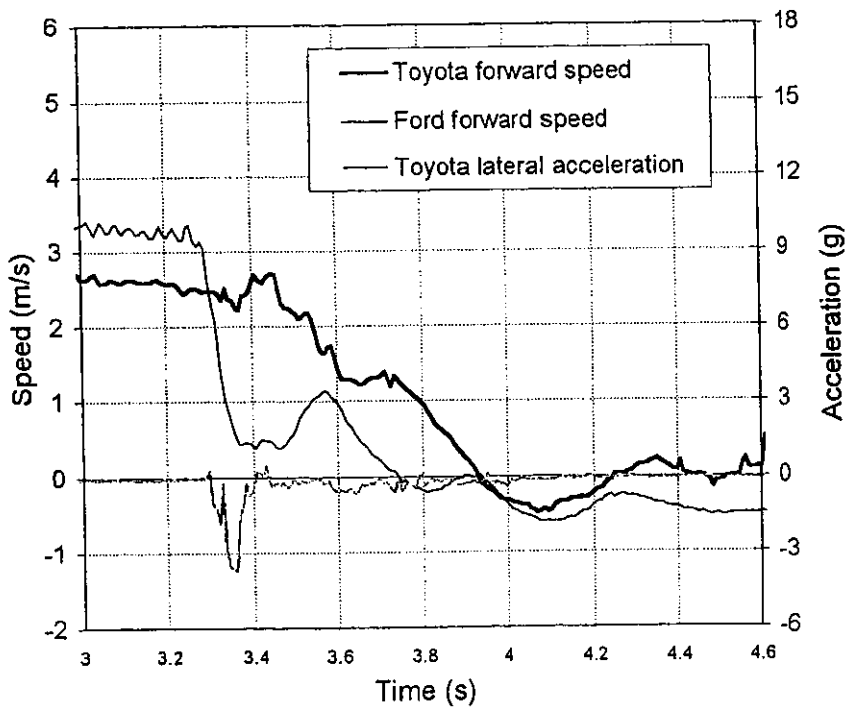
Figure 20. Speed and acceleration for test 2. New damage to right front door. Old damage to right fender from test 1.

In Test 2 there was a 95 cm long contact mark on the right front door that reached a maximum depth of 9 cm. The right front window was rolled down prior to the impact, and shattered as a result of the impact. Even though the window was down, glass fragments were found inside and outside the vehicle. The impact changed the Toyota's heading by 10° clockwise. This rotation was the opposite direction from the previous test because the impact force was directed aft of the Toyota centre of mass. Figure 20 shows the Ford initial speed was approximately 11.5 km/h and its  $\Delta V$  was approximately 7.2 km/h. The Toyota was initially moving forward at approximately 9 km/h and slowed to zero in about 800 ms, an average deceleration of about 0.32g. The Toyota lateral acceleration peaked at about 4g. The lateral  $\Delta V$  was estimated to be approximately 6.2 km/h using equations 10 to 13. The total change in kinetic energy was approximately 3895 Joules.

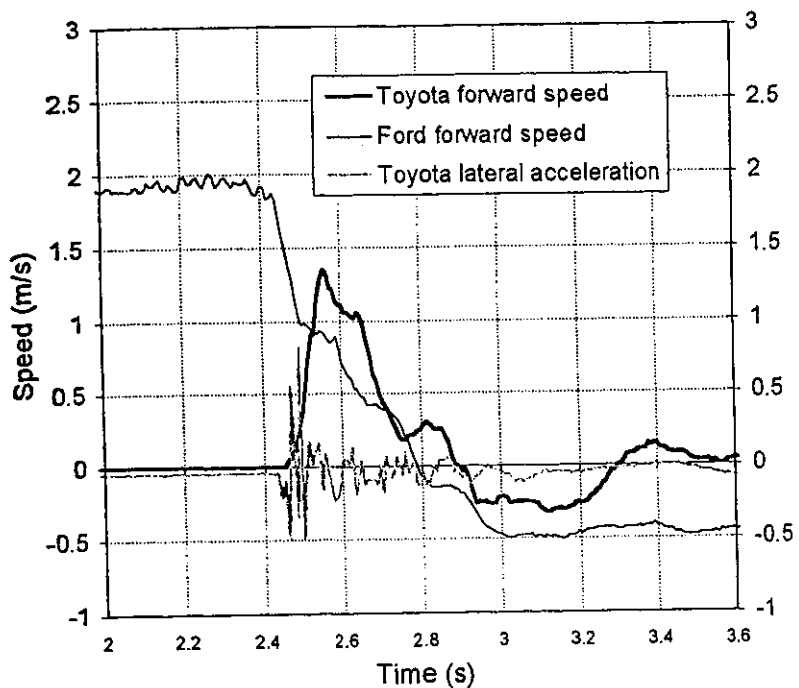
Figure 21. Speed and acceleration for test 3. Additional damage to lower right front door. Same area was damaged in test 2.

In Tests 3 and 4 the target Toyota was stationary and the impact was concentrated over the right doors and B-pillar. Some of the damage was superimposed over damage from test 2. In Test 3 (Figure 21) there was very slight crush to the B-pillar and a small lateral displacement. The Ford frontal  $\Delta V$  was 3.5 km/h. The Toyota lateral acceleration had several peaks of less than 1g with pulse widths less than 20 ms. In the more severe Test 4 (Figure 22) there was approximately 40 mm of crush to the B-pillar, the front and rear axles moved sideways 280 and 500 mm, and there was bumper contact across both right side doors. The Ford frontal  $\Delta V$  was 5.4 km/h. The

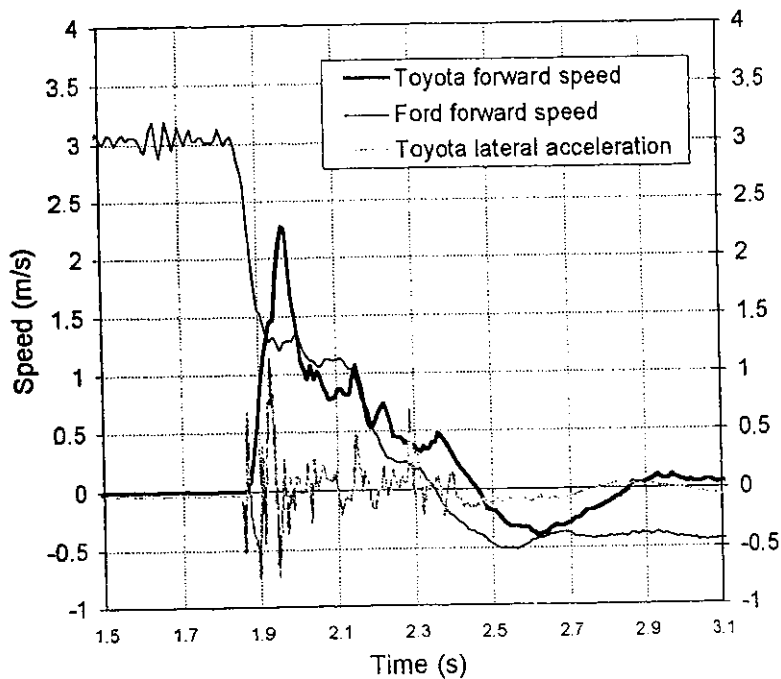
Figure 22. Speed and acceleration for test 4. Damage right rear door and B-pillar.

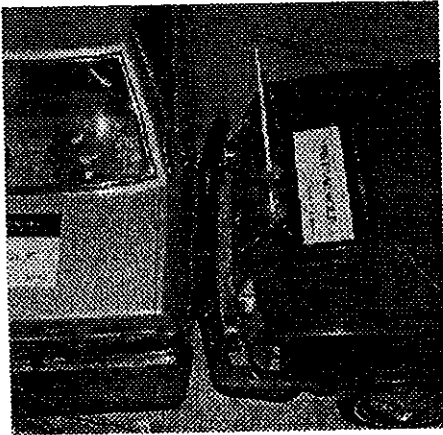
Figure 23. Vehicle engagement in tests 18 to 21.

In Tests 18 to 21. The vehicles were aligned at 90°, with the left front corner of the Ford aligned with the right rear corner of the Toyota (Figure 23).

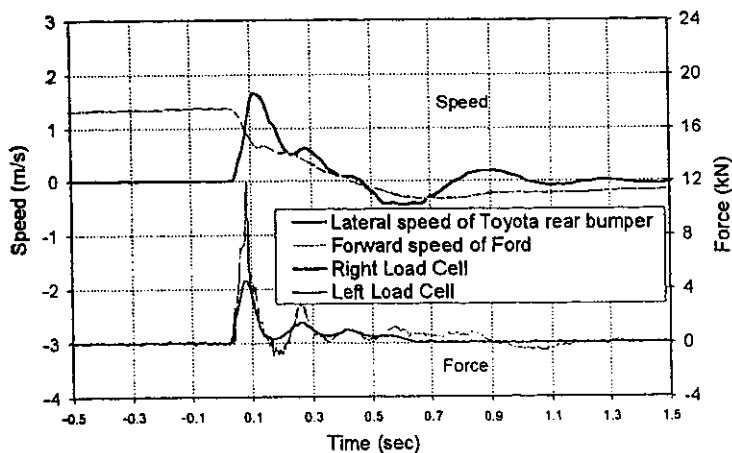
Figure 25. Speed and force data, test 19. Damage shown at right.

Dent in quarter panel, 200 mm diameter, 18 mm maximum depth.

In Test 19 the engagement was identical to Test 18, but the closing speed was higher. The dent was at the same location on the target Toyota, only it was 200 mm in diameter and 18 mm deep at the centre and centred 301 cm from the front axle. There was also a small scrape on the rear of the right rear wheel arch of the Toyota from the bumper of the Ford. Neither of the Ford isolators compressed. The rear bumper of the target vehicle displaced sideways 19 cm relative to the ground. Figure 25 shows that the closing speed of the bullet Ford was approximately 1.4 m/s. After the first 100 ms the force between the vehicles dropped to zero. Unlike the previous test, the target vehicle slid sideways, so the bullet rolled ahead until it contacted it a second time and decelerated with it, but with very little force between the vehicles. Eventually the bullet vehicle disengaged and rolled away backwards. The  $\Delta V$ 's at the Ford and Toyota centres of mass were approximately 0.8 and 0.5 m/s and the change in kinetic energy pre- and post-impact was approximately 438 Joules. 321 Joules were accounted for by the sliding tires, and the remaining 116 Joules were associated with the damage to the Toyota. The roof-top acceleration had a 2.3g peak with a 12 ms pulse width above a background of lower peaks that lasted a total of 100 ms.

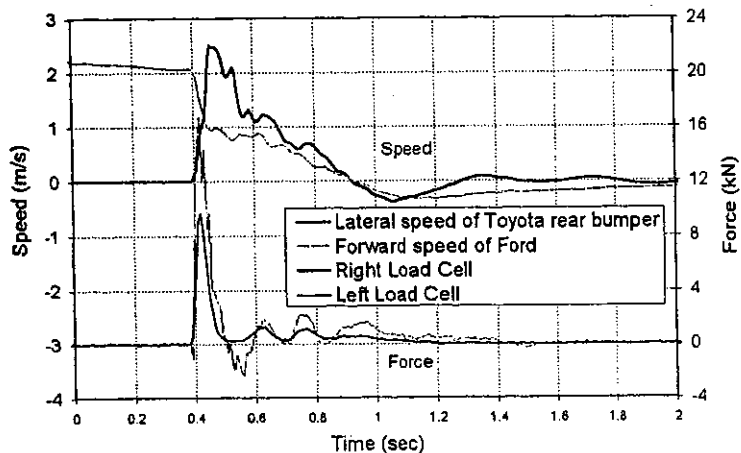
Figure 26. Speed and force data for test 20. Damage shown at right.

Dent in quarter panel 11 cm farther forward than test 19, plus small dent in wheel arch leading edge.

In Test 20 the alignment was similar to the two previous tests, but the closing speed was high enough to cause 2 and 13 mm compression on the left and right Ford isolators. The target Toyota rear bumper moved 45 cm sideways relative to the ground. The front axle did not move sideways. The portion of the right quarter panel that was hit in the previous test was hit again in this test, causing the dent to increase in size. The dent was centred 290 cm from the front axle (11 cm closer). There was some new damage ahead of the target Toyota right rear wheel arch that was 6 cm in height, 4 cm in length and approximately 1 cm in depth. Figure 26 shows that the dynamics were similar to the previous test. The impact lasted approximately 100 ms, then the force between the vehicles dropped to near zero and then the vehicles decelerated in unison. The peak force at the bumper of the bullet was approximately 25 kN for an average isolator compression of 7.5 mm (front-end vehicle-to-barrier impact: peak force=24 kN, isolator compression=7.5 mm). The change in kinetic energy pre- and post-impact was approximately 1092 Joules. 569 Joules were associated with isolator compression and work done by the sliding tires, and 523 were associated with the Toyota damage. The top accelerometer measured a 3.5g peak with pulse duration of 10 ms above a background of lower peaks.

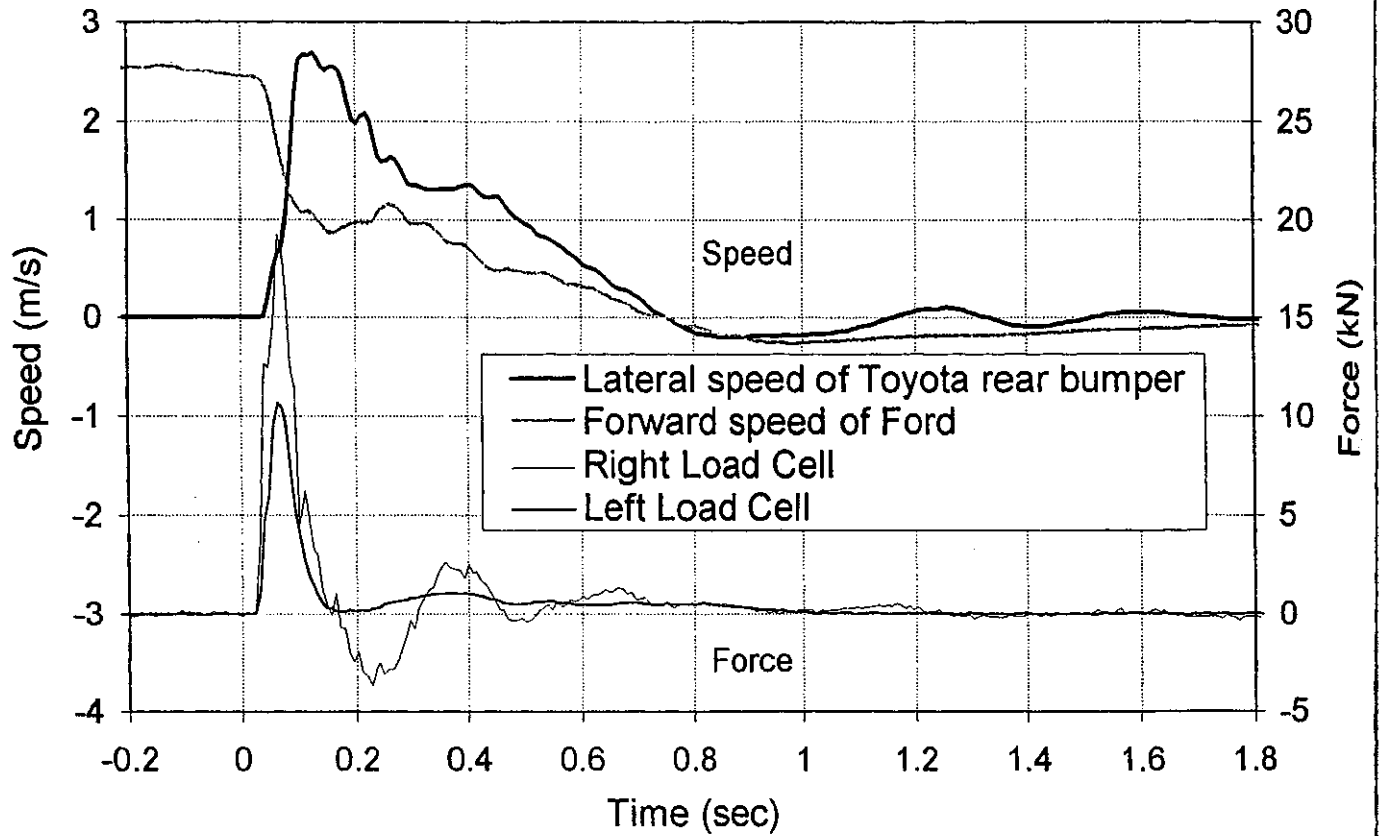
Figure 27 (a). Speed and force data for test 21.

In Test 21 the alignment was similar to the three previous tests, but the bullet Ford was slightly more forward. The impact speed was 8.6 km/h. On the Toyota there was a 16 cm long dent in the rear door approximately 20 mm deep. There was a black scuff in the dent that went forward and downward. It was caused by the motion of the Toyota relative to the Ford, which was upward and backward. The dent in the Toyota right rear wheel arch had doubled in depth to 2 cm. There was 7 and 20 mm compression on the left and right Ford isolators. The target Toyota rear bumper moved 79 cm sideways relative to the ground and the front axle did not move. Figure 27 (a) shows that the dynamics are again similar to the previous tests. The change in kinetic energy pre- and post-impact was approximately 1638 Joules. The energy absorption associated with the 13.5 mm average compression is 460 Joules. 733 Joules were associated with the Toyota damage. The top accelerometer measured a 4g peak with a 110 ms pulse width (Figure 27 (b)).

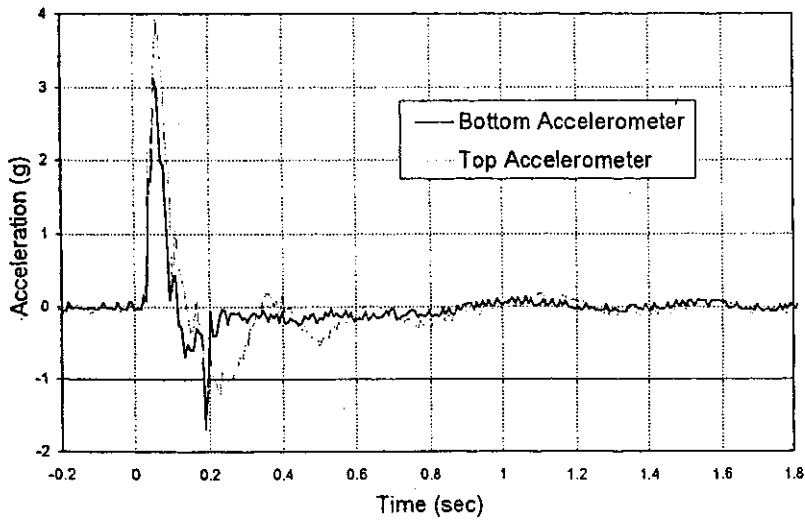
Figure 27 (b). Acceleration at transmission tunnel and roof for test 21. Damage shown at right.

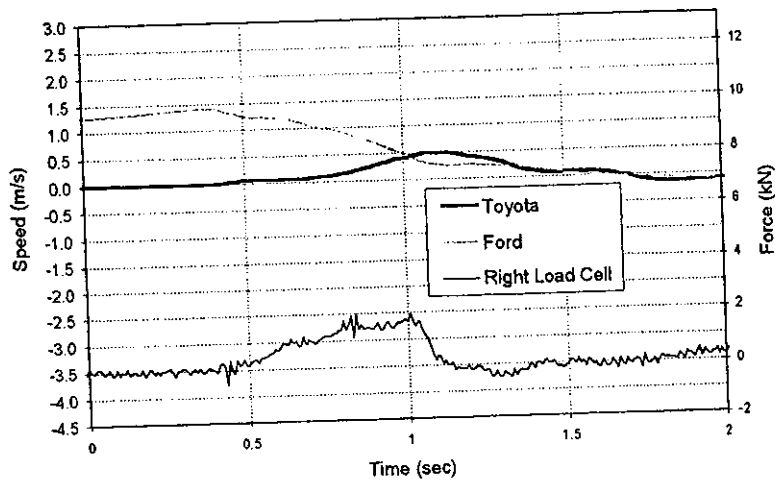
Figure 33. Speed and force for test 23. Damage at right.

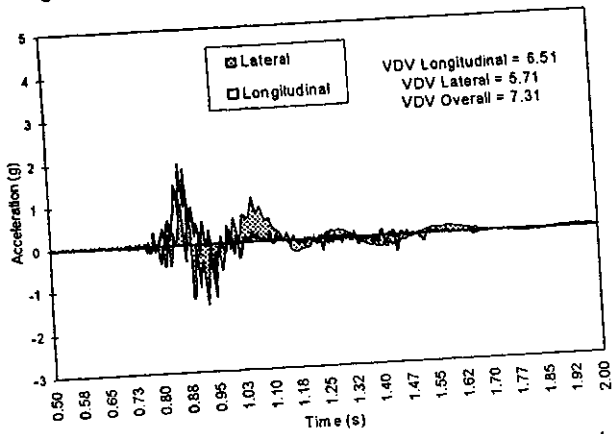
Figure 36. Acceleration for test SS10. Damage at right.

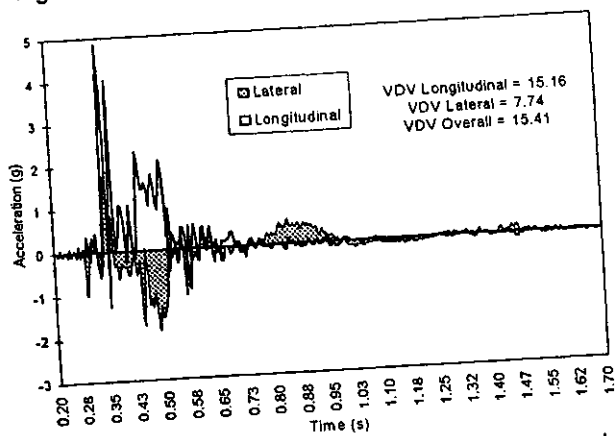
Figure 37. Acceleration for test SS11. Damage at right.

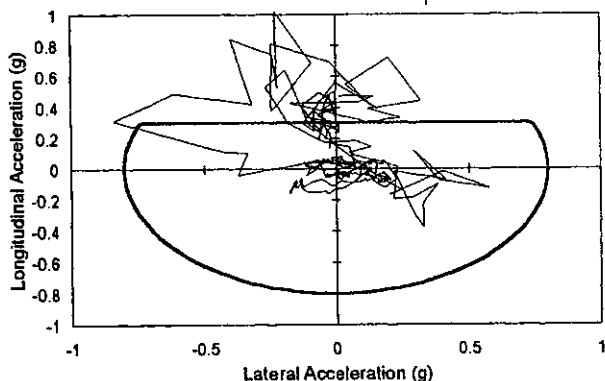
Figure 43. Accelerations in test 12 compared to driving maneuver envelope.

Where there was no snagging, much of the disturbance was within what the car could experience during driving. Figure 43 shows the acceleration data from test 12, where there was a shallow door crease and no snagging, superimposed on the traction envelope<sup>22</sup> for 0.8g (corresponding to dry pavement and an average forward acceleration capability of 0.3g).
