**2003-01-0492**

# **Practical Analysis Methodology for Low Speed Vehicle Collisions Involving Vehicles with Modern Bumper Systems**

**Andrew J. Happer, Mark C. Hughes, Michael D. Peck and Susanne M. Boehme**  
Sintra Engineering Inc.

**Reprinted From: Accident Reconstruction 2003  
(SP-1773/SP-1773CD)**

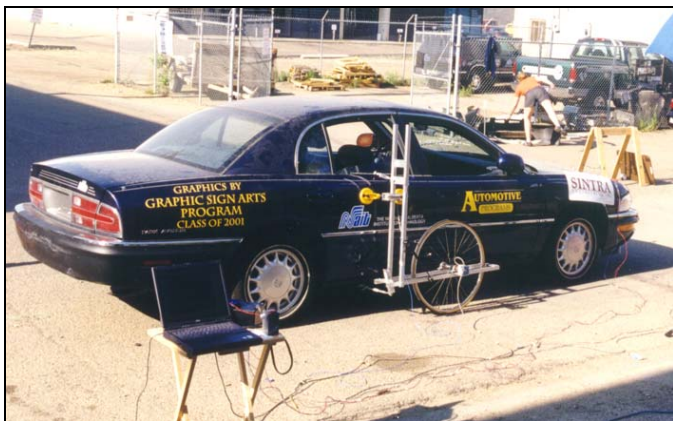
**Figure 1 – Sintra Engineering 5<sup>th</sup> Wheel Mounted to Buick Park Avenue for Vehicle-Vehicle Test**

wheel and aluminum frame assembly that was firmly attached to the test vehicles. A shaft encoder was mounted to each bicycle wheel axle that read pulses into a laptop data acquisition card. The encoder generated 1000 pulses per rotation of the bicycle wheel and produced a resolution of about 2 mm. These pulse counts were analyzed by customized software that calculated instantaneous vehicle velocity at a frequency of 50 Hz.

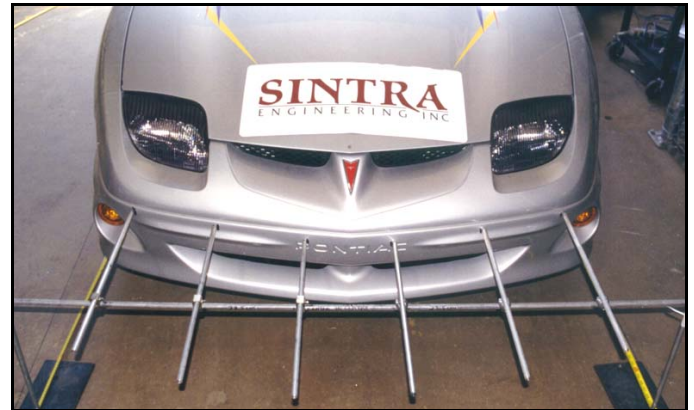
**Figure 2 - Measurement Jig Aligned with Pontiac Sunfire's Front Bumper**

Each impact test was documented by video and 35 mm camera photography. In addition, the extent of damage sustained by the involved vehicles was recorded. A customized measurement jig (Figure 2) was utilized to measure the pre-testing bumper geometries. After each test, the jig was used to measure the extent of bumper displacement with respect to the initial undamaged position; the distance of bumper displacement was measured in millimeters. This jig was used in all barrier tests but only for some of the vehicles during the

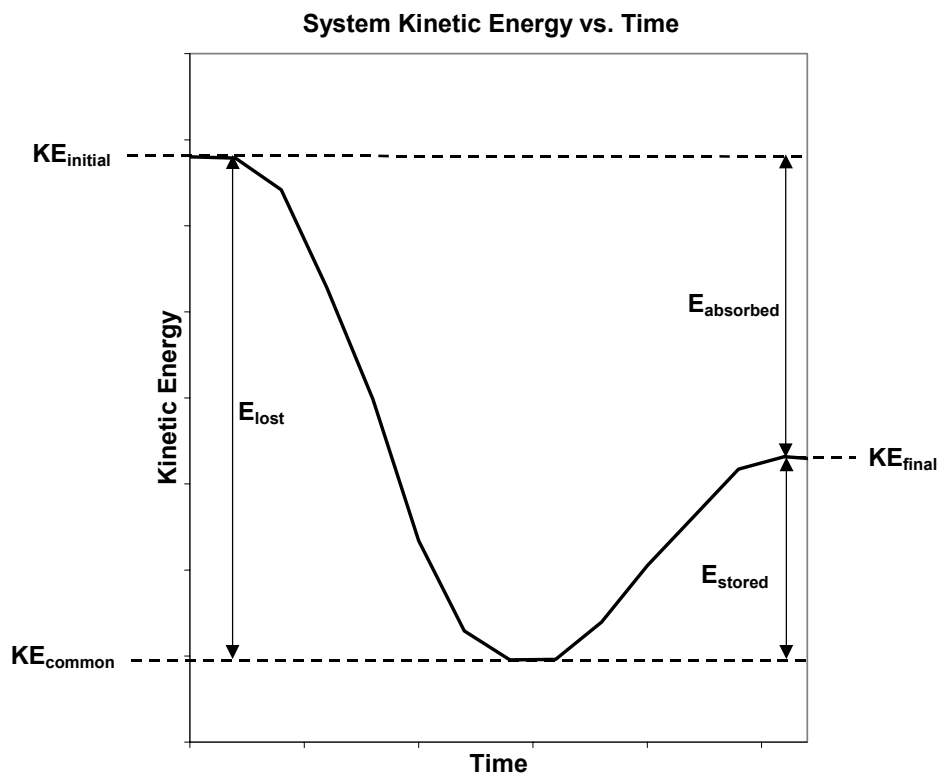
Figure A1 - Change in Kinetic Energy During a Collision

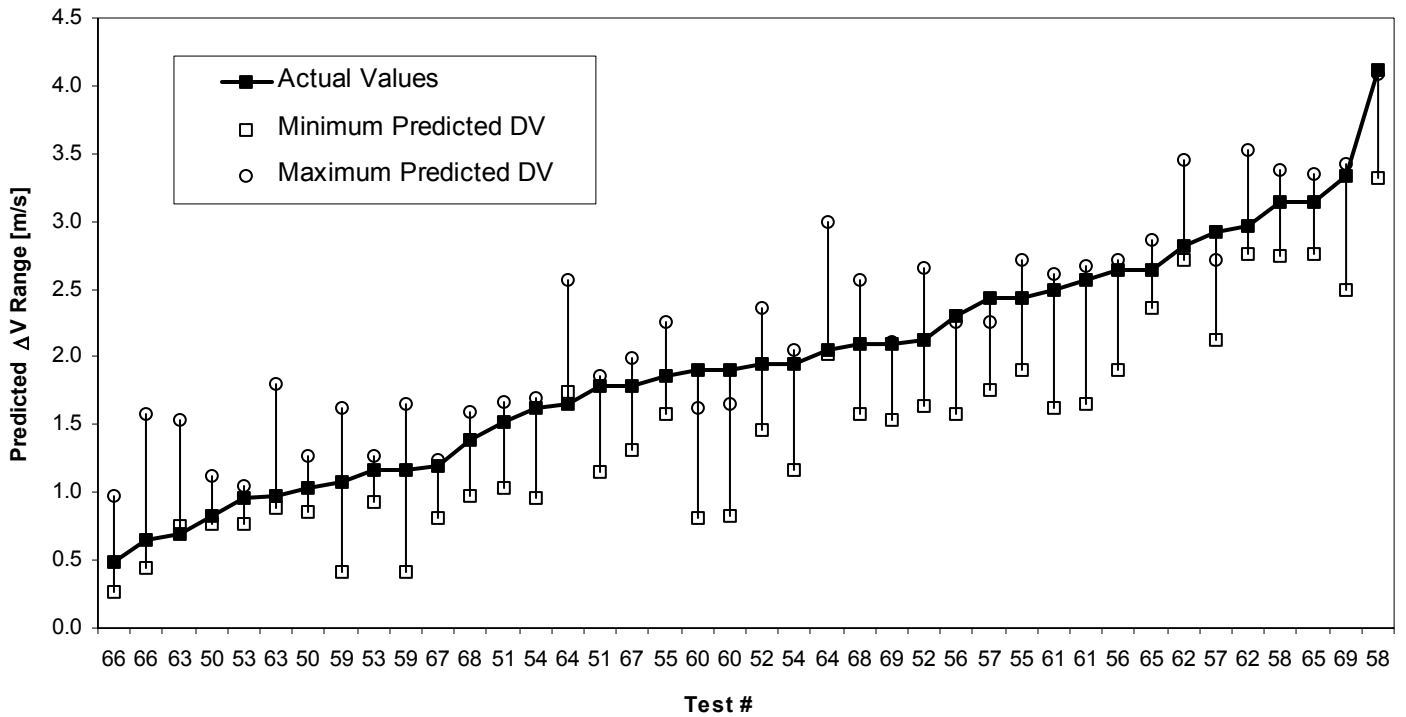
Predicted  $\Delta V$  Ranges vs. Actual  $\Delta V$  Comparison

Figure A5 – Predicted  $\Delta V$  Ranges Compared with Actual  $\Delta V$  Values Measured in Vehicle-Vehicle Collisions

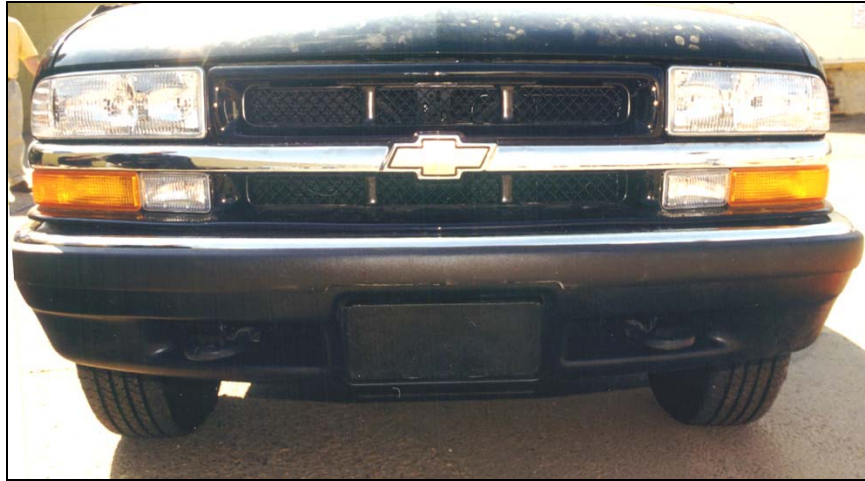
Photo D1 – Front of 1999 Chevrolet Blazer exhibits minor scuff marks on impact strip.

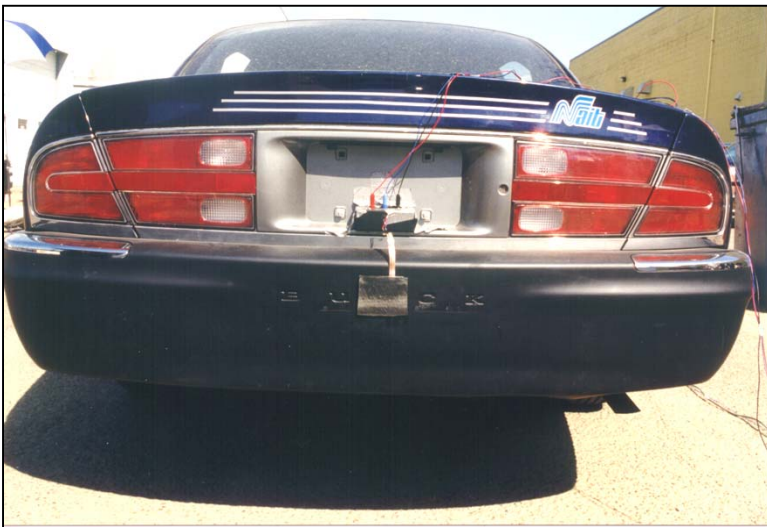
Photo D2 – Rear of 1998 Buick Park Avenue.

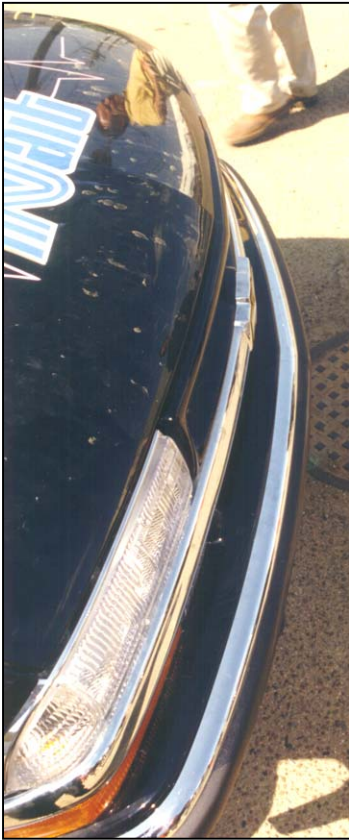
**Photo D4 – Front face bar of 1999 Chevrolet Blazer displaced rearward by 6 mm.**

In vehicle-vehicle Test #51, the Chevrolet Blazer's front face bar was displaced rearward by 6 mm and a left bumper mounting bolt was shifted (Photo D4). Similarly, in barrier Test #2, the Chevrolet Blazer's face bar exhibited an average displacement of 6 mm and mounting bolts on both sides were shifted about 2 mm. The centre of the face bar showed localized deformation during the barrier impacts that was not observed in the vehicle-vehicle testing. This damage was not observed during the tests with the Buick Park Avenue as the impact force was distributed more evenly over the front surface of the face bar during the vehicle-vehicle tests. Nonetheless, the 450 J absorbed by the Chevrolet Blazer during barrier Test #2 likely provides a lower limit.

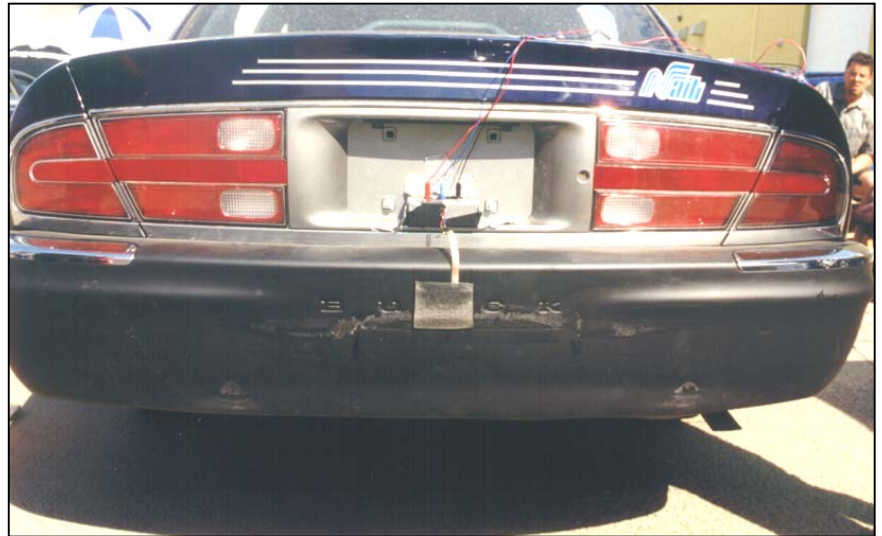
**Photo D5 – Rear of 1998 Buick Park Avenue exhibits scuff marks and tow hook imprints on bumper cover.**

During vehicle-vehicle Test #51, the Buick Park Avenue exhibited two localized regions with scuff marks on the rear surface of its bumper cover (Photo D5). These marks were from contact with the Chevrolet Blazer's tow hooks and this damage was not observed during the Buick's barrier tests. The Buick Park Avenue also exhibited longitudinal scuff marks on the top surface of its bumper cover that extended 21 mm from the trunk lid. In its lowest severity barrier impact (Test #17), the Buick Park Avenue absorbed 407 J but did not exhibit any damage. Thus, this energy value provides a lower limit to that absorbed by the Buick during vehicle-vehicle Test #51.

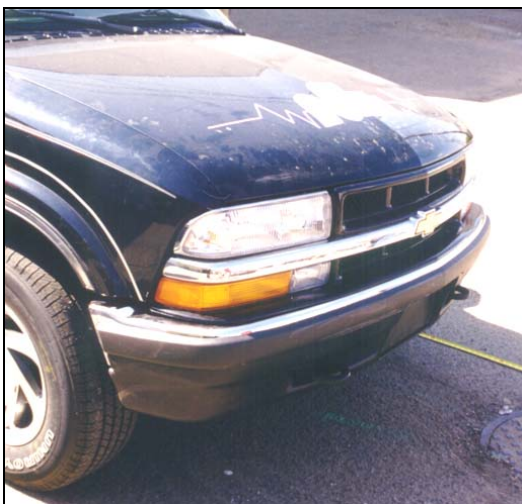
**Photo D6 – Front face bar of 1999 Chevrolet Blazer tilted downward and displaced rearward by 12 mm. Lower portion of face bar is also locally deformed.**

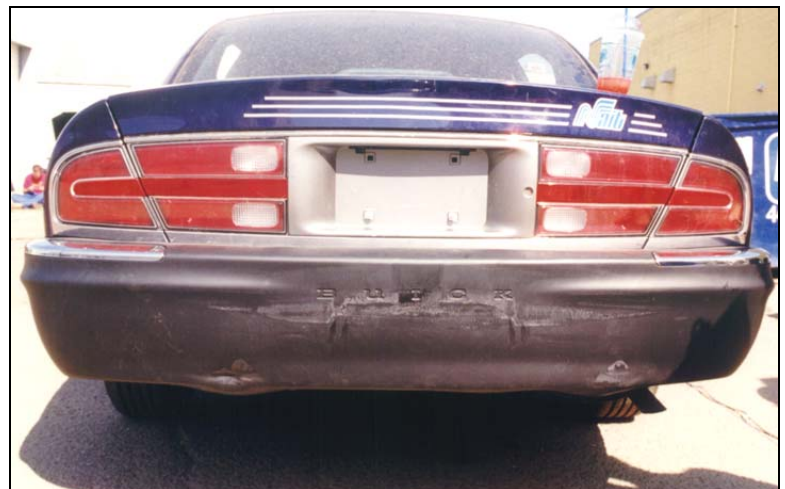
**Photo D7 – Rear bumper cover of 1998 Buick Park Avenue exhibits more pronounced tow hook imprints and is flexed upward. Reinforcement beam and impact absorber displaced forward.**
