# **Vehicle and Occupant Kinematics in Low-Speed Override/Underride Collisions**

**Thomas F. Fugger, Jr. and Bryan C. Randles**  
Accident Research and Biomechanics, Inc

**Judson B. Welcher and Thomas J. Szabo**  
Biomechanical Research and Testing, LLP

**Reprinted From: Biomechanics  
(SP-1784)**

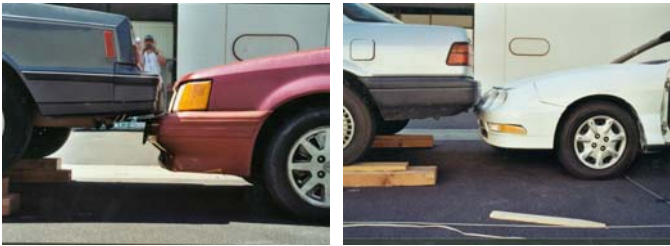
**Figure 1: Exemplar pre-test override/underride configurations**

**TEST PROCEDURE** – Two impacts were performed to the rear of each of the vehicles. The impact speeds were based on approximate Delta V's ranging from 3.2 to 9.6 kph (2 to 6 mph) calculated using an assumed coefficient of restitution. The first impact in each of the five series was a bumper-to-bumper impact. The second impact was an underride impact run as close to the impact velocity of the previous collision as possible. The underride condition was created by placing the target vehicle on wood planks. The planks consisted of 2 x 10 and 4 x 10 boards stacked at an appropriate height to create the override/underride condition. Exemplar side views of the override/underride test setup can be seen in the photographs in Figure 1.
