# **Data and Methods for Estimating the Severity of Minor Impacts**

**Mark N. Bailey, Bing C. Wong, and Jonathan M. Lawrence**  
MacInnis Engineering Associates Ltd.

**Reprinted from: Accident Reconstruction: Technology and Animation V  
(SP-1083)**

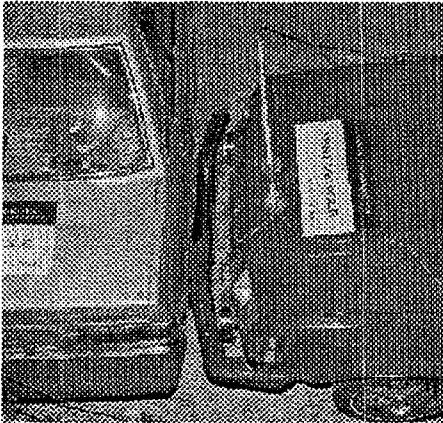
Figure 23. Vehicle engagement in tests 18 to 21.

In Tests 18 to 21. The vehicles were aligned at 90°, with the left front corner of the Ford aligned with the right rear corner of the Toyota (Figure 23).

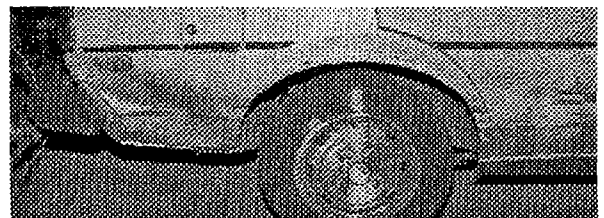
Figure 26. Speed and force data for test 20. Damage shown at right.

Dent in quarter panel 11 cm farther forward than test 19, plus small dent in wheel arch leading edge.

In Test 20 the alignment was similar to the two previous tests, but the closing speed was high enough to cause 2 and 13 mm compression on the left and right Ford isolators. The target Toyota rear bumper moved 45 cm sideways relative to the ground. The front axle did not move sideways. The portion of the right quarter panel that was hit in the previous test was hit again in this test, causing the dent to increase in size. The dent was centred 290 cm from the front axle (11 cm closer). There was some new damage ahead of the target Toyota right rear wheel arch that was 6 cm in height, 4 cm in length and approximately 1 cm in depth. Figure 26 shows that the dynamics were similar to the previous test. The impact lasted approximately 100 ms, then the force between the vehicles dropped to near zero and then the vehicles decelerated in unison. The peak force at the bumper of the bullet was approximately 25 kN for an average isolator compression of 7.5 mm (front-end vehicle-to-barrier impact: peak force=24 kN, isolator compression=7.5 mm). The change in kinetic energy pre- and post-impact was approximately 1092 Joules. 569 Joules were associated with isolator compression and work done by the sliding tires, and 523 were associated with the Toyota damage. The top accelerometer measured a 3.5g peak with pulse duration of 10 ms above a background of lower peaks.

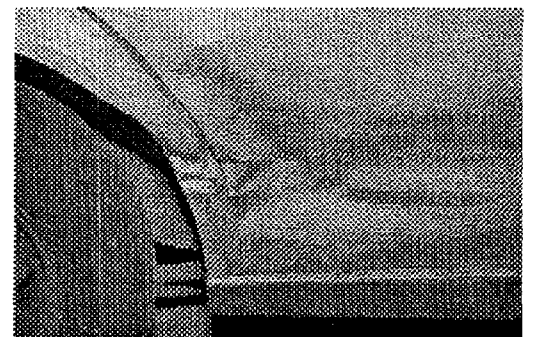
Figure 27 (b). Acceleration at transmission tunnel and roof for test 21. Damage shown at right.

In Test 21 the alignment was similar to the three previous tests, but the bullet Ford was slightly more forward. The impact speed was 8.6 km/h. On the Toyota there was a 16 cm long dent in the rear door approximately 20 mm deep. There was a black scuff in the dent that went forward and downward. It was caused by the motion of the Toyota relative to the Ford, which was upward and backward. The dent in the Toyota right rear wheel arch had doubled in depth to 2 cm. There was 7 and 20 mm compression on the left and right Ford isolators. The target Toyota rear bumper moved 79 cm sideways relative to the ground and the front axle did not move. Figure 27 (a) shows that the dynamics are again similar to the previous tests. The change in kinetic energy pre- and post-impact was approximately 1638 Joules. The energy absorption associated with the 13.5 mm average compression is 460 Joules. 733 Joules were associated with the Toyota damage. The top accelerometer measured a 4g peak with a 110 ms pulse width (Figure 27 (b)).
