## European Spine Society – The AcroMed Prize for Spinal Research 1997

### Do “whiplash injuries” occur in low-speed rear impacts?

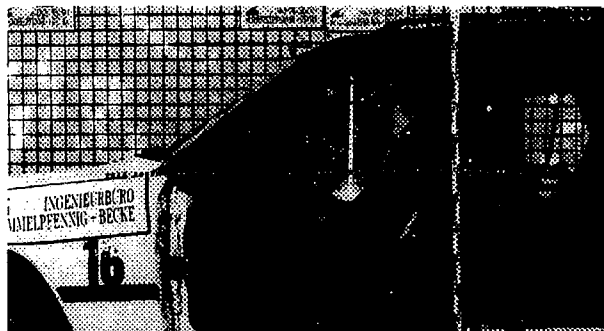
**Fig. 2** Initial position of a male test subject immediately before a two-car collision. Note the blinds, the headset, and the leads connecting the test subject to biomechanical acceleration and electromyography (EMG) sensors

Anticipation by the test subjects was largely neutralized. Their vision was obscured by opaque eyeglasses and loud rock music was played on a Walkman (Fig. 2). In two test subjects, anticipation could not be excluded because the music was interrupted and the approaching vehicle could be heard. Activity of the neck muscles (sternocleidomastoideus, trapezius, and splenius capitis) was continuously recorded via surface electromyography (EMG). In two test subjects a complete EMG recording could not be achieved due to technical problems.

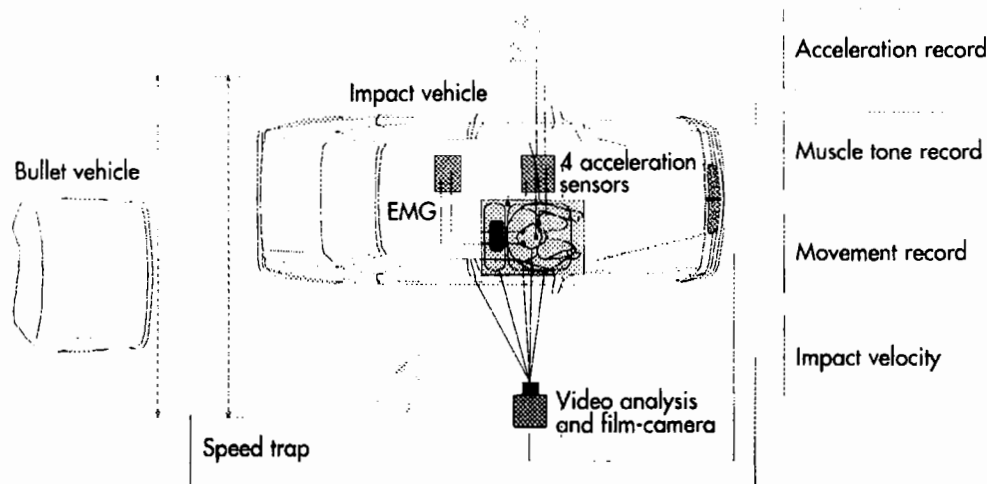
Fig. 3 Design of the experiment

The movements of the test subjects were recorded with a high-speed camera (60 or 100 frames per second), a video camera (25 frames per second), and a recording unit for motion analysis. The two-dimensional motions were recorded with a Hamamatsu C1161 camera with a Nikon 35-mm small-image lens positioned perpendicular to the target vehicle. The respective motions of the vehicle,

seat, headrest, and test subject were recorded using movement markers. These markers were made of reflective Scotch Lite foil, with a diameter of 10–20 mm. Using ten movement markers, the system screen frequency was 732 Hz. The data obtained in 12 of the 20 crashes were sufficient for a motion analysis to be made, although in 4 of these some markers were lost during the impact. In the remaining eight crashes a motion analysis was not possible because too many markers were lost. Accident data recorders manufactured by Mannesmann-Kienzle were installed in the target and bullet vehicles. This allowed recording of the longitudinal and transverse vehicle acceleration. Velocity was also measured by a photoelectric barrier (Alge-Sporttiming) immediately in front of the collision site. A computerized crash data acquisition system in the target vehicle (custom design by Ingenieurbüro Schimmelpfen-

nig und Becke) was used to record the longitudinal and vertical acceleration of the passenger compartments and the acceleration of the test subject's chest and head. Figure 3 provides an overview of the design of the complete experiment. All acceleration data were acquired simultaneously with the EMG data.

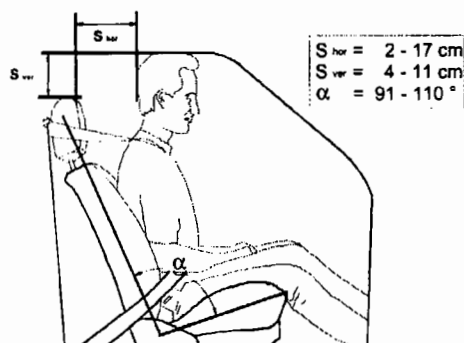
Fig. 4 Initial position in the car seat

The sitting position of all test subjects in the vehicle and the seat adjustments were photographed a few minutes before the test with a tripod camera under defined conditions (distance, height, and angle). The precise position of the movement markers, the horizontal distance between the head and headrest, and the vertical distance between the top of the head and the top of the headrest were measured and recorded. The horizontal distance  $s_{hor}$  ranged from 2 to 17 cm and the vertical distance  $s_{ver}$  ranged between 4 and 11 cm. The angle of inclination between the surface of the seat and the backrest varied between  $91^\circ$  and  $110^\circ$  (Fig. 4).

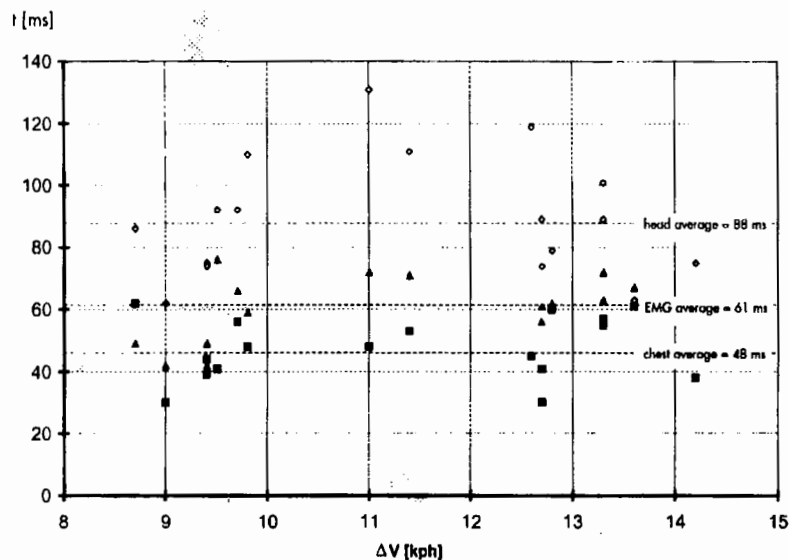
**Fig. 5** Time delay between the beginning of acceleration of the passengers compartment and the biomechanical signals from the chest (■) and head (◇) together with the onset of the EMG signal (▲) over the velocity change due to collision

The time delay between the beginning of acceleration of the passenger compartment and the biomechanical signals from the chest and head together with the onset of the EMG signal, as a function of the velocity change due to collision for all two-car impacts is shown in Fig. 5. In this graph, the zero point is defined as the beginning of acceleration of the passenger compartment. Movement of the upper body (chest) begins on average approximately 48 ms after the beginning of acceleration of the passenger compartment, whereas a significant movement of the head is only detected about 90 ms after initial contact between the two vehicles. The detected neuromuscular reaction of the muscles of the back of the neck begins on average about 60 ms after the passenger compartment begins to accelerate and approximately 20 ms after the chest movement begins.

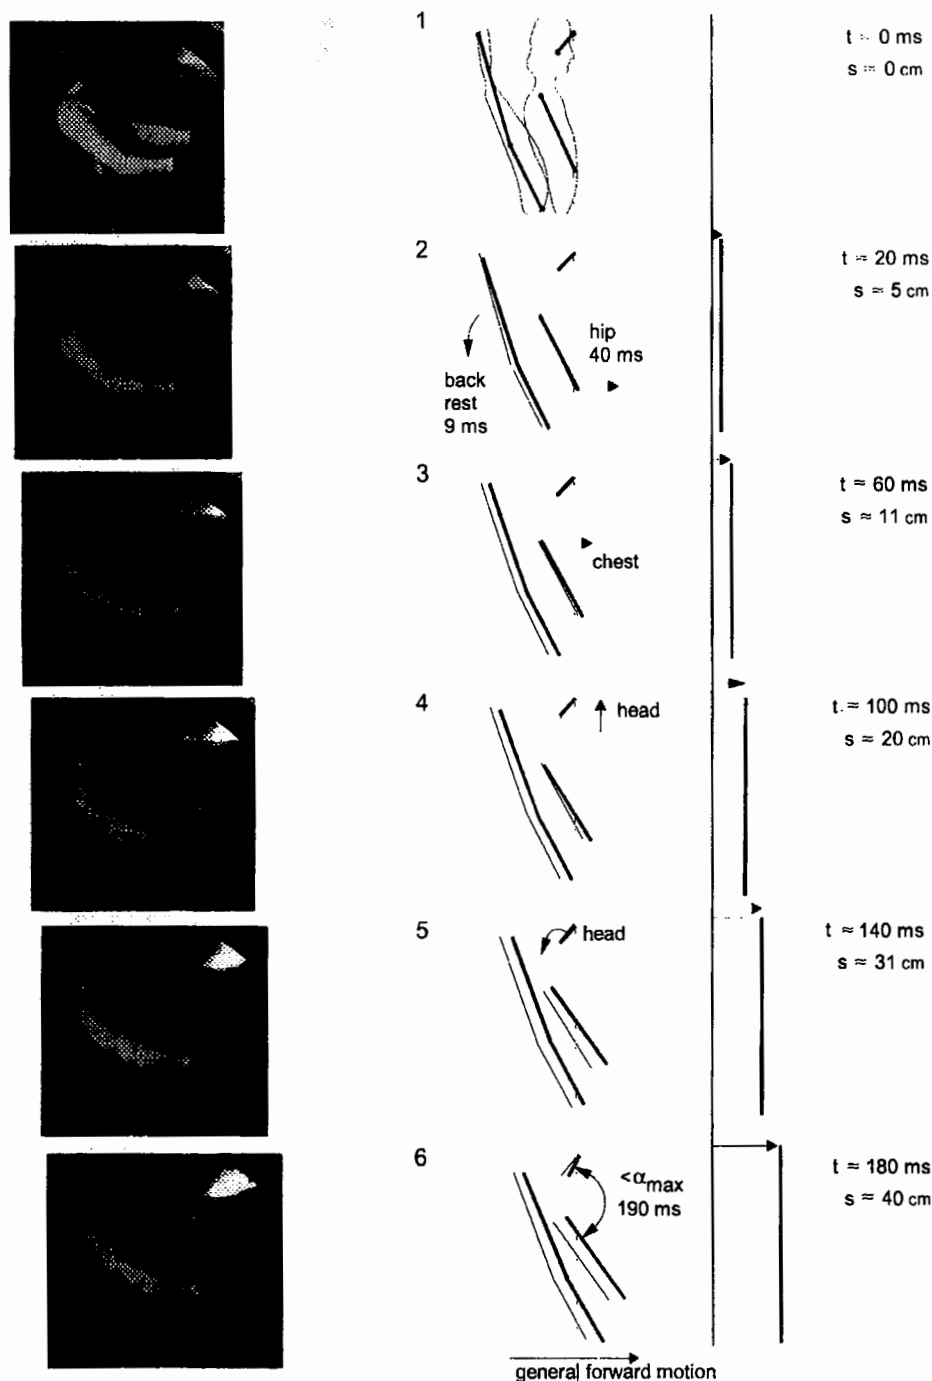
**Fig. 6** Analysis of a primary motion with six constantly recurring motion phases. The images from the video camera are shown on the *left*. The movement markers are visible as bright spots on the seat and test person (forehead, center of gravity of the head, shoulder, and hip). As shown in the *top middle image*, these points were corrected together to allow separate tracking of the absolute motion of the seat, upper body, and head. In each of the consecutively numbered line diagrams, the current positions are shown with *solid lines* and the respective previous positions (approximately 40 ms previously) are shown with *dotted lines*. The times  $t$  and absolute distances  $s$  of the passenger compartment, relative to the time of initial contact of the vehicles and the rest position of the target vehicle respectively, are specified in the *right section* of the Figure. A description of the various phases is given in the text

Using the preliminary data of the biomechanical acceleration signals measured at the head and chest and the ten movement markers, we were able to divide passenger motion in a rear-end collision into one primary motion involving six constantly recurring phases (Fig. 6) and one secondary motion.

**Phase 1:** The passenger compartment and seat move toward the passenger's resting body. By definition, the beginning of this phase is identical to the beginning of the collision, i.e., the time of the initial contact between the two cars. During this phase, the lower seat upholstery of the backrest is deformed in the region corresponding to the passenger's pelvis.

**Phase 2:** This phase begins with the forward motion of the test subject's pelvis. The friction between the surface of the seat and the volunteer's thighs, and the frictional connection between the lumbar spine and the backrest, cause the passenger's lower body to move forward. This reduces the angles between the torso and the head, although the head and upper body are not yet in forward motion. This produces flexion in the cervical spine.

**Phase 3:** Onset of upper body motion (chest). Because the force transmitted by the frictional connection between the backrest and the passenger continues upward to the thoracic spine from below through the hip, pelvis, and lumbar spine, the chest begins to participate in the forward motion. The head remains at rest. This introduces a relative translational motion between the upper body and the head. Remarkably, at the onset of this shear stress, the passenger compartment and seat have already moved forward approximately 11 cm.

**Phase 4:** The force travelling upward through the frictional connection reaches the shoulder blades, forcing the passenger into extension. The passenger appears to rise up in the seat in what is known as "ramping". By this time, the seat and passenger compartment have already moved

**Phase 5:** This phase is characterized by the maximum angle of deformation of the backrest and the completion of passenger extension. The extension motion of the head has begun, i.e., the angle between the upper body and the head increases noticeably.

**Phase 6:** The maximum angle of extension is reached after the back of the head has come into contact with the headrest. The passenger is in full extension, and now every part of the body is involved in the forward motion of the seat and passenger compartment.

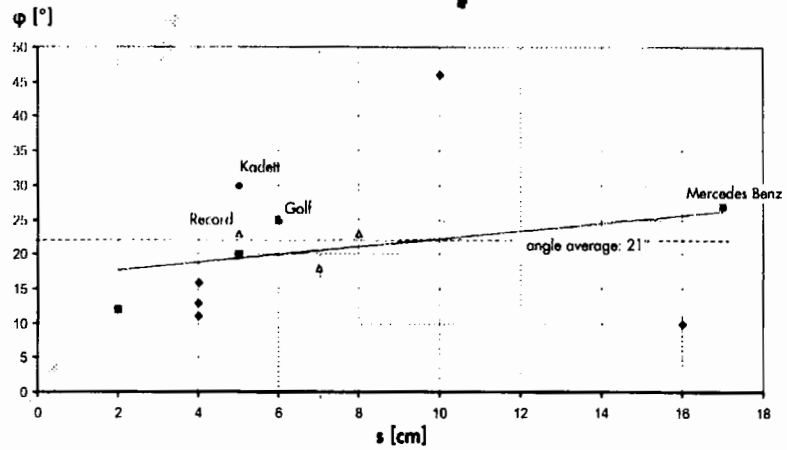
**Fig. 7** Relative angle in relation to the distance from the headrest

Motion analysis can determine the maximum angle and the maximum relative angular velocities (12 of 17 car collisions) between the upper body and the head in the extension motion. Figure 7 shows the resulting relative angle as a function of the horizontal distance between the back of the test subject's head and the headrest. This varied between slightly less than 10° and 47°. The average extension angle was 20°. The maximum relative angular velocities (Fig. 8) ranged between 200° per second and a

Motion analyses of the test persons during the entire collision phase revealed the trend that the maximum resulting relative angle between the upper body and the head increases with the increase in the horizontal distance between the back of the head and the headrest. However, hyperextension of the cervical spine, which has been discussed in the literature [10, 19] as a possible cause of injury, definitely does not occur in vehicles equipped with headrests at a  $\Delta V$  of up to 15 km/h. This finding concurs with the data of Szabo and Welcher [18], who also failed to observe hyperextension. A notable finding in our examination was the extent of the relative translational motion between the upper body and the head (phase 3 of the motion analysis). The significance of such a translation as a possible cause of injury is not yet clear. Penning [10]

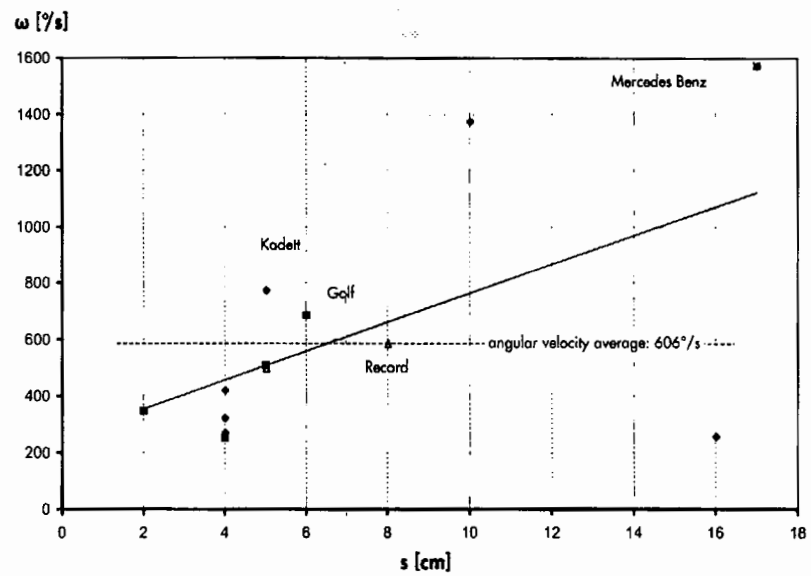
**Fig. 8** Relative angular velocity in relation to the distance from the headrest

maximum of slightly less than  $1600^\circ$  per second. The average angular velocity was  $606^\circ$  per second (12 of 17 car collisions).

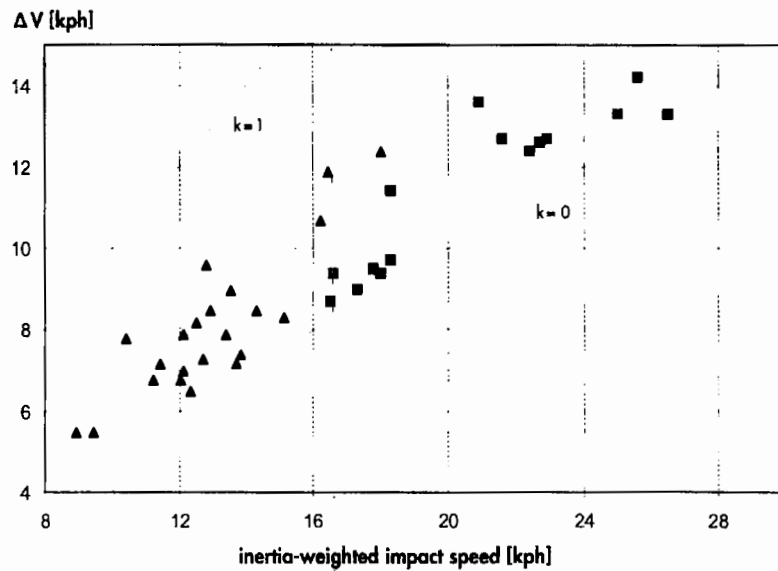
**Fig. 9** Change in speed due to the collision ( $\Delta V$ ) in relation to the inertia-weighted impact speed  $v_i$  (boundary cases:  $k = 0$ : plastic collision;  $k = 1$ : elastic collision)  
 ■ = Study 1997; ▲ = pre-study 1993

Figure 9 documents the inertia-weighted impact speed via the velocity change due to collision for all the crash tests. The inertia-weighted impact speed neutralizes the influence of differences in vehicle weight and is thus more suitable for comparing collision processes.

The inertia-weighted impact speed of the bullet car ranged from 16.4 km/h to 26.4 km/h (average 20.9 km/h). The change in velocity ranged from 8.7 km/h to 14.2 km/h (average 11.4 km/h). The mean acceleration of the target car ranged from 2.1 g to 3.6 g (average 2.7 g). The impact speed of the bullet bumper car ranged from 11.0 km/h to 13.5 km/h (average 12.2 km/h). The change in velocity ranged from 8.3 km/h to 10.6 km/h (average 9.9 km/h). The mean acceleration of the target bumper car ranged from 1.8 g to 2.6 g (average 2.2 g). The velocity change of the test vehicles due to collision could be precisely calculated by integrating the acceleration signals from the passenger compartments over time.

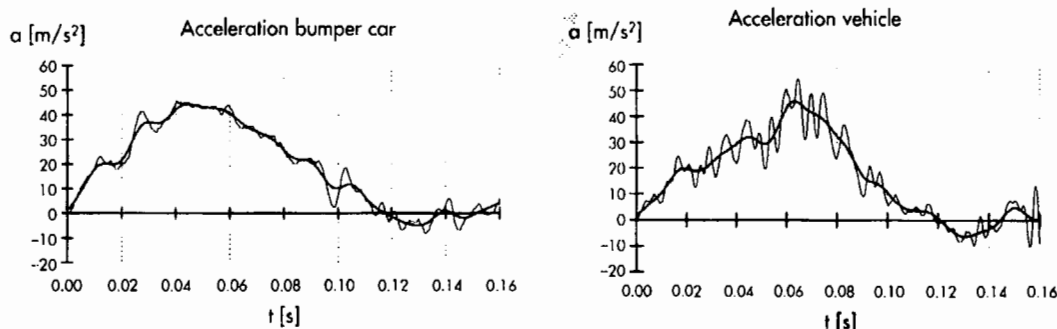
**Fig. 10** Comparison of the acceleration signals from the bumper car (left) and automobile (right)

Comparison of the acceleration signals between automobile and bumper car collisions resulted in very similar curves (Fig. 10). Deviations were seen only in head acceleration as a result of unrestricted head motion in the bumper car.
