Human Subject Responses to Repeated Low Speed Impacts Using Utility Vehicles

G. P. Nielsen, J. P. Gough, D. M. Little, D. H. West, and V. T. Baker
Baker Materials Engineering Ltd.

**Reprinted from: Occupant Protection and Injury
Assessment in the Automotive Crash Environment
(SP-1231)**

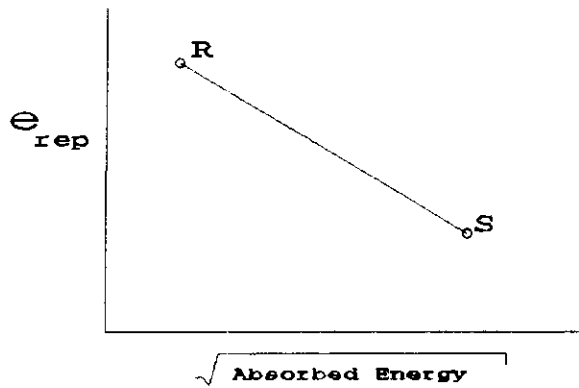
Figure 1

The relationship between e_{rep} and the square root of absorbed energy is modelled as linear. Thus, a graph of these two parameters would have the following form:

Location R on the above graph is determined for the initially undamaged test vehicle from data obtained in the first impact of a test series: e_{rep} is set to equal e_{meas} . The energy absorbed by the two collision vehicles is taken to be the decrease in the kinetic energy of the system (the system being the two vehicles).

Location S can be determined experimentally by colliding test vehicles, identical to those of the test series of interest, at a speed approaching the upper limit of the low level collision event. This requires two identical pairs of test vehicles (four vehicles in total) to conduct one test series. In the absence of such resources, the location of S can be approximated based on the work of Siegmund et al². Its location was assumed to correspond to a collision having a coefficient of restitution of 0.25 and a speed change, experienced by the lighter vehicle, of 13 km/h.

After generating the curve of restitution versus the square root of absorbed energy (connecting points R and S on the restitution versus absorbed energy graph), the representative speed change for the nth impact of a test series can be calculated. The energy absorbed by all collisions up to and including the nth impact are summed. This value is used with the generated graph to obtain e_{rep} for the nth impact. The summed energy is then used, along with the obtained value of e_{rep} , in Equation 2 to calculate ΔV_{rep} . Appendix B contains a calculation demonstrating the generation of the graph of e_{rep} versus the root of absorbed energy for test series A, and the calculation of ΔV_{rep} for impact A6.

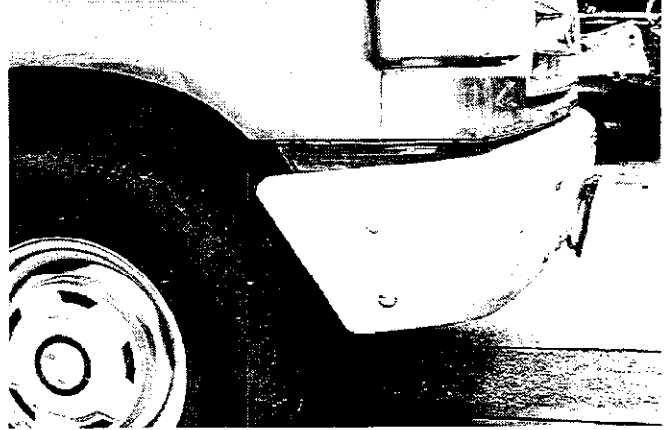
Figure 2. Striker damage after test A3.

The van's bumper configuration was a pressed steel shell, rigidly mounted to the frame rails via two metal brackets. The shell was a "C" section, joined by weldments to the leading edge of the horizontal elements forming the frame rails. A plastic impact strip covered the bottom half of the bumper face.

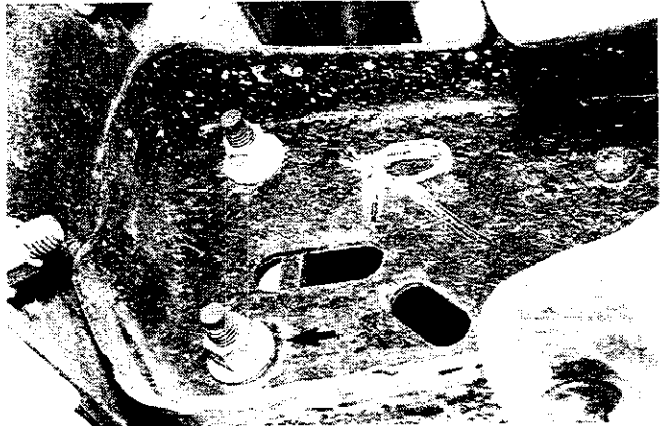
Figure 3. Shift of striker's bumper bolts, test A4.

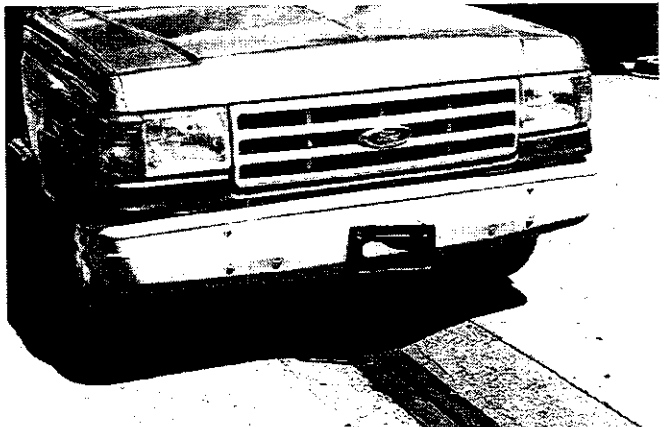
Figure 4. Accumulated damage to striker, test A7.

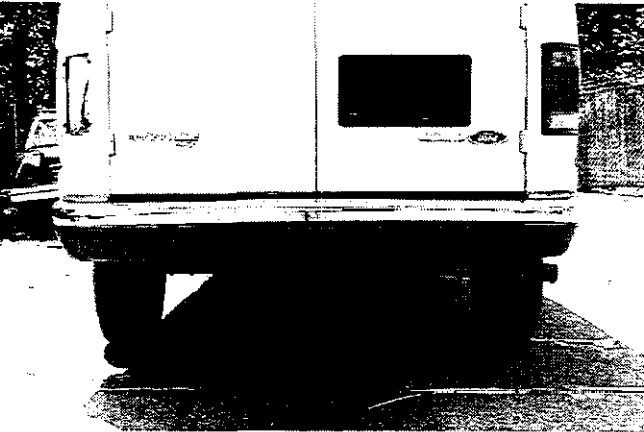
Figure 6. Slight bumper deformation, test A6.

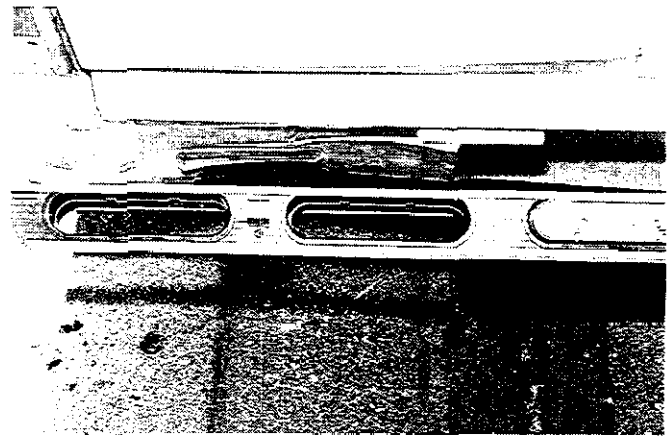
Figure 8. Increased panel deformation, test B2.

SERIES B (Figure 7 and 8, and Table 3) - A 1988 Toyota Celica GTS 4 wheel drive ($m = 1617$ kg) was guided into the rear of a 1989 Mazda B2200 pickup truck ($m = 1311$ kg). The pickup truck's rear bumper was removed for this test series¹. The Toyota's front bumper made contact with the Mazda's rear end panel at striking speeds of 4.3 and 5.2 km/h. No damage was sustained by the Toyota.

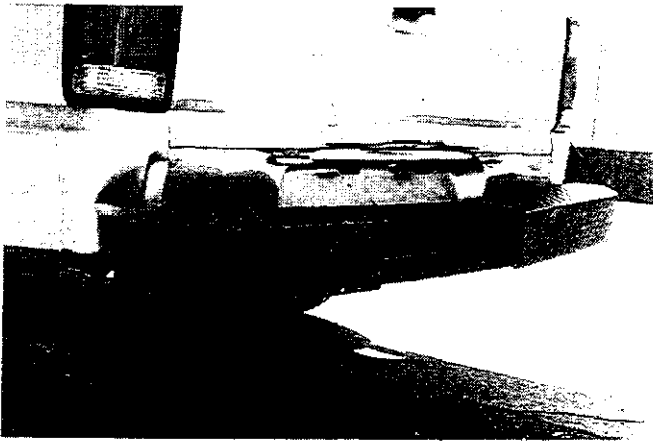
Figure 10. Damage to step bumper, test C5.

The Mazda's rear bumper was at a lower elevation than the Ford van's front bumper. Contact between these two vehicles occurred with the rearward canted section of the Ford's front bumper striking the top edge of the Mazda's rear bumper. Consequently, the struck vehicle's induced motion consisted of two components: 1) The forward speed change normally associated with rear impacts, and 2) a vertical displacement initiated as the striking vehicle's front bumper forced the Mazda's rear bumper down during collision contact.

C5	5.3	7.7	Visible flattening of bumper at the vehicle centre (Figure 9). Paint had transferred to the bumper bar from the Mazda's rear bumper. The left edge of the bumper bar was slightly misaligned with its adjacent fender.	9.0	13.1	Rear bumper set down 5 mm at the left edge, and 11 mm at the left bumper mount (Figure 10). Damage was considered obvious and visible.	0.42	0.23	0.23	-2696

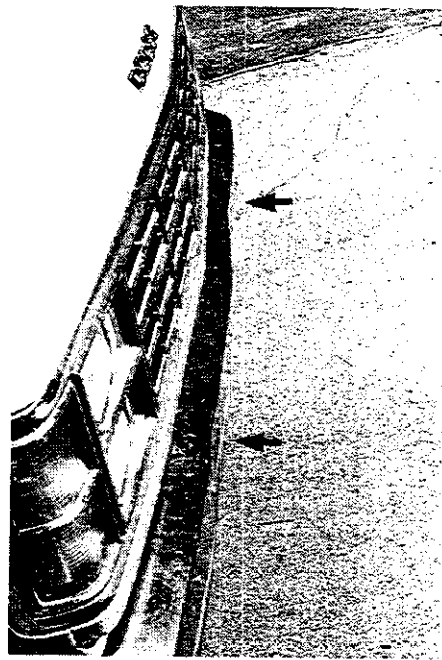
Figure 12. Two dents to bumper bar, test D3.

The Jeep's rear bumper was constructed of a lightweight metal "C" channel that was attached to the chassis via two metal brackets. Plastic end caps flanked the bumper bar. Two vertical plastic bumper guards were mounted on the bumper's rear surface. They projected rearward of the Jeep's bumper bar. Contact between the two vehicles occurred with the relatively flat face of the Dodge van's front bumper striking the two plastic vertical guards.

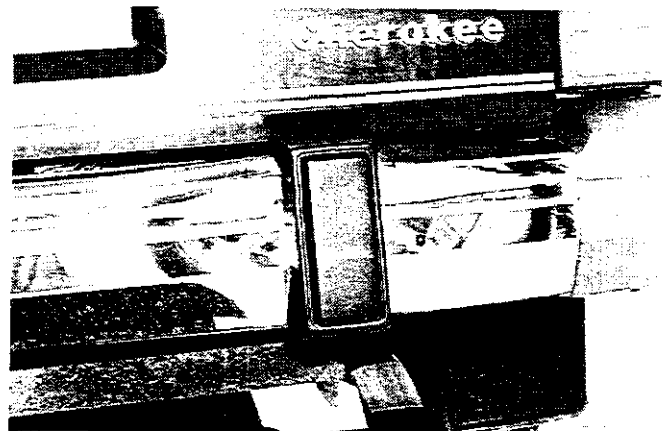
Figure 13. Damage about bumper guard, test D2.

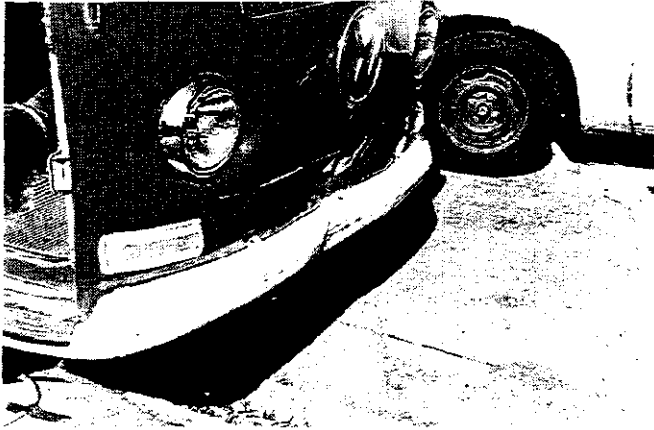
Figure 14. Front panel damage, test E2.

SERIES E (Figure 14, and Table 3) - A 1971 Volkswagen van (m = 1400 kg) was twice guided into a rigid barrier. The barrier was constructed of concrete blocks fronted by two 13 x 13 cm cedar posts. The posts were stacked one on top of the other. They occupied an elevation of 36 to 62 cm above ground with the intention of simulating the geometry of a bus bumper. The first test saw this Volkswagen strike the barrier at a speed of 4.7 km/h. Contact with the barrier was made by the spare tire that was mounted to the Volkswagen's front panel. The front bumper did not touch the barrier. The van rebounded from the barrier at a speed of 2.3 km/h, resulting in a net speed change of 7.0 km/h. The spare tire was removed from the front of the Volkswagen prior to test E2. Contact with the barrier was made by the front bumper in the second test.

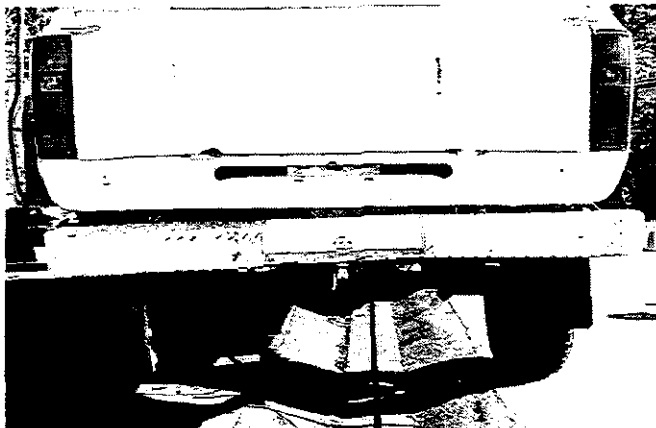
Figure 15. Bumper misalignment, test F2.

The Toyota's rear bumper was constructed of checkered metal plate that formed left and right box channels. These two box channels were coupled together by an "L" shaped metal plate. The bumper assembly was cantilevered to the frame rails by two metal plates that were used as mounting brackets.

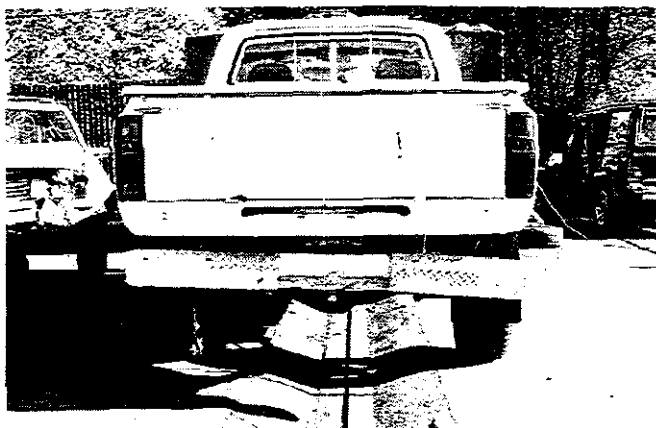
Figure 16. Increased bumper misalignment, test F3.

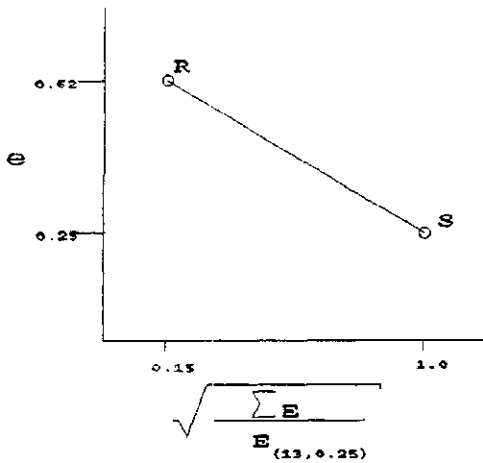
Figure 18

Location S has an assumed value for e of 0.25. The normalization procedure sets the abscissa of point S equal to unity.

The graph has the form:

A general equation for e, application to test series A, is readily obtained:
