# **Coefficients of Restitution for Low and Moderate Speed Impacts with Non-Standard Impact Configurations**

**C. Brian Tanner, John F. Wiechel, Ron A. Bixel and Philip H. Cheng**  
S.E.A., Inc.

**Reprinted From: Accident Reconstruction-Crash Analysis  
(SP-1572)**

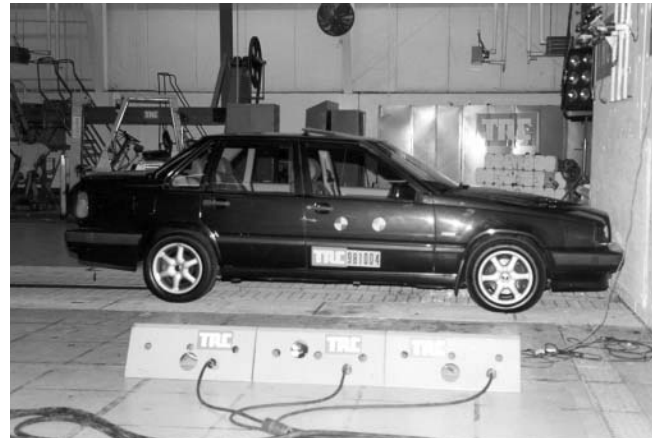
**Figure 1 - 1993 Volvo 850/Barrier Impact Configuration**

**VOLVO TO BARRIER IMPACTS** - A total of three impacts were conducted in this configuration with impact speeds of about 9.26, 11.21, and 20.89 kilometers per hour. Figure 1 shows the vehicle and the impact configuration, while Figures 2 and 3 show an undamaged vehicle.

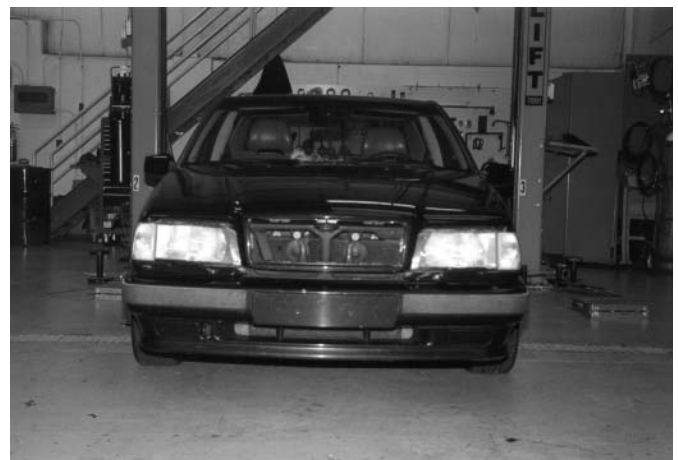
**Figure 2 - Frontal View of the Undamaged Volvo**

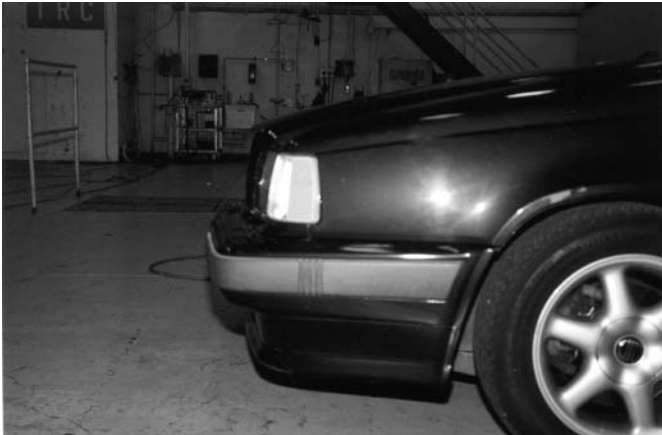
**Figure 3 - Side View of the Undamaged Volvo**

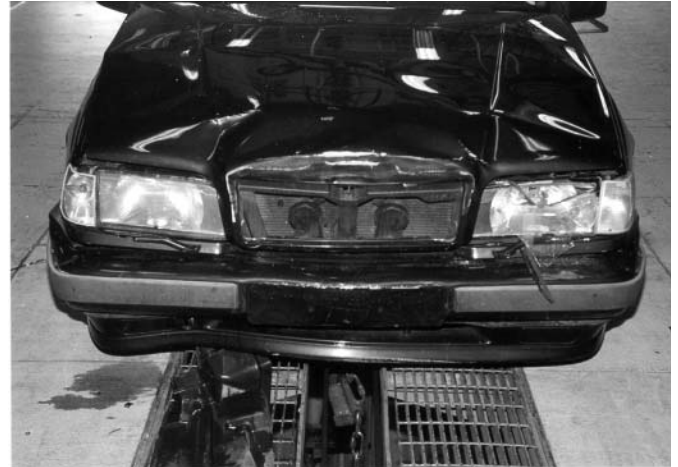
**Figure 6-Damage After the 20.89 kph Impact.**

restitution was determined by dividing the impact speed by the difference between the speed change and the impact speed. Figures 4-9 show the impact damage and the acceleration and speed change data for the tests.

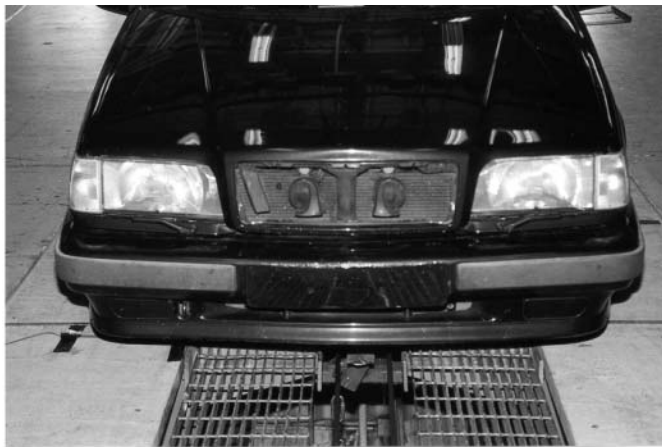
**Figure 4 - Bumper Surface Damage after the 11.21 kph Impact.**

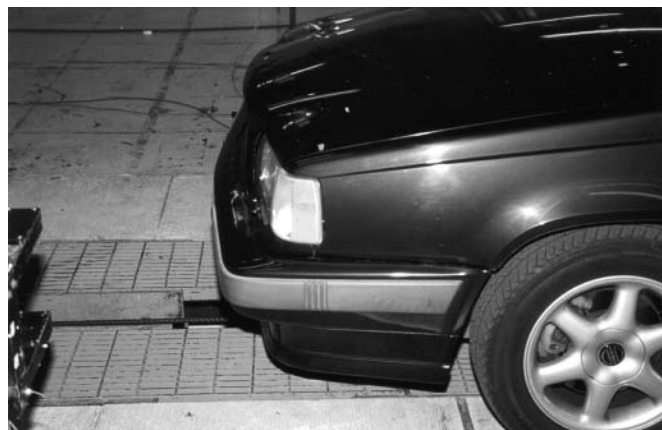
**Figure 5 - Side View after the 11.21 kph Impact.**

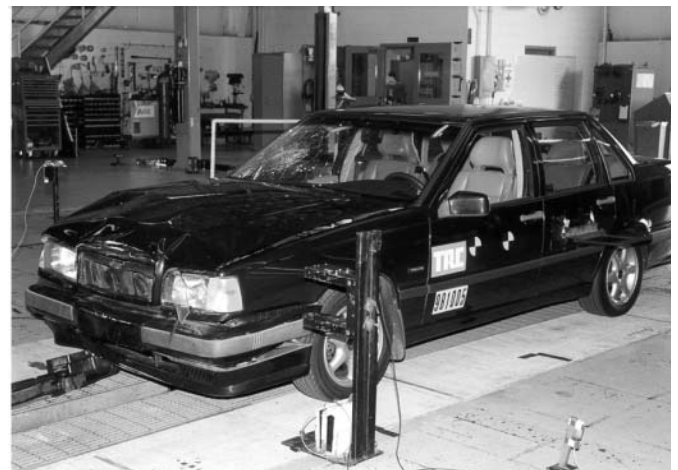
**Figure 7-Side View of the 20.89 kph Impact Damage.**

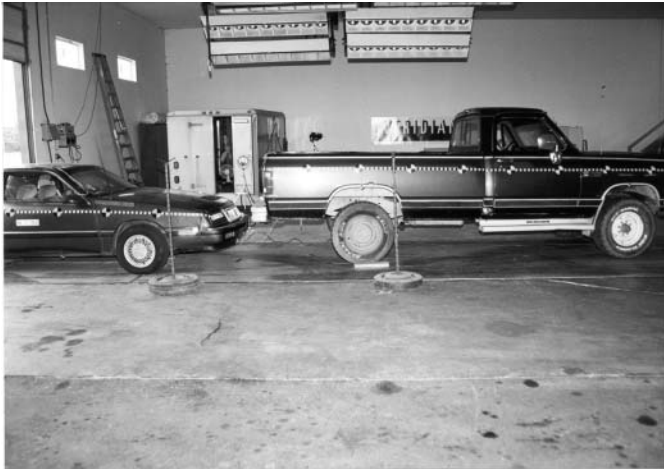
**Figure 10- The LeBaron to pickup Impact Configuration.**

The alignment of the vehicles was controlled so that the impact occurred between the trailer hitch ball on the pickup and the center of the bumper on the LeBaron. In addition, the LeBarons were offset toward the right of the pickup by about 25 centimeters, and there was a slight left to right heading of the cars. Tri-axial accelerations were measured by rigidly mounted accelerometers near the center of gravity of the LeBaron's, and standard video and high speed film was shot of each of the impacts from several angles.

Figures 10 and 11 show the impact alignment of the vehicles for this test series, and Figure 12 shows the pre-impact, undamaged configuration for the Chrysler LeBarons. It should be noted that the design of the Chrysler LeBaron front bumper consists of a stamped metal bumper reinforcement bar behind a plastic cover. The bar attaches to the vehicle chassis through stamped metal energy absorbers shaped so that they will buckle at a certain level of load. The bumper on the Dodge pickup was stamped metal attached directly through stamped metal brackets to the vehicle frame. The trailer hitch consisted of a heavy steel receiver section that bolted directly to the pickup frame, with a heavy steel insert and ball that pinned into the receiver.

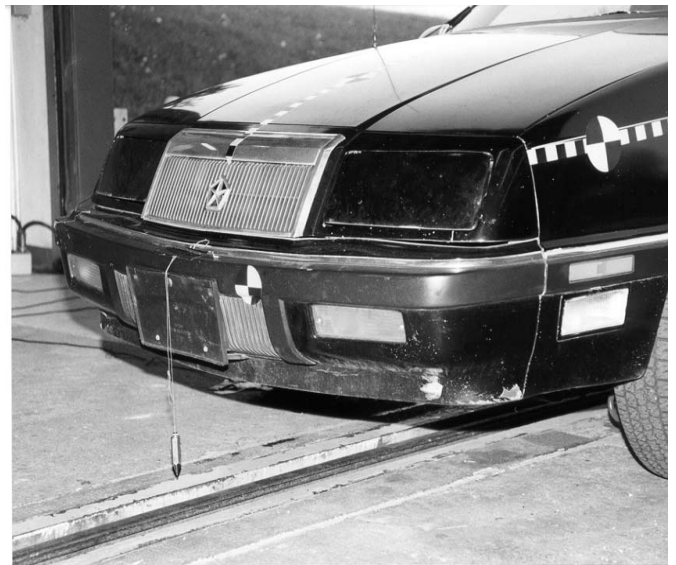
**Figure 12 - Undamaged LeBaron. Target shows Hitch Ball Impact Point.**

Except for the color, each of the LeBaron's in the impacts was essentially identical to the configuration shown in Figure 12. The pickup was not damaged in any of the tests and was reused each time.

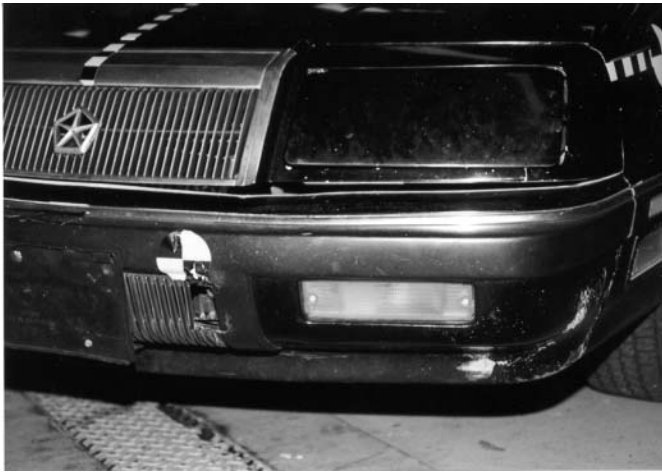
**Figure 13 - External Damage in the 11.29 kph Impact. Target indicates Hitch Ball Impact Position.**

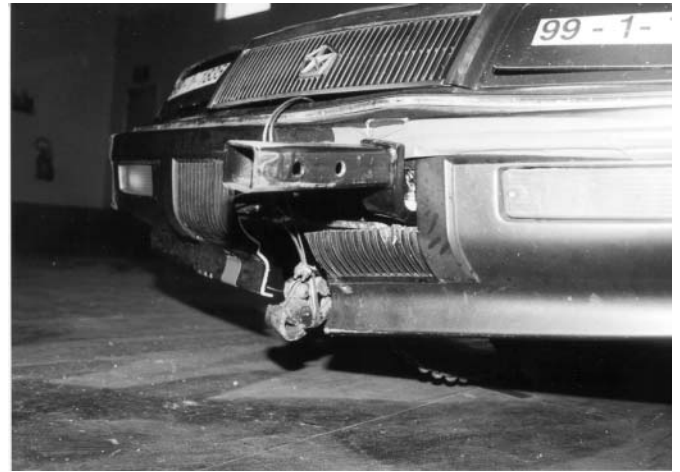
**Figure 15 - External Damage in the 11.45 kph Impact.**

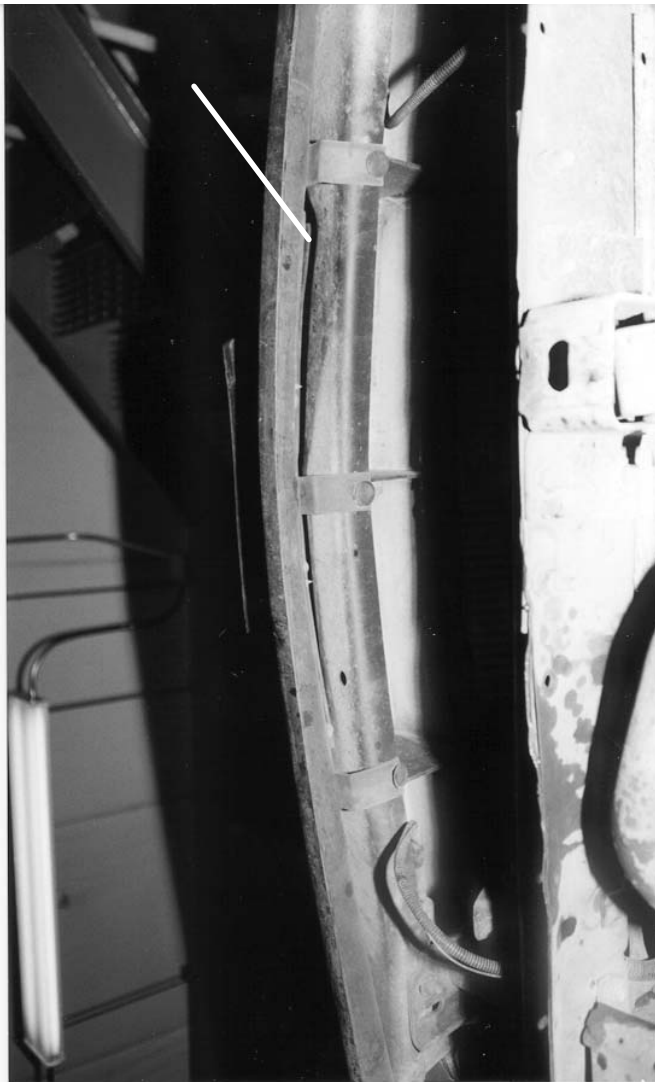
**Figure 14 - Reinforcement Bar Damage from the 11.29 kph Impact**

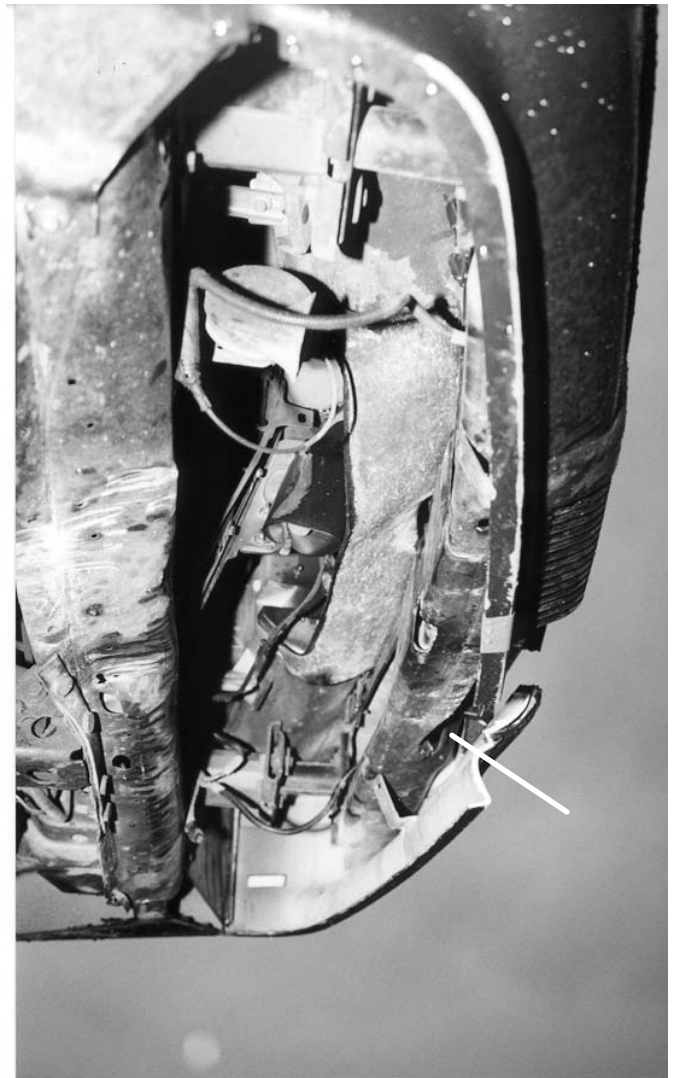
**Figure 16 - Reinforcement Bar Damage from the 11.45 kph Impact**

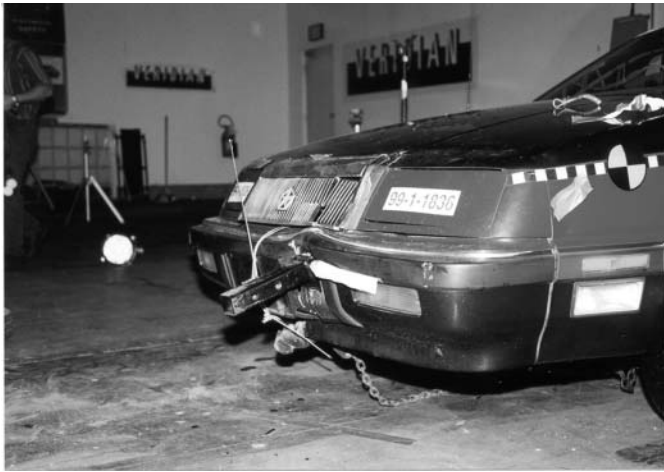
Figure 17 - External Damage in the 17.74 kph Impact

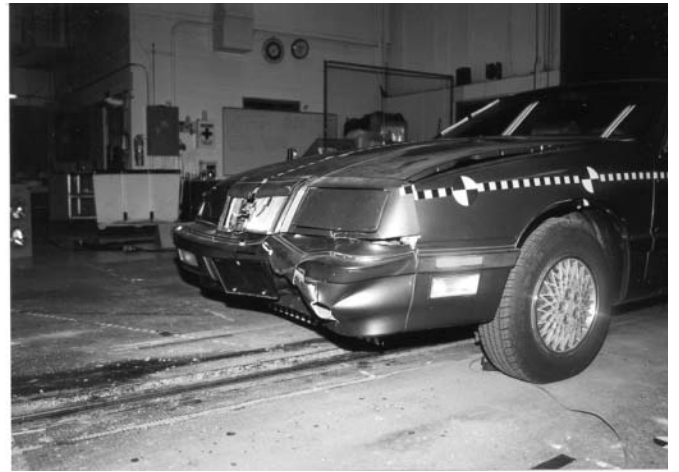
Figure 19 - External Damage in the 19.35 kph Impact

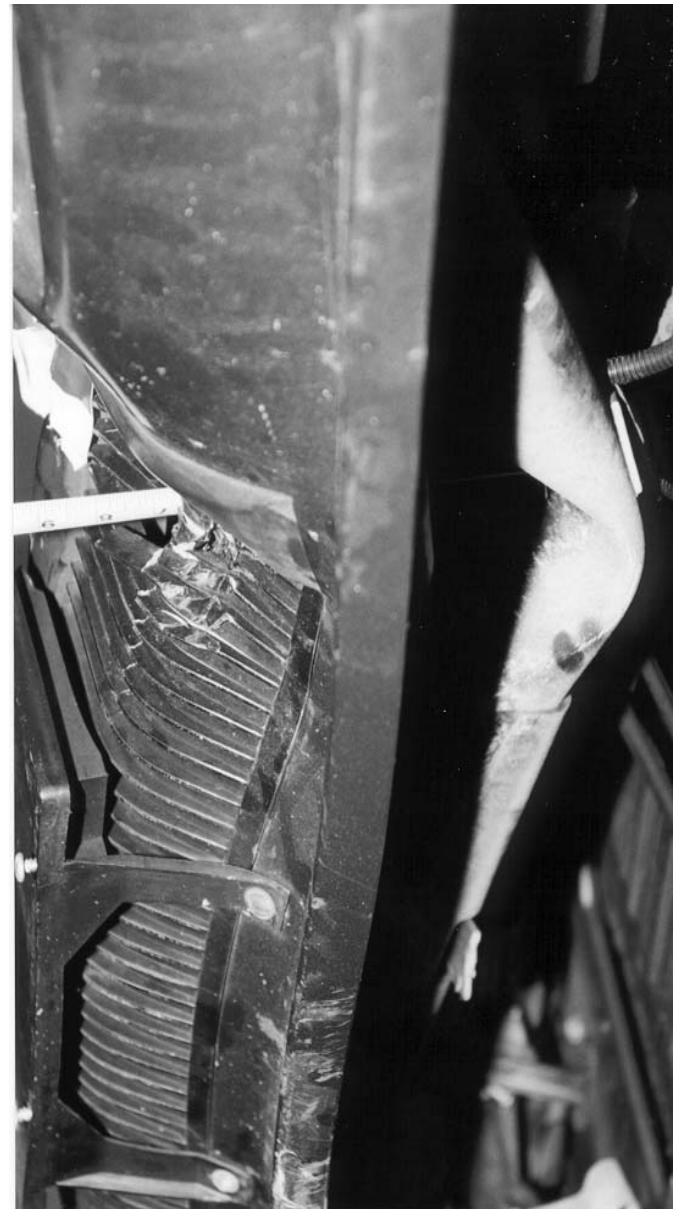
Figure 20 - Reinforcement Bar Damage in the 19.35 kph Impact.

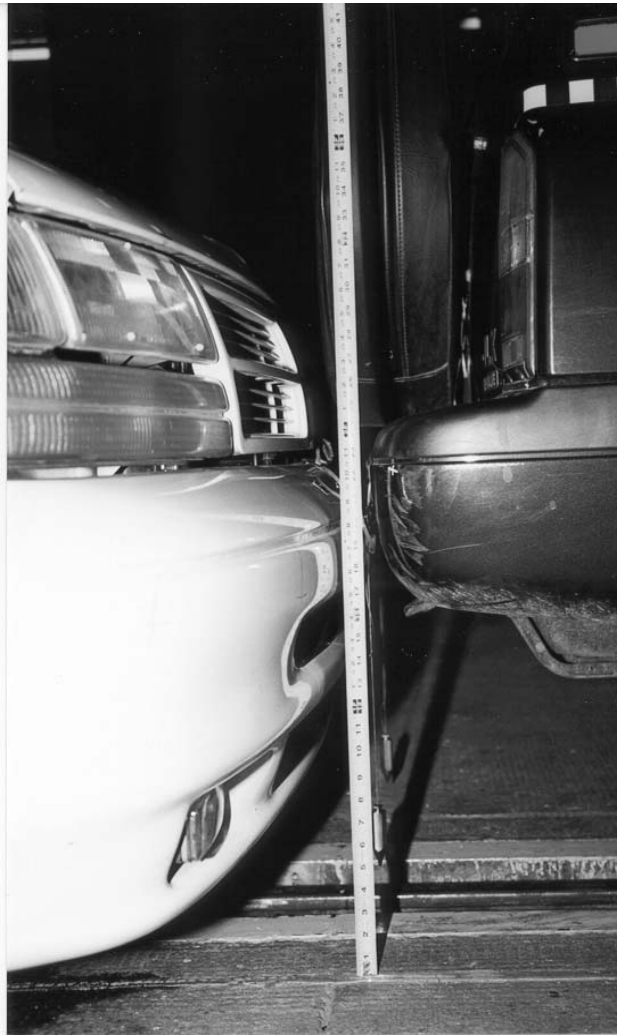
**Figure 23 - Impact Configuration of the Grand Caravan into the Suzuki Sidekick.**

IMPACT OF 1994 DODGE GRAND CARAVANS TO 1995 SUZUKI SIDEKICK WITH REAR MOUNTED SPARE TIRE - For this test series, moderate impact speeds of 18.71 and 32.42 kilometers per hour were used. In addition, the front of the Grand Caravans were lowered to simulate a braked configuration. In this orientation, the upper half of the Grand Caravan front bumpers contacted the lower half of the Suzuki rear bumpers. Perhaps more importantly, at the impact speeds used in these tests, contact also occurred between upper grill, radiator support and hood edge of the Grand Caravan and the lower portion of the inflated, rear mounted spare tire on the Suzuki. Once again, in these tests, the Grand Caravans were offset to the right of the Suzukis nearly 30.5 centimeters. Neither the Grand Caravans or the Suzukis have any energy absorbers incorporated into their bumper designs.

Figure 23 shows the impact configuration for the tests in this series, and Figures 24 and 25 show the front of one of the Grand Caravans and the rear of one of the Suzukis in their undamaged conditions before impact. Figures 26-29 show the vehicle acceleration and speed change data for the tests, and Figures 30-33 show the damage to the vehicles from the impacts.

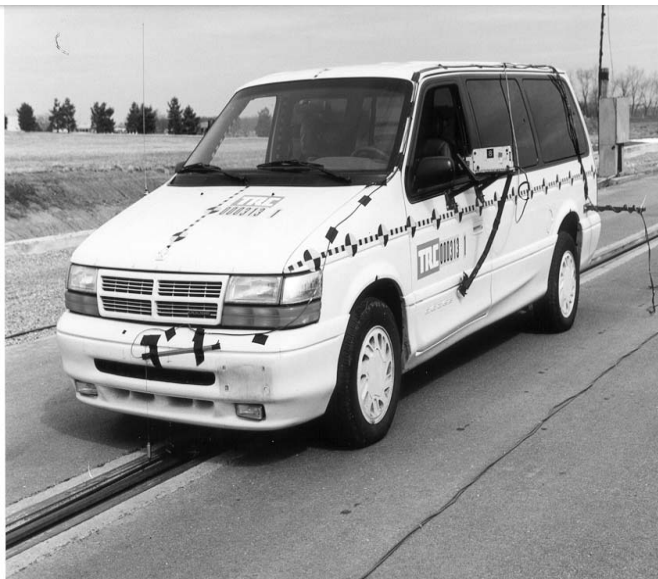
**Figure 24 - Pre-impact geometry of the Grand Caravan**

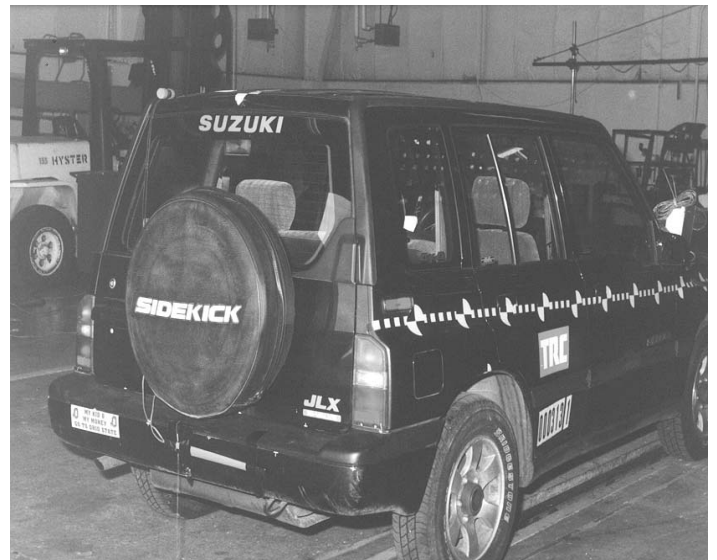
**Figure 25 - Pre-impact Geometry of the Suzuki Sidekick**

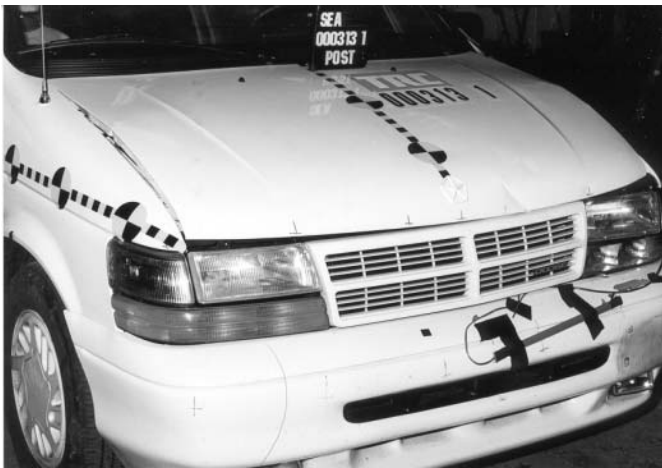
Figure 30 - Grand Caravan Damage in the 17.91 kph Impact

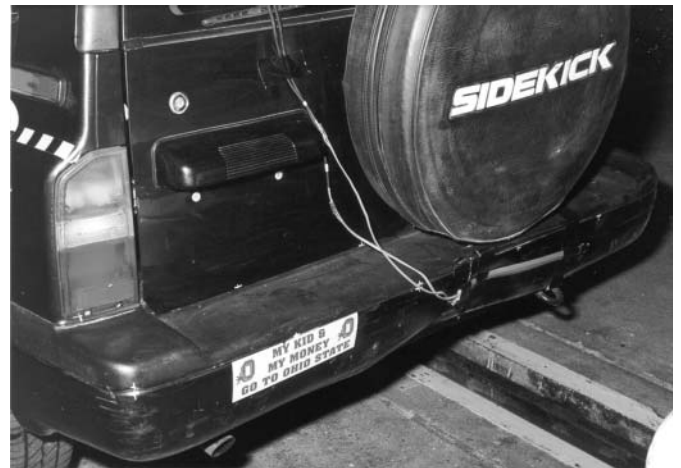
Figure 32 - Suzuki Damage in the 17.91 kph Impact

Another interesting feature of these tests is that the least amount of restitution occurred for the LeBaron to pickup impacts, while by far, the highest amount of restitution occurred for the Grand Caravan to Suzuki impacts, despite the fact that the highest impact speeds were utilized in the Grand Caravan to Suzuki impacts. The reason for this is most likely that the impact configuration between the Grand Caravan and Suzuki allowed the hood of the Grand Caravan to engage only the inflated portion of the Suzuki spare tire and wheel assembly. In addition, the impacts were not sufficient to cut or debond the Suzuki spare tire. Thus, the tire acted as an elastic

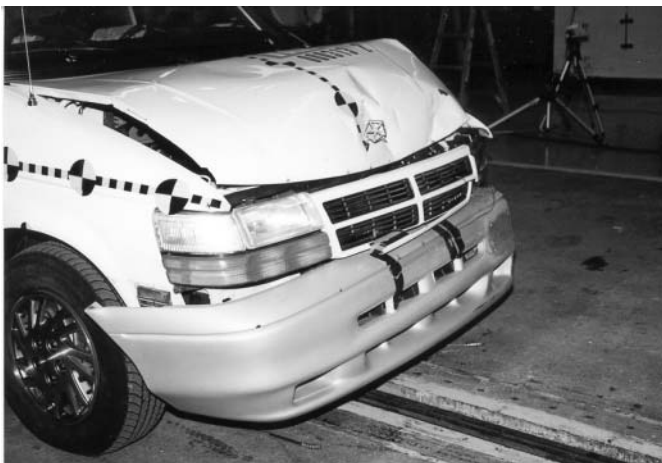
Figure 31 - Grand Caravan Damage in the 32.42 kph Impact

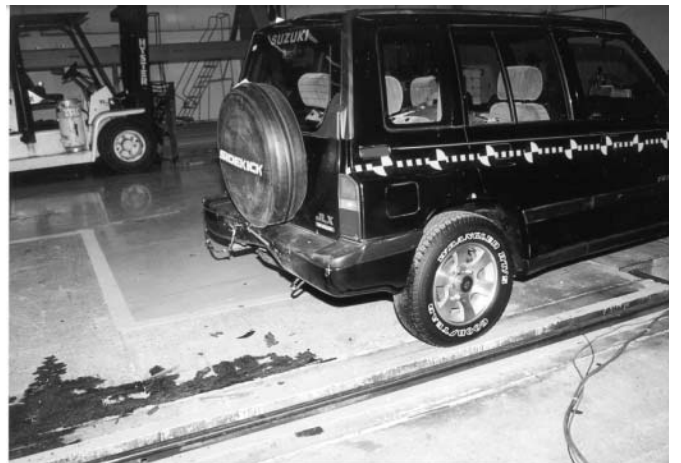
Figure 33 - Suzuki Damage in the 32.42 kph Impact
