RTE 29 NBL/SBL OVER NS RR (JUMBOS) RTE 29 NBL OVER NS RR (AIRPORT)

VTCA - Lynchburg District Dialogue April 2023

April 20, 2023

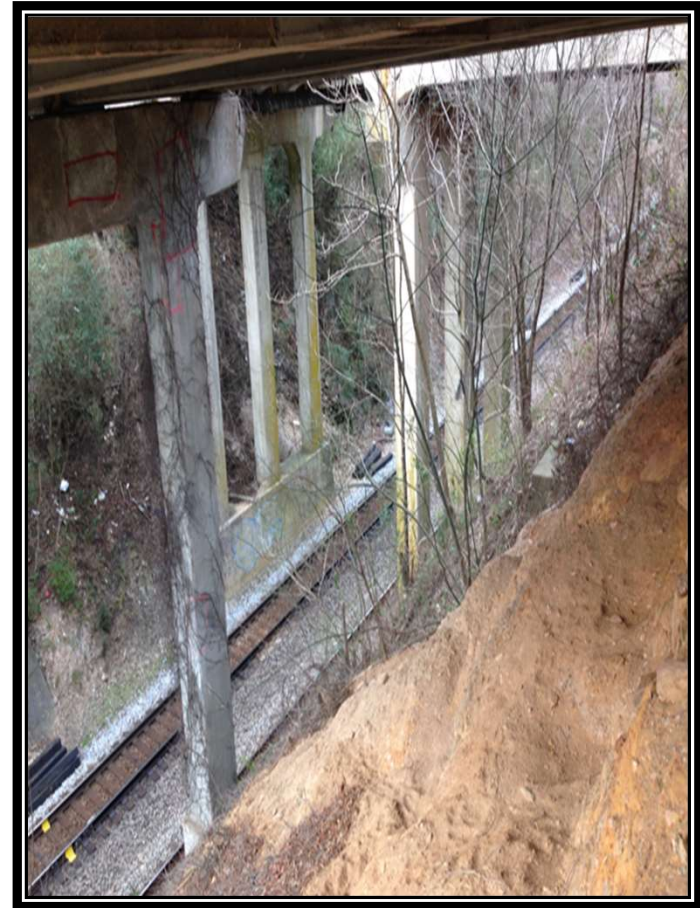
Typical Wall Elevation View

- **Stair stepped levels**
- **Excavation**
- **Drill Anchors**
- **Shotcrete wall**
- **Poured in place concrete walls**
- **One sided forms**

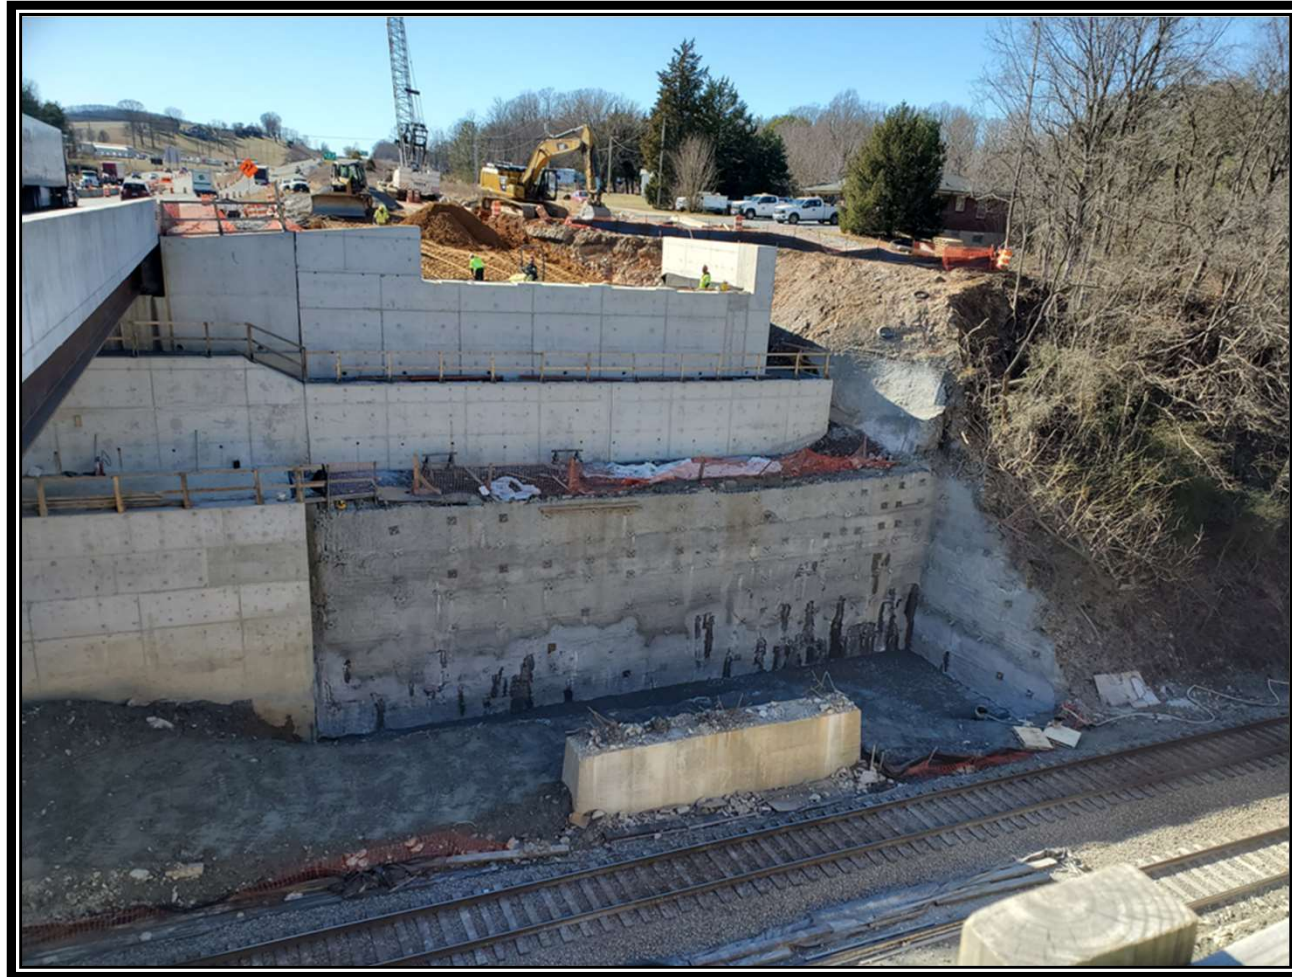
Rock Excavation for Wall

Mini Excavator with hoe ram set on ledge by crane

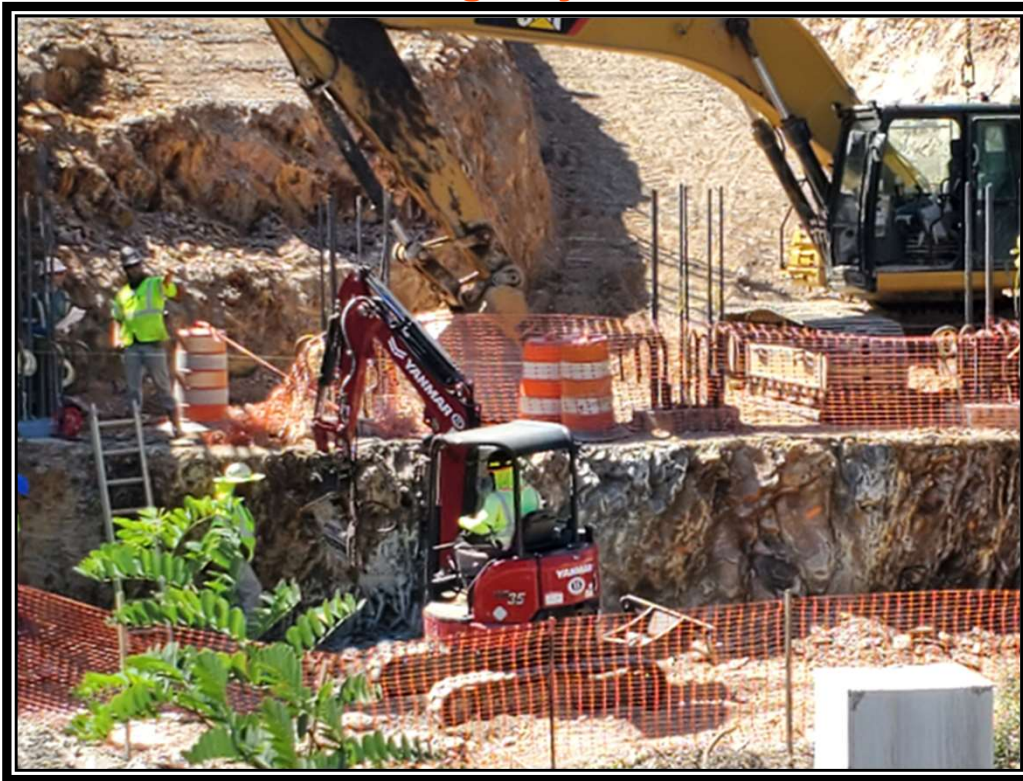
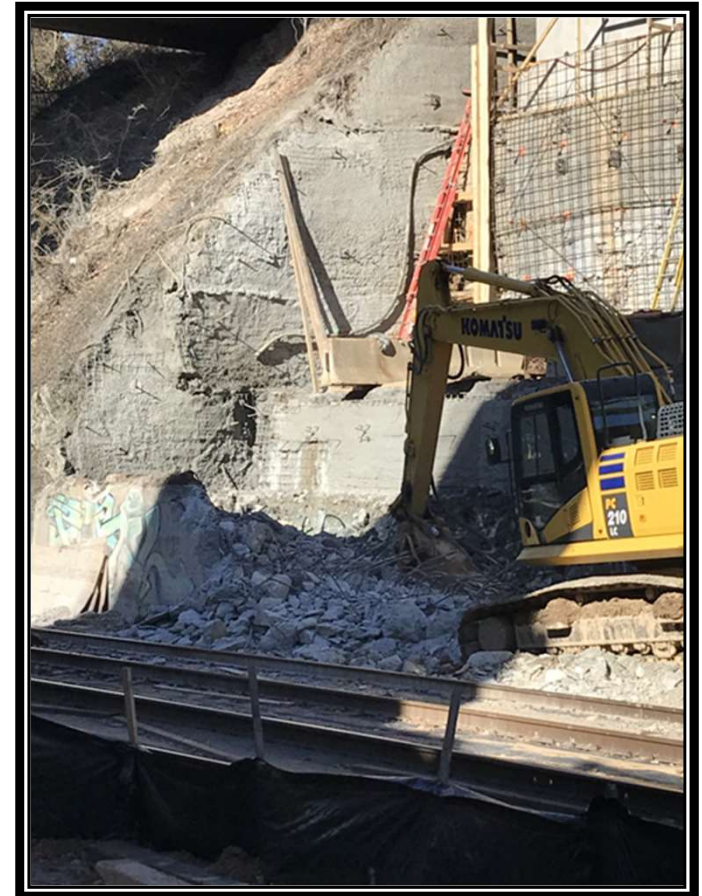
Excavator with hoe ram accessed from the bottom

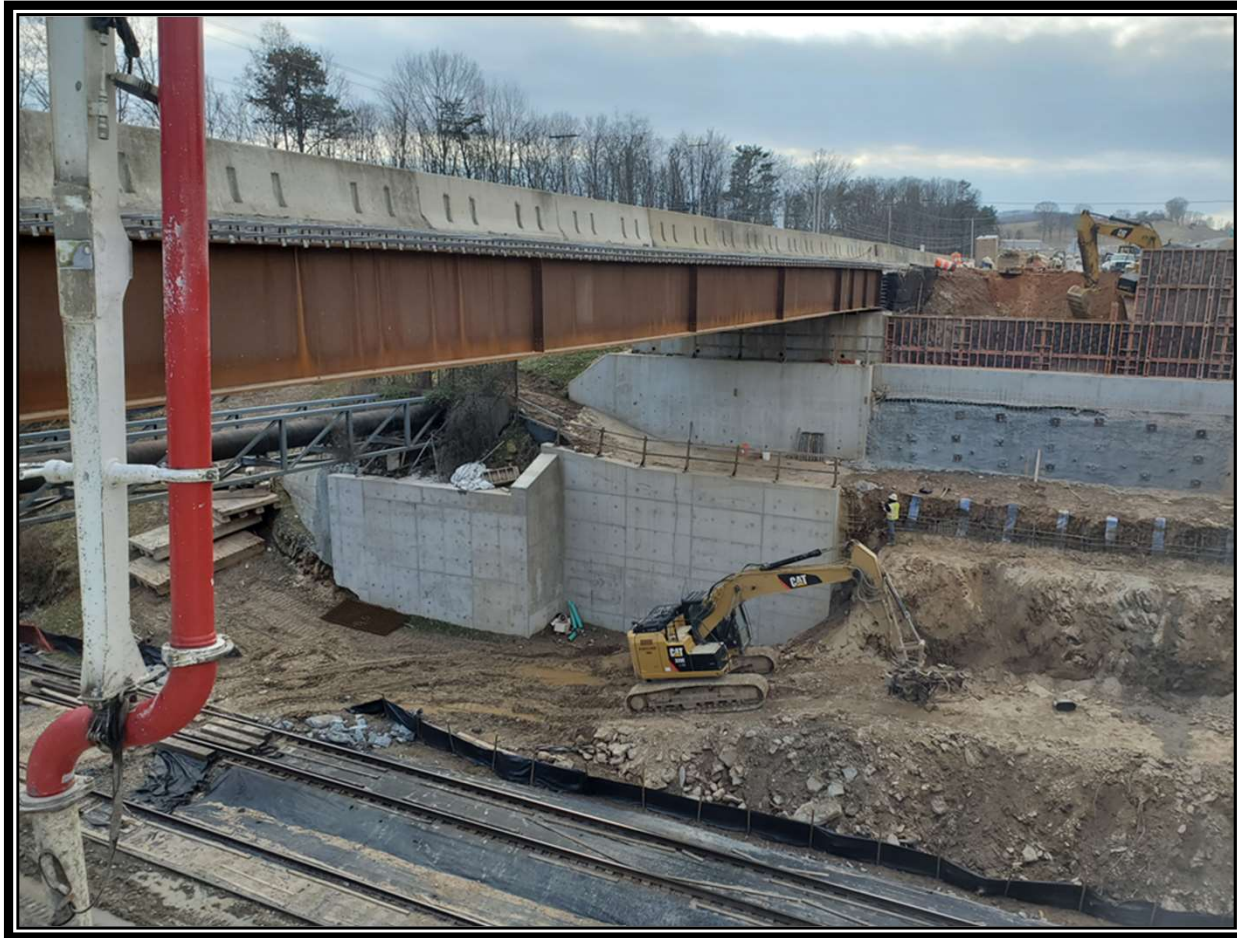
Drilling Soil Anchors

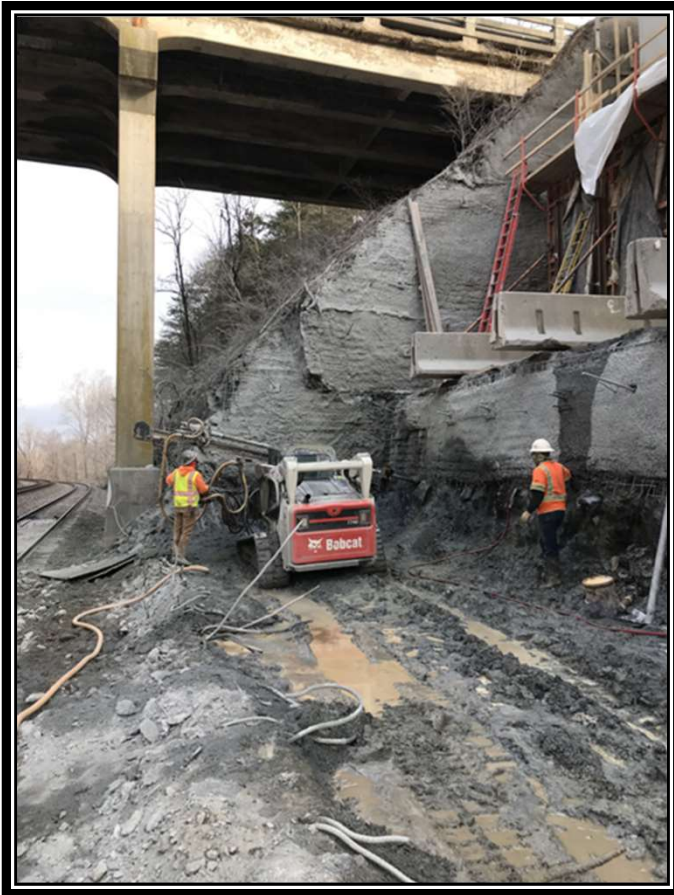
Installing soil nails with Bobcat

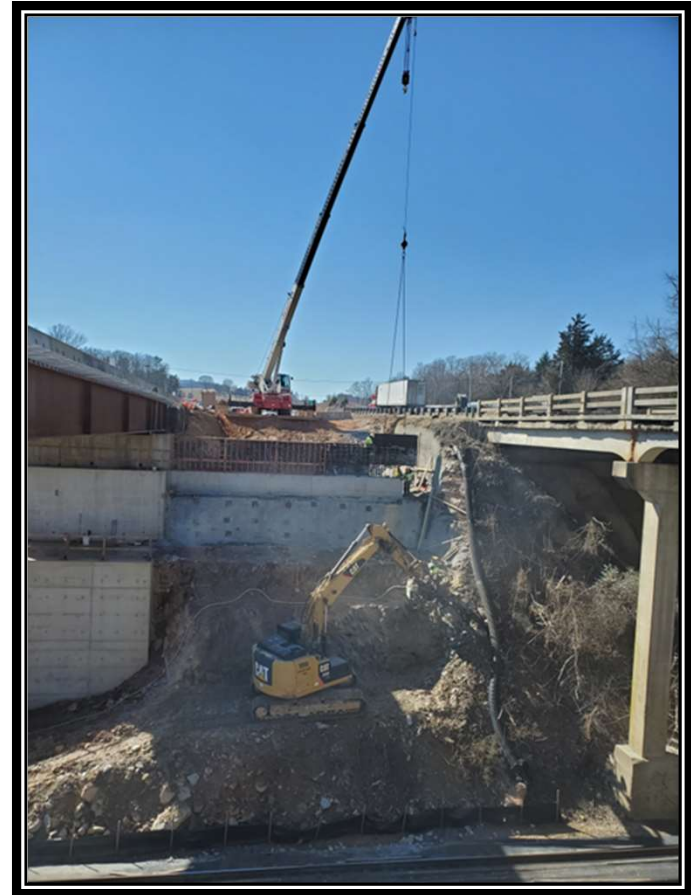
Installing soil nails with excavator

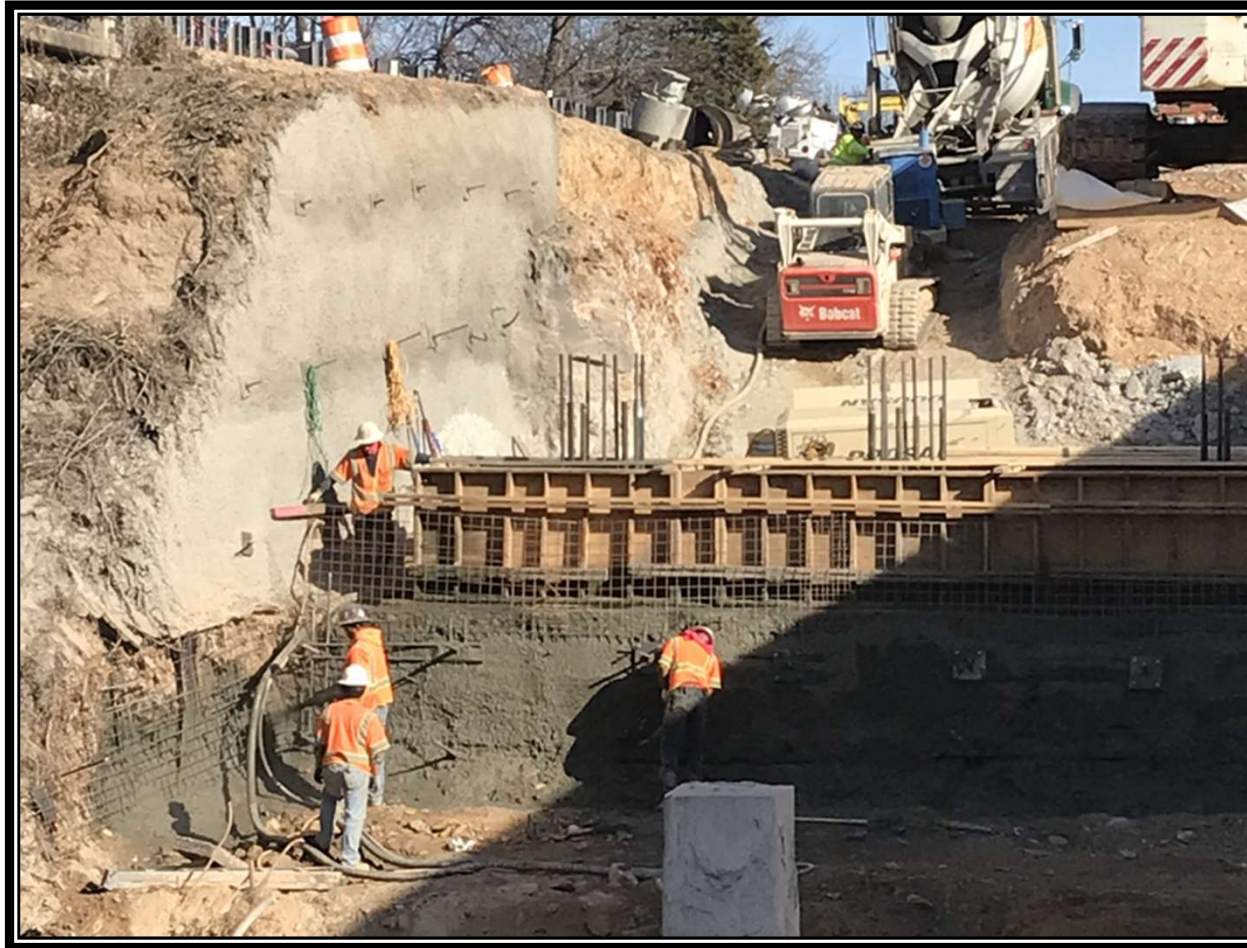
Pouring Cast in place Concrete Portion of Wall

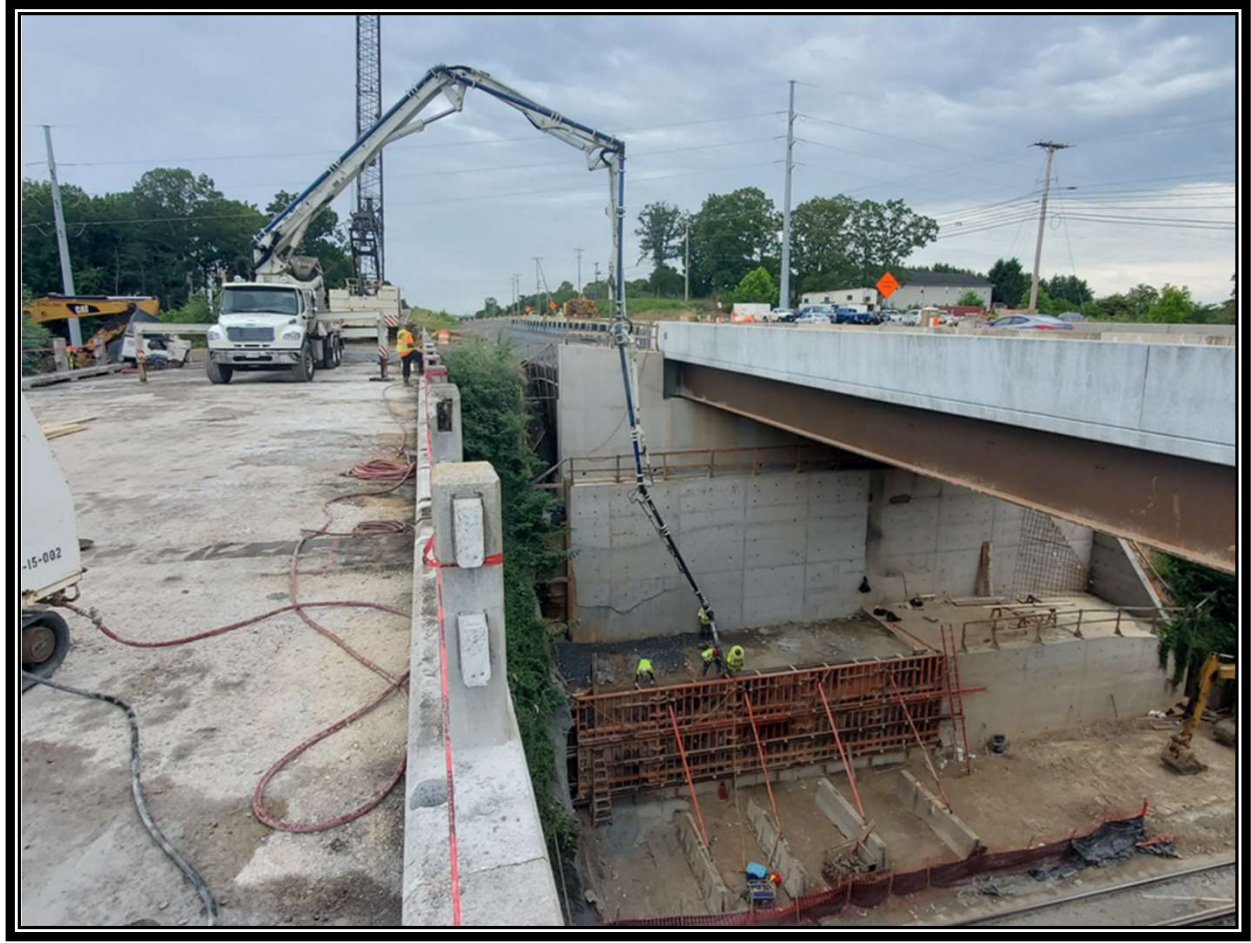
One Sided Forms

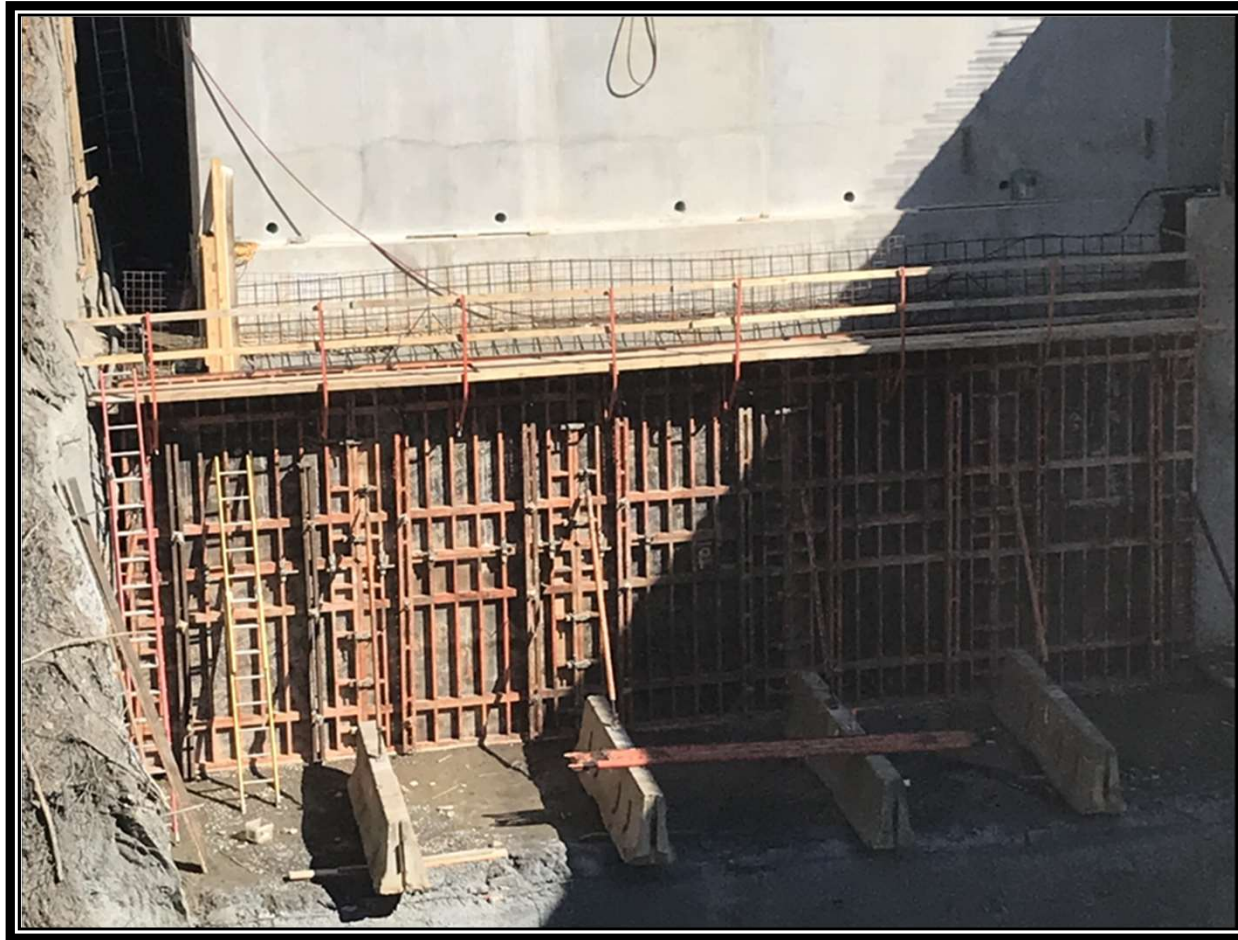
Modified Wall

Modified wall layout to protect existing waterline bridge

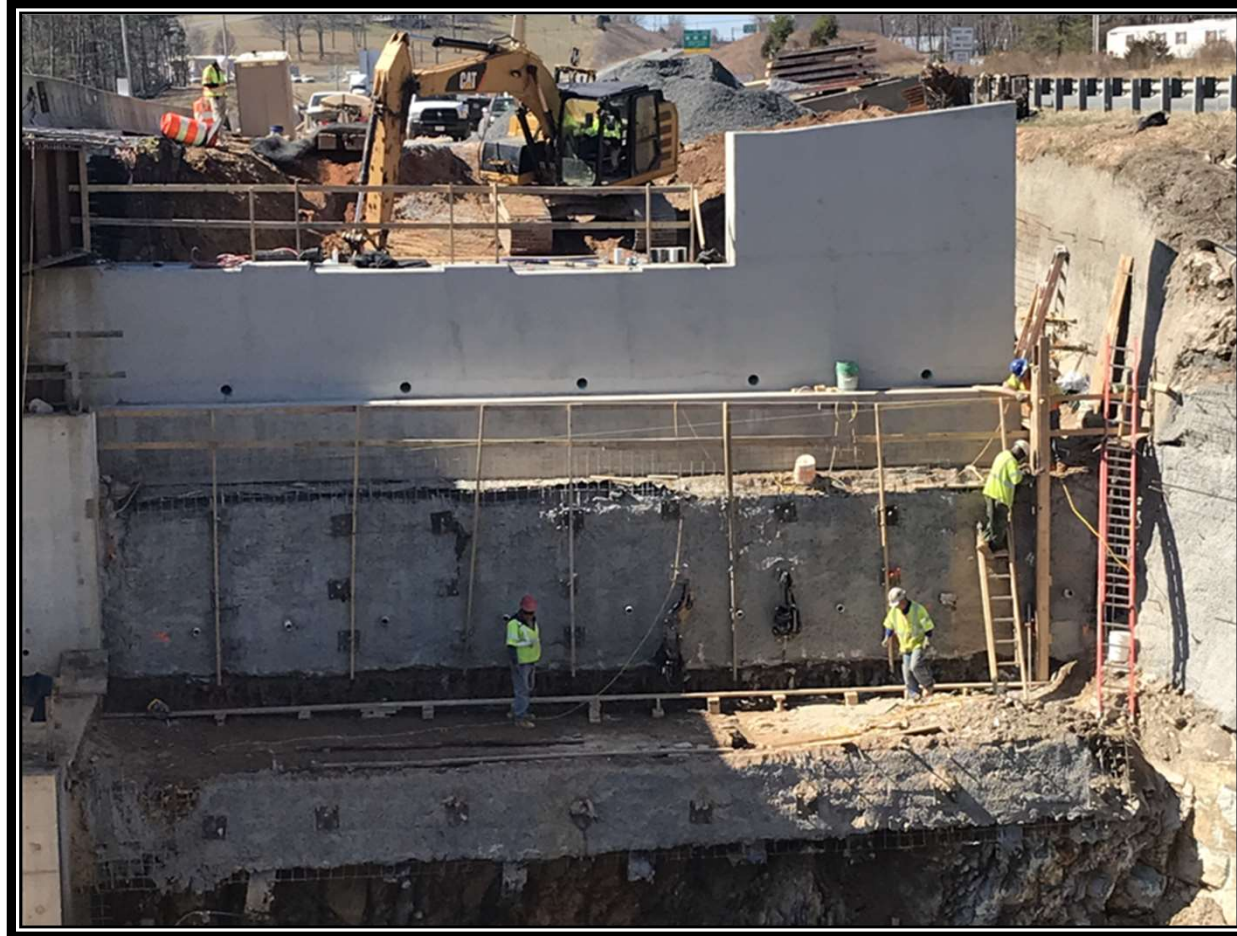
Soil-nail wall with shot-crete

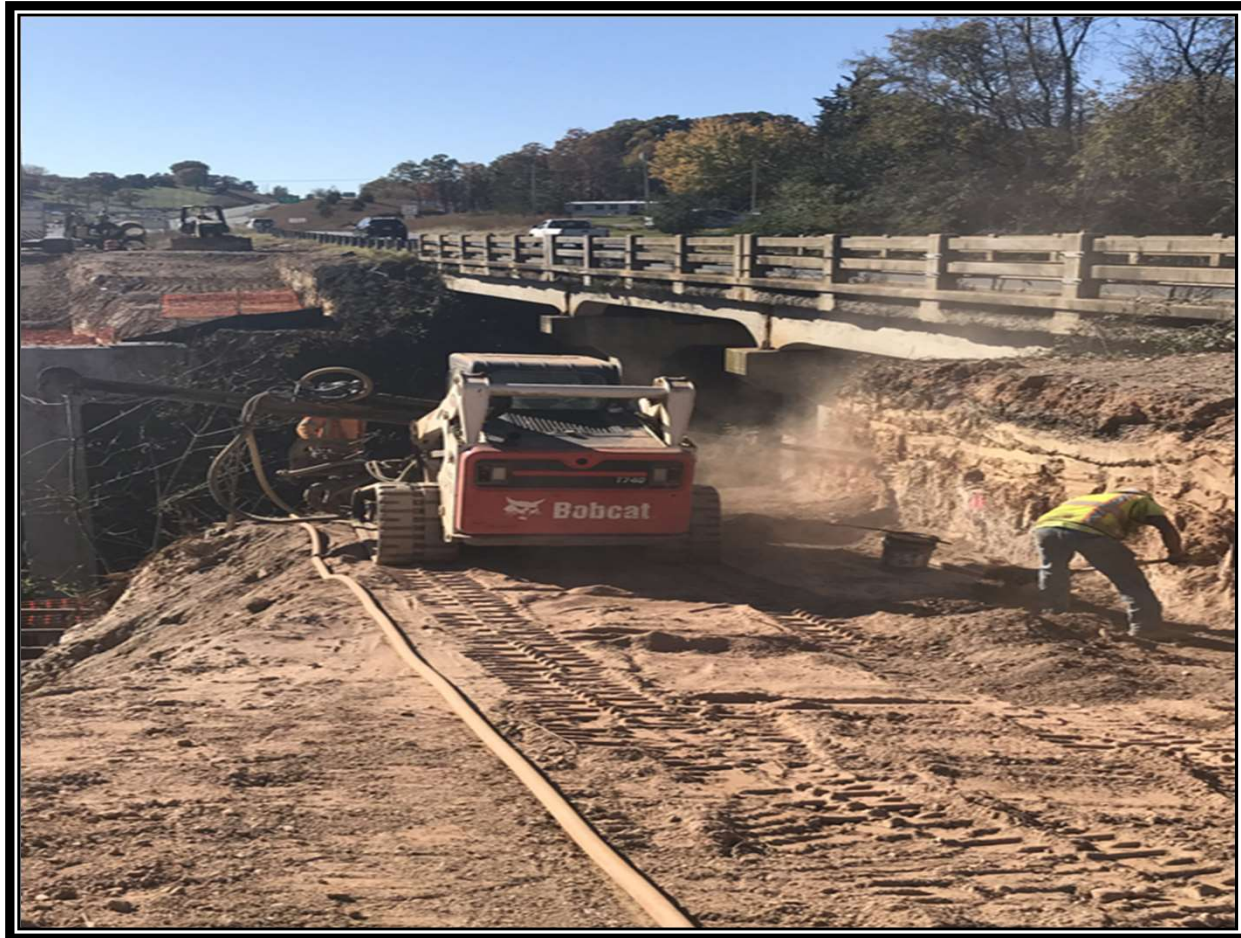
Soil nails to
the left and
Wire
Baskets to
the right

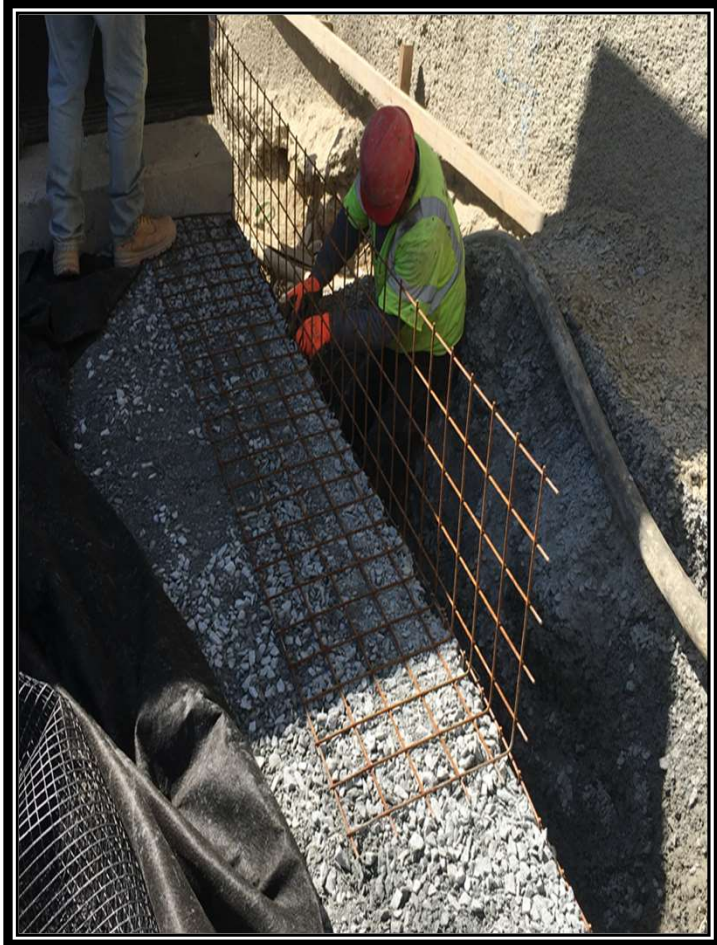
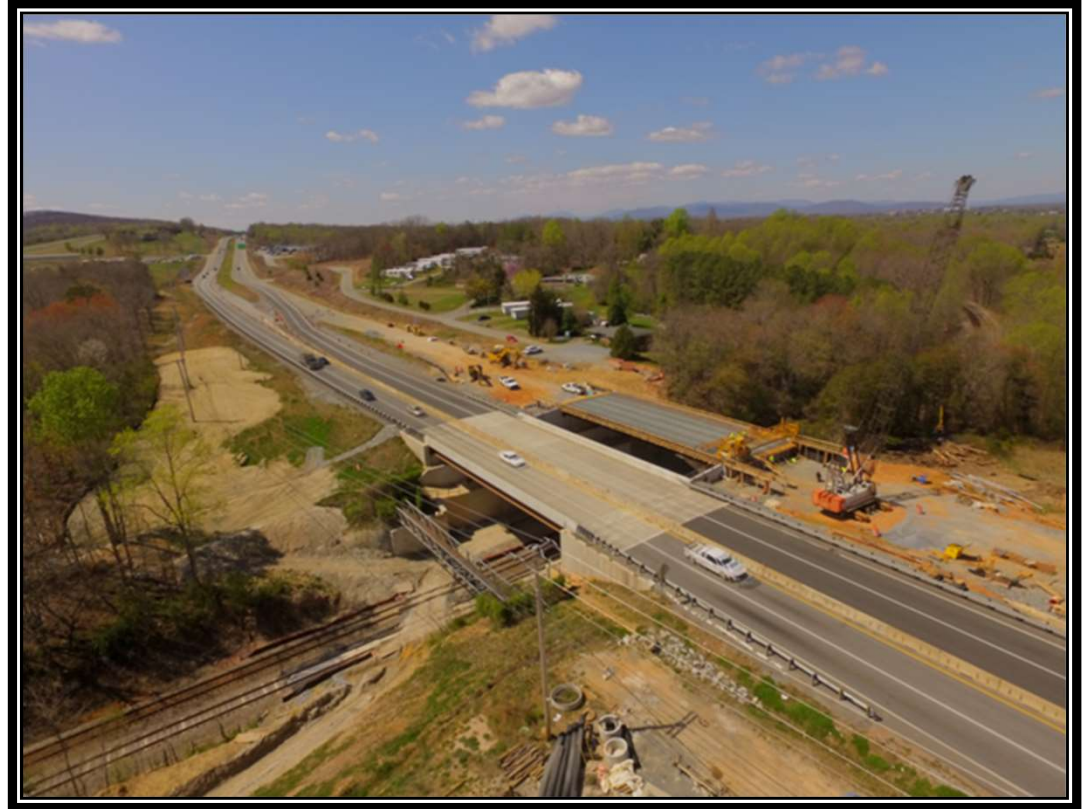
Wire Basket Shoring

Geogrid
Geotextile
Wire Basket and select aggregate fill

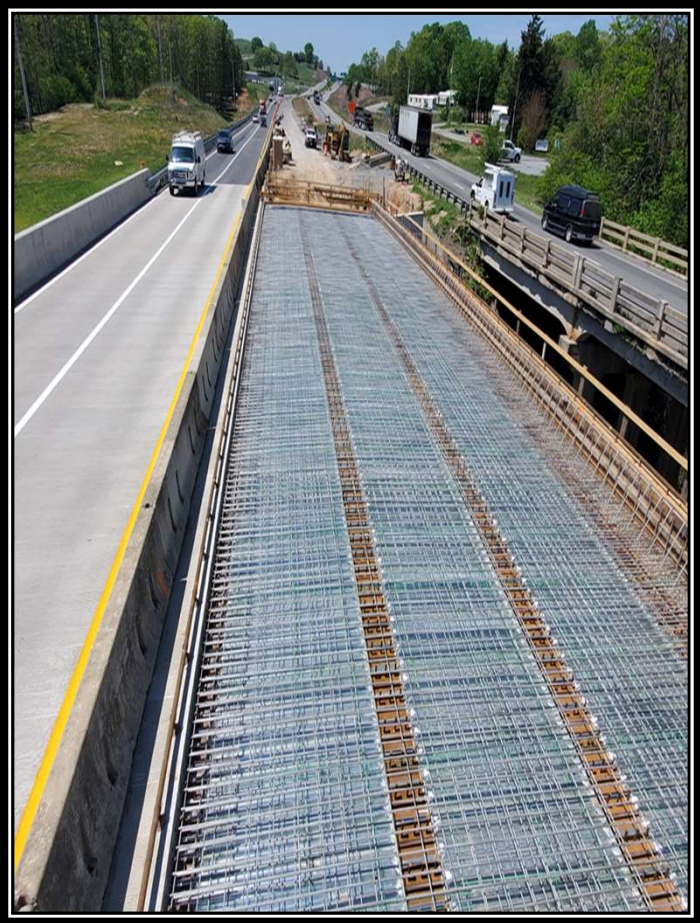
Phase 2 Deck

Screed support on left side on girder partially loaded in Phase 1

Right side supported by unloaded girder

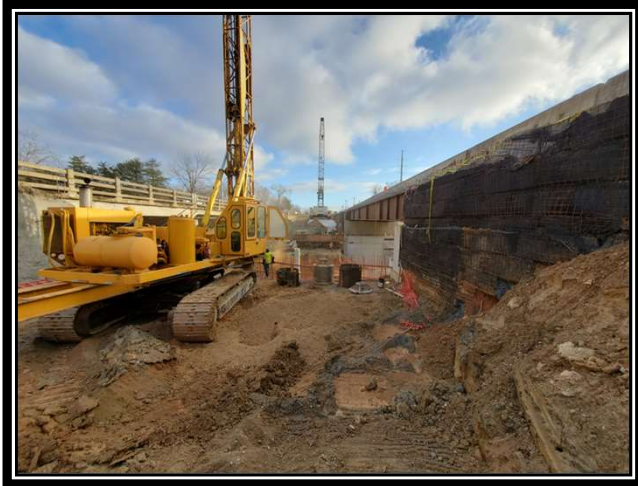
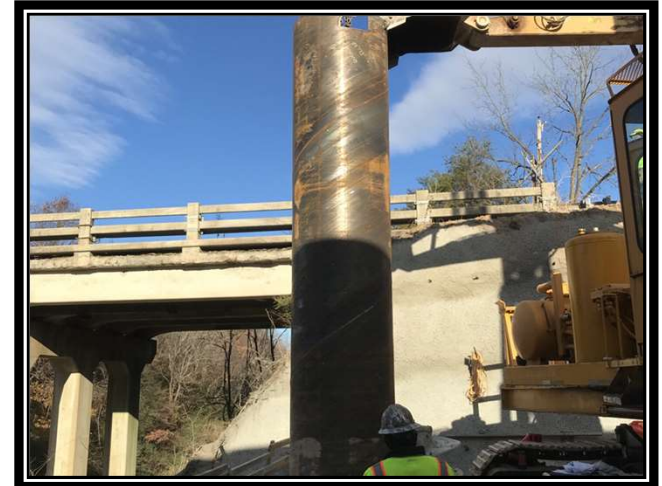
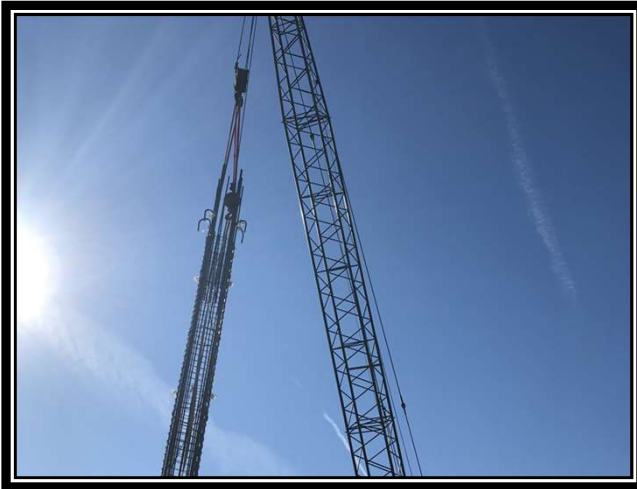
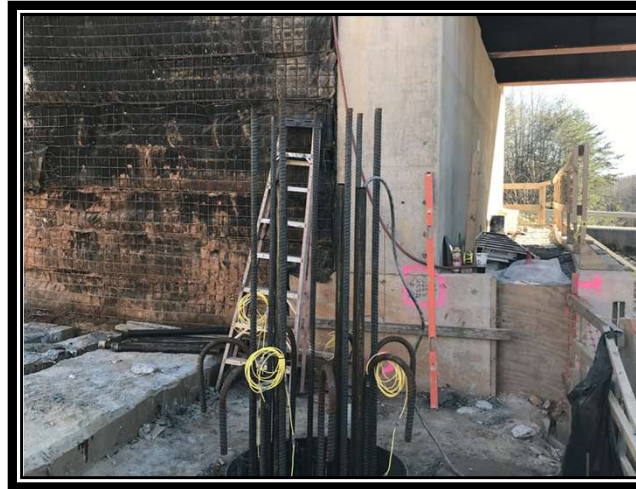
- 42" Drilled Shafts
- Permanent Steel Casing
- CSL and TIP Testing
- 37 shafts total

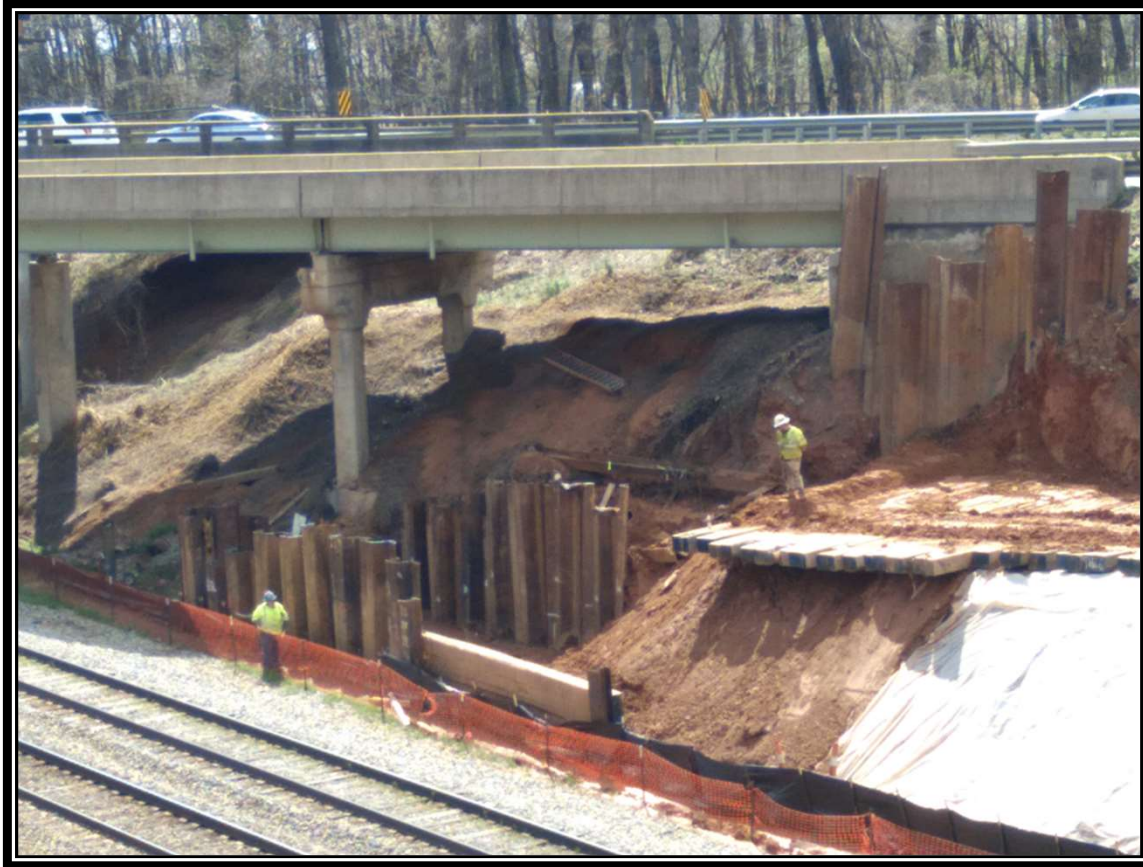
Limit of Pier 2 Shoring to Plans

Pier 2 Foundation redesigned based on site conditions observed in the field.

- **Bed Rock climbed significantly from west to east**
- **Pier 2 Shoring and Pile could not be installed per plan**
- **Pier 1 was proactively drilled by WCE and the same issue was found. The footing was redesigned.**

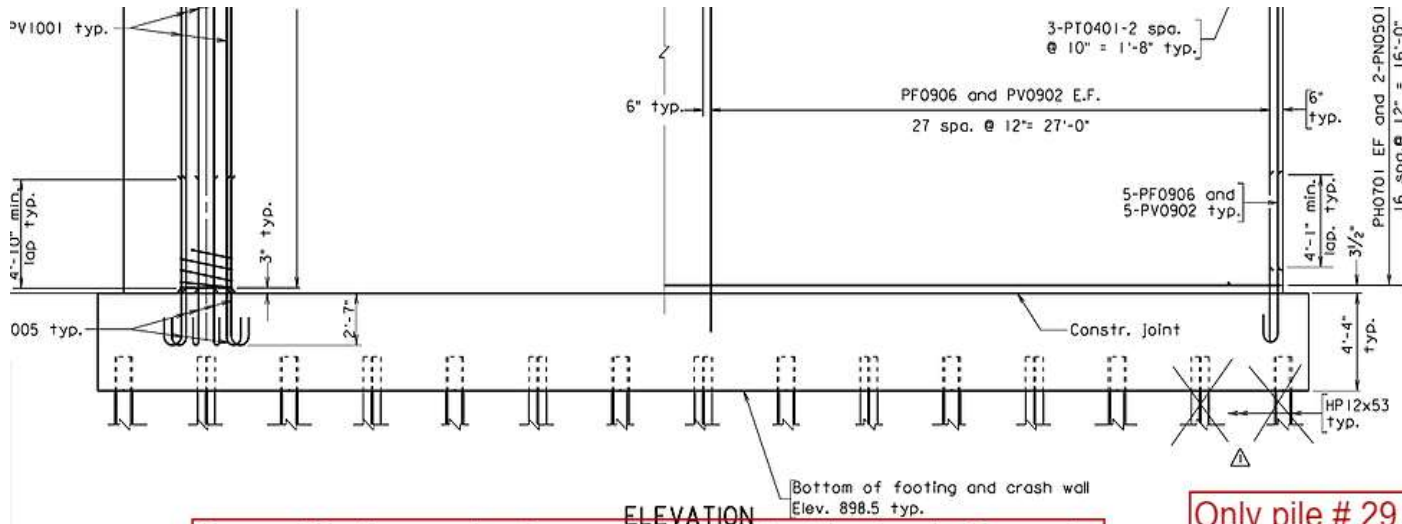
Pier 2 Revision

Spread footing region bears on competent bedrock. Spread footing designed for a factored bearing resistance of 15.4

Only pile # 29 and 30 are omitted

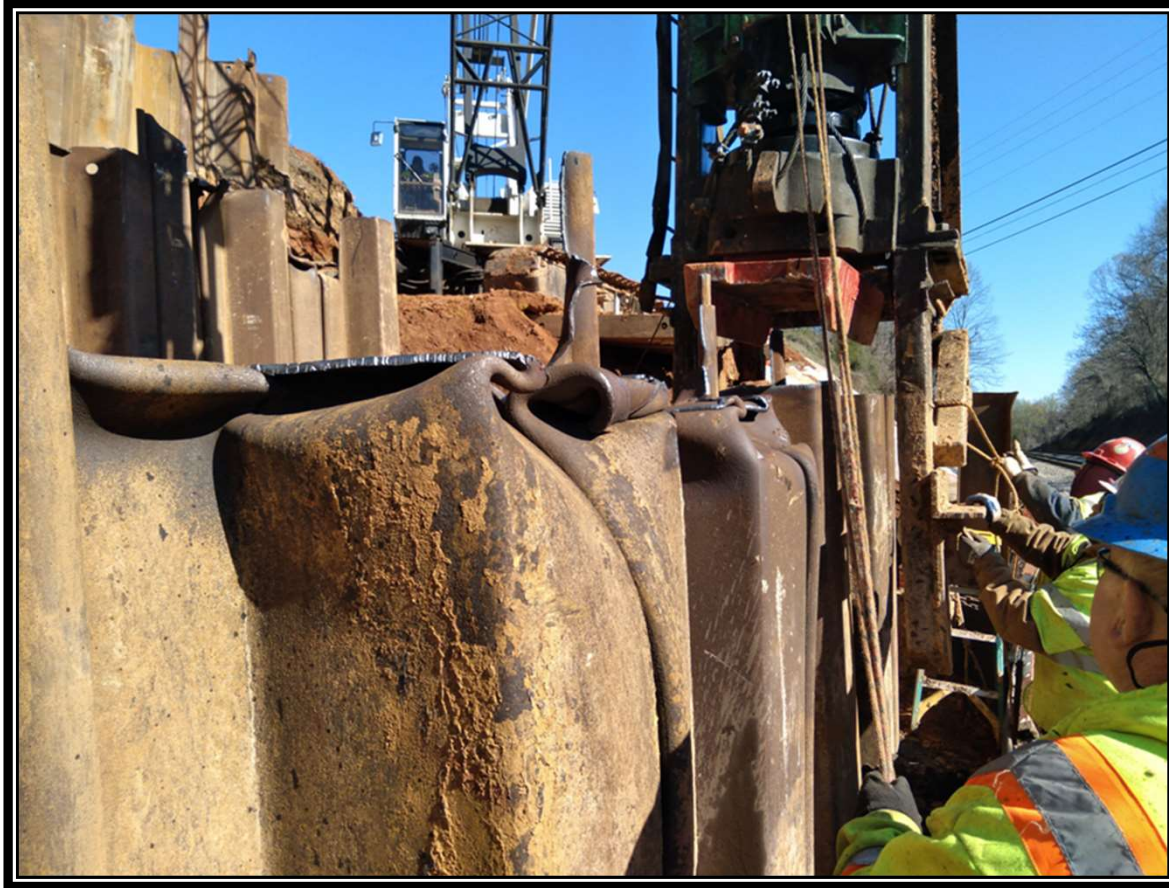
Sheet Pile Driven past refusal

“Yes we are sure we have driven as deep as possible”

Footing for Pier 2 was redesigned

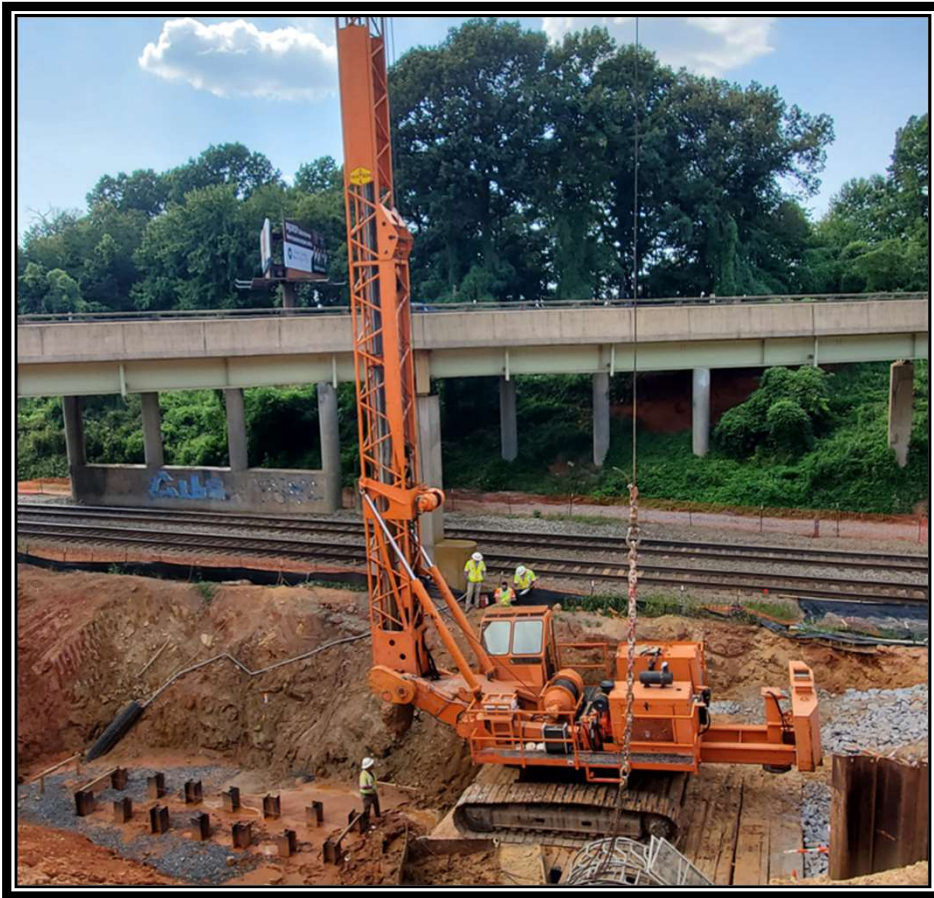
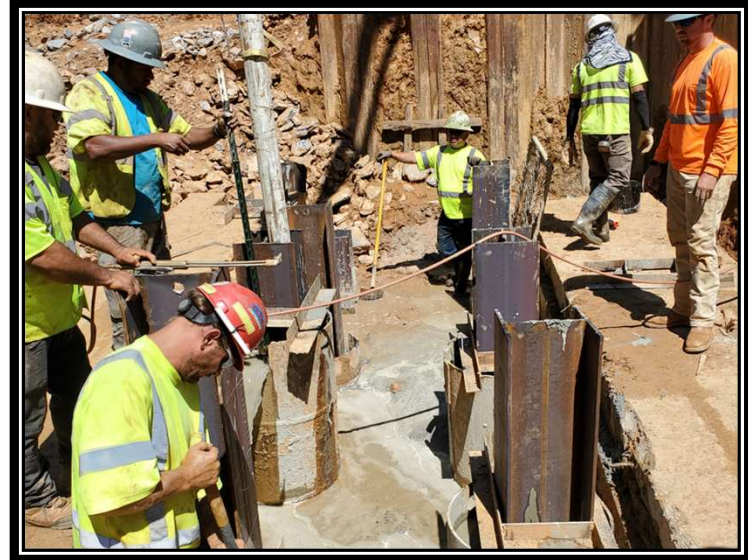
Drilled Piles Pier 1

To avoid the issues at Pier 2 borings were done and pier 1 was redesigned to pre bore for the piles

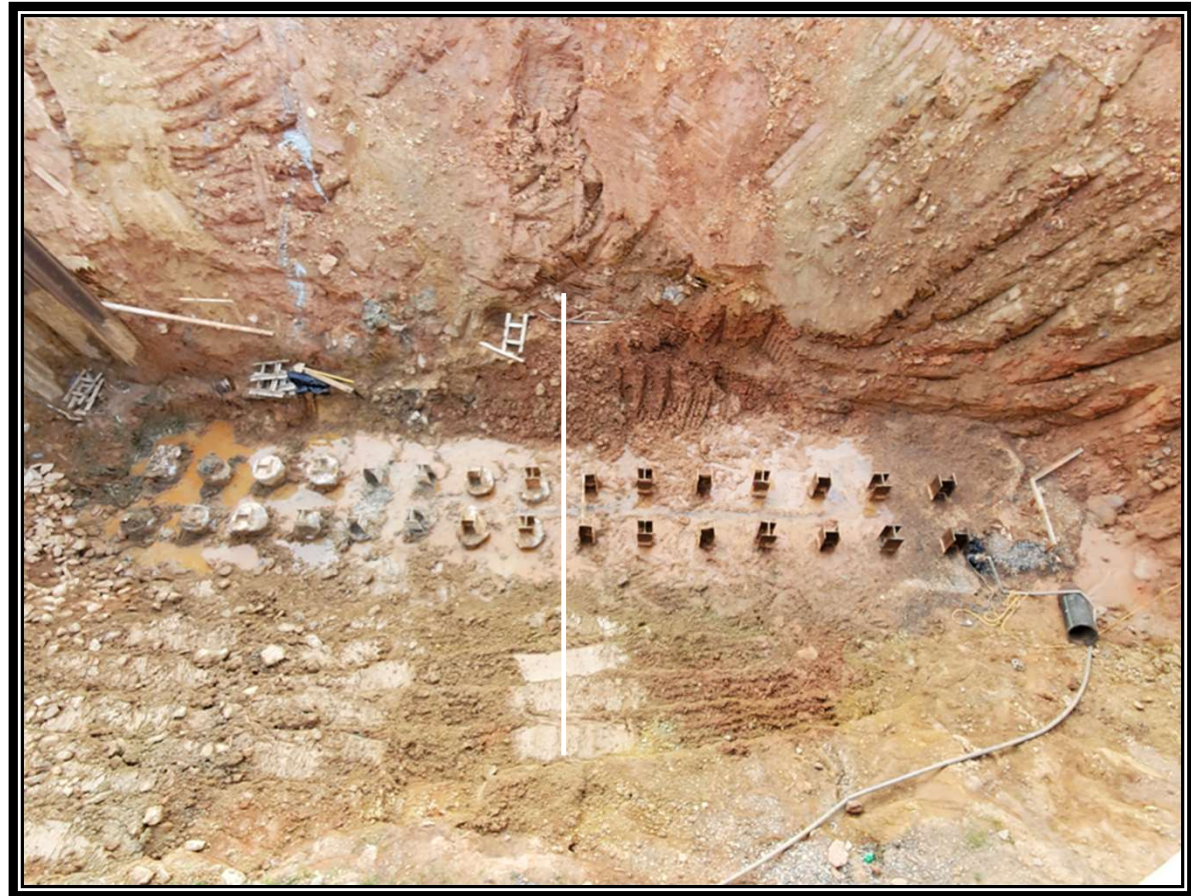
Pier 1 Piles

Approximately
half driven as
planned and
half pre drilled
and grouted in
place

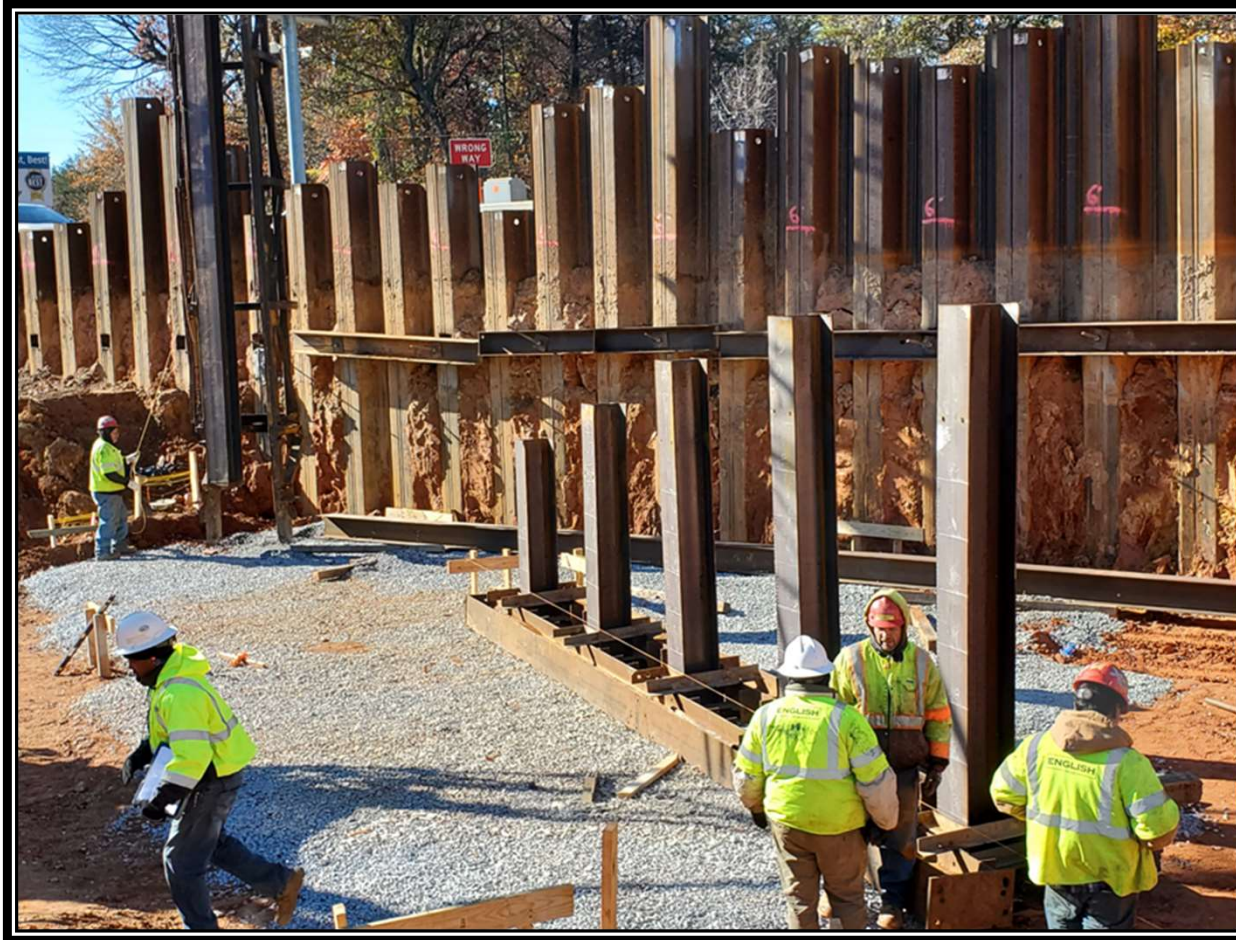
Shoring With Tiebacks

- Tie back shoring
- Problems with battering pile and conflict with sheetpile and the hammer being over a lane of traffic

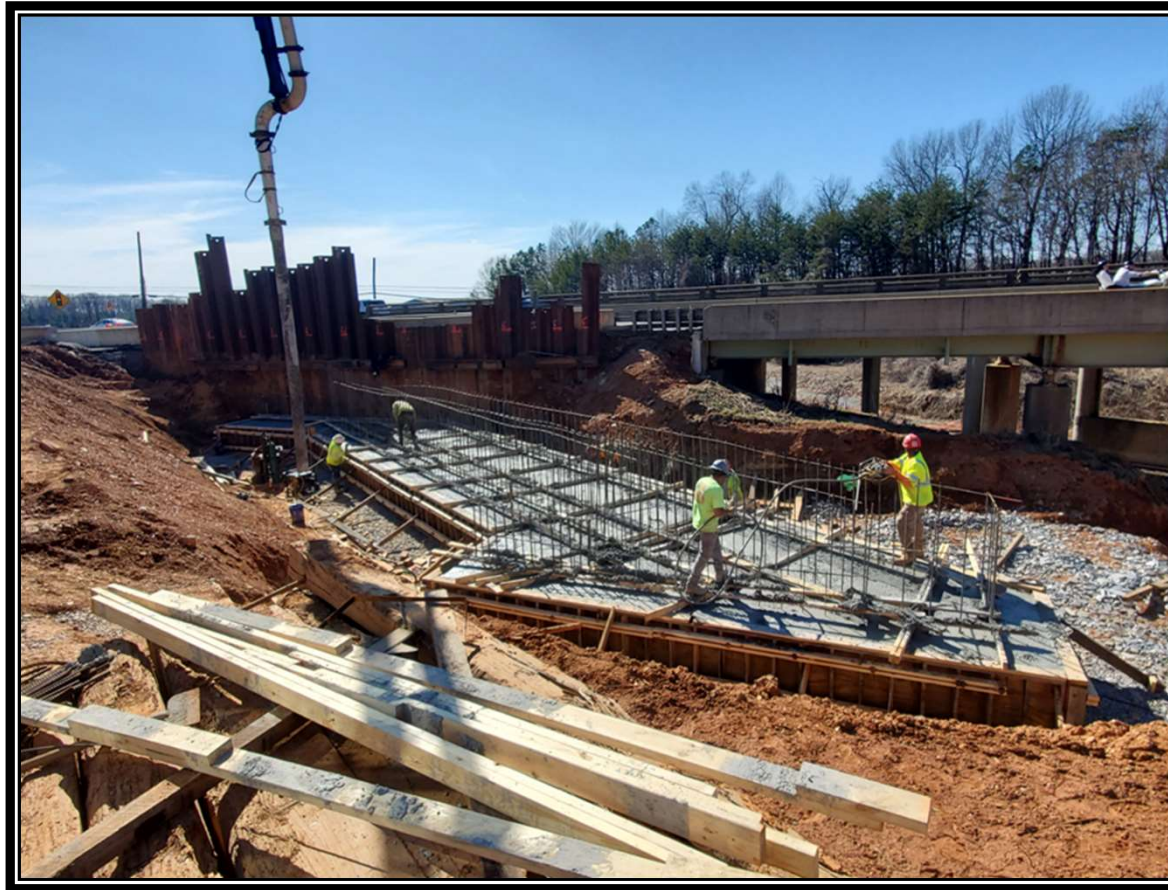
Abutment Footing

- 70 feet long
