RTE 29 NBL/SBL OVER NS RR (JUMBOS) RTE 29 NBL OVER NS RR (AIRPORT)

VTCA - Lynchburg District Dialogue April 2023

April 20, 2023

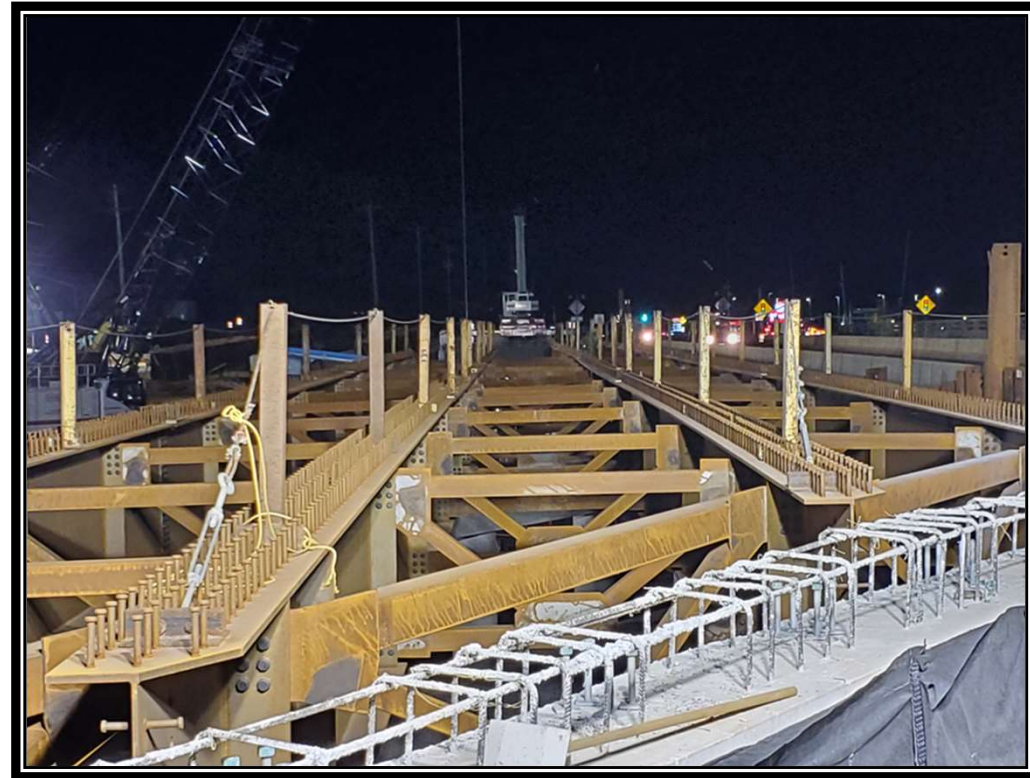
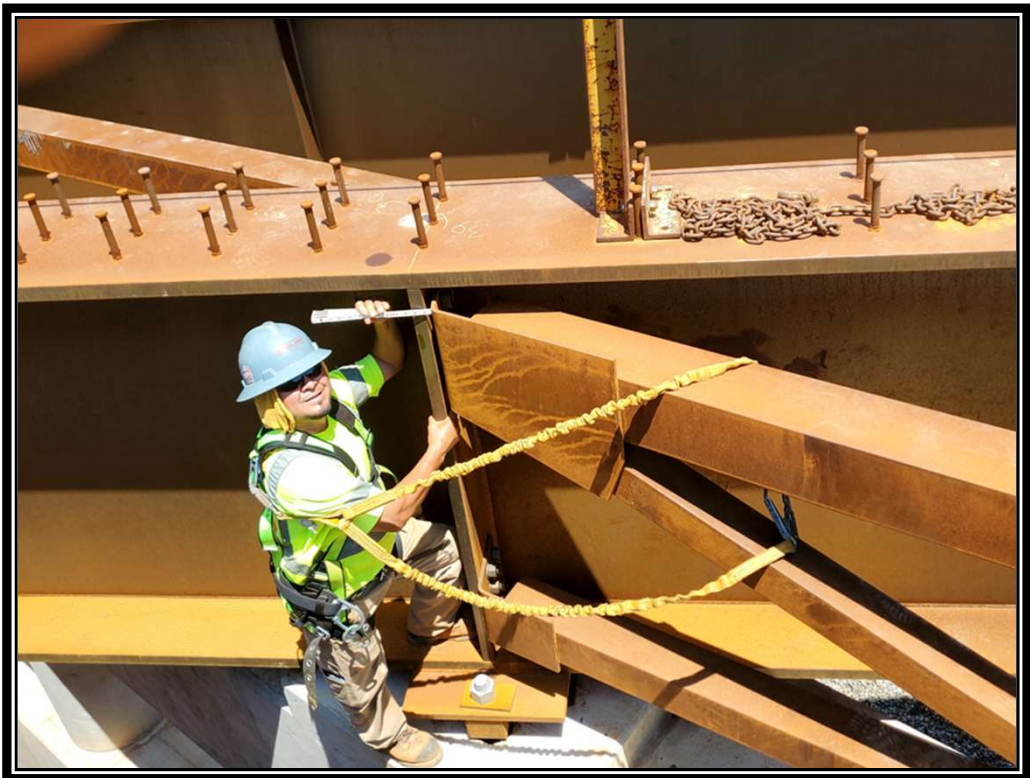
Setting Structural Steel

Skew made fit up of diaphragms harder

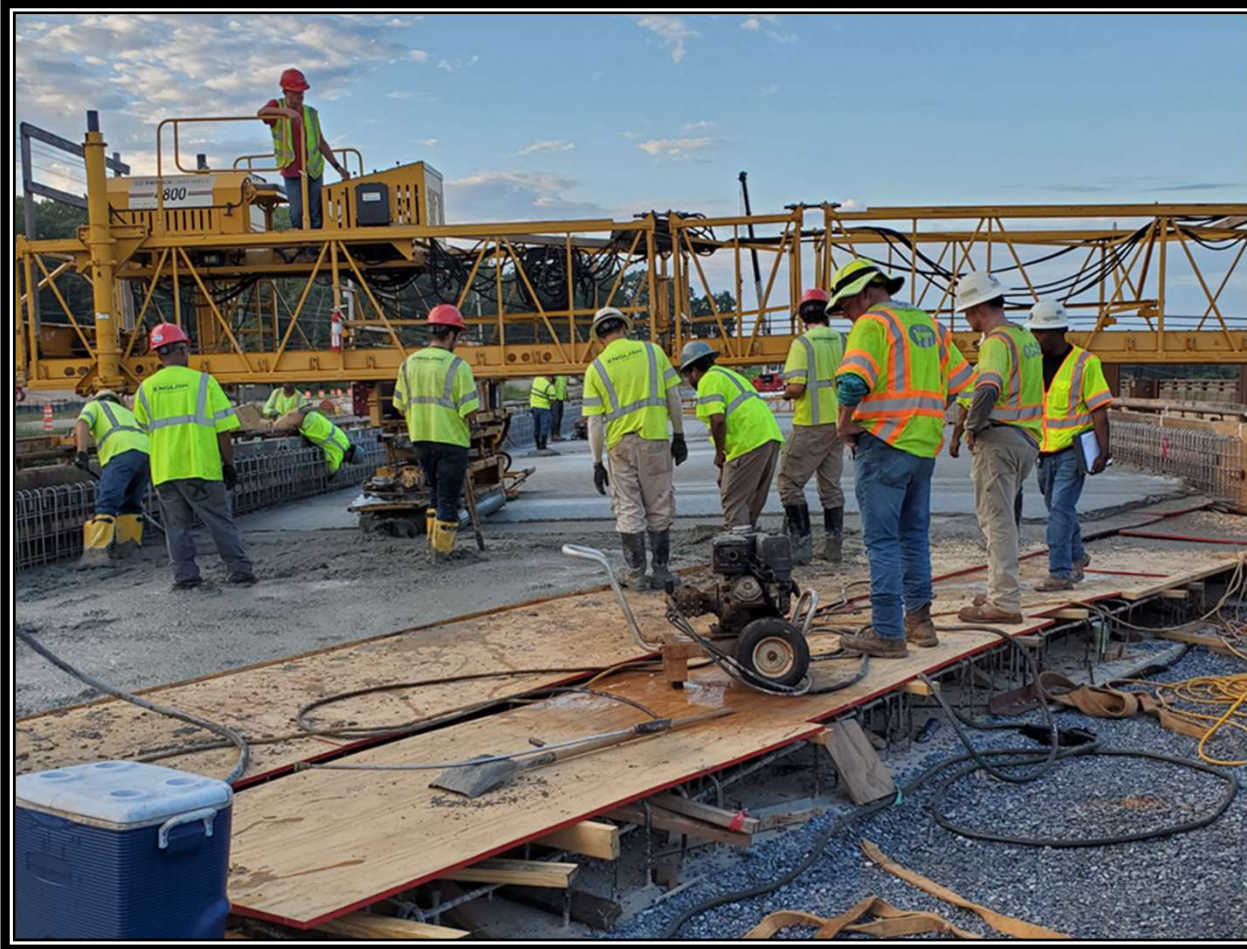
Deck Poured on Square

- When screed was set up on the skew one side stuck out in traffic so it was poured on the square.
- This makes it more difficult to deal with the end of the screed at a different deflection point that the other side.
