SAE TECHNICAL PAPER SERIES

2003-01-0492

Practical Analysis Methodology for Low Speed Vehicle Collisions Involving Vehicles with Modern Bumper Systems

Andrew J. Happer, Mark C. Hughes, Michael D. Peck and Susanne M. Boehme
Sintra Engineering Inc.

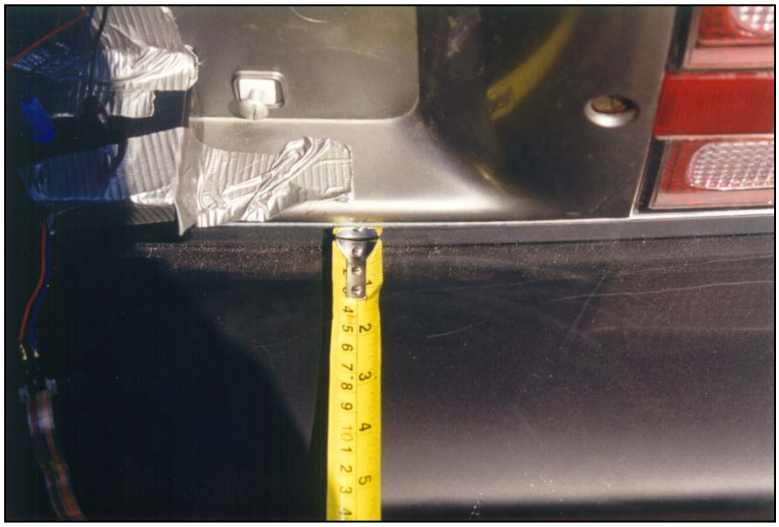
TEST #51: 2.34 M/S CLOSING SPEED

During vehicle-vehicle Test #51, the Buick Park Avenue exhibited two localized regions with scuff marks on the rear surface of its bumper cover (Photo D5). These marks were from contact with the Chevrolet Blazer's tow hooks and this damage was not observed during the Buick's barrier tests. The Buick Park Avenue also exhibited longitudinal scuff marks on the top surface of its bumper cover that extended 21 mm from the trunk lid. In its lowest severity barrier impact (Test #17), the Buick Park Avenue absorbed 407 J but did not exhibit any damage. Thus, this energy value provides a lower limit to that absorbed by the Buick during vehicle-vehicle Test #51.

Photo D5 – Rear of 1998 Buick Park Avenue exhibits scuff marks and tow hook imprints on bumper cover.

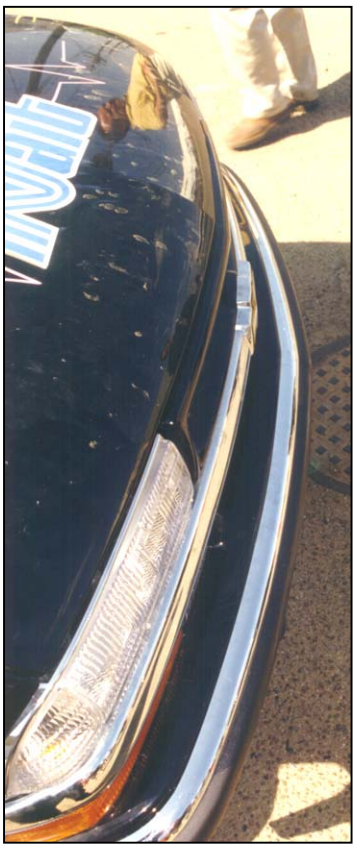
In vehicle-vehicle Test #51, the Chevrolet Blazer's front face bar was displaced rearward by 6 mm and a left bumper mounting bolt was shifted (Photo D4). Similarly, in barrier Test #2, the Chevrolet Blazer's face bar exhibited an average displacement of 6 mm and mounting bolts on both sides were shifted about 2 mm. The centre of the face bar showed localized deformation during the barrier impacts that was not observed in the vehicle-vehicle testing. This damage was not observed during the tests with the Buick Park Avenue as the impact force was distributed more evenly over the front surface of the face bar during the vehicle-vehicle tests. Nonetheless, the 450 J absorbed by the Chevrolet Blazer during barrier Test #2 likely provides a lower limit.

Photo D4 – Front face bar of 1999 Chevrolet Blazer displaced rearward by 6 mm.
