Program Summary:

A restoration reclaiming the cathedral's historic beauty, blending craftsmanship with modern systems and preserving its sacred character.

This 1916 Dutch Romanesque Revival church had undergone several renovations. The most recent in 1984 covered much of the original ornamentation. The building suffered from water infiltration, peeling plaster, and harsh acoustics due to a crudely installed HVAC system. The stained glass was obscured by yellowed Plexiglas that trapped moisture, and the lighting was ineffective. What began as a renovation soon turned into a reclamation of the church's original grandeur. Historic photos revealed its former beauty, guiding our approach to restore and enhance the space. We sought to blend the craftsmanship of artisans with modern innovations in acoustics, mechanics, and lighting engineers to create a design faithful to the past, but with an eye towards the future. The exterior was restored to prevent water infiltration, and the Plexiglas was replaced with vented glass to protect the stained glass. Interior plaster walls were repaired and adorned with artwork reflecting the church's 1916 heritage. Lighting was updated, and acoustics i

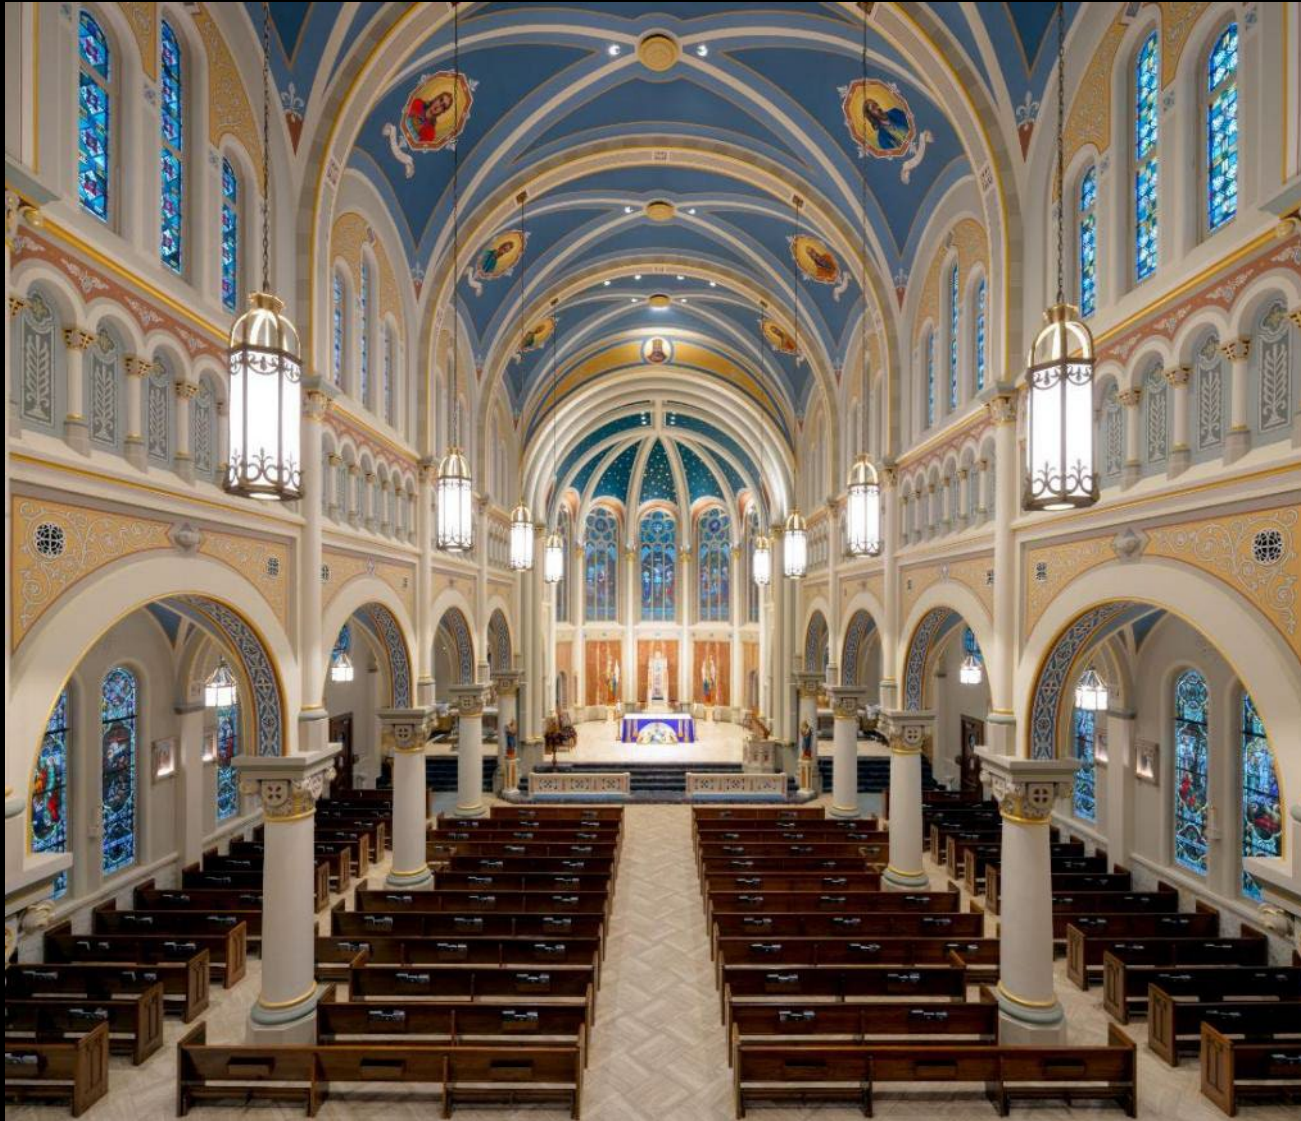
RR205.07

Restored and renovated cathedral interior from the choir loft.

The renovation repaired and restored the cathedral's details throughout while integrating improved acoustics, lighting, and mechanical systems into the structure.

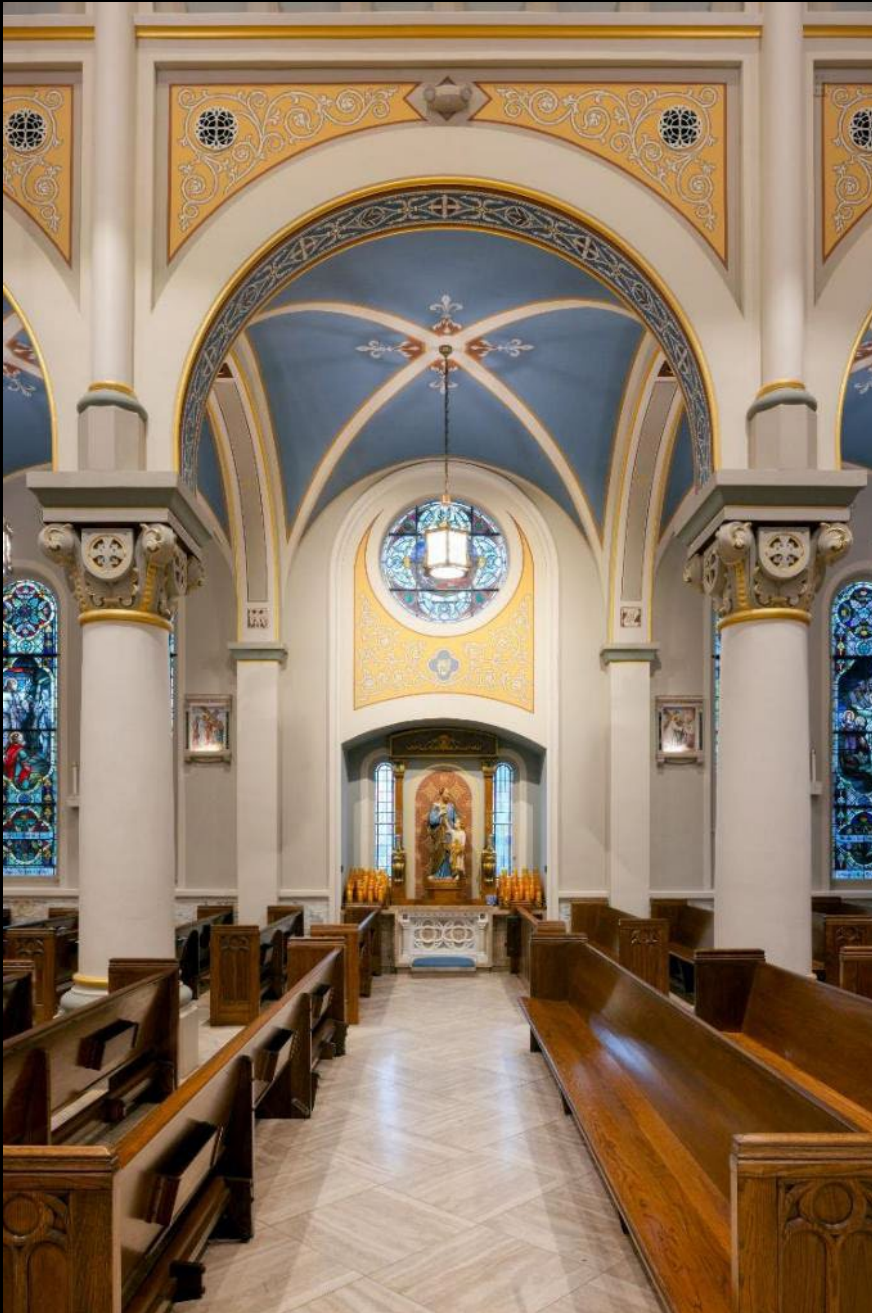
RR205.08

The renovation highlights the side shrines with new artwork and improved lighting and mechanical systems.

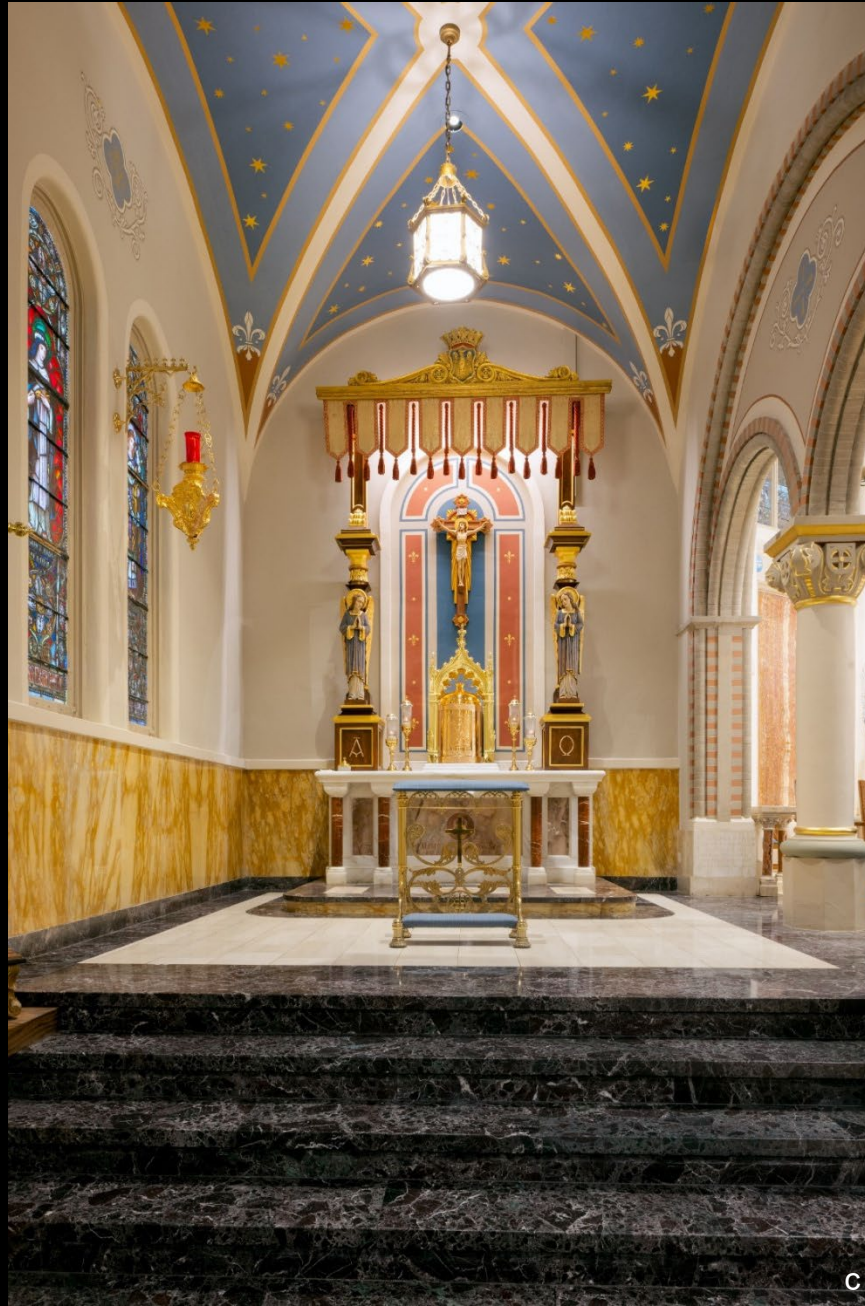
c

Side shrine after renovation. (c)

Ineffective and distorted lighting was replaced with new or refurbished fixtures.

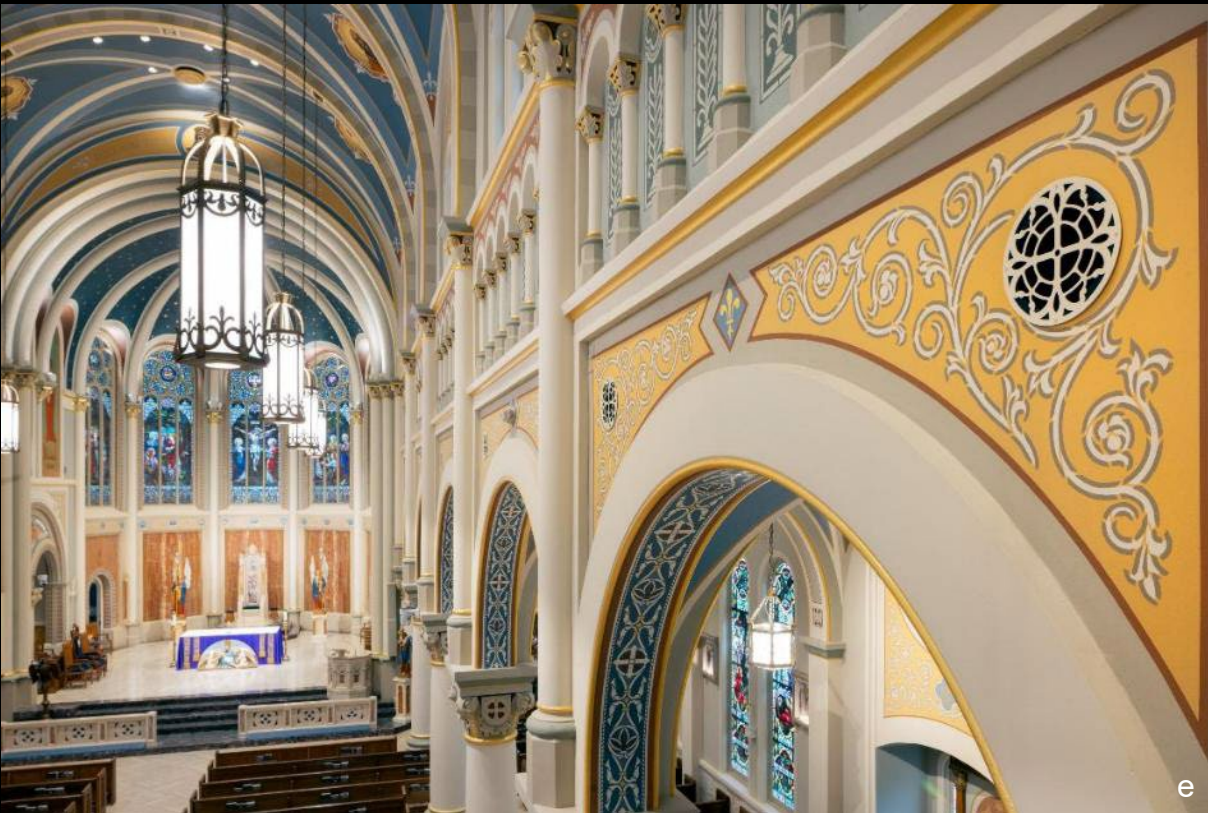
Diffusers after renovation. (e)

Ineffective, loud, and prominent diffusers and exposed ducts were replaced with a quieter and discreet diffusers that condition the air more evenly throughout the space.

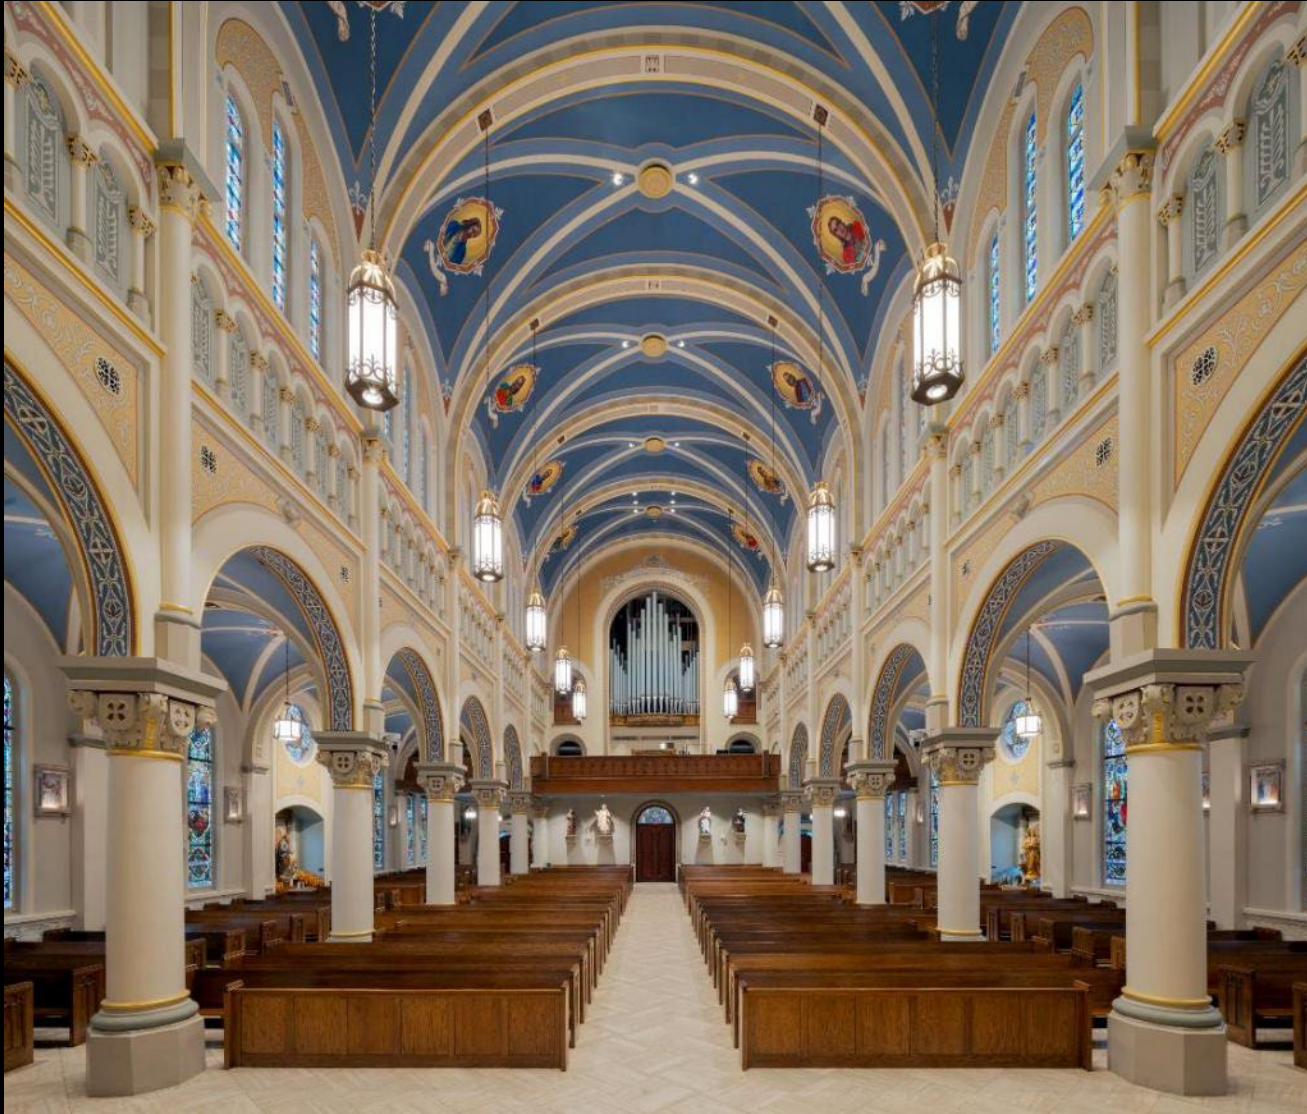
RR205.12

Restored and renovated cathedral interior from the sanctuary.

From the repaired plaster to the updated artwork and mechanical systems the renovation addressed both functional and artistic aspects of the cathedral to enhance the sacred nature of the space.
