Florida Department of
TRANSPORTATION

Experimental Project 1

High Polymer (HP)

SR 45 / US 41, Nebraska Avenue

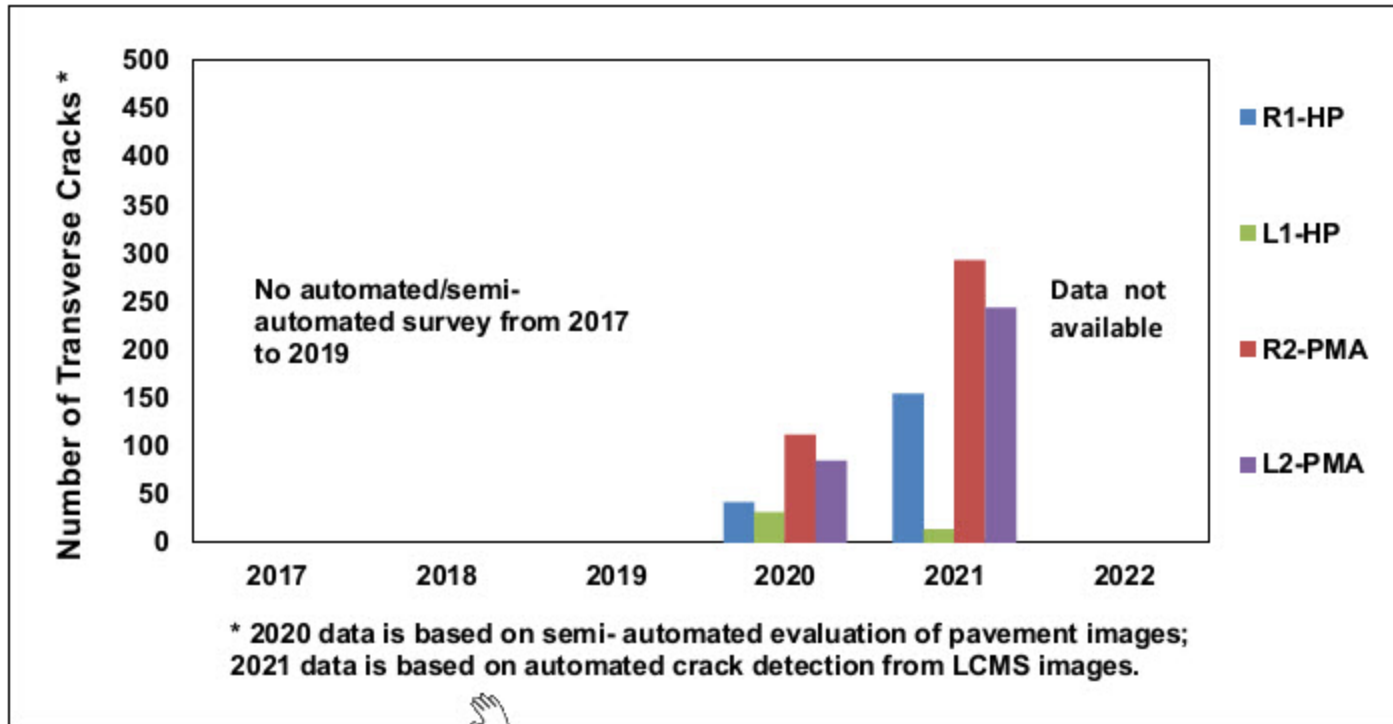
Figure 5 Transverse Cracking

Performance is evaluated in terms of cracking and rutting from 06/2017 to 05/2021.
