Gypsum Joint Ridging and Cracking Prevention

Overview

Revised 2/16/2017

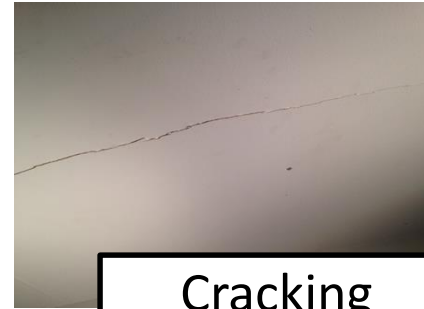
- Cracking and ridging are common problems that typically occur along large open spans.
- Both occur after drywall is exposed to alternating periods of high and low temperature and humidity.

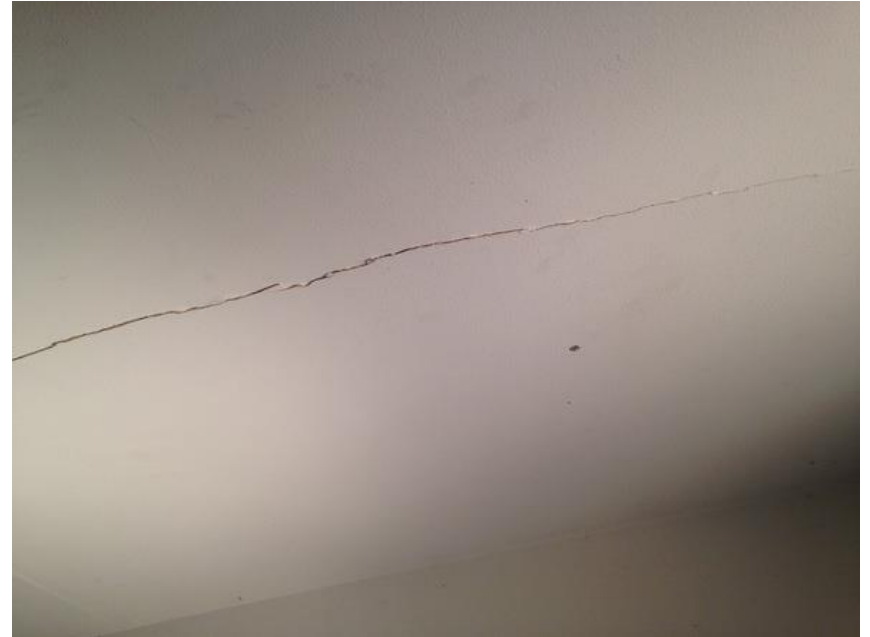
- Cracks
 - Often develop in the center of taped joints running parallel to tapered edges or factory seams.
 - May tear the drywall tape and grow over time.
 - May vary in width cyclically as the seasons change.

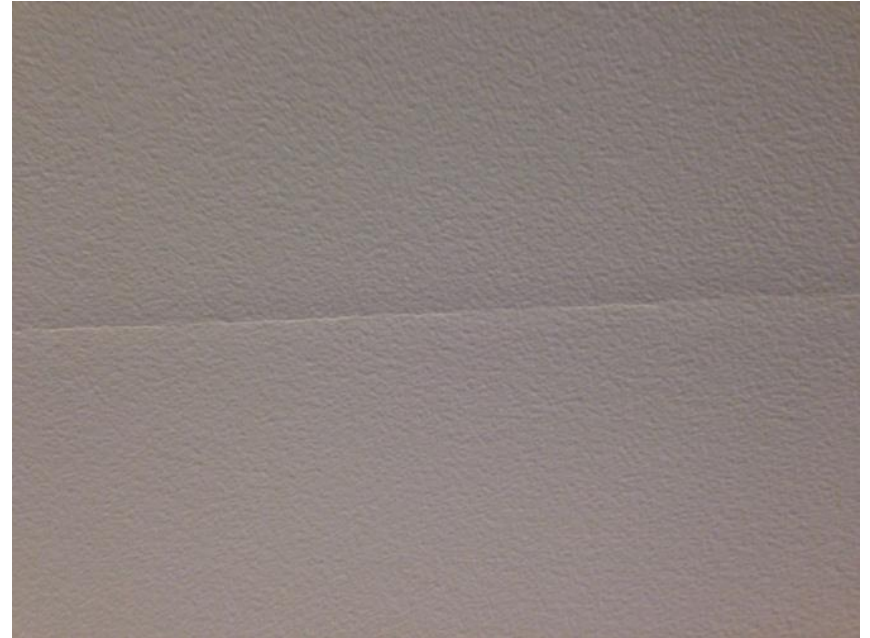
- Ridges:
 - Are small humps ($\approx 3/8$ " wide) along the taped joint of ceilings.
 - Are caused by the compression of panel ends or edges.

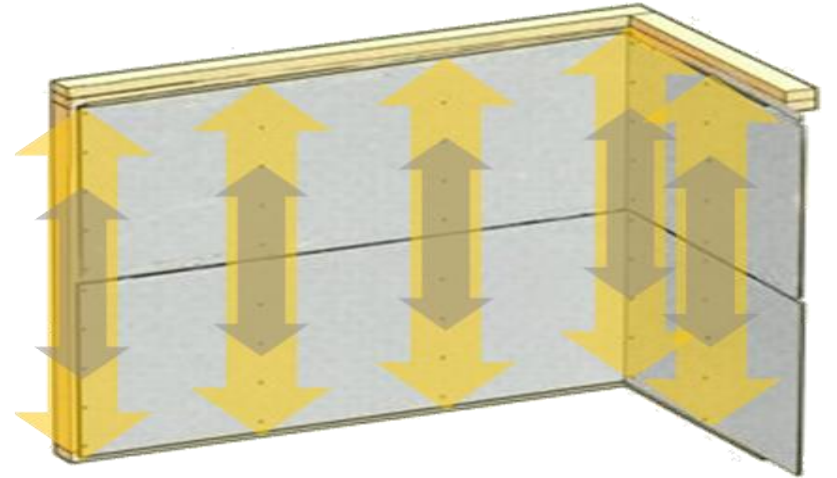
- When residences constructed in summer are subjected to increased humidity in winter, all of the construction materials expand.
- However, the framing lumber increases in length to a greater extent than the drywall.
- The different increase in length causes tension in the drywall, pulling the taped joints apart.

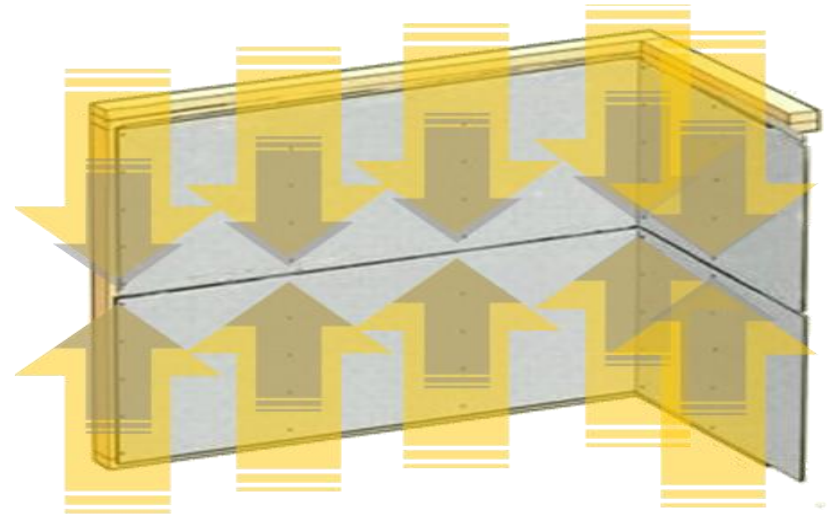
- When the same assembly is constructed in winter, the materials shrink in the drier summer months.
- Because the lumber shrinks more than the drywall, compression occurs in the drywall, producing ridging at the tape joint.

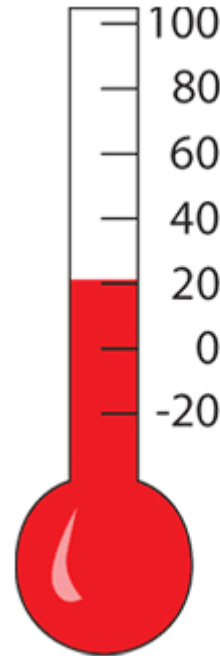
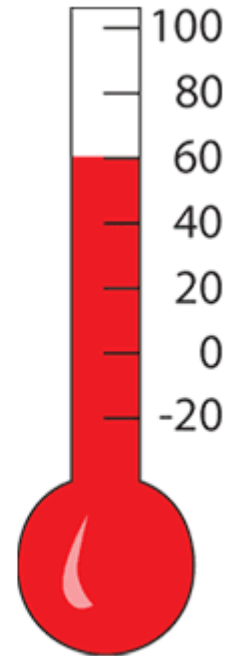
- Temperature shifts do not impact GRC strongly.
- Effects are generally immediate (within 24-36 hours) and small (less than 20% of the overall movement required to generate a crack).

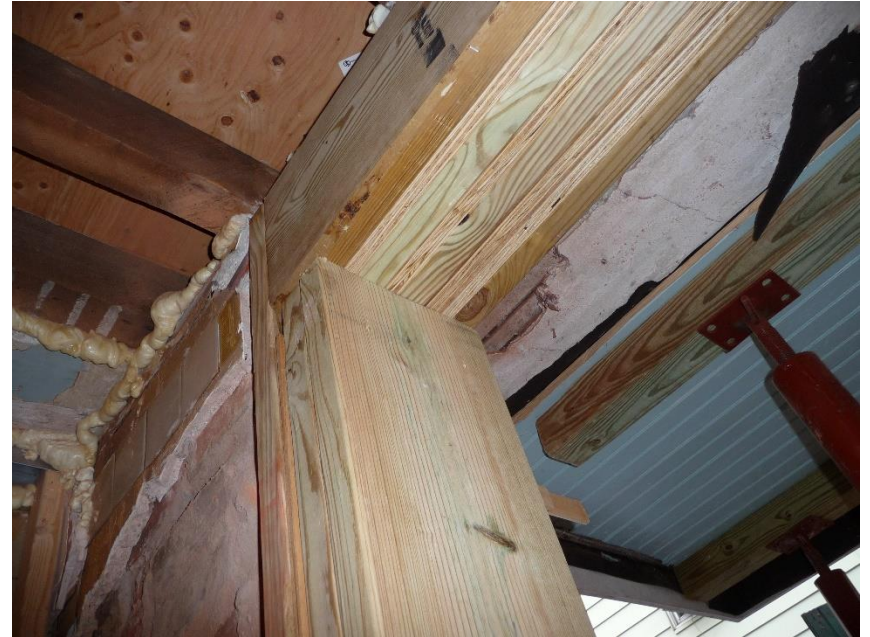
- Unseasoned (wet) lumber used in ceilings.
- Misaligned studs and headers around doors and windows.
 - Joints must fit tightly. There should be no gaps between the jack studs and the headers.
 - Headers need to be tight against the top plate of the wall or the cripple studs above the header.

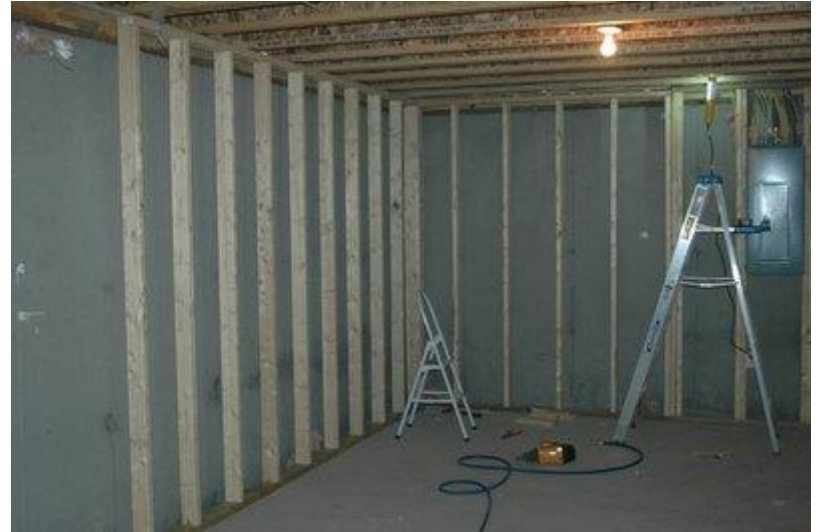
- Gaps:
 - Between wall top plates due to improper attachment.
 - Between studs and plates.
 - Caused by studs that vary in length.
- Long walls or ceilings with no breaks.

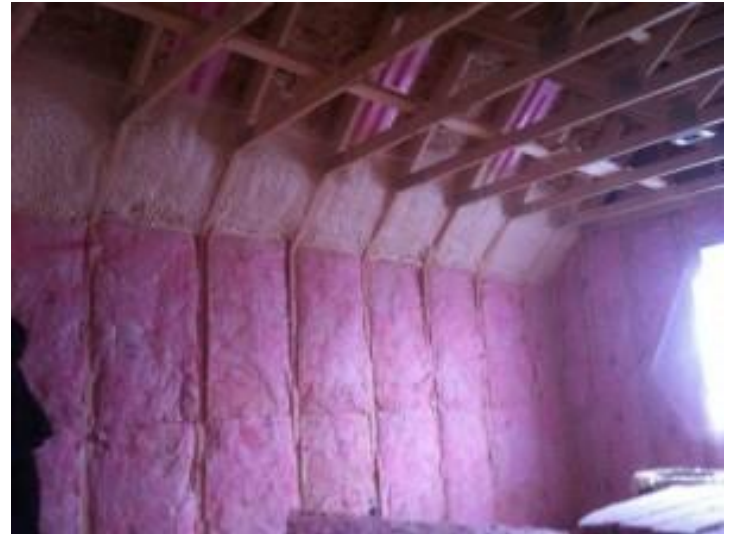
- Crooked framing
 - Often missed until drywall is being attached or taped, or trim is being attached.
- Poor insulation installation
 - Can make drywall difficult to attach.
 - Can lead to excessive stresses in the gypsum joints.

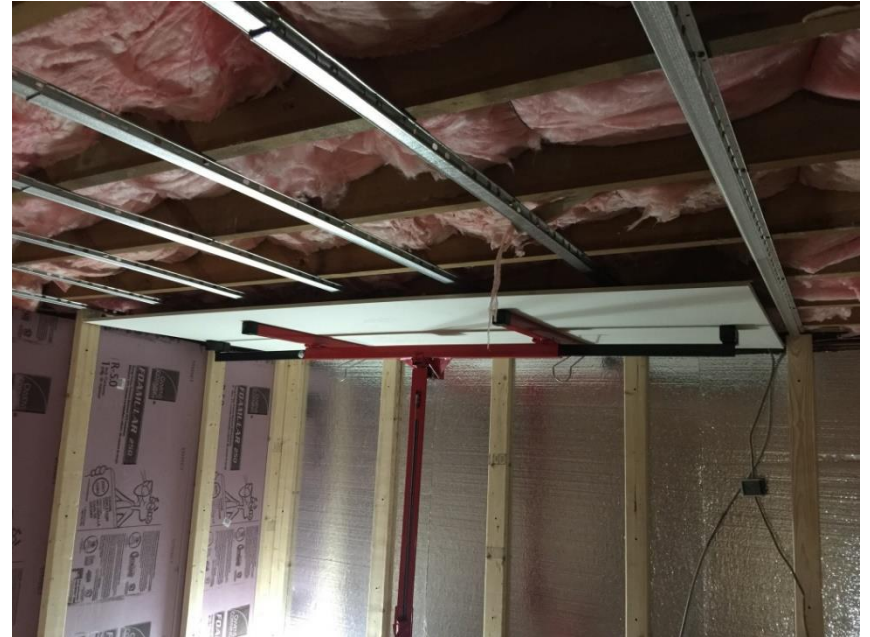
- Use kiln-dried lumber in trusses.
- Condition homes for 24 hours prior to installing gypsum board.
- **Use resilient channel between the drywall and ceiling framing.**
 - This is the most consistently effective strategy.

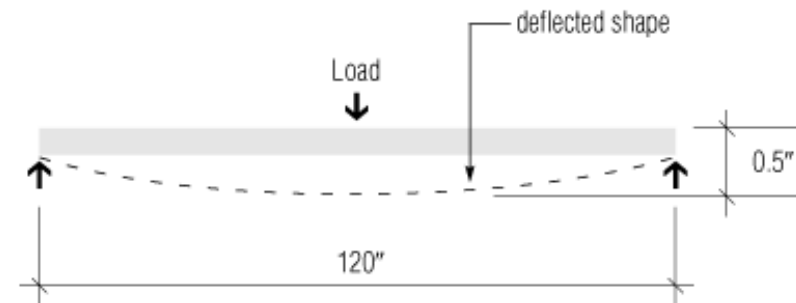
- Allowable deflection criteria:
 - For drywall assemblies:
 - **L/240 is desirable**
 - **Limit of L/120 (L/180 in some codes)**
 - For veneer assemblies:
 - **L/360 is desirable**
 - **Limit of L/240**
- Minimum lateral loading:
 - For interior partitions: 5 psf
 - For exterior walls: 15-45 psf (or greater depending on building height and geographic location)

Calculating deflection for a 10' span between framing members:

$$D = \text{Deflection Limit} = \frac{L}{240}$$

$$L = 10' \text{ or } 120''$$

$$D = \frac{120}{240} = 0.5''$$
