THE MILLER PROJECT

SlateTec Vermont Slate

JOB OF THE YEAR

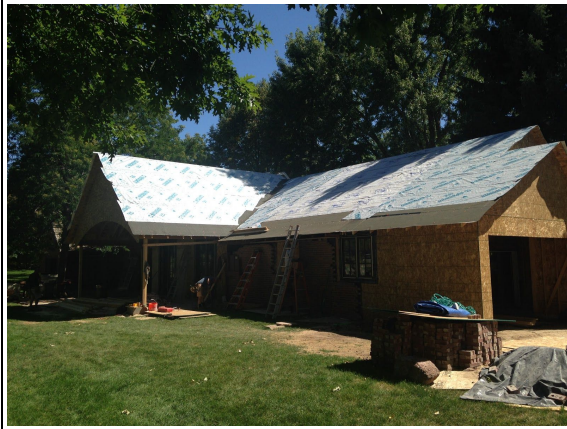
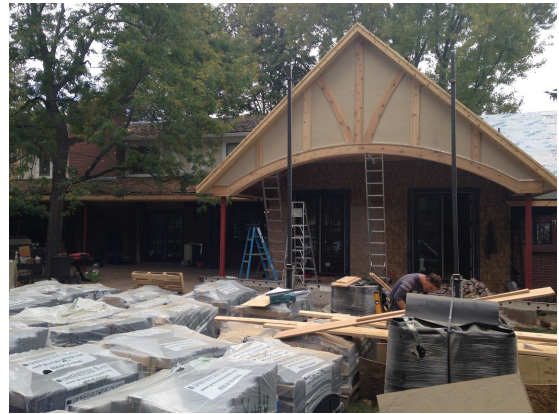
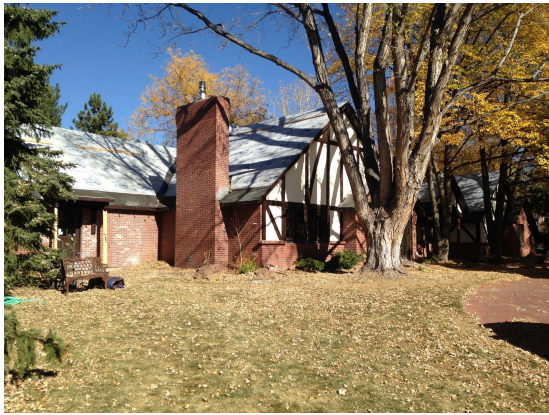
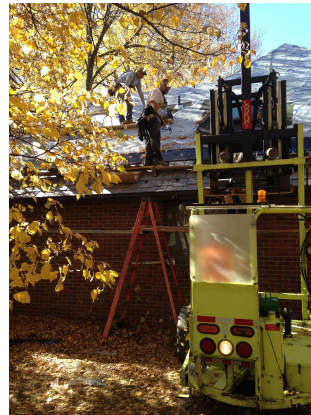
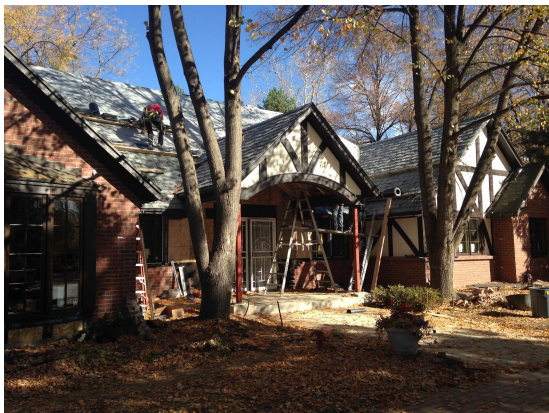
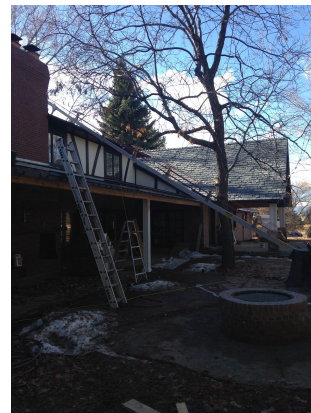
DURING

*The tear off and dry in of the existing shake shingle roof was performed using *Tamko Moisture Guard* Ice and Water shield at all eaves and valleys with *Sharkskin Ultra* and Titanium Synthetic underlayments. The Standing Seam Metal roof was installed over *Sharkskin Ultra SA High Temp Ice and Water shield*.

*The SlateTec tile was delivered by road from Vermont to Denver and ground dropped onsite by American Roofing Supply. The tile was then painstakingly mixed on the ground to insure all slate widths, thicknesses and dropdowns were in the correct order and position for the installation.

*The slate was moved around the site using a donkey lift.

*The slate was then manually loaded using the donkey and an in house loading machine onto roof jacks spread out around the roof. The slate was expertly installed by our in house crew. In using the SlateTec system, all layers were "laced" using the patented interlayment to install the system as per manufacturer specifications.

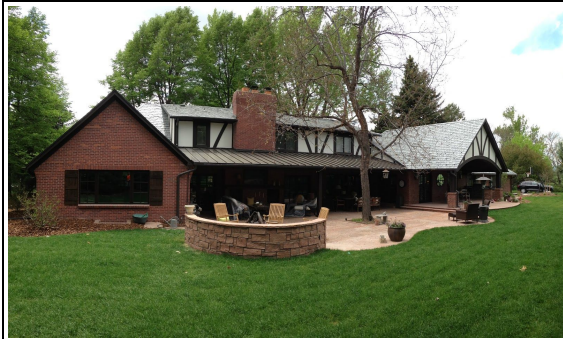
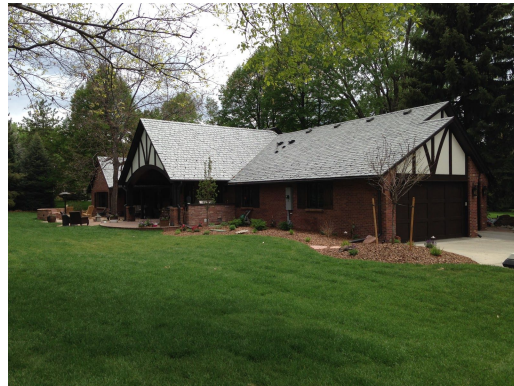
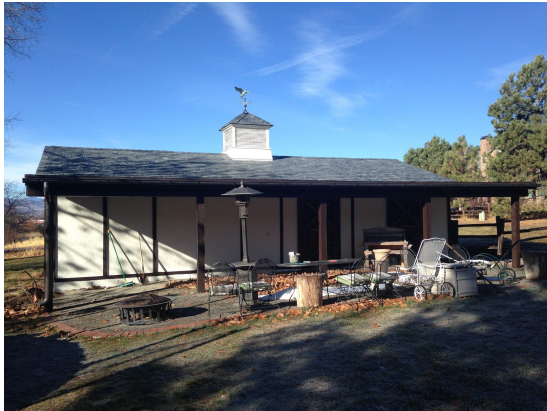
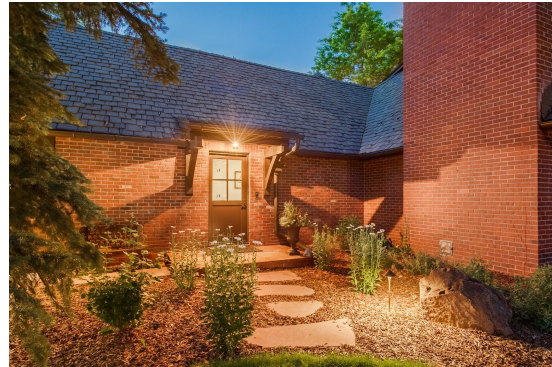
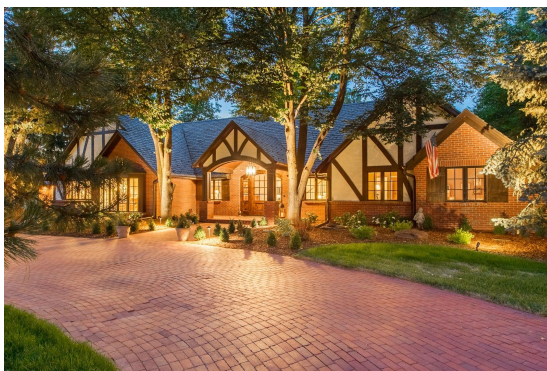
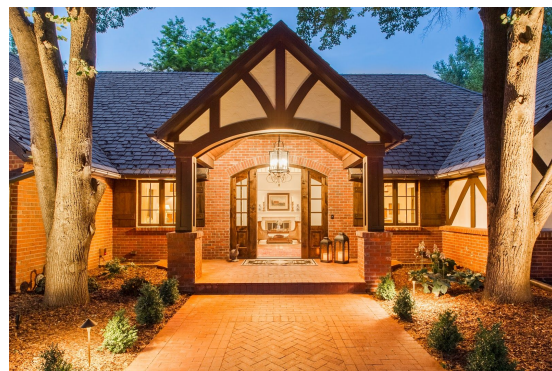
AFTER

The result was a stunning slate roof for the Miller family and one that Kudu Roofing is extremely proud to include as a project for job of the year consideration. (Under \$150,000)
