# LIGHT, RECLAIMED

Residential Bath | \$40,000–\$70,000

# A concealed window inspired the transformation

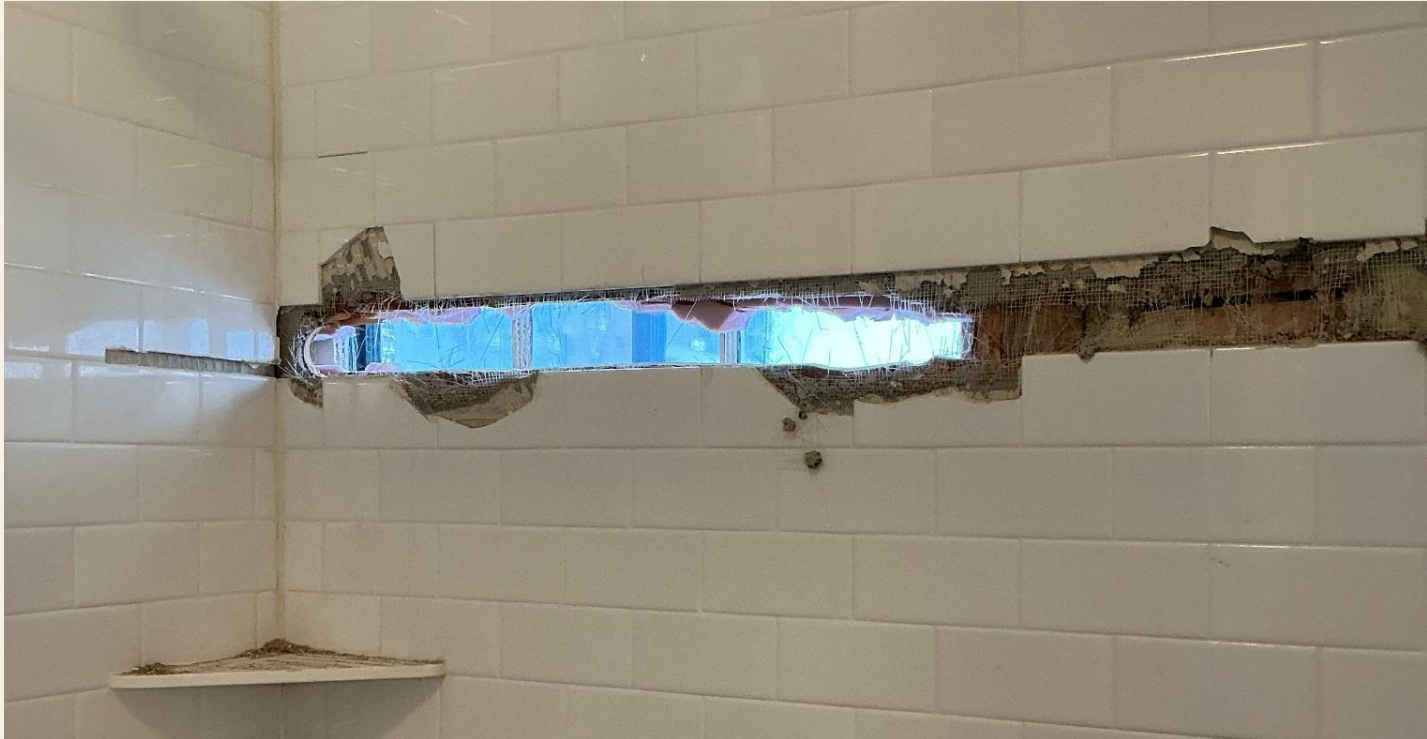
Removal of the surround exposed an existing exterior opening behind the tile.

## CONCEALED IN PLAIN SIGHT

The discovery became the organizing feature of the new shower.

The opening confirmed what the homeowners could see from outside: a window had been covered during an earlier remodel. Reusing its exact location restored daylight without requiring exterior alteration.

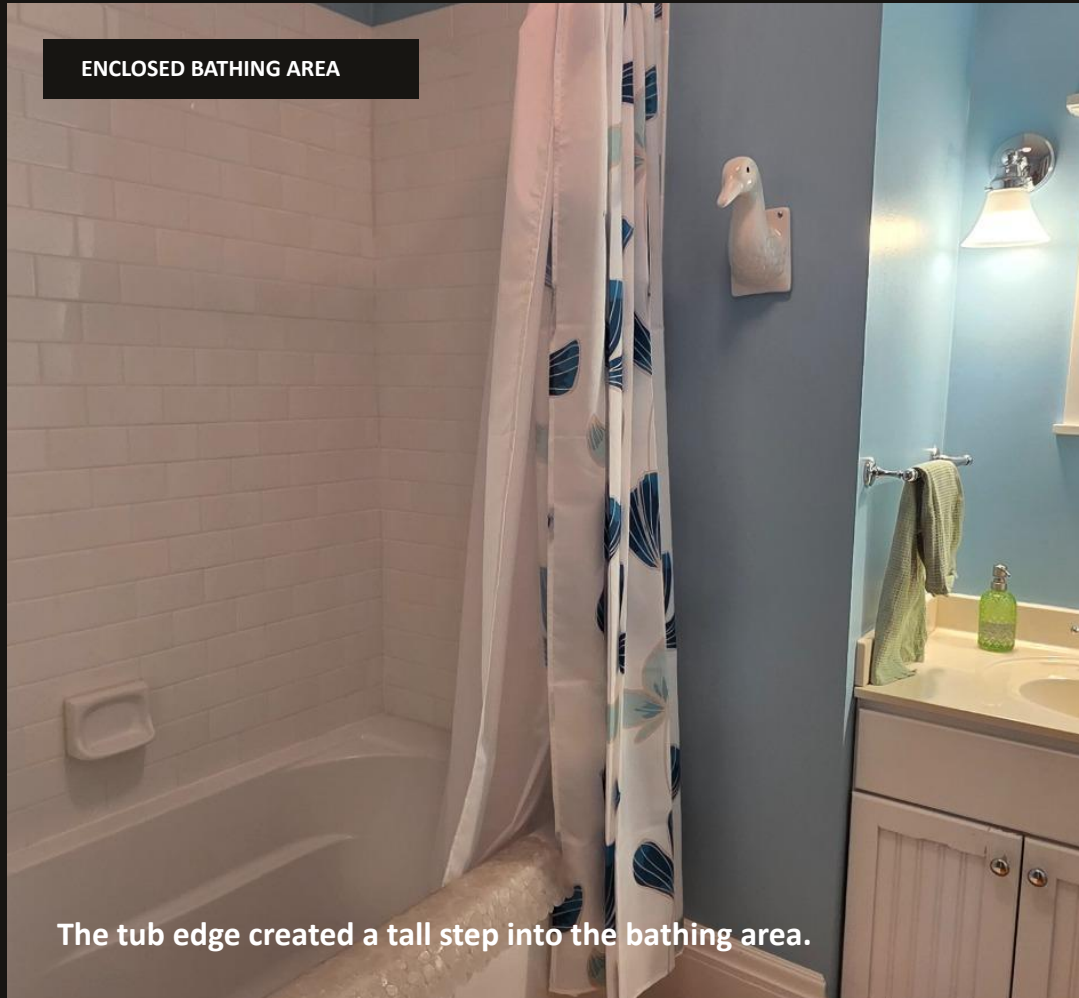
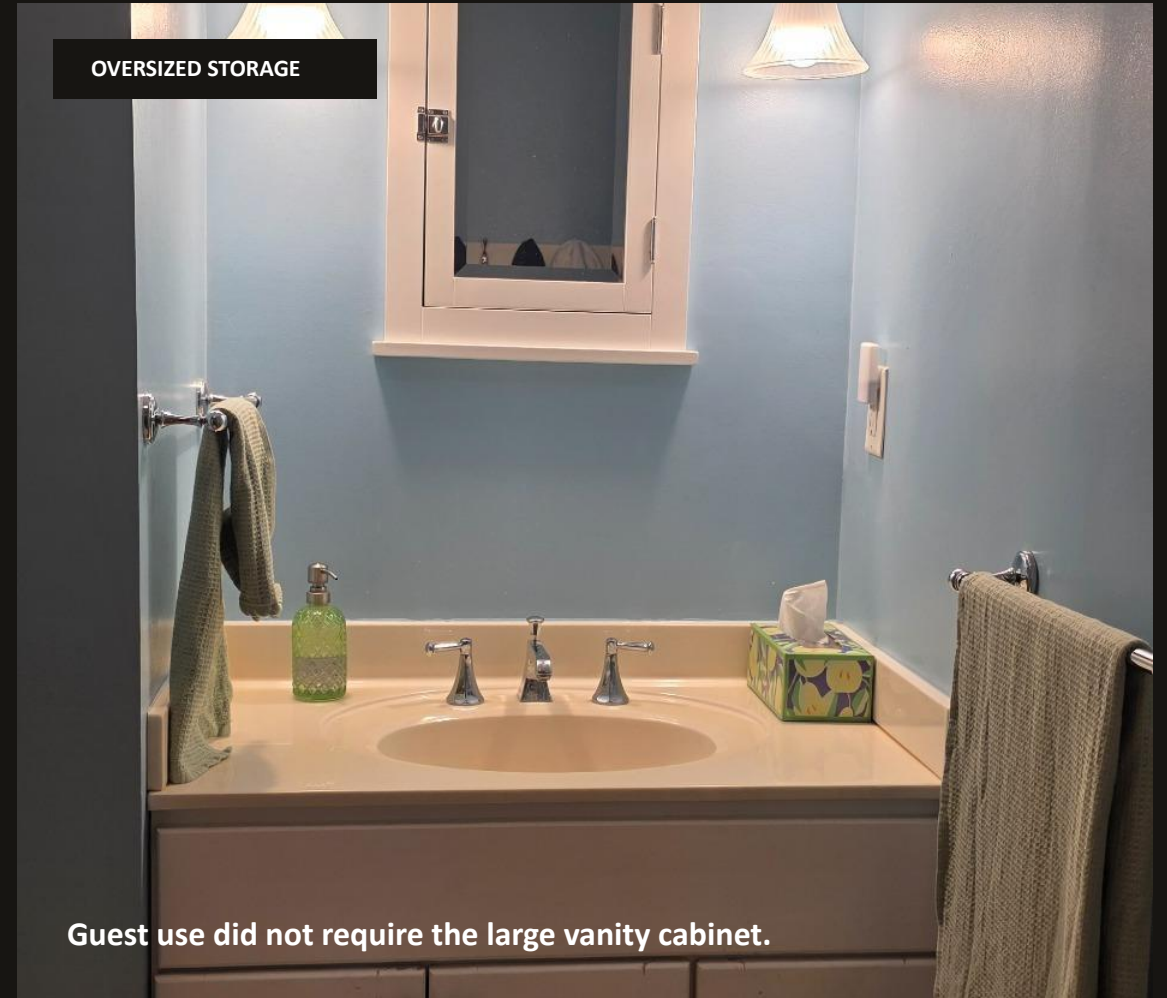
# The existing bath concealed its best source of light

A bulky surround, shower curtain and vanity made the narrow room feel enclosed.

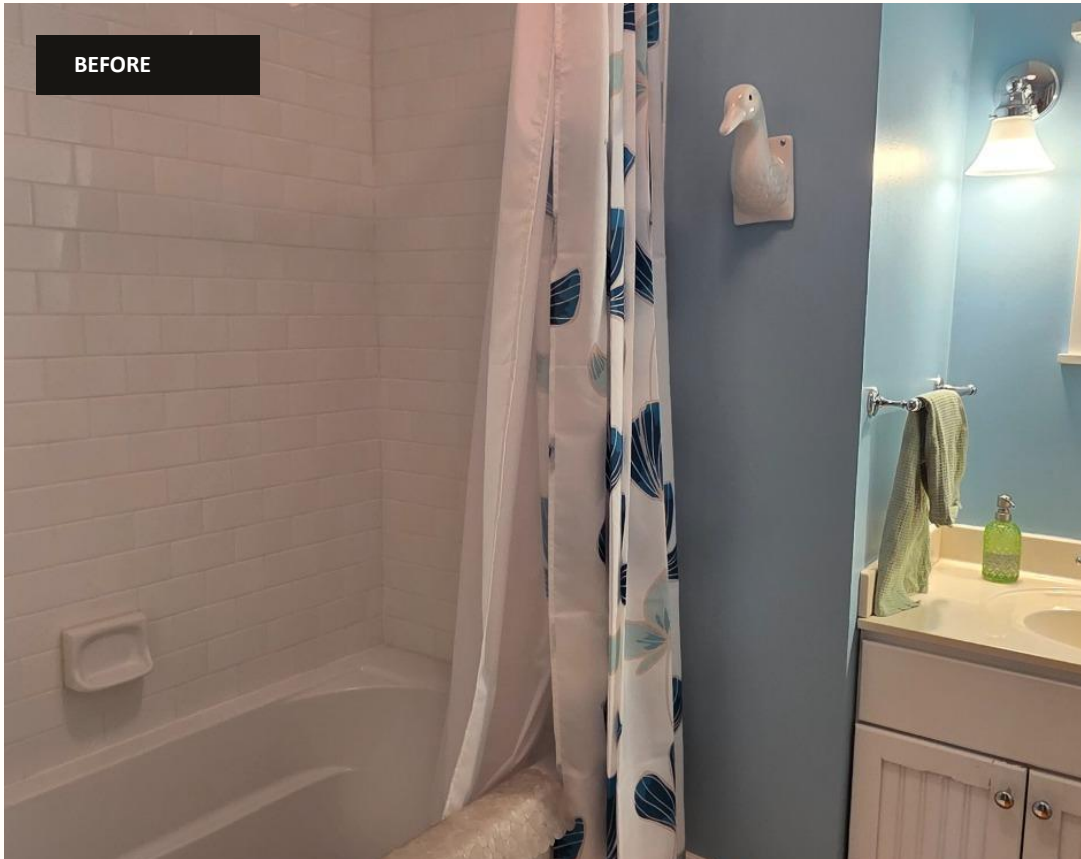
The original tub and curtain blocked the window and narrowed the bathing area.

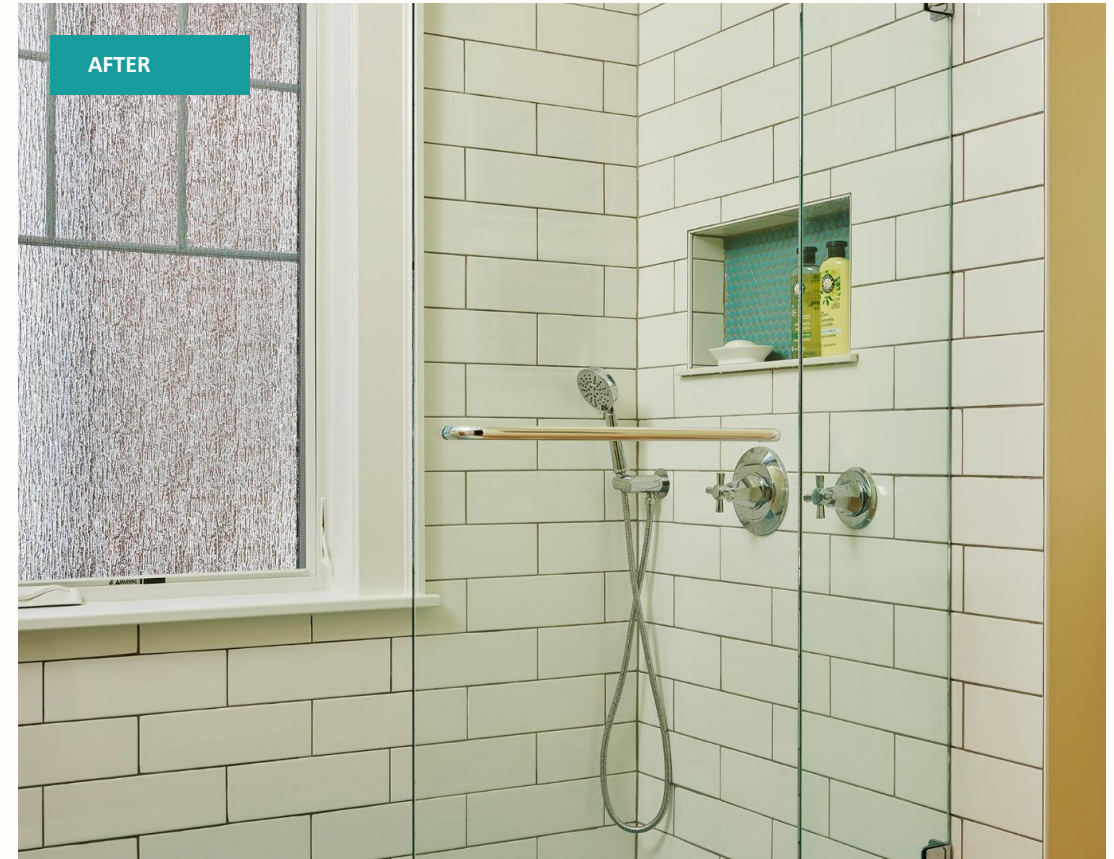
Clear glass and the restored window visually enlarge the room.

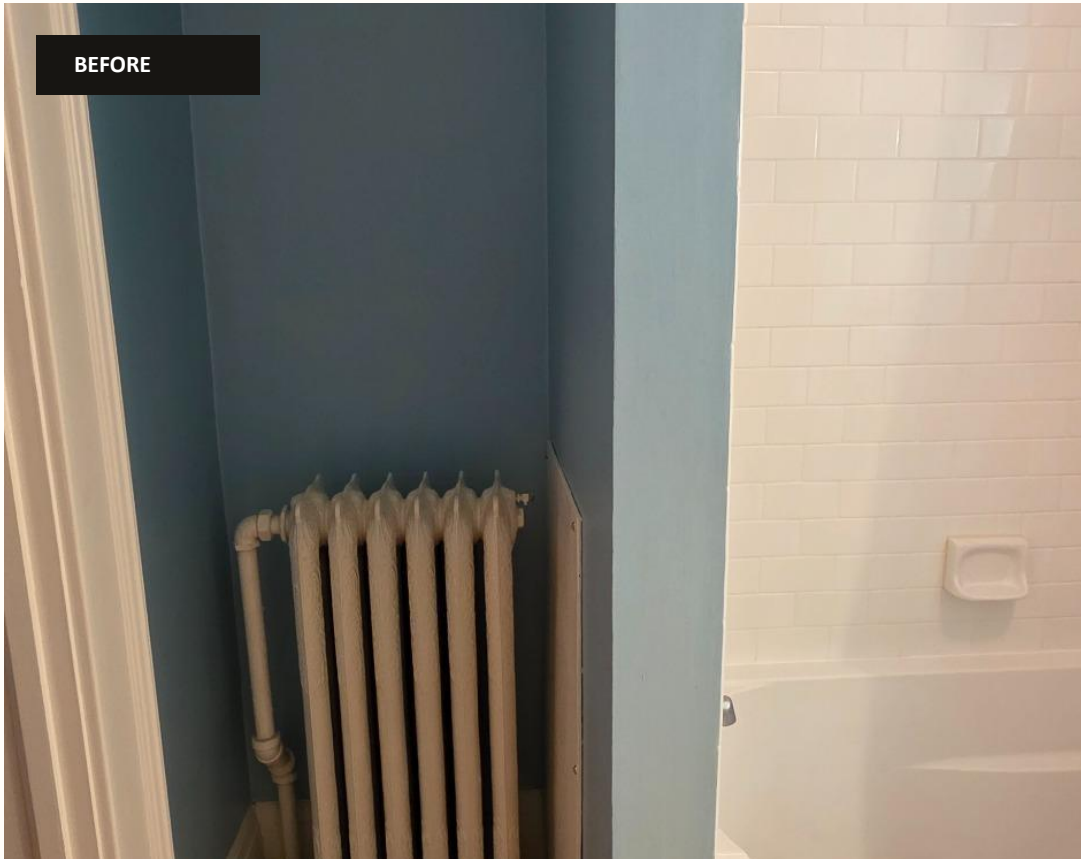
A tub wall and radiator niche fragmented the compact room.

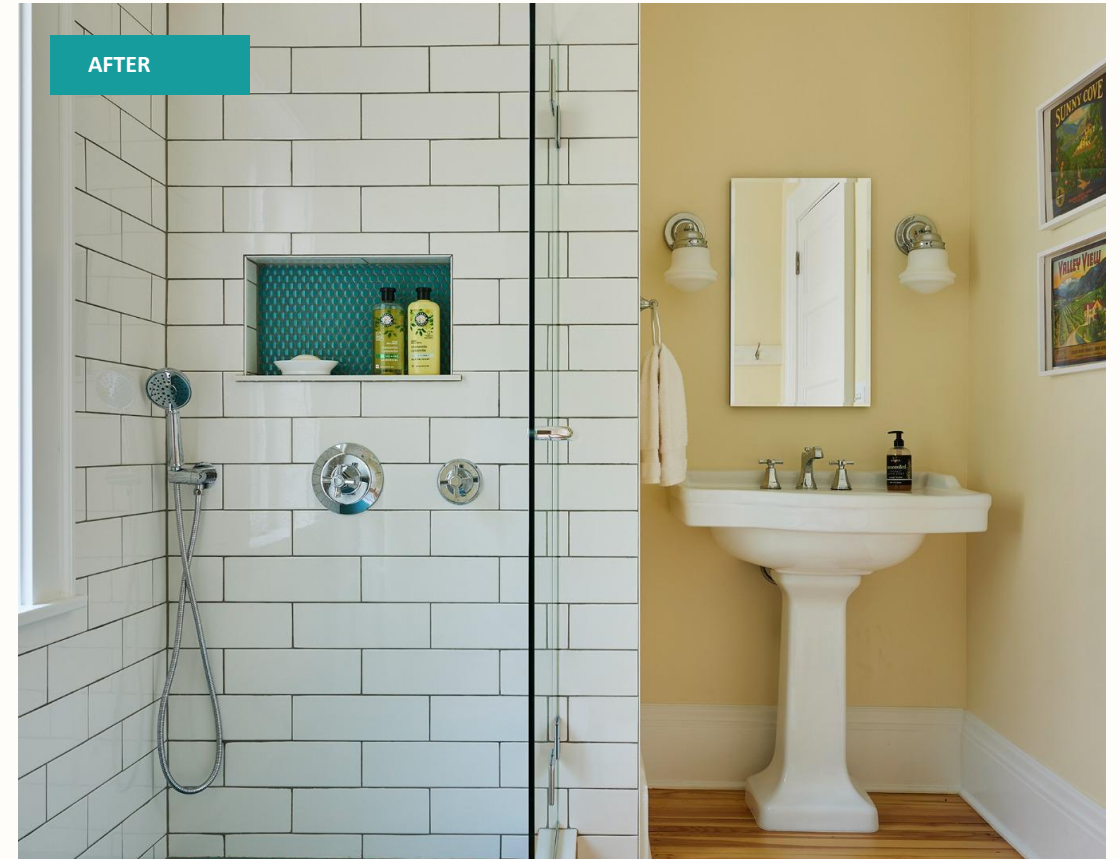
A pedestal sink and open glass enclosure reduce visual bulk.

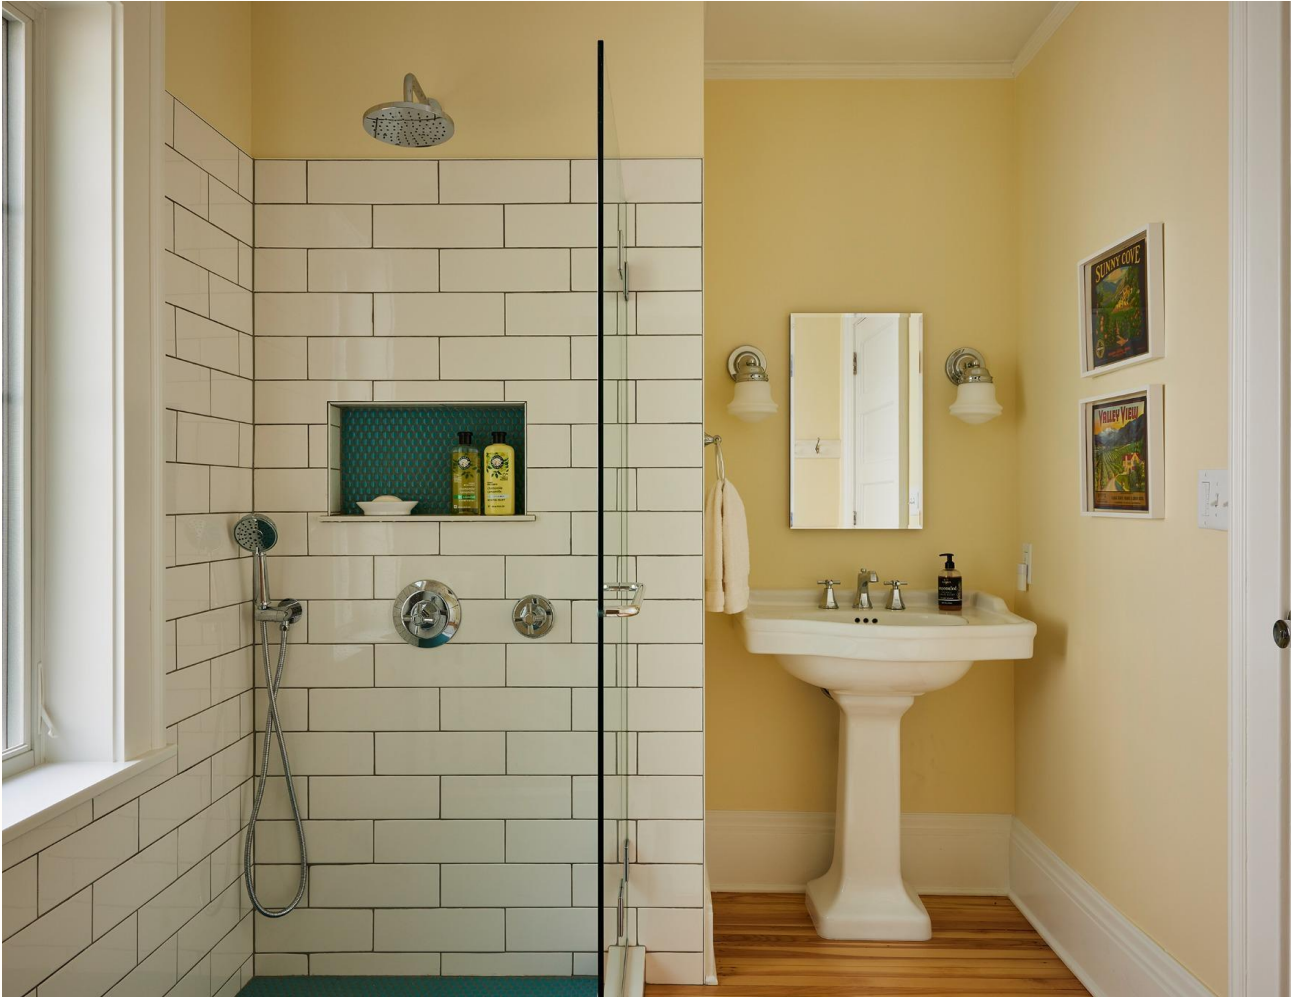
- **Rhythm and continuity**

White subway tile, dark grout and rectangular window muntins establish a consistent grid.

- **Color and contrast**

Turquoise penny rounds energize the shower floor and niche against warm yellow walls.

- **Visual balance**

The shower and pedestal sink share the wall without crowding the narrow room.

- **Open character**

Clear glass keeps sightlines intact and allows daylight to travel through the space.

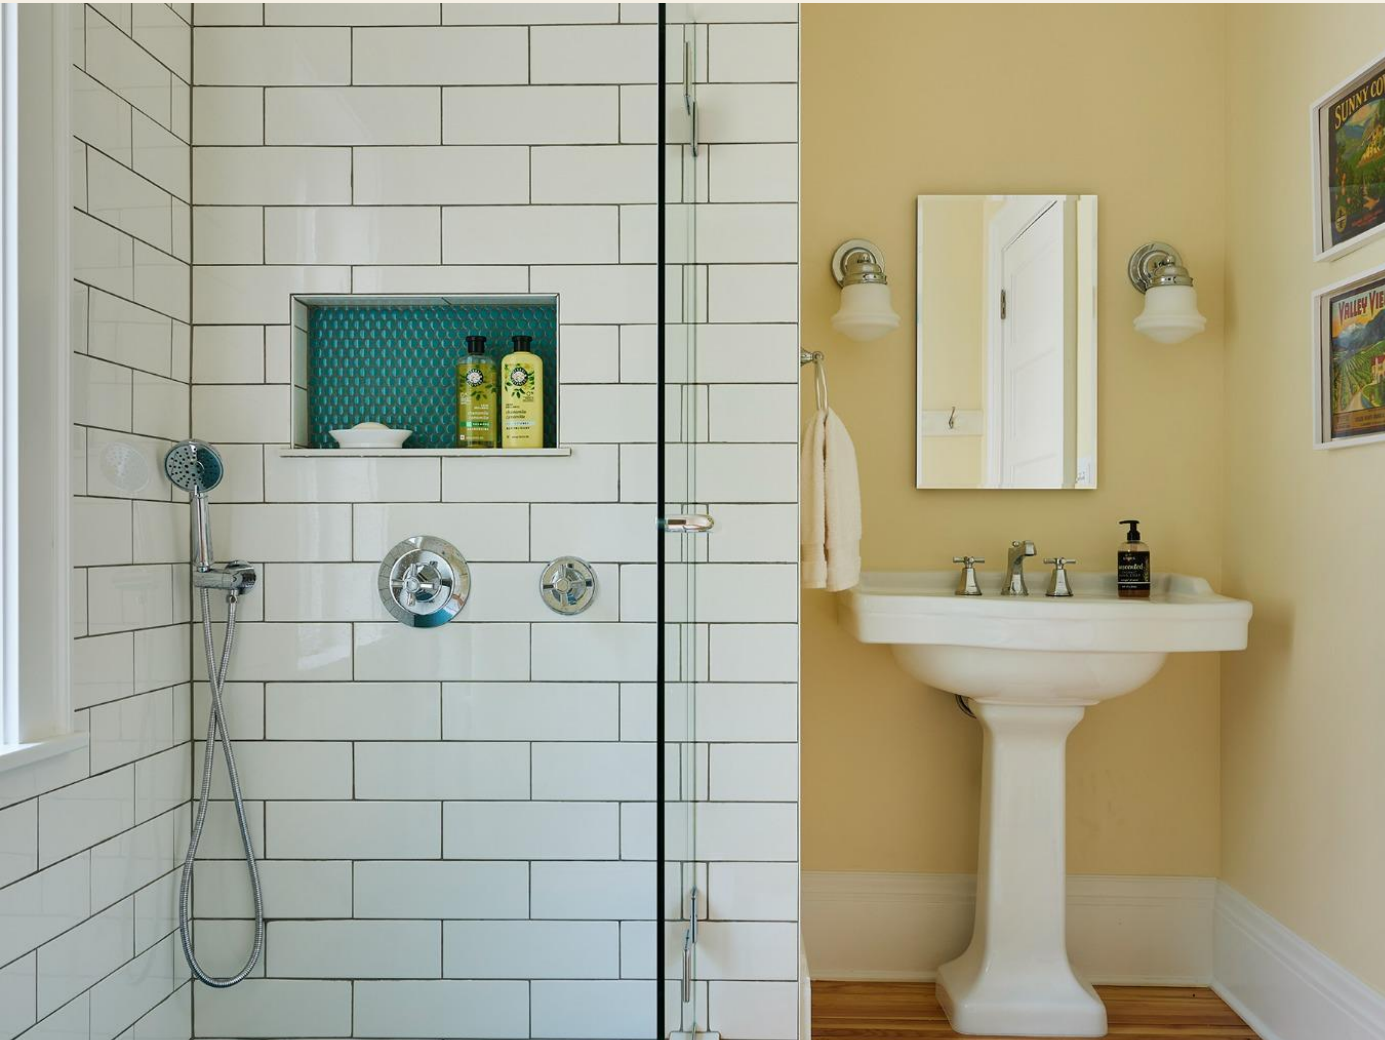
- **Easier entry**

The custom shower curb is substantially easier to cross than the former tub wall.

- **Dry control access**

The door can be opened while the valve is reached from outside the spray zone.

- **Privacy with ventilation**

Obscure glass allows the casement window to open a few inches discreetly.

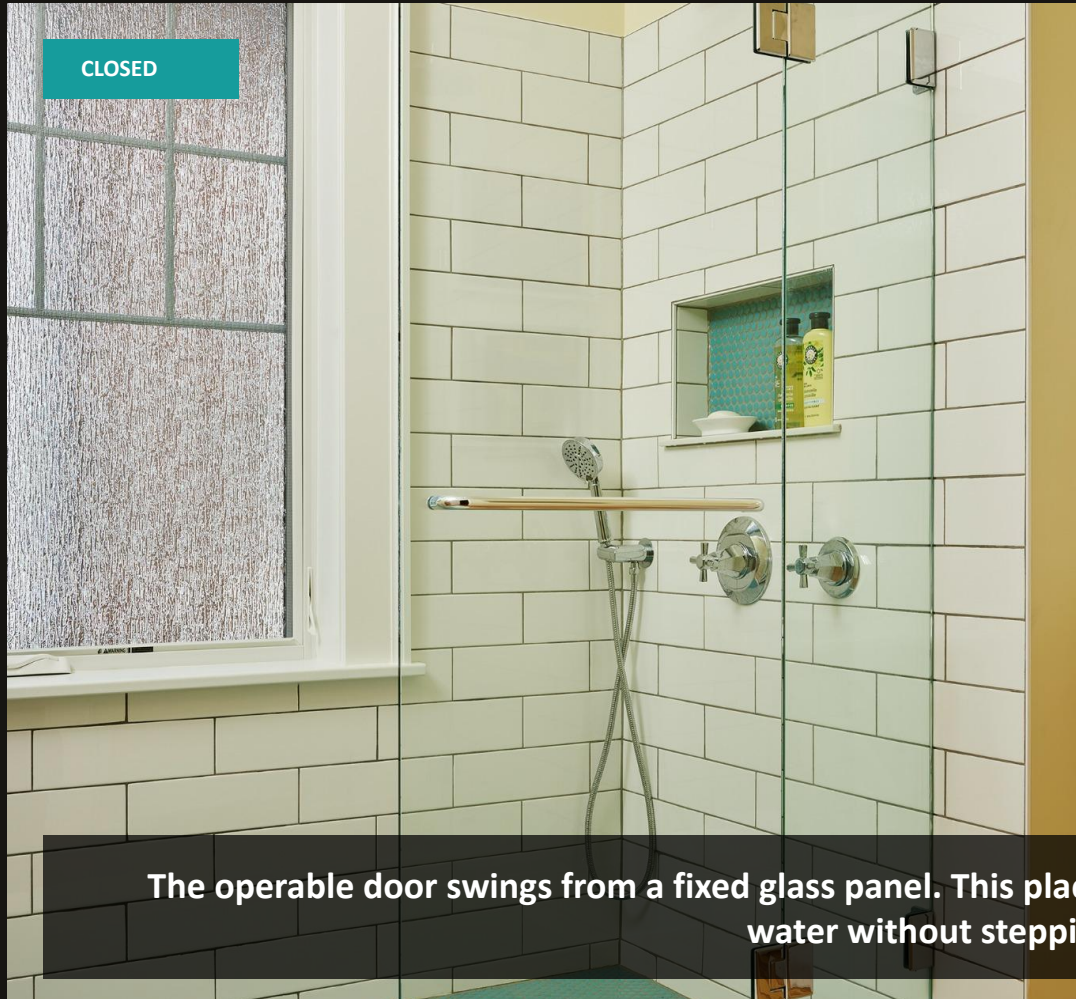
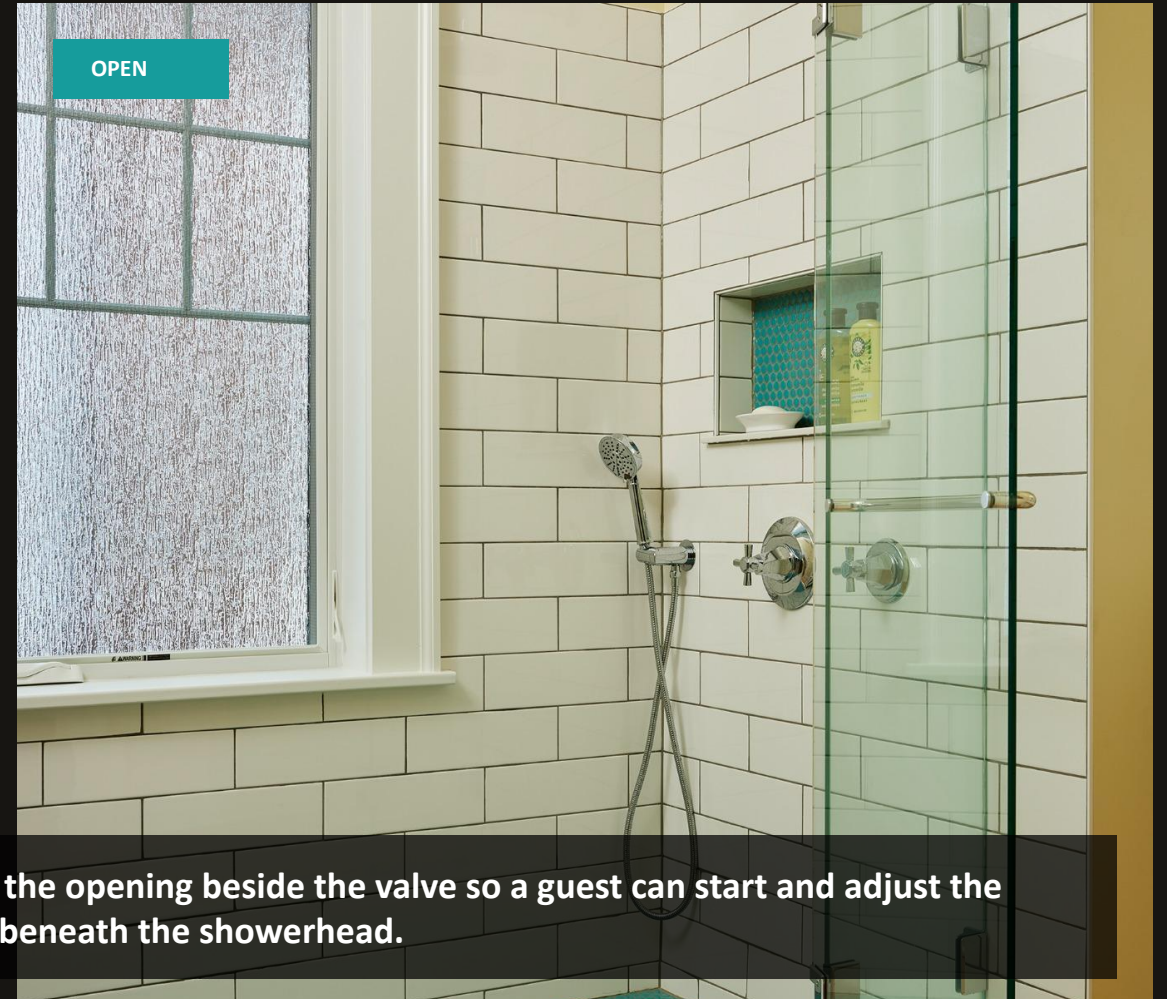
A custom hinge arrangement improves access to the shower controls.

The operable door swings from a fixed glass panel. This places the opening beside the valve so a guest can start and adjust the water without stepping beneath the showerhead.

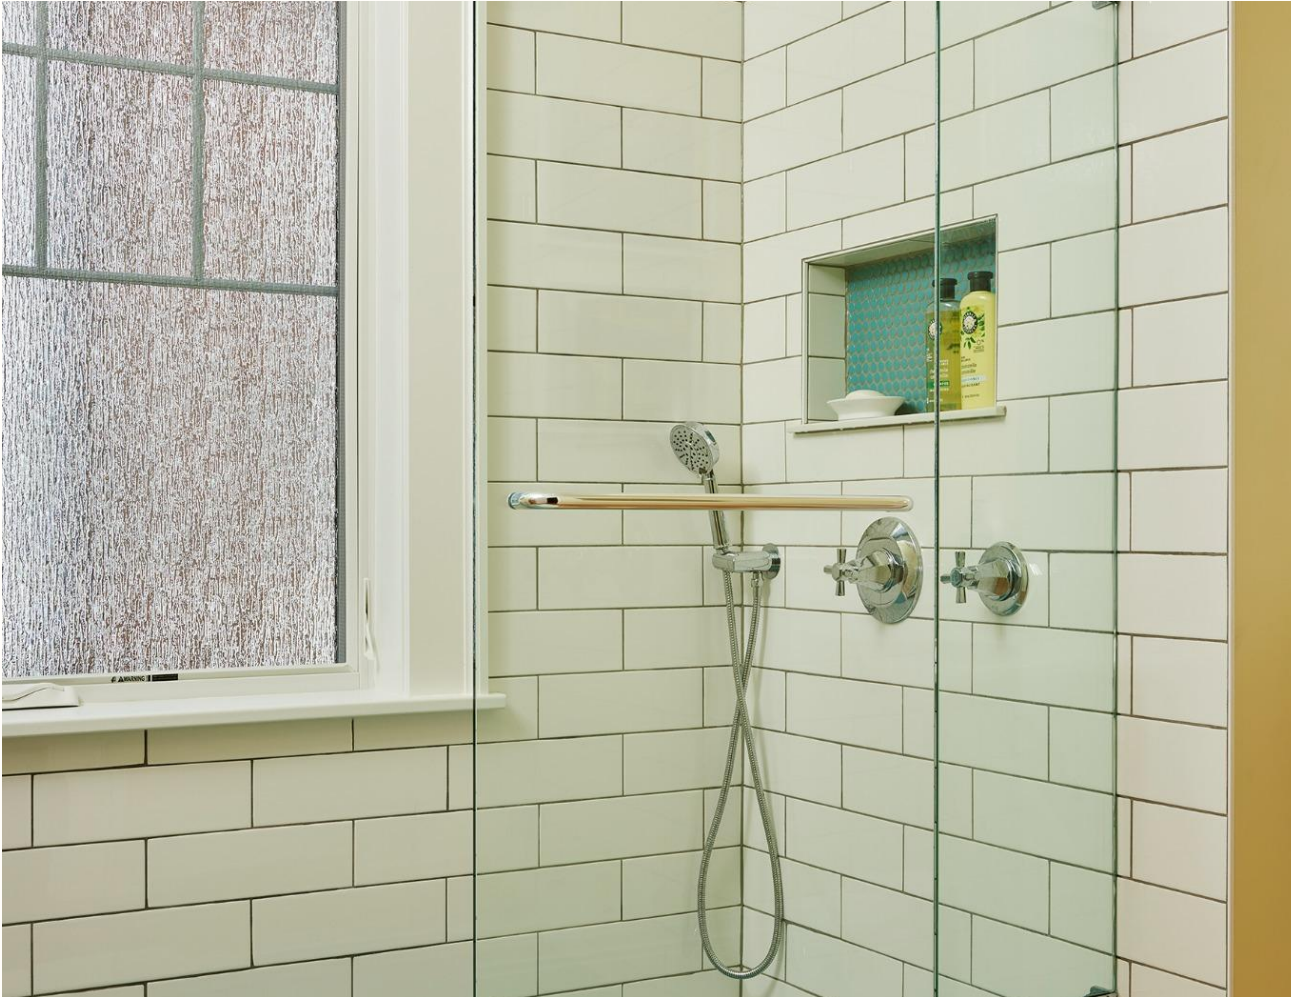
Careful waterproofing allows the original opening to become a practical shower feature.

- **Complete waterproofing**  
The Schluter system extends through the window area to protect a demanding transition.
- **Purpose-built window**  
A vinyl casement unit resists moisture and fits the existing exterior opening.
- **Privacy considered**  
Obscure glazing maintains privacy even when the sash is opened slightly.
- **Water managed**  
Fixture placement and shower head angle reduce direct spray at the window.

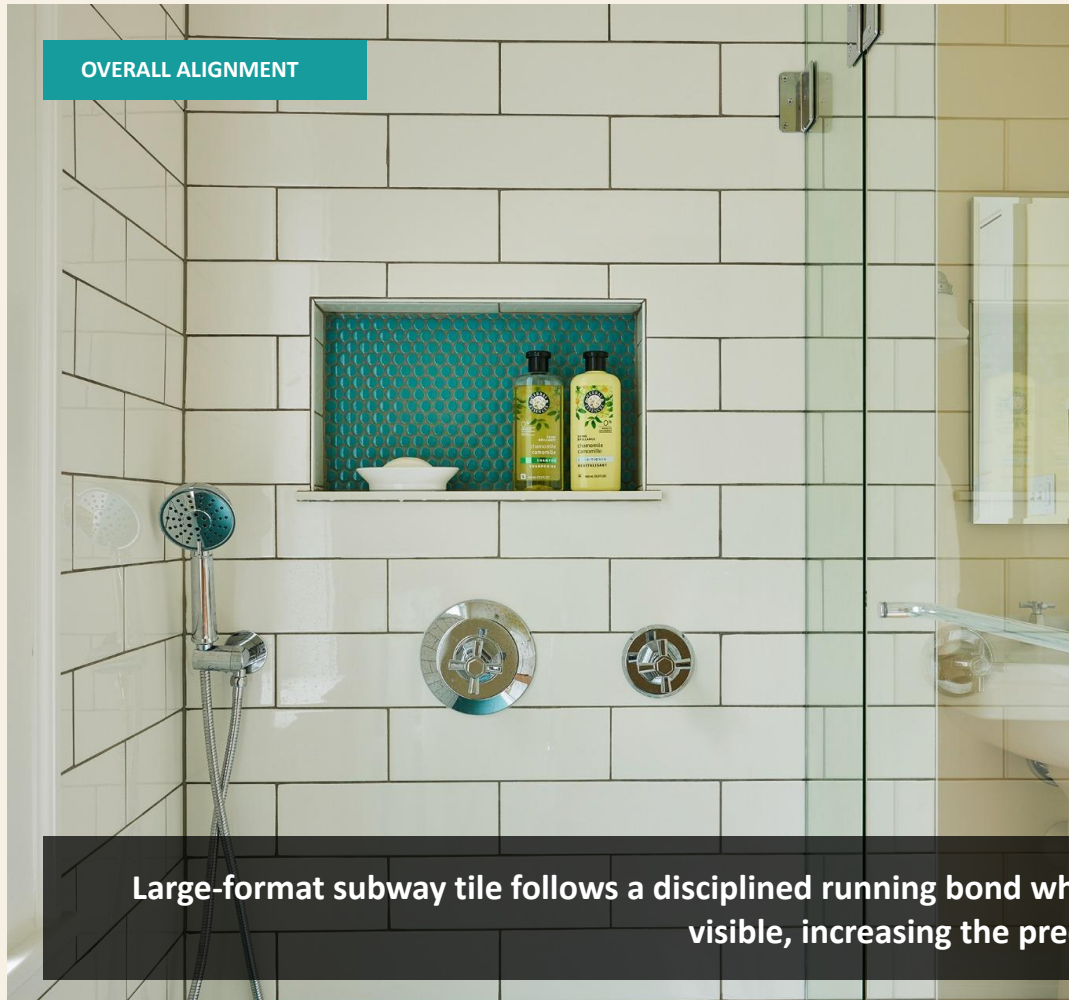
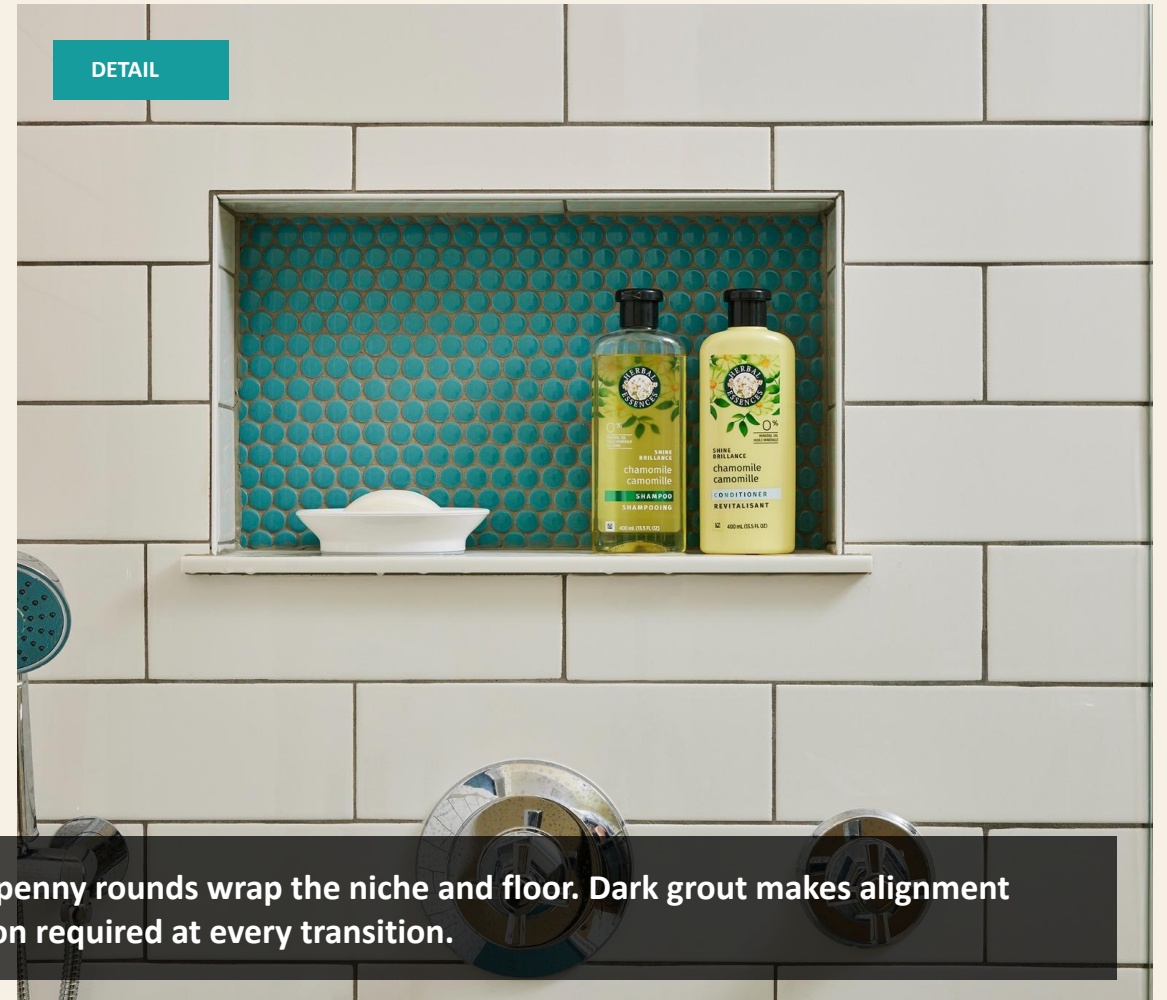
Two formats meet cleanly across the shower floor, niche, corners and glass edges.

Large-format subway tile follows a disciplined running bond while penny rounds wrap the niche and floor. Dark grout makes alignment visible, increasing the precision required at every transition.
